REF: 2392/PYC/LetRep/sdi

## **RE: 1 BRYN ISSA, PENYCAE – MINING INVESTIGATION**

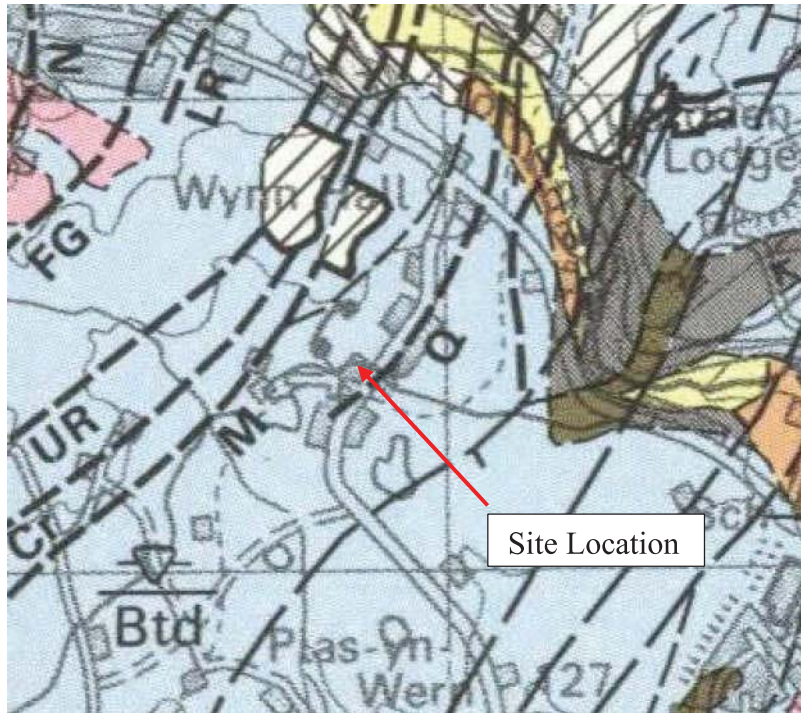
Extract of Sheet 121 Wrexham

The Quaker coal seam is shown to outcrop immediately east of the site, with the Main Coal shown to outcrop some 200m to the west of the site. Both seams trend in a southwest to northeast direction, and dip gently towards the southeast. The Main Coal will therefore underlie the site area at shallow depth.

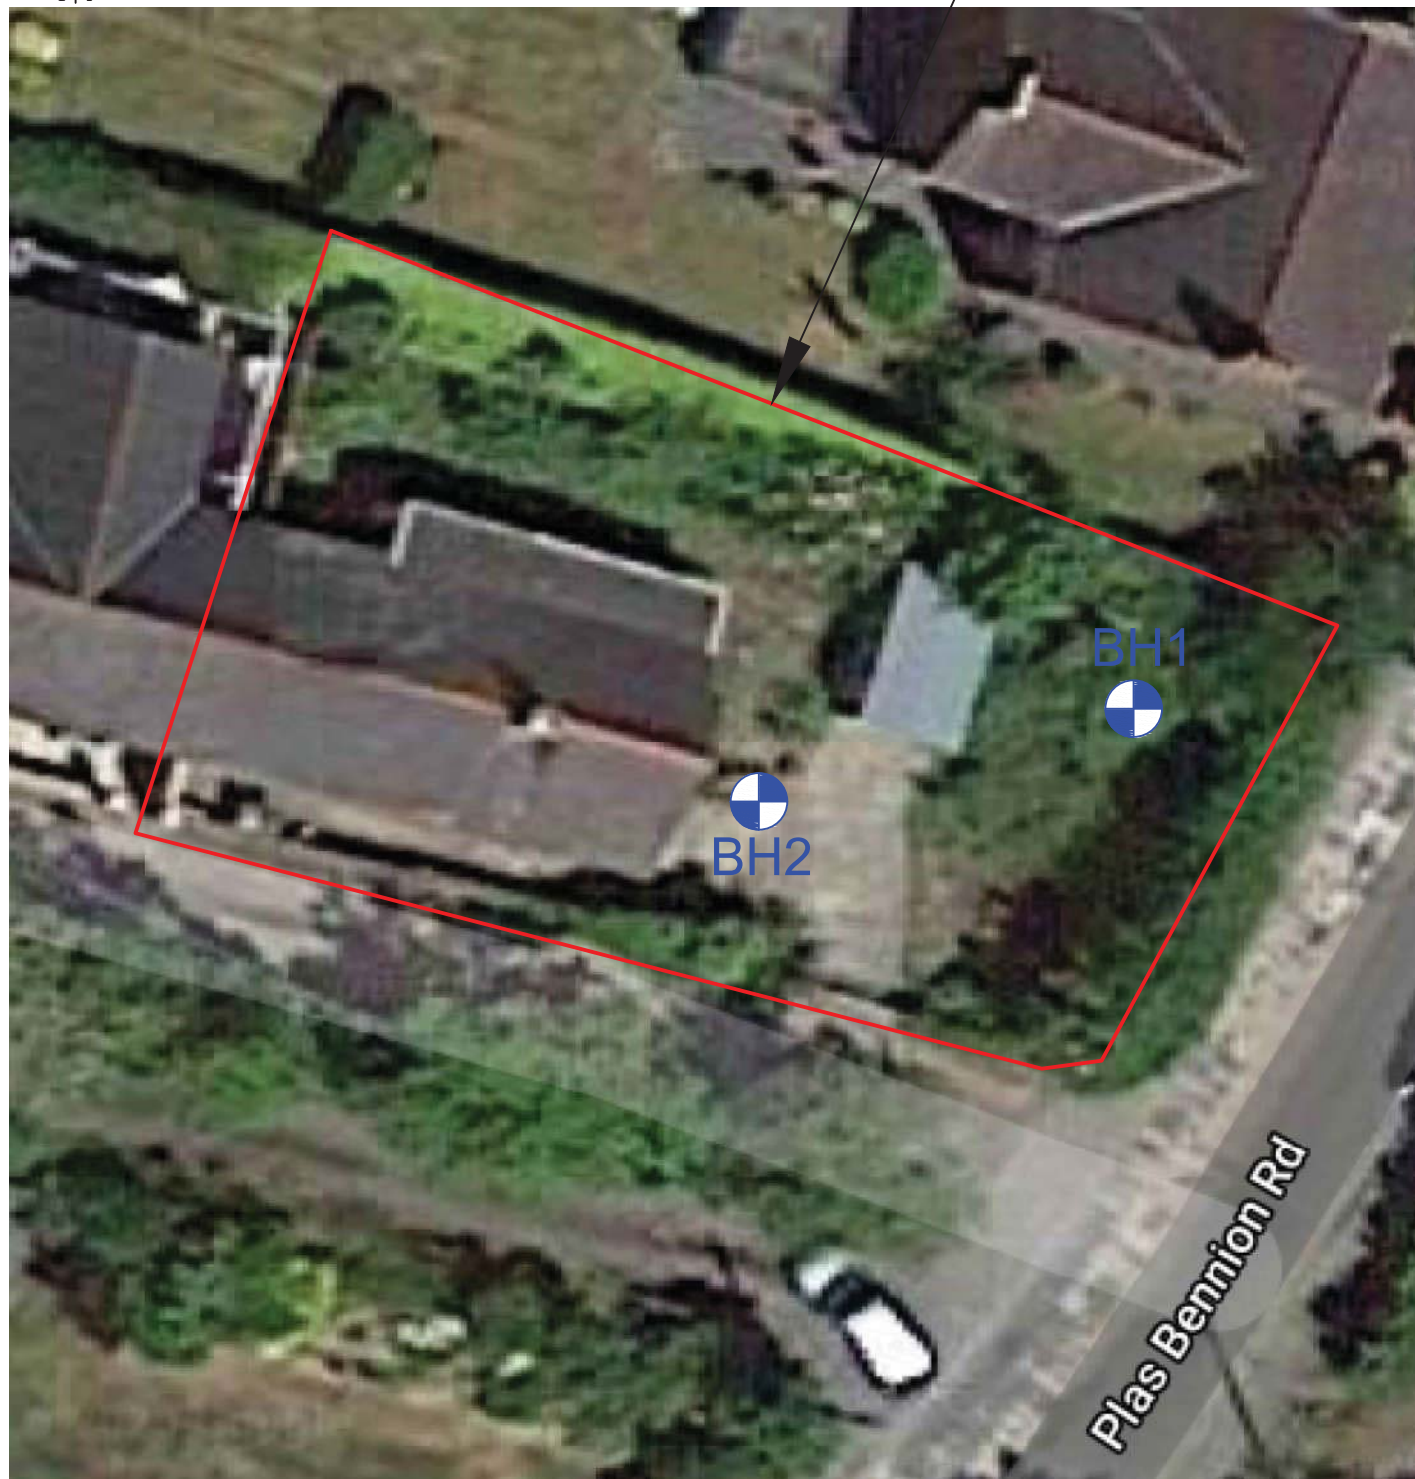
FIGURE 2

The borehole locations are presented on Figure 2, and the borehole logs presented in Appendix C.

Borehole 1 encountered a void between 24.5m and 26.0m, where all flush returns were lost and no significant resistance to drilling was detected. Hard drilling returned at 26m, although due to the flush loss the geology could not be confirmed. The drill bit proved difficult to extract from within the void, suggesting that the void was loosely backfilled, and the borehole was therefore terminated at 26m depth.

It is therefore recommended that the low risk of potential ground movement due to shallow mining is addressed by constructing the new building on a reinforced concrete raft foundation. The raft should be designed to be capable of spanning a 3.0m wide void and cantilevering 1.5m at the corners.
