**PLOT 7  
HOME FARM BUILDINGS  
RUTHIN ROAD  
COEDPOETH  
WREXHAM  
LL11 3BP**

**BUILDING DEVELOPMENT**

**Bat Mitigation Audit**

| <b>Reference</b> | <b>122020/BAR/CS</b> |

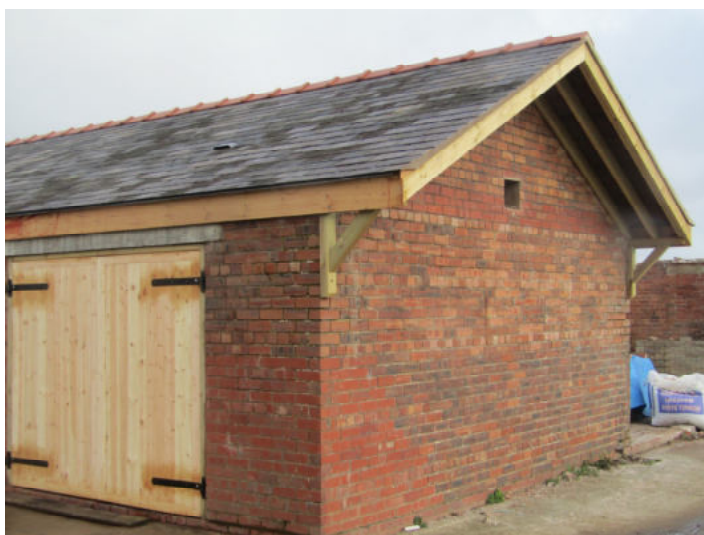
New bat loft, Plot 7, Plas Power, Coedpoeth.

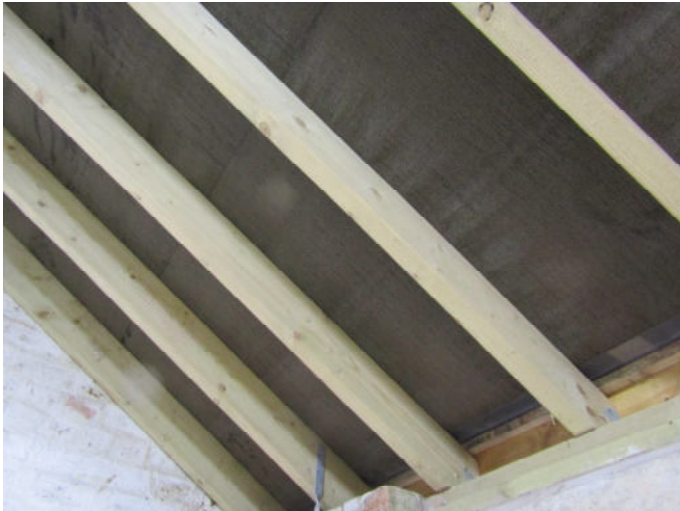
Photo 1: 1F bitumastic felt used beneath slates in new bat loft.

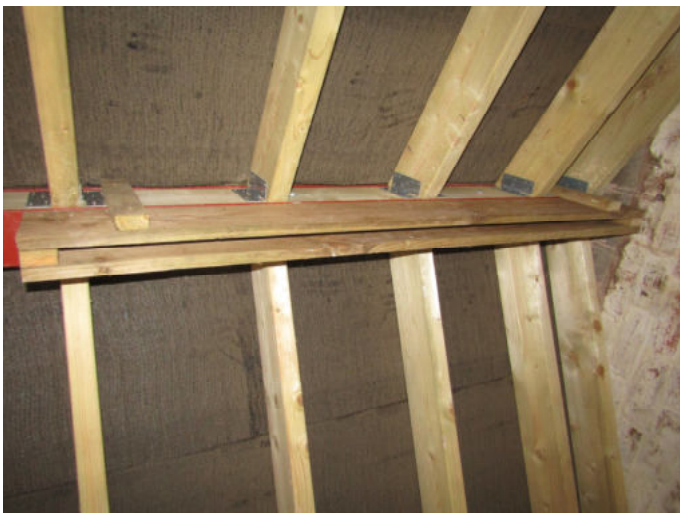
Photo 2: Crevice boxes have been installed in the new bat loft.

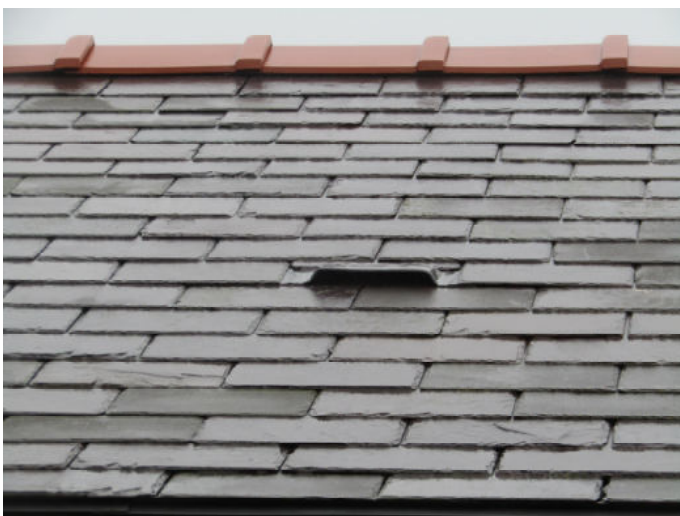
Photo 3: Bat slate installed into slate roof.

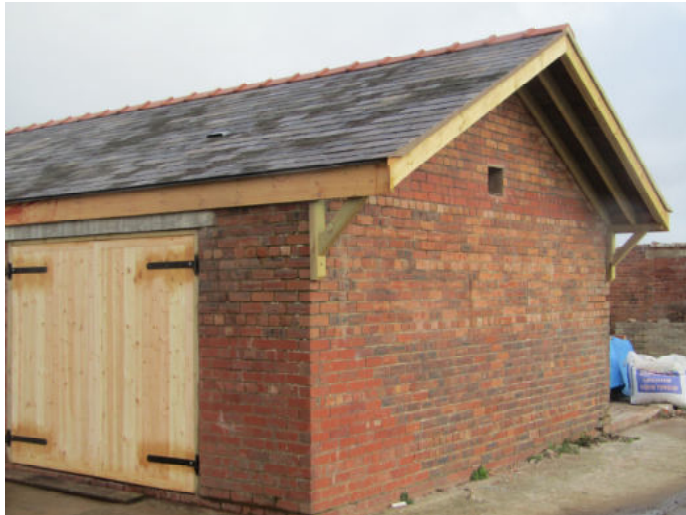
Photo 4: Open ‘fly-in’ access provided in South gable-end.

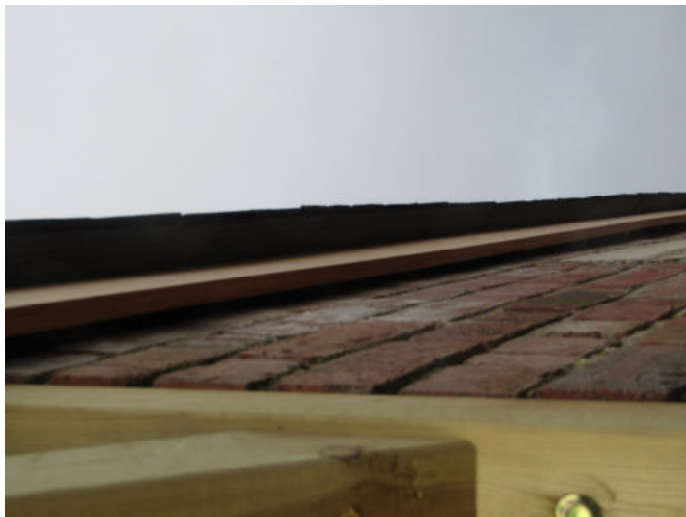
Photo 5: Gaps left between wall and eaves for access for crevice-dwelling bat species.
