**ARBORICULTURAL REPORT (BS 5837:2012)**  
**FOR DEVELOPMENT**  
**AT**  
**GATEWEN LANE**  
**REAR OF OAKFIELD COURT**  
**NEW BROUGHTON**  
**WREXHAM**

**C/PM/14/03/21**

**Date: March 2021**

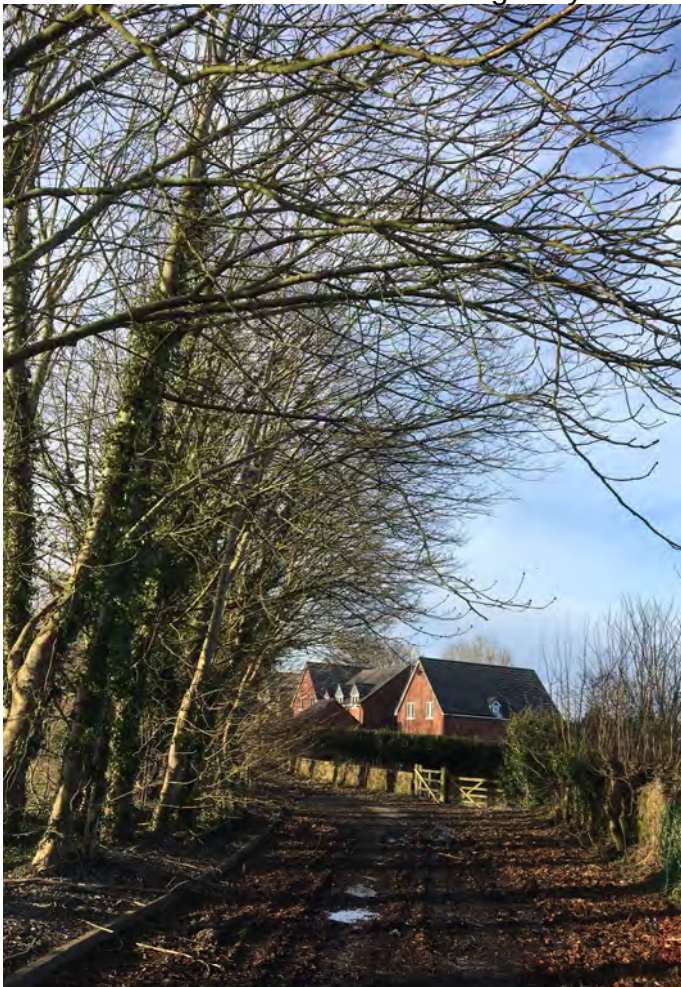
G1 low branches over old highway

| Tree No. | Proposed Works |
|---|---|
| G1 | Raise crowns for access by the removal of minor lower branches to a height of approximately 5m. |

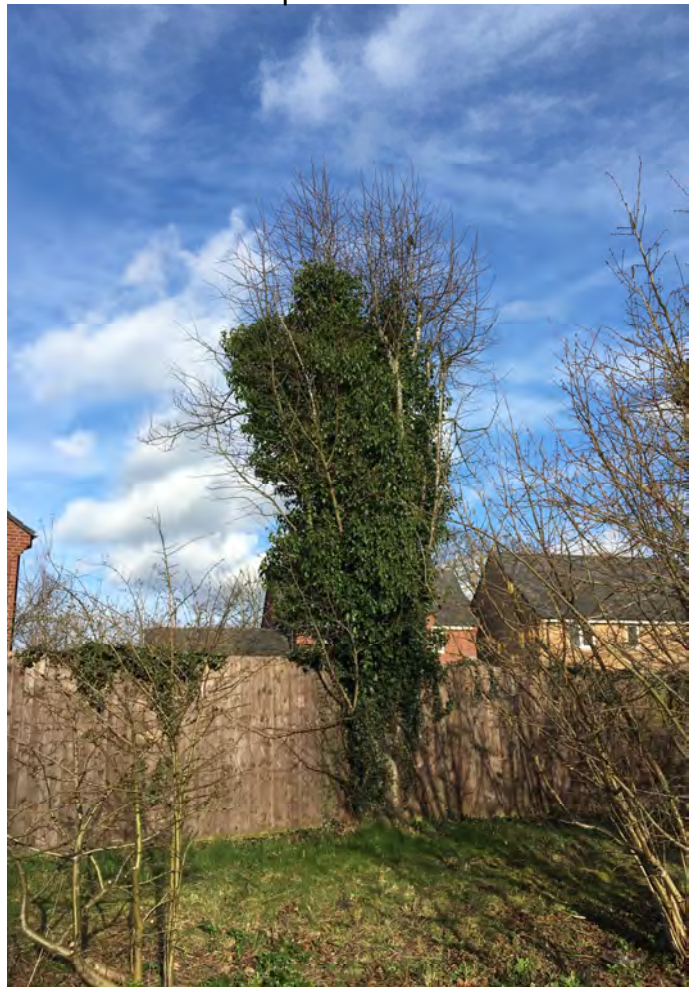
- 5.1.3 The proposed new dwelling is approximately 4m from T1, which is a Whitebeam exhibiting poor form and swamped in Ivy. The north spread of this tree has previously been kept back from the highway and is approximately 2m so well outside the build line.
- 5.1.4 The proposed garage is to be constructed on four concrete pads within the old highway and as with T1 there is unlikely to be any root activity within this area from any of the trees within G1.
- 5.1.5 Whilst on site it was noted that that many of the trees within G1 had low branching over the site and regardless of the development of the garage area they would need pruning for existing access to the container/storage area.
- 5.1.6 A clear tree works specification and details of all tree protective measures can be found in the following Arboricultural Method Statement.

T1 poor tree

| Tree No. | Proposed Works |
|---|---|
| T1, T2 & T3 | Sever Ivy at base to 1m. |

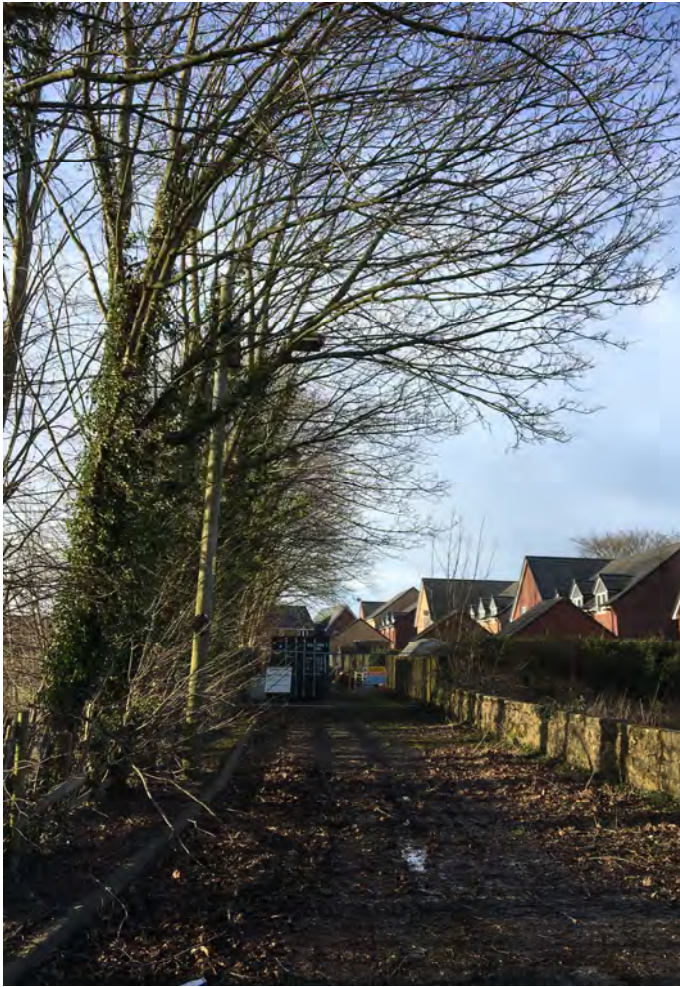
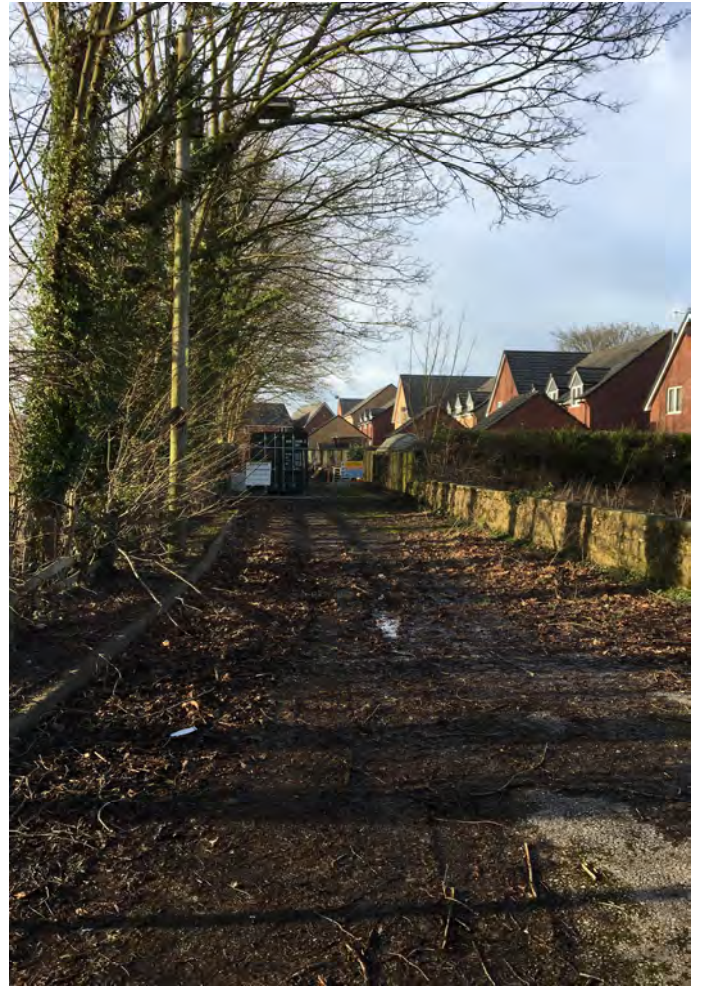
5.1.2 However, the site concerned is a previous highway and the ground is a typical heavily compacted and well-constructed tarmacadam surface so there is unlikely to be any root growth beneath it. Therefore, the RPA of all these trees will be within the green area west of the application site. There is some scrub growth forming within the site at the northern end but this is within soil placed on top of the original surfacing.

G1 & existing highway surfacing

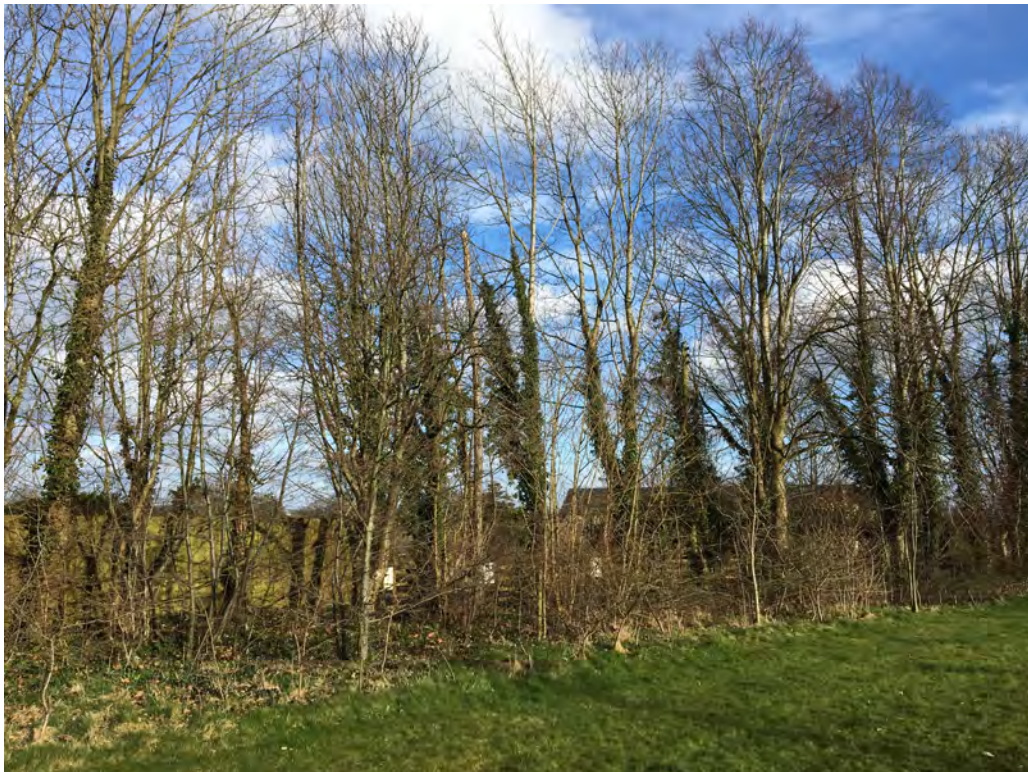
| Arboricultural Data Sheet: Gatewen Lane, New Broughton, Wrexham | | | | | | | | | | Weather: Dry and bright | | Date of Survey: 13/03/2021 | | | Surveyor: PM | |
|---|---|---|---|---|---|---|---|---|---|---|---|---|---|---|---|---|
| G1 | Group – Whitebeam, Norway Maple, Field Maple, Lime & Horse Chestnut | <450 | <16 | EM | 6 | 6 | 6 | 6 | 4 | B | A mixed double row of deciduous trees closely spaced. The majority of trees on the site side are Norway Maple & Horse Chestnut. They are all tall leggy specimens forcing each other on within the group. Historic pruning over old roadside and several minor basal wounds present along row. | Raise crowns for access by the removal of minor lower branches to a height of approximately 5m. | 20+ | B2 | <91.61 | <5.40 |
