**Tree Condition Report  
Arboricultural Impact Assessment  
Arboricultural Method Statement  
Tree Protection Plan**

**Land at The Sheepfold Farm, Bronington,  
Near Whitchurch**

**Farm Adventure Ltd**

**23.11.2020**

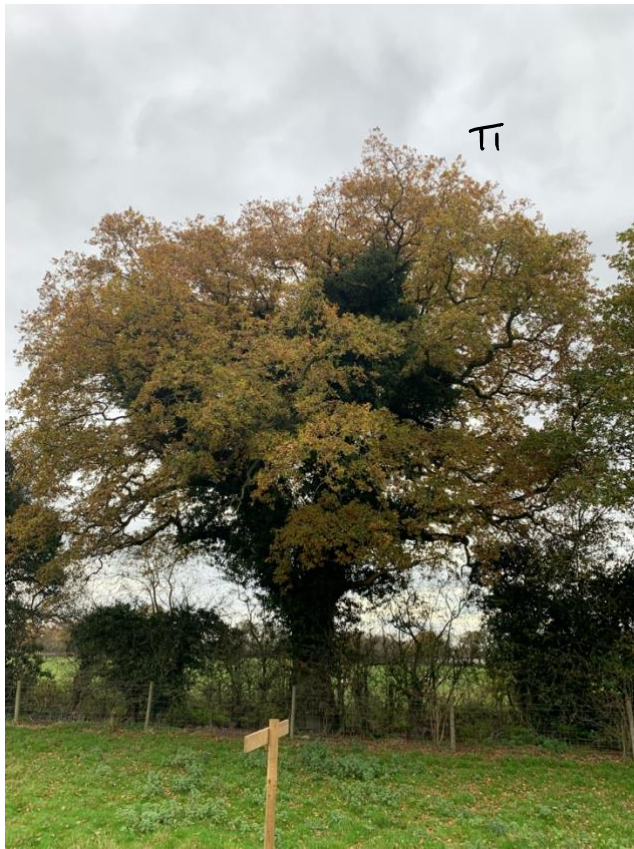
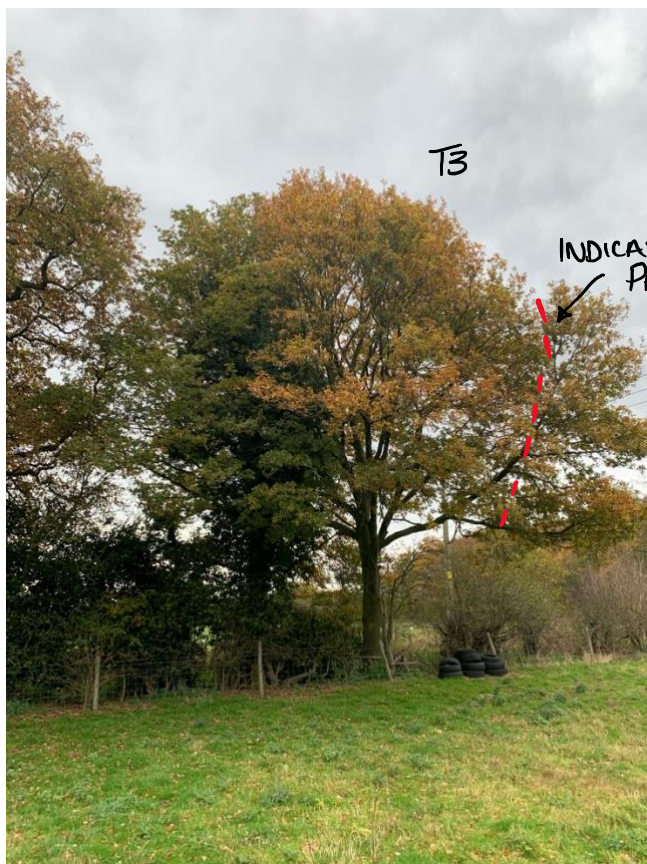
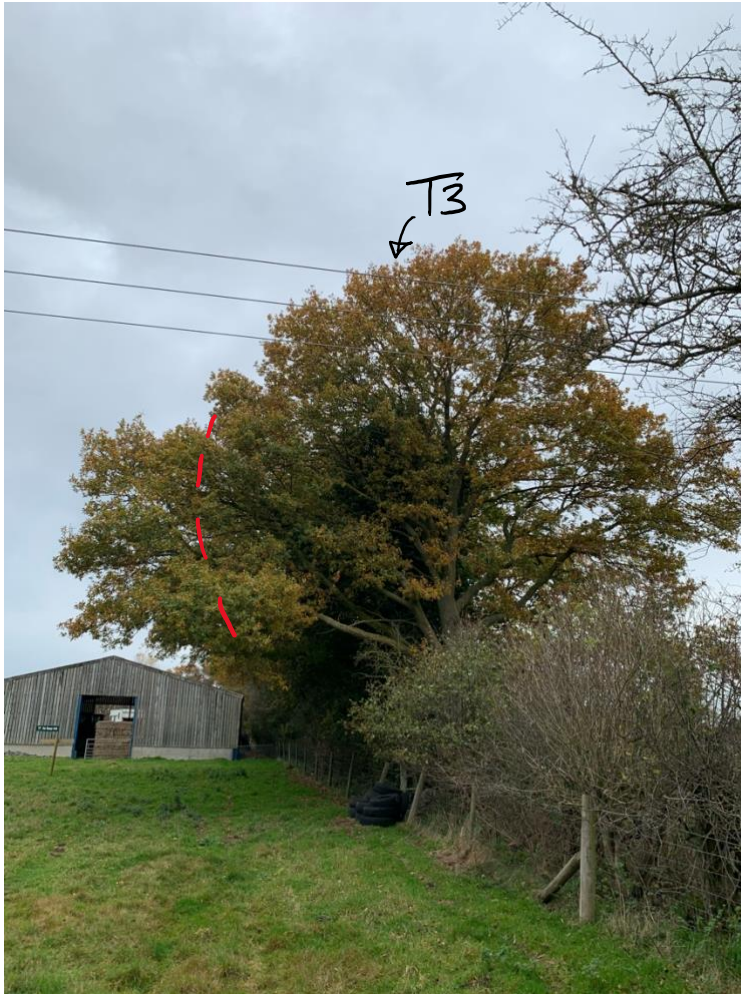
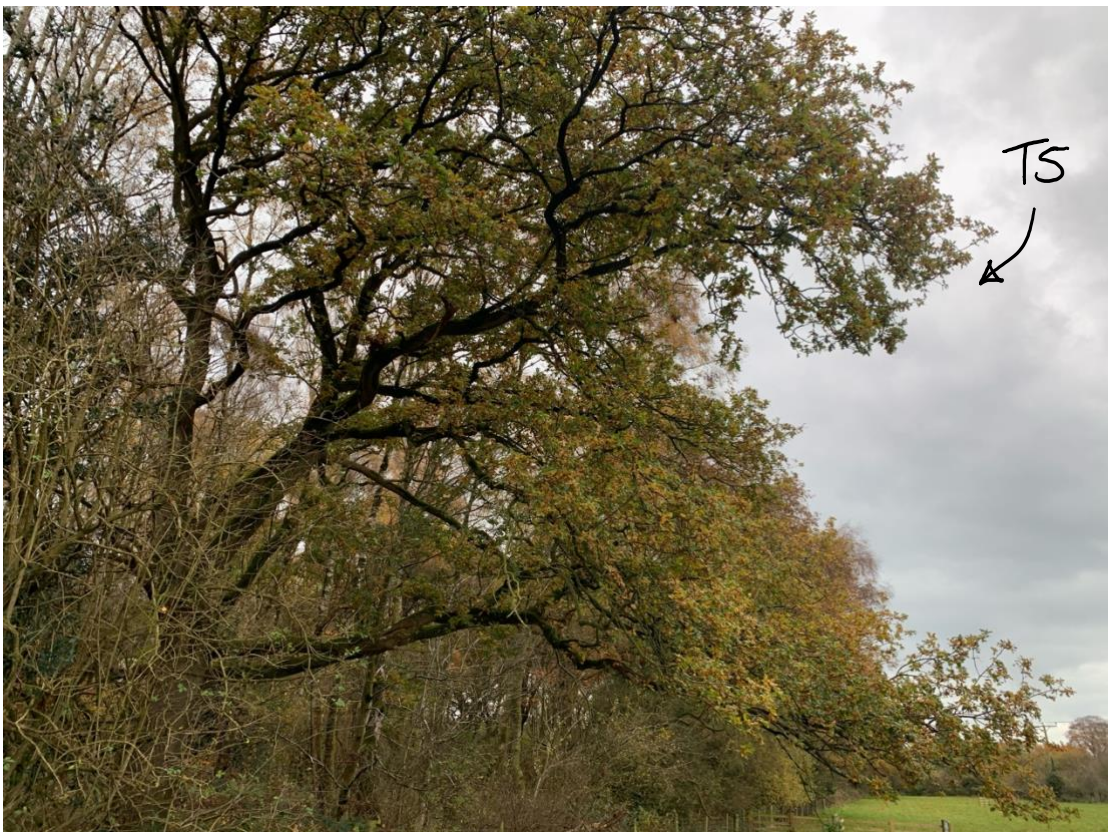
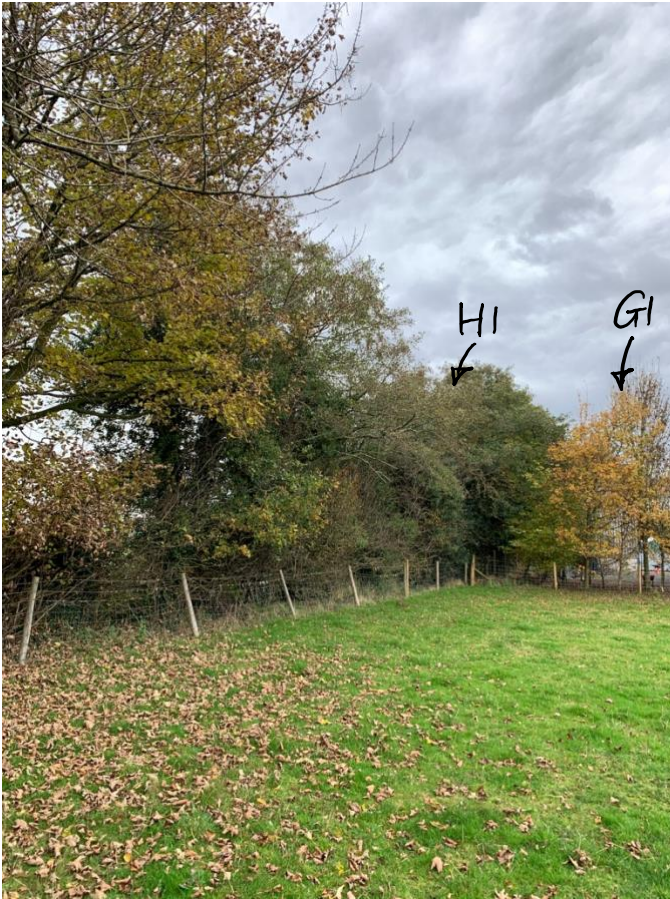
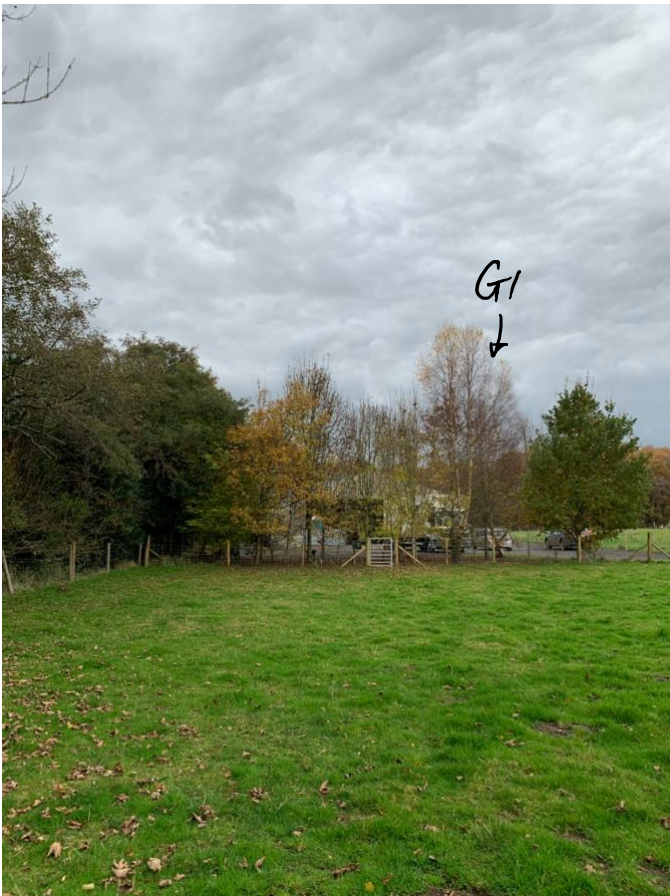
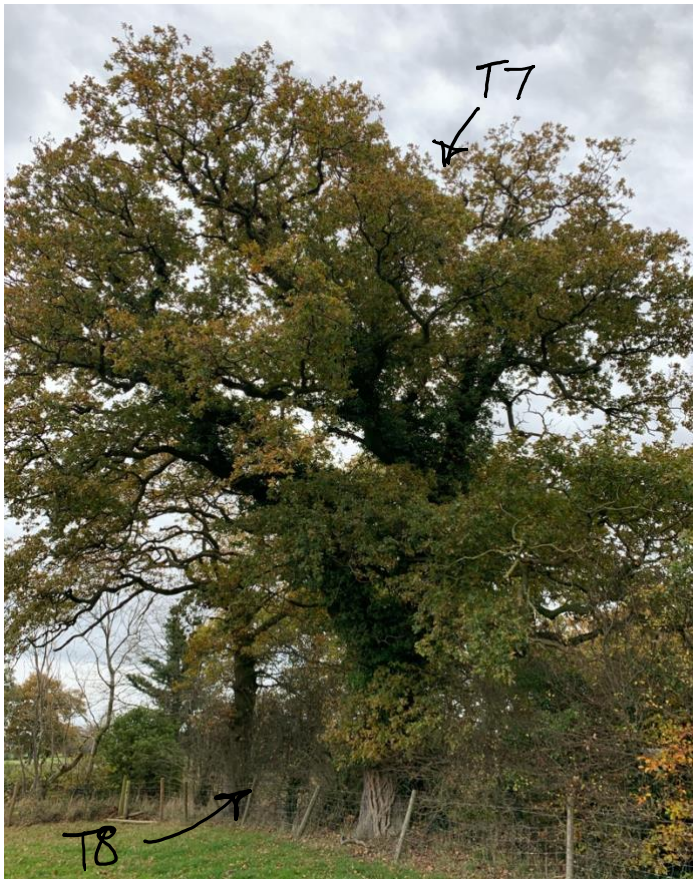
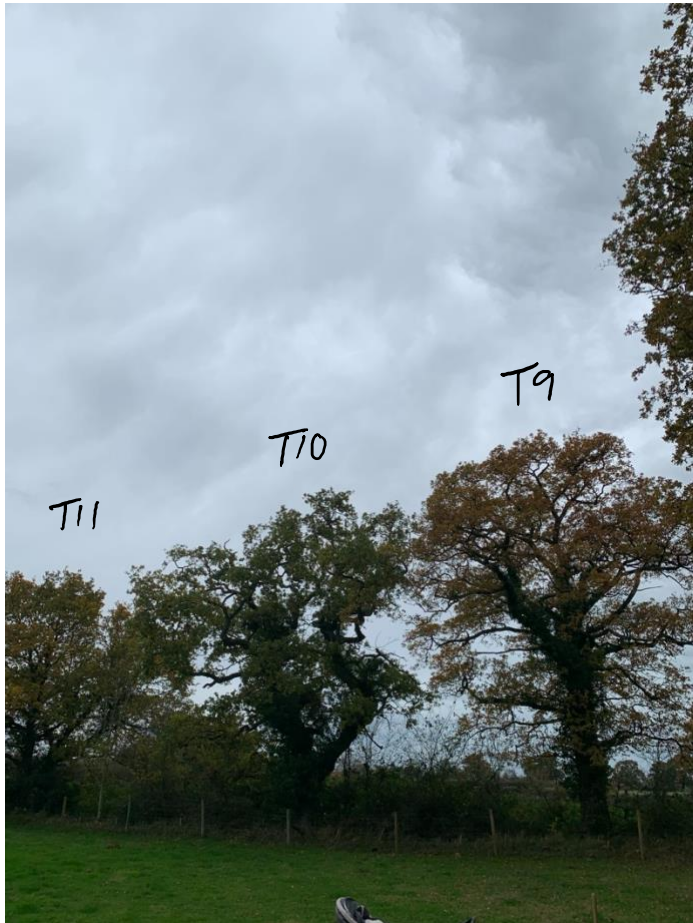
Photo Detail: Tree condition illustration ref. Sect 2.2

| <p><b>Tree Condition:</b><br/> <b>Root:</b> No evidence of soil movement.<br/> <b>Stem:</b> no evidence of fungi or bark necrosis.<br/> <b>Crown:</b> Asymmetric development over the development side which needs reducing, as it is at risk of failure over the development side. No recent breakouts or significant dieback.<br/> <b>Tree Quality Assessment:</b> Ref.BS5837 (2012) 4.5.1 <b>Category A2</b> Significant tree in landscape. Life expectancy &gt; 40years<br/> <b>Water Demand NHBC 4.2-B: High</b><br/> <b>Root Protection Area RPA:</b> for tree of 45cm diameter at 1.5m (<math>0.45 \times 12</math>) = <b>5.4m Radius</b><br/> Total RPA required at current stage of growth = 92m<sup>2</sup><br/> <b>Arboricultural Impact Assessment AIA:</b> <ul style="list-style-type: none"> <li>The shepherds huts fall outside the RPA of T3</li> <li>No alteration of soil levels are permitted within the RPA of T3</li> <li>No trench excavation is permitted within the RPA of T3</li> </ul> <b>Method Statement:</b> Installation of shepherds huts <ul style="list-style-type: none"> <li>Install the section of Heras fence barrier, positioned as indicated on the tree protection plan. Specification as recommended in BS5837 (2012) fig 3 appended</li> </ul> </p> | |

INDICATIVE  
PRUNING  
POSITION
