Our Ref: 7565TWNW210121L

21 January 2021

**Re: Ground Assessments at “Lagoon Site”, Parc Brymbo, Wrexham.**

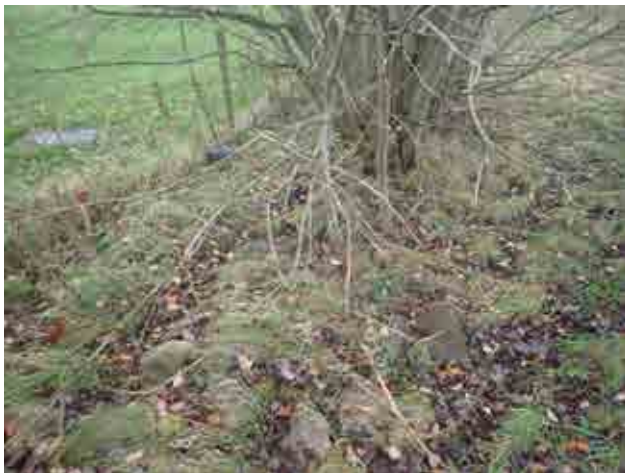
The eastern boundary which bordered the managed sports pitches was level with the off-site playing fields and consisted of a wood pole fence and medium sized trees. A suspected 'French drain' was also likely to be present parallel to this boundary, and clues to its possible existence were present in the form of a linear feature of angular cobbles running the length of this boundary alongside the fence (refer to photograph 3). In a number of places around the site, concrete pads with rusted metal bars protruding out of them had been left in place following on from settlement monitoring carried out during the remediation phase (refer to photograph 4).

*Photograph 3: Suspected French drain.*

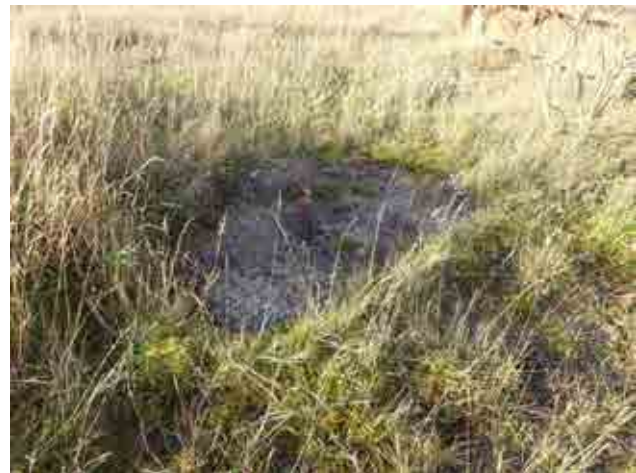
*Photograph 4: Concrete pad with metal bar protruding left over from settlement monitoring.*

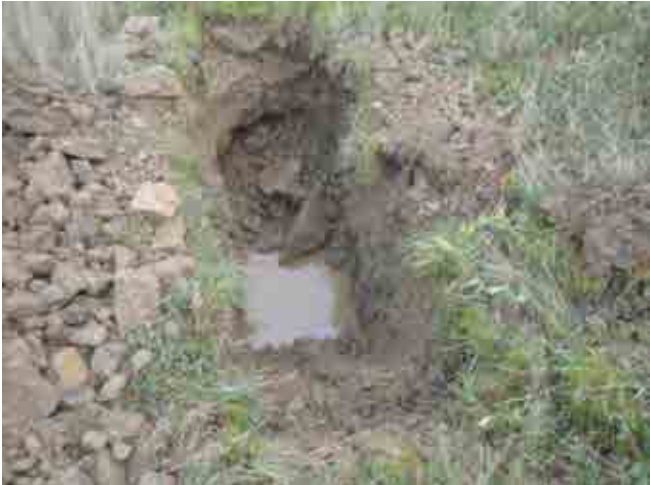
| <div> <div>Coopers (Chester) Ltd</div> <div>tel: 01244 684 910</div> <div>web: www.coopers.co.uk</div> <div>email: admin@coopers.co.uk</div> </div> | | | | <b>Site</b><br>PARC BRYMBO, WREXHAM - LAGOON SITE | | <b>Trial Pit Number</b><br><b>TP03</b> | | | |
|---|---|---|---|---|---|---|---|---|--|
| 0.90 | B | | Seepage during excavation(1) at 1.20m. | | 1.10 | Complete at 1.30m | | ∇1 | |
| | | | | | | <b>Remarks</b><br><br>Location CAT scanned prior to excavation.<br>Spalling of larger material causing local instability, otherwise stable.<br>Groundwater seepage at 1.20m during excavation.<br>*Based upon trenchside stability characteristics.<br>Please note that discolouration of photographs may occur when viewed on screen as a PDF, or when printed as a hard copy.<br>Trial pit backfilled with arisings upon completion. | | | |

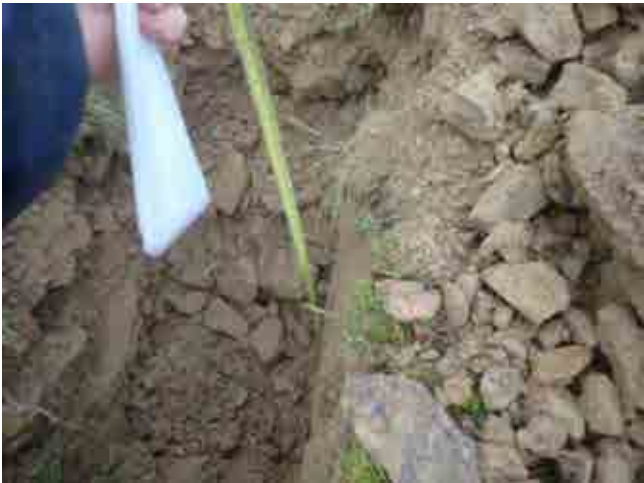
| <b>Remarks</b><br><br>Location CAT scanned prior to excavation.<br>Sides stable during excavation. Spalling only.<br>No groundwater encountered during excavation.<br>*Based upon trenchside stability characteristics.<br>Please note that discolouration of photographs may occur when viewed on screen as a PDF, or when printed as a hard copy.<br>Trial pit backfilled with arisings upon completion. | | | | | | | | | |

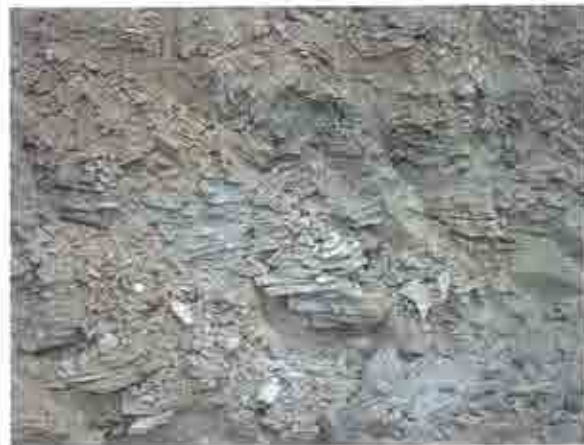
On-going re-compaction of materials in LRDM  
(July – October 2007)

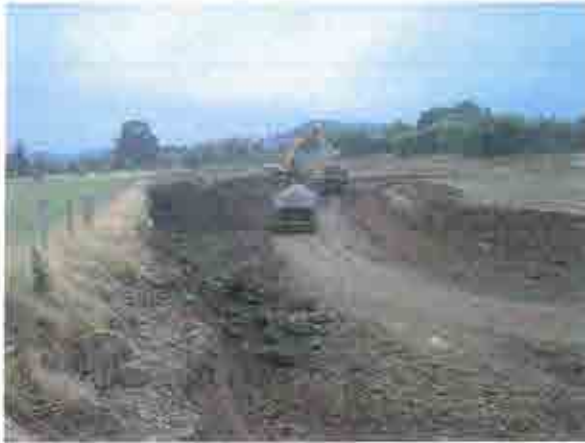
Typical sandstones encountered within LRDM  
during excavation and replacement activities
