## Photographic Survey Report

**Knolton Farm, Oswestry Road, Overton  
Wrexham LL13 0LG**

Planning Reference: OVE P/2020/0198

**Prepared by:** David Owen C.Build E FCABE of Shenton Owen Planning & Design

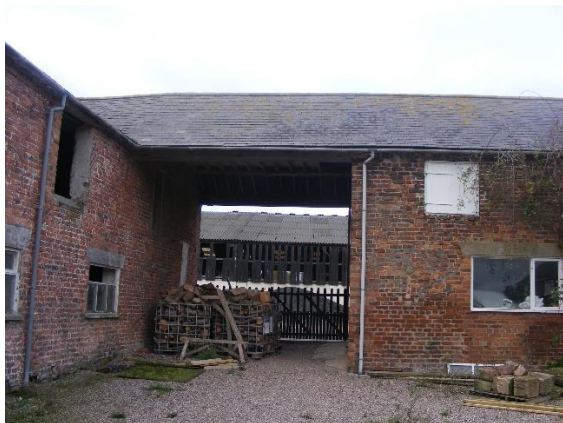
Photo 1

- Photo 1:** Viewing west through archway.
- Photo 2:** View to underside archway showing bat loft in place.
- Photo 3:** General view north elevation between arch link to the west and single storey section to the east.

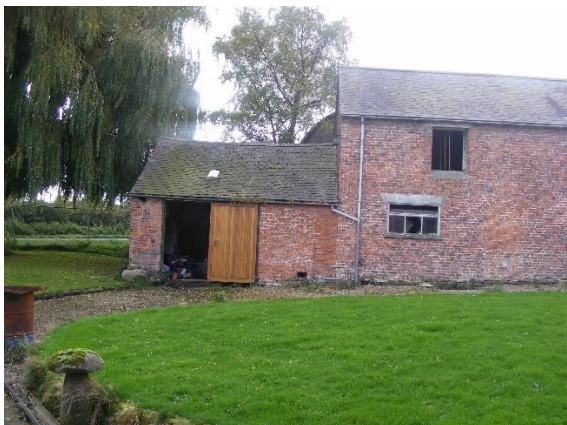
Photo 4

- Photo 4:** North elevation view of single storey section to east of main barn.
- Photo 5:** General view looking southwest showing north and east elevations.

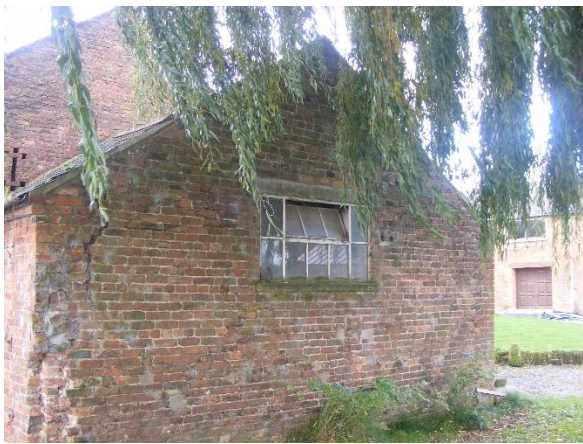
Photo 6

- Photo 6:** East elevation of single storey part.
- Photo 7:** General view (looking northwest) of south elevation.
- Photo 8:** General view (looking northeast) of south elevation.

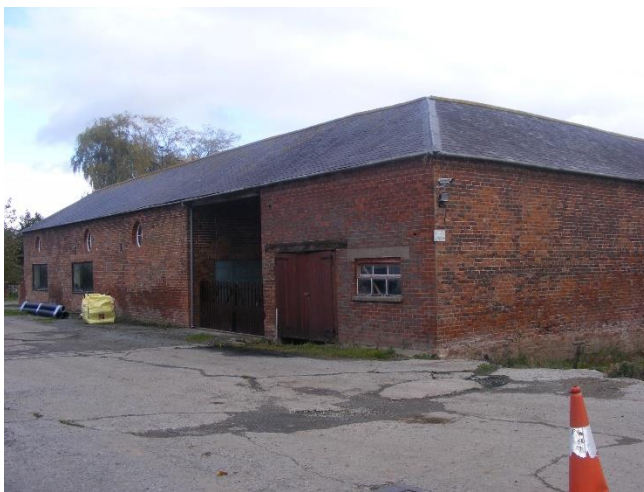
Photo 9

- Photo 9:** General view (looking northeast) of west elevation.
- Photo 10:** High level opening underside of arch north elevation.
- Photo 11:** High level opening north elevation and ground floor window opening 3 over 3 casement with upper 3 hoppered. Note concrete lintel suggesting later opening. Also showing plastic rwg,s to eaves and downpipes.

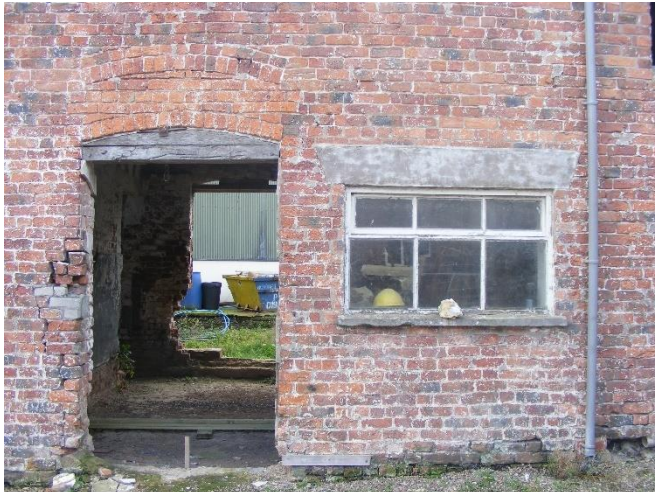
Photo 12

- Photo 12:** North elevation opening 3 over 3 as described above, and ground level door access in reduced head opening. Note original arched head retained.

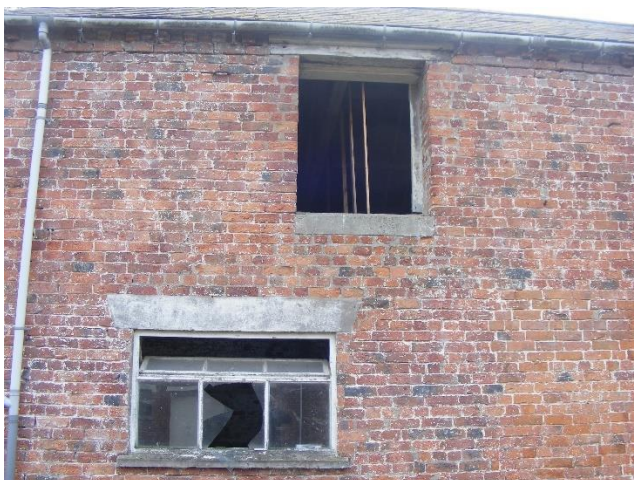
Photo 13

- Photo 13:** North elevation 3 over 3 oping as described above and high level opening above with sill strengthened with concrete.
- Photo 14:** View of single storey section showing roof in welsh slate and walls constructed in orange/red locally sourced handmade brick. Modern door inserted in enlarged opening.

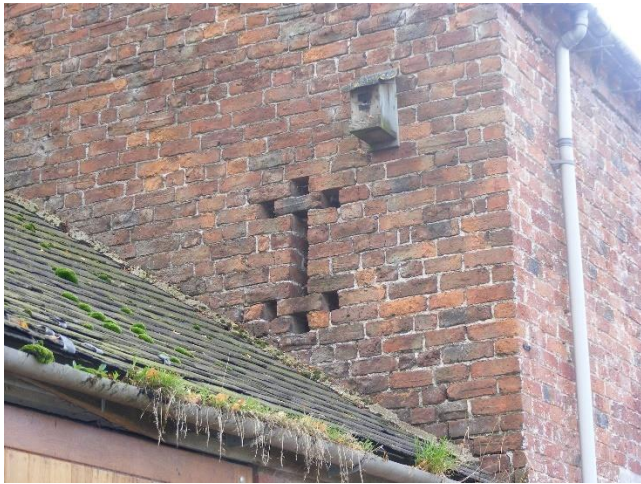
Photo 15

- Photo 15:** Ventilation detail east gable.
- Photo 16:** 5 over 5 Crittal type window with upper 3 central panes hoppered. Note concrete lintel and sill.

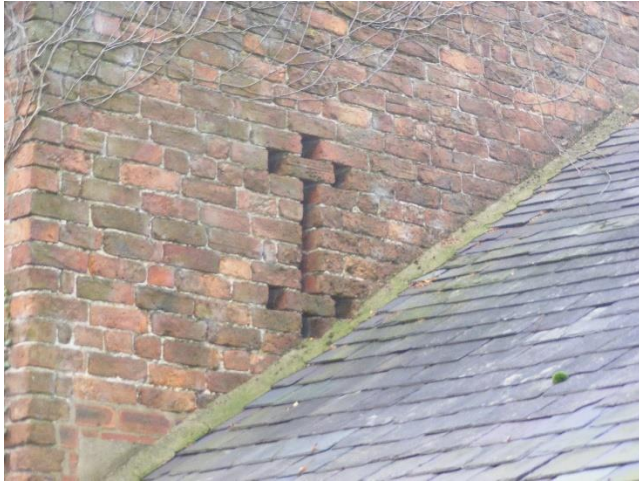
Photo 17

- Photo 17:** Ventilation detail east gable.
- Photo 18:** Former window with brickwork below removed to form door access.
- Photo 19:** West wall openings 3 over 3 window as previously described alongside large

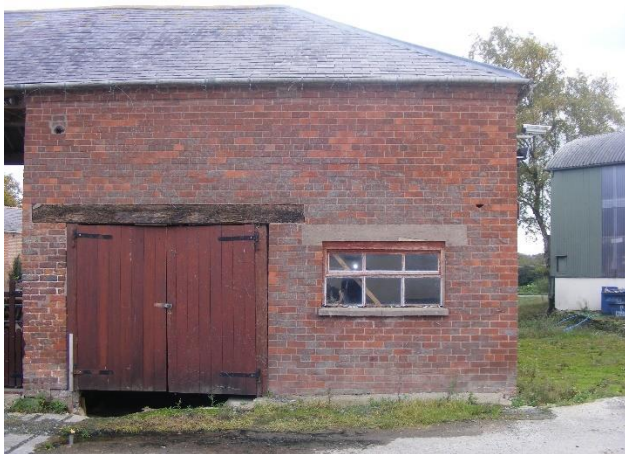
Photo 19

boarded door inserted under timber lintel. This shows the hip arrangement to the roof which is covered in welsh slate over orange/red locally sourced handmade brick.

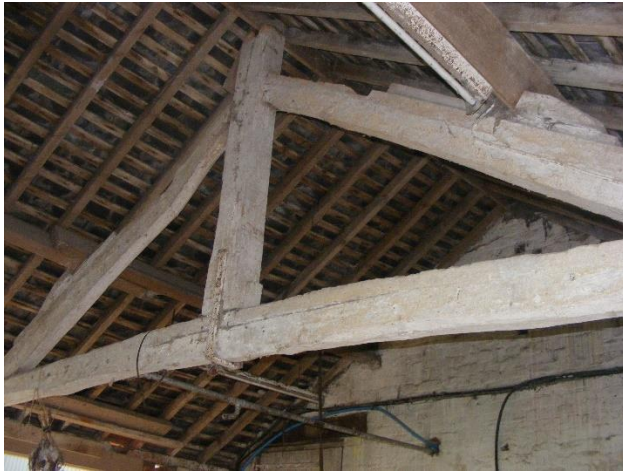
Photo 20

- Photo 20:** Internal view of structure to single storey section. All timbers appear badly affected by insect attack compounded by members being over spanned.

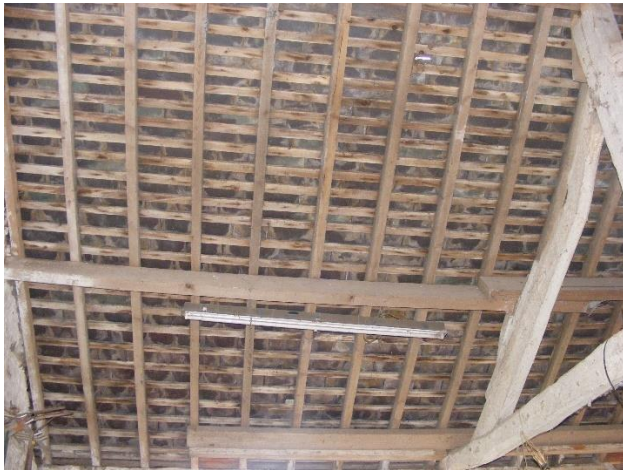
Photo 21

- Photo 21:** Further detail of single storey roof note over spanned purlins.
- Photo 22:** General internal view of single storey section.
- Photo 23:** General view of roof members in bay 1 showing king post truss and two rows of purlins to each slope.

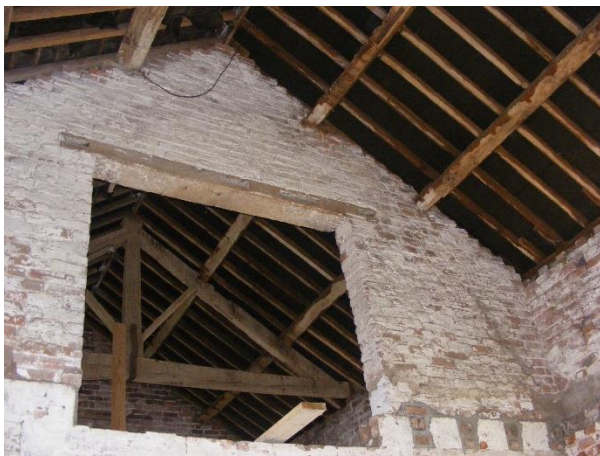
Photo 24

- Photo 24:** General view of roof members in bay 2 showing two rows of purlins to each slope supported of internal flanking walls.
- Photo 25:** Further view of bay two roof makeup.

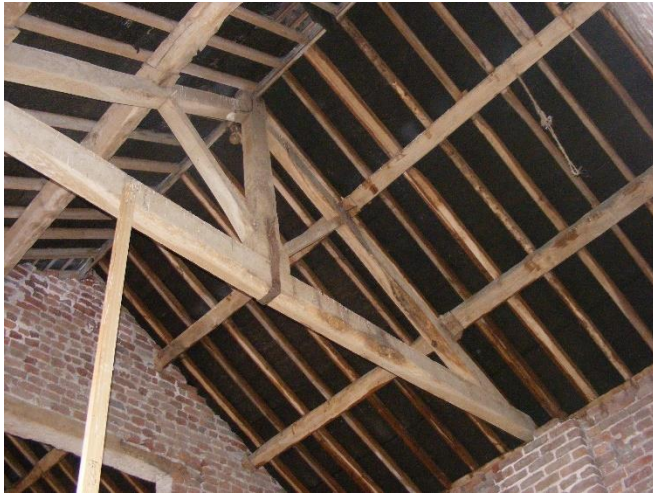
Photo 26

- Photo 26:** General view of bay 3 roof construction showing king post truss with the continuation of two rows of purlins to both roof slopes.
- Photo 27:** Bay 4 roof detail showing hip structure. Note dragon tie at base of hip to prevent spread of wall plates at base of hip.

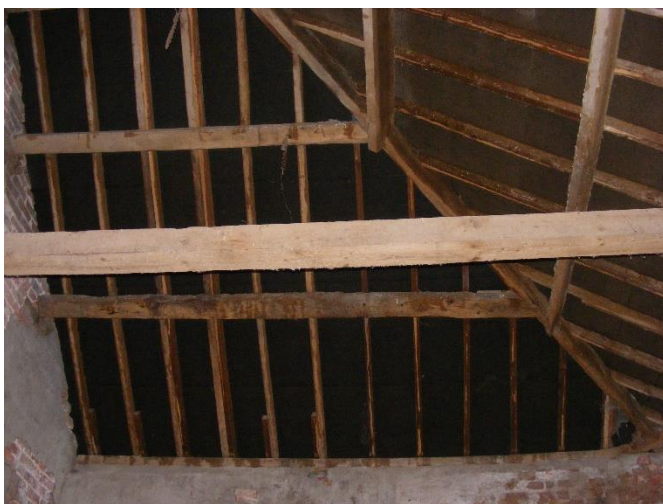
Photo 28

- Photo 28:** Further detail of bay 4 roof structure.
- Photo 29:** Further detail of bay 4 roof structure showing valley make up and support at junction of roofs.

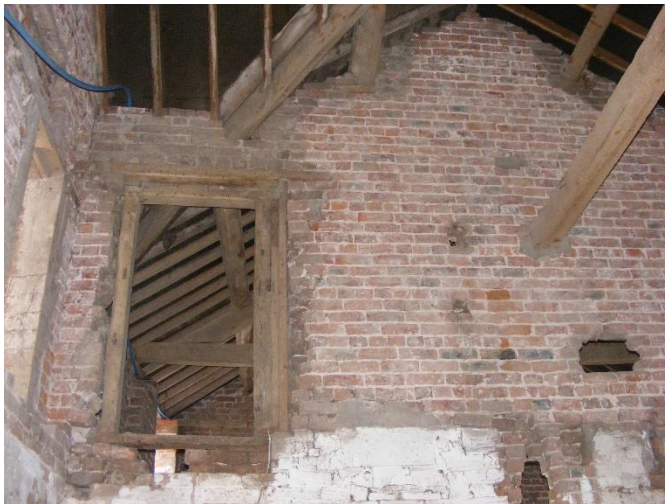
Photo 30

- Photo 30:** Internal view high level openings bay 4.
- Photo 31:** Internal view high level openings bay 4.
