Holt Hill – 19169

Site visit 28.01.2021

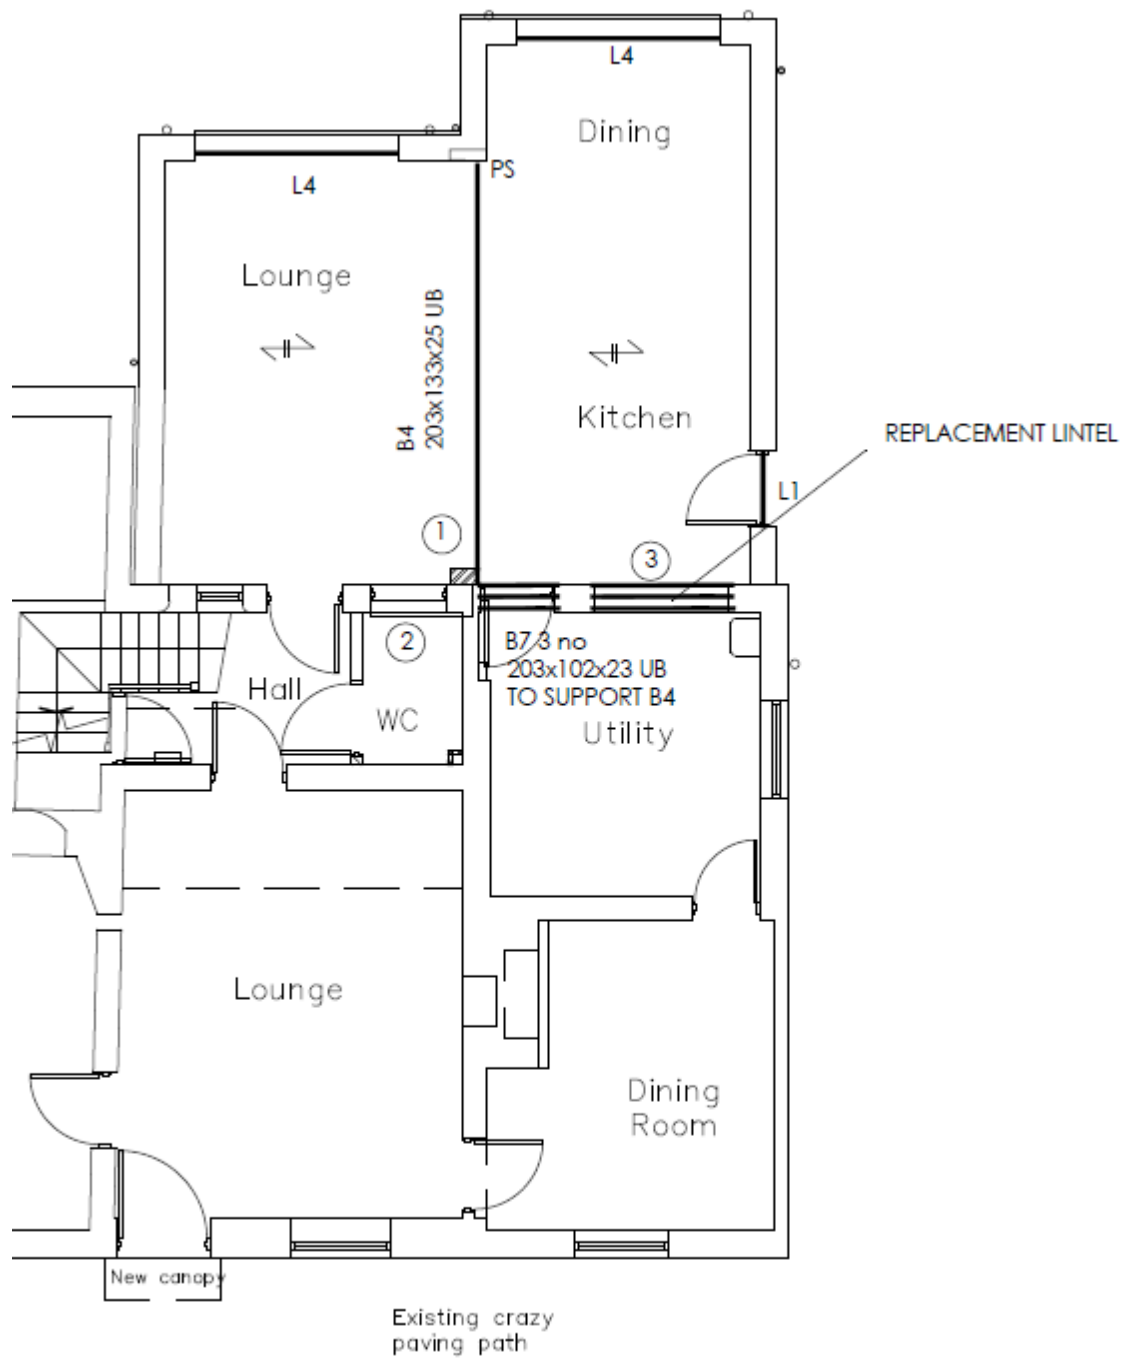
SITE VISIT 28.01.2021  
1:100

1 – existing masonry pillar fixed to face of house wall has no support therefore cut back brickwork flush with adjacent house face.

2 – existing doorway to be infilled, provide new 400x225 GEN1 concrete footing and extend this sufficiently to underpin the pier between the two openings. Infill to be 3.5N solid block in class ii mortar tied in to existing masonry on both sides.

3 – existing timber lintel is rotted and no longer serviceable, replace with 3 number 152x89x16 UB bolted together (wall thickness may require 4 beams)

B7 – make B7 same depth as B4 for practical connection detail, note multiple are required due to wall thickness.

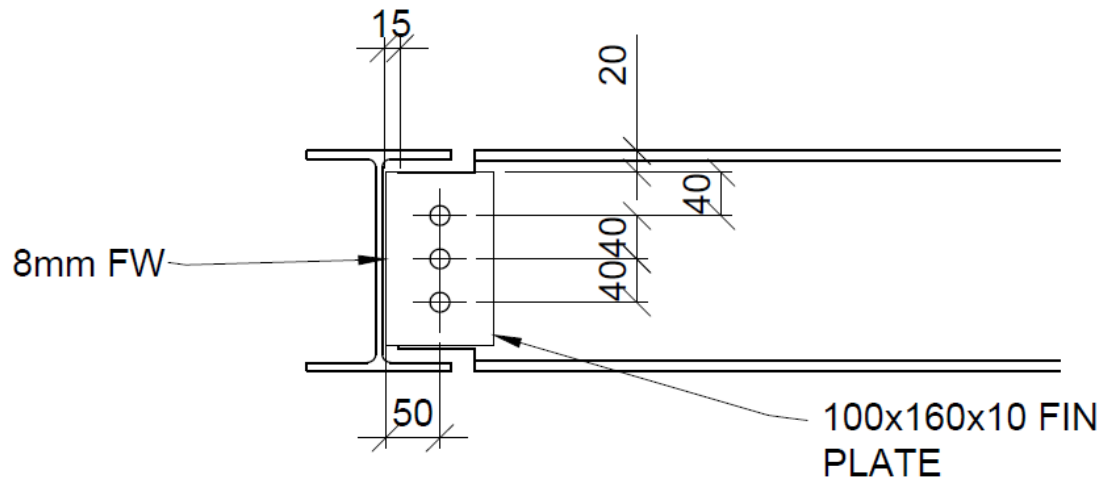
CONNECTION  
DETAIL B4 TO B7

M16 GRADE 8.8 BOLTS IN STANDARD HOLES, 8mm FW, INCOMING BEAM TO HAVE 70x20 NOTCHES.
