# Structural Report

Coed Derwen  
Erbistock  
Wrexham  
LL13 0DN

CLIENT  
Etonbrook Limited

DOCUMENT NUMBER  
AJF-21081-R01

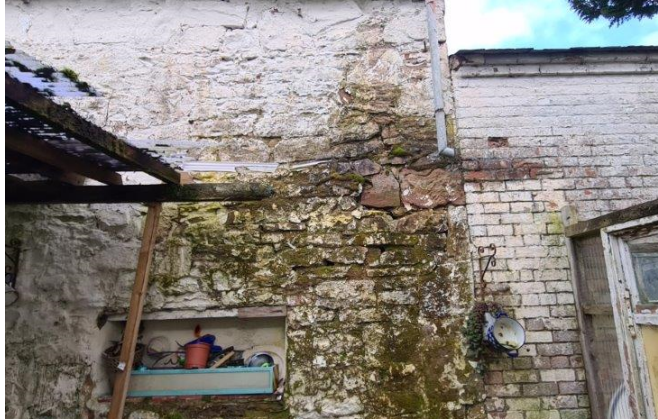
- 3.1. The external walls of the main barn appear to be in relatively good condition however suffer from a general lack of maintenance. Cracking is mainly located above openings where there is an absence of a lintel or lintel failure. The stonework to the south elevation is in poor condition.

- 4.4. Although there are areas of masonry showing signs of deterioration, the walls appear relatively plumb with no visible signs of historic or ongoing excessive settlement. **The areas of the masonry showing signs of severe deterioration should be rebuilt locally and the whole building repointed as required. Consideration should be given to the proposed mortar mixes due to the varying nature of the existing masonry.**

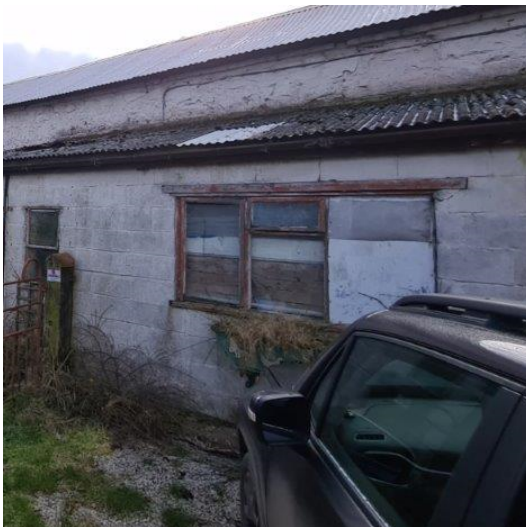
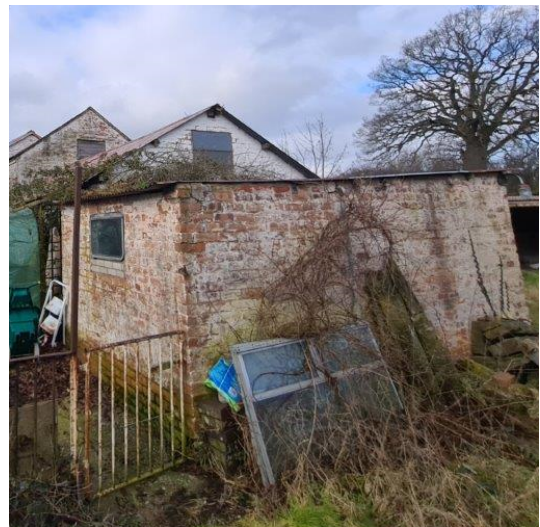
- 3.2. The roof appears to be in relatively good condition when viewed from outside however some areas have deteriorated.
- 3.3. The rooves to the lean-to structures are generally in poor condition. They show signs of structural distress and suffer from a general lack of maintenance.
- 3.4. The various lean-to structures are of single skin masonry construction and not generally considered suitable for residential dwellings.

- 4.3. The associated lean-to structures and various agricultural out-buildings are of single skin masonry construction and they are unlikely to have adequate foundations. They are not considered suitable for conversion into residential dwellings. **The lean-to structures could be used for residential purposes following some remedial works.**

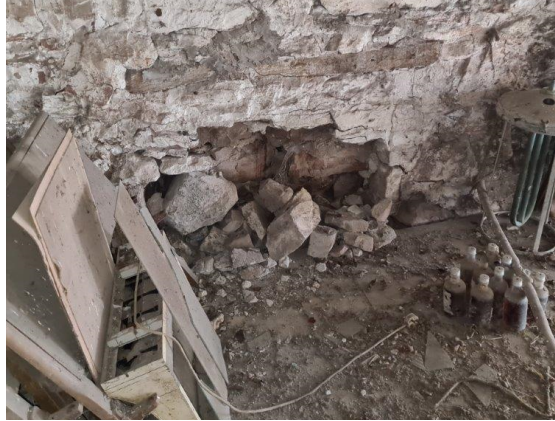
- 3.6. The masonry appears to generally be in good condition however localised areas show signs of severe deterioration. There also appears to be localised masonry bearing failure below timber purlins. The areas showing signs of deterioration are generally mirrored on the external elevations.

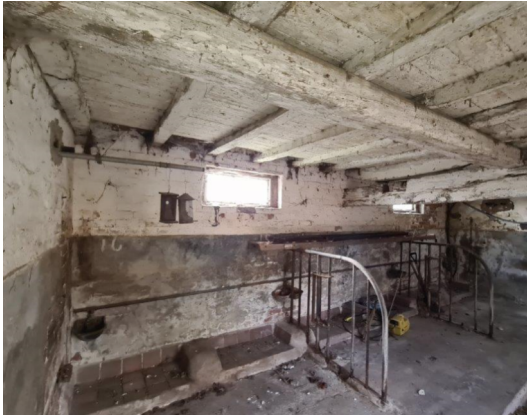
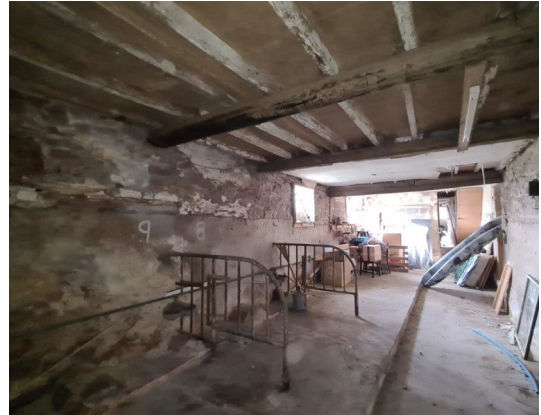
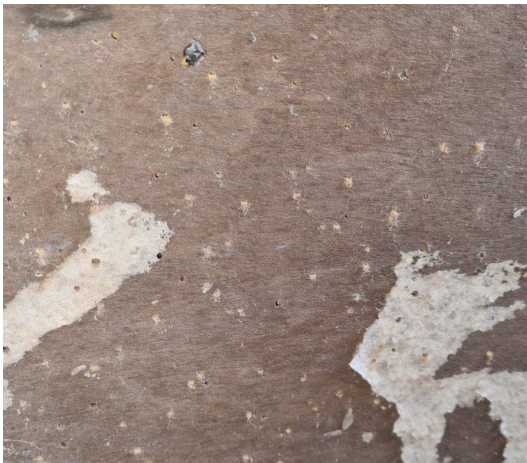
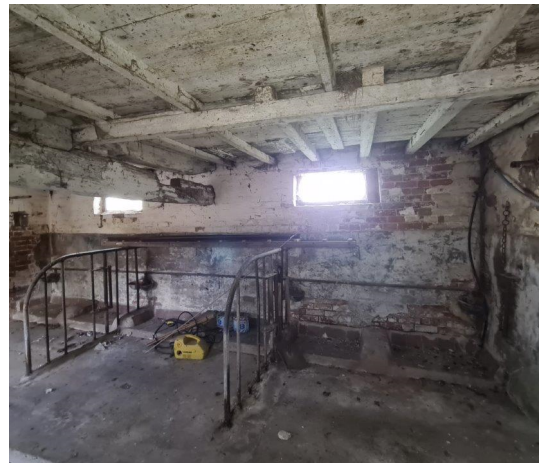
- 3.7. The first-floor joists appear to be in poor condition and feel unstable underfoot. There is also evidence of ongoing woodborer activity.

- 4.5. The timber elements within the building vary in condition and there is evidence of ongoing woodborer activity. **Any existing timber that is proposed to remain should be examined by a suitably qualified and insured specialist.**

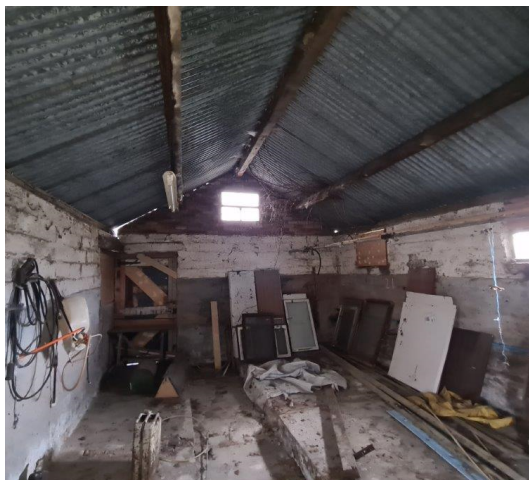
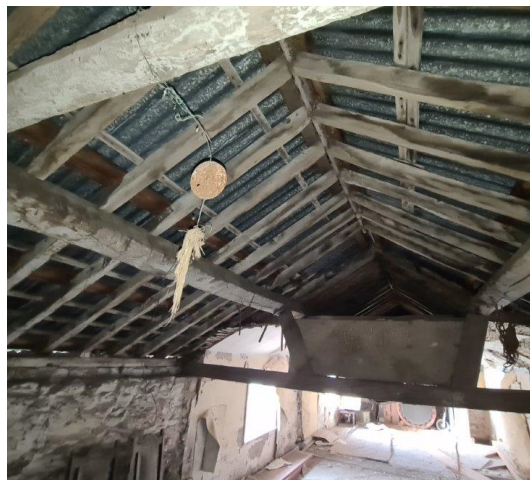
- 3.8. The roof structures throughout appear to be in relatively poor condition. There is evidence of water ingress and ongoing woodborer activity throughout.
