2153  
21. December 2020

**RE: Proposed Conversion of Barn at Tyddyn – Dedwydd LL14 4ND. Structural report.**

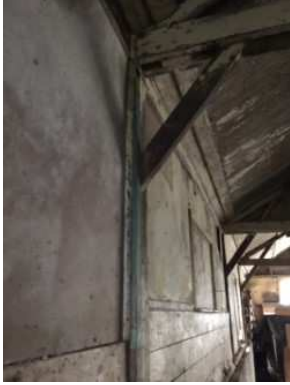
Roof Support

2.2 The duo pitched roof is supported on timber trusses rafters spanning onto timber posts supported on the front and rear walls. No signs of significant movement, deformation or cracking indicative of foundations and/or super structure failure was apparent in the roof and its structural timber framed support system.

- D. It is feasible to replace the roof covering with light weight artificial slate or sheeting without significant strengthening of the existing trussed rafters. A heavier roof covering is also feasible subject to detail structural assessment and local strengthening of the timber trusses.

- The foundations are underpinned to 750mm below ground level to comply with current guidance for foundations in Clay.
  - The timber Posts labelled detail A on plan below should be provided with steel shoes at support on the block walls.

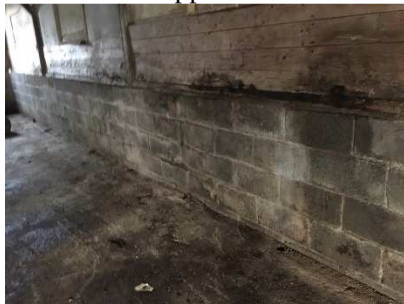
Perimeter Wall

2.4 The lower portions of the external walls approximately 1.5 m high are in 215 thick concrete blockwork. A small area of the front portion of the external Right-Hand side block wall approximately 2 m<sup>2</sup> in area contained a diagonal 5-10mm crack and horizontal displacement caused by vehicle impact. Elsewhere no signs of significant movement, deformation or cracking indicative of foundations and/or super structure failure was apparent.

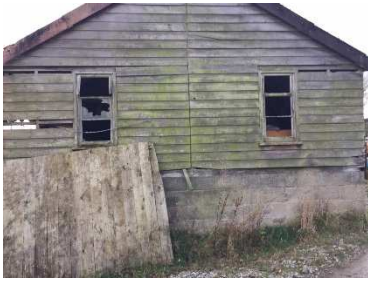
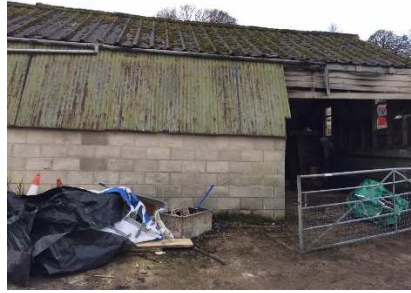
Wall Cladding types.

2.5 The upper portions of the walls are in a mixture of profiled sheeting and timber board cladding. The upper cladding does not contribute to the structural stability of the building. It is proposed to be replaced.

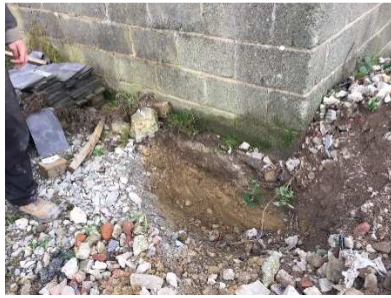
2.6 Foundations at the rear Left- hand corner of the barn was exposed. A Strip footing with spread of 150mm and 150mm thick was noted to bear onto a firm sandy clay at approx 400mm below ground .No signs of significant movement , deformation or cracking indicative of foundations was apparent.
