**OAK TREE  
28 RHODFA GANOL  
NANT PARC  
JOHNSTON  
WREXHAM  
LL14 1PW**

**ADVANCED TREE INSPECTION UTILISING THE PICUS  
SONIC AND PICUS TREE TRONIC DECAY DETECTION  
EQUIPMENT**

| <b>Reference</b> | <b>092020/ATI/DL</b> |

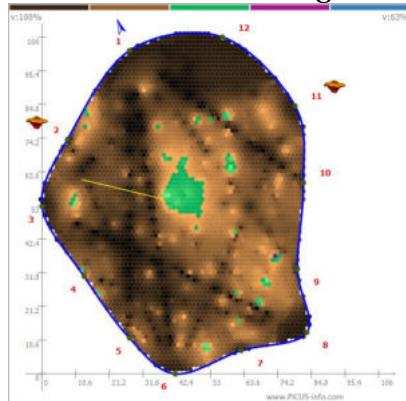
Figure 4: SoT of Oak at 45cm height.

The sonic tomograph (SoT) in *Fig.4* indicates a small area of early-stage decay (green colours) at the centre of the trunk. The light brown colours indicate a slight reduction in velocity of the sonic waves, where a fungus has inoculated the wood and is just beginning to affect the structure of the wood cells. A possible crack/bark inclusion in the Northwest of the trunk is indicated by the superimposed yellow line, that the Picus Q73 Expert software has detected. The symbols indicate the locations of the fungal fruiting brackets.

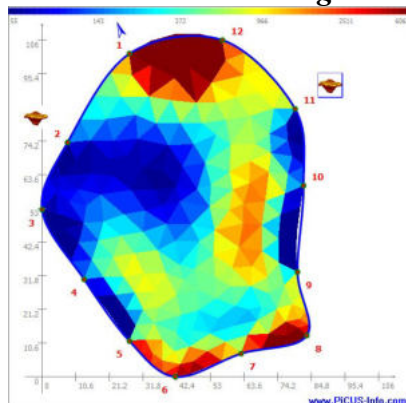
Figure 5: EIT of Oak at 45cm height.

The electrical impedance tomograph (EIT) in *Fig.5* indicates a typical EIT Type 3 ring-like distribution, with higher conductivity (blue colours) on the outside (sapwood), an inner ring of high resistance (red/yellow colours) and high conductivity towards the centre, across the South of the trunk. The disruption of the inner ring across the North of the trunk is typical of an active fungal decay.

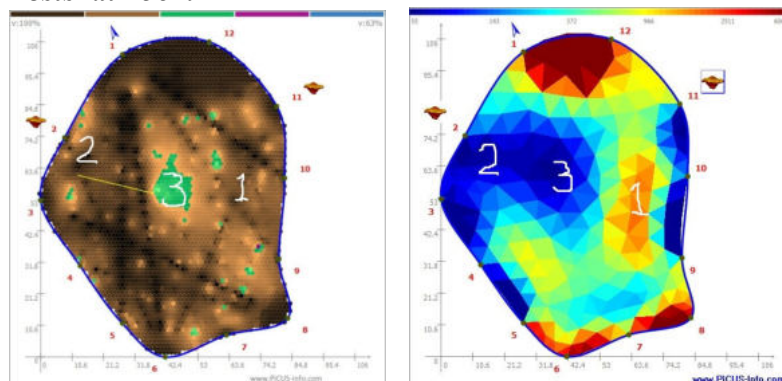
Figure 14: Analysis of SoT and EIT of Oak at 45cm height.

The tomographs show a combination of high velocity SoT (brown) and high resistance EIT (red/yellow) indicating healthy wood, at the Southeast (MP9-10) of the inner trunk [labelled 1], where the inner red ring remains intact. The disruption to the inner red ring (EIT) in the Northwest (MP1-3) of the trunk, due to an increase in conductivity in the wood, is an indication of a defect [labelled 2]. The TreeTronic generates an electric field above and below the test position, whereas the Sonic Tomograph only measures in a horizontal plane across the trunk. When a fungus inoculates the wood and begins to start attacking the cells, it releases enzymes to digest the wood, which increases the moisture content. This increase in conductivity indicates that there may be fungal activity in the walls of the wood cells, in the lower trunk/base below the test position. The green colours on the SoT in the centre of the trunk indicate a decrease in velocity of the sonic waves, indicating early-stage fungal decay. The combination of decreasing velocity SoT (green) and high conductivity EIT (blue), in the centre, indicates an area of active fungal decay [labelled 3].

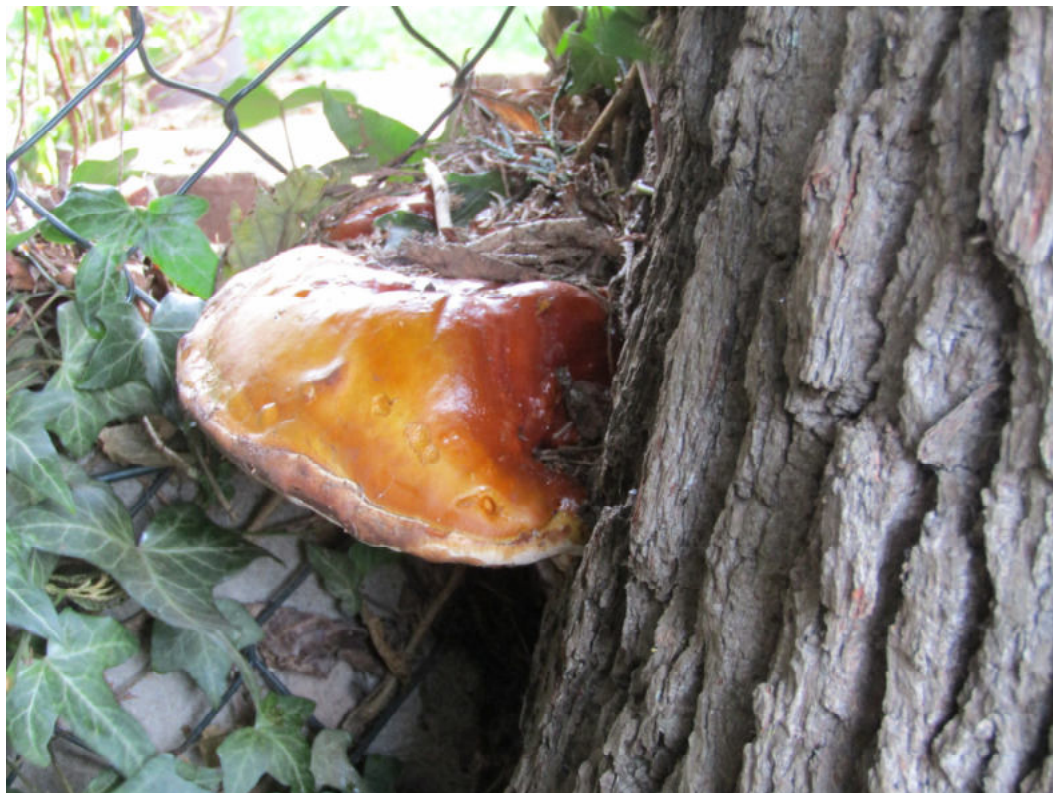
Lacquered Bracket (*Ganoderma resinaceum*) causes a white rot, where the fungus preferentially decays the lignin within the wood, leaving the cellulose relatively intact. The fungus targets the roots and stem base. White rot causes wood softening and can result in a ductile fracture of the trunk, or windthrow as a result of root fracture.

Photo 1: Lacquered Bracket (*Ganoderma resinaceum*) at Northwest of the trunk base.

Another option to consider is to apply Avengelus [improved Basic granule formula] as a surface dressing under the crown area and apply Avengelus gel to the fungal brackets. Avengelus contains *Trichoderma atrobrunneum*, a naturally occurring environmentally-friendly organism that fights many of the common wood decay fungi (*Kretzschmaria deusta*, *Armillaria mellea*, *Meripilus giganteus*, *Ganoderma adpersum*, *Laetiporus sulphureus*, *Inonotus hispidus*, *Phaeolus schweinitzii*). As a population of *Trichoderma* develops in the soil (and on the fungal brackets), it grows specifically towards the hyphae of the host fungus, attaches on and penetrates the cell wall of the decay fungal hyphae, feeds on the cell contents, thus destroying the fungus.

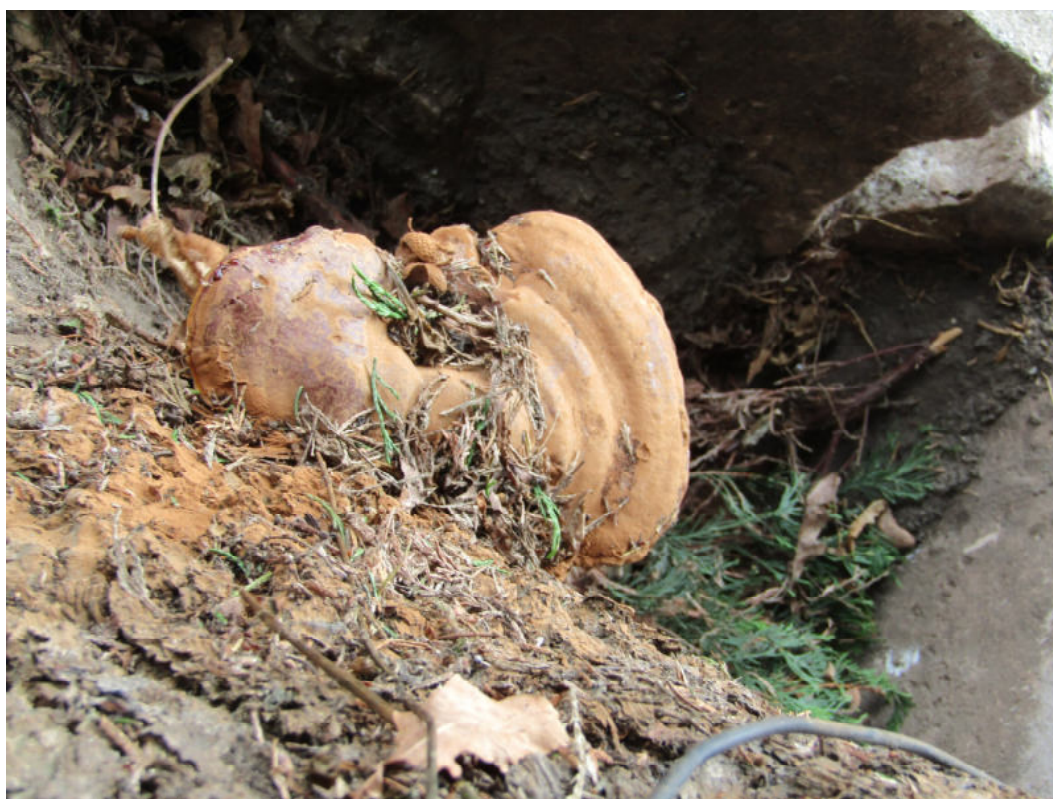
Photo 2: Lacquered Bracket (*Ganoderma resinaceum*) at East of the trunk base.

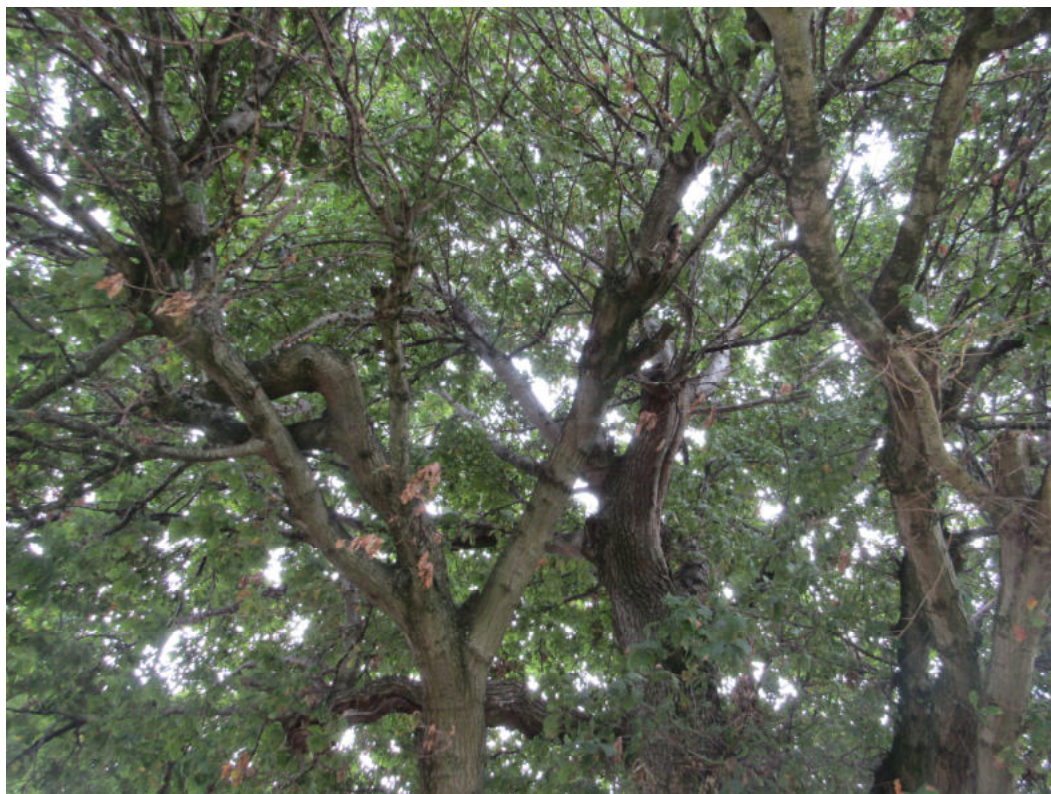
Photo 3: There are a number of dead branches within the crown.

The tree should be crown cleaned, to remove any large deadwood (>35mm diam.), broken/hanging branches and damaged branches.
