**Tree Condition Report  
Arboricultural Impact Assessment  
Arboricultural Method Statement  
Tree Protection Plan**

**Land at The Sheepfold Farm, Bronington,  
Near Whitchurch**

**Farm Adventure Ltd**

**23.11.2020**

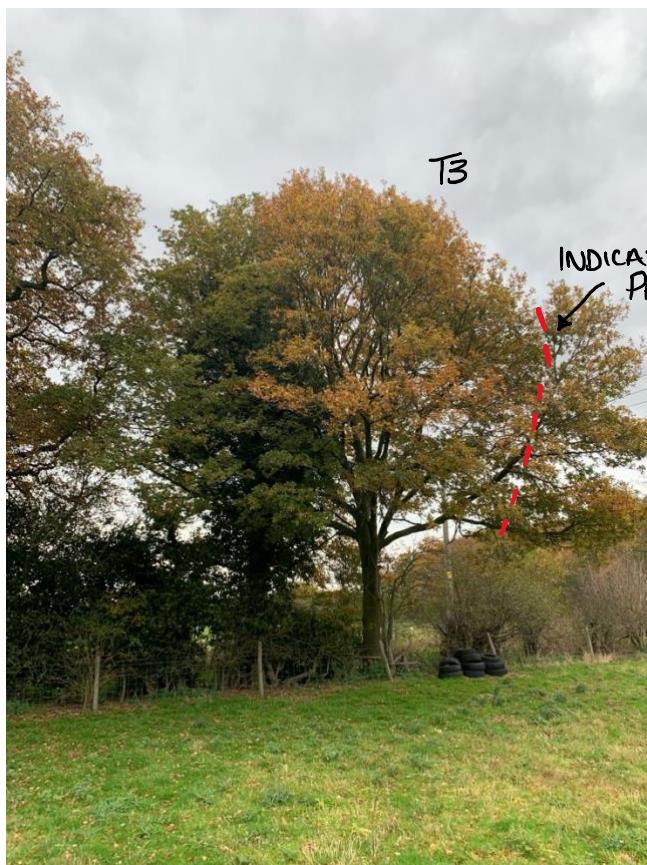
| <p><b>Tree Condition:</b><br/> <b>Root:</b> No evidence of soil movement.<br/> <b>Stem:</b> no evidence of fungi or bark necrosis.<br/> <b>Crown:</b> Asymmetric development over the development side which needs reducing, as it is at risk of failure over the development side. No recent breakouts or significant dieback.<br/> <b>Tree Quality Assessment:</b> Ref.BS5837 (2012) 4.5.1 <b>Category A2</b> Significant tree in landscape. Life expectancy &gt; 40years<br/> <b>Water Demand NHBC 4.2-B: High</b><br/> <b>Root Protection Area RPA:</b> for tree of 45cm diameter at 1.5m (<math>0.45 \times 12</math>) = <b>5.4m Radius</b><br/> Total RPA required at current stage of growth = 92m<sup>2</sup><br/> <b>Arboricultural Impact Assessment AIA:</b> <ul style="list-style-type: none"> <li>The WC Block will fall outside the RPA of T3</li> <li>No alteration of soil levels are permitted within the RPA of T3</li> <li>No trench excavation is permitted within the RPA of T3</li> </ul> <b>Method Statement:</b> Installation of proposed WC Block <ul style="list-style-type: none"> <li>Install the section of Heras fence barrier, positioned as indicated on the tree protection plan. Specification as recommended in BS5837 (2012) fig 3 appended</li> </ul> </p> | |

INDICATIVE  
PRUNING  
POSITION
