# **STRUCTURAL CONDITION SURVEY**

## **ROSE HILL LODGE,**

## **WREXHAM**

**Date**  
**June 2020**

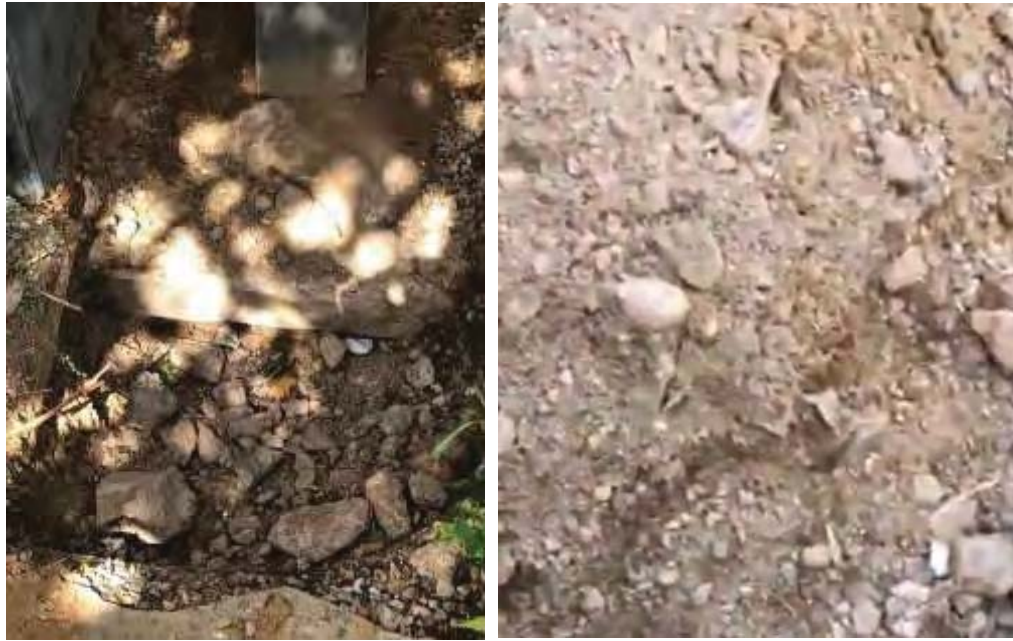
*Figure 2 - Ground Conditions*

- 4.4. The natural strata directly beneath the foundations consist of a light brown, very loose, silty soil matrix with small to medium, sub angular cobbles throughout. Prior to the site investigation the client penetrated the strata beneath the foundation with a 50mm diameter steel bar, resulting in the easy penetration to an approximate depth of 1.2m, therefore confirming the loose, uncompacted nature of the underlying strata. Groundwater was not encountered within the trial holes during the exposure of the foundations. Reference is made to Figure 2 below.

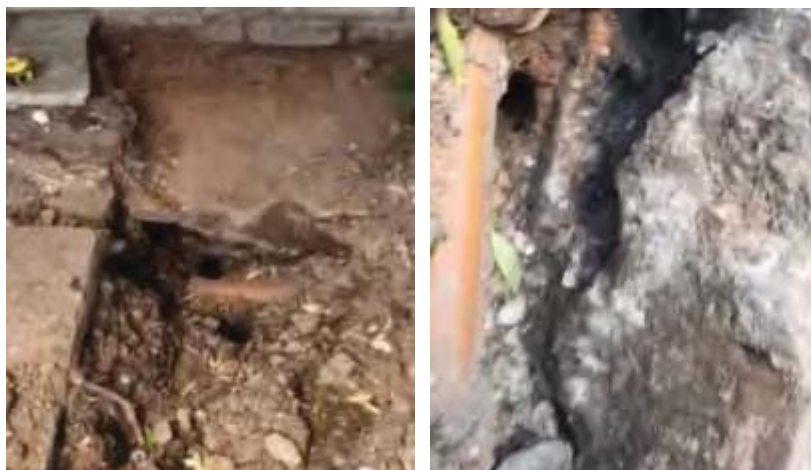
*Figure 3 - Surface water drainage*

- 4.5. Although unconfirmed, the ground floor and basement level are expected to consist of ground bearing slab, with the kitchen extension and first floor assumed to consist of suspended timber construction.
- 4.6. The rainwater goods for the later kitchen extension is situated along the gable wall above ground and within close proximity to the concrete strip foundations below ground. Reference is made to Figure 3 below. Due to the sewer network consisting of thermoplastic pipework the risk of surface water seepage through construction joints is considered negligible due to the standard manufacturing lengths of pipework being 3m, making the need for construction joints across the gable negligible and general condition of surrounding strata.

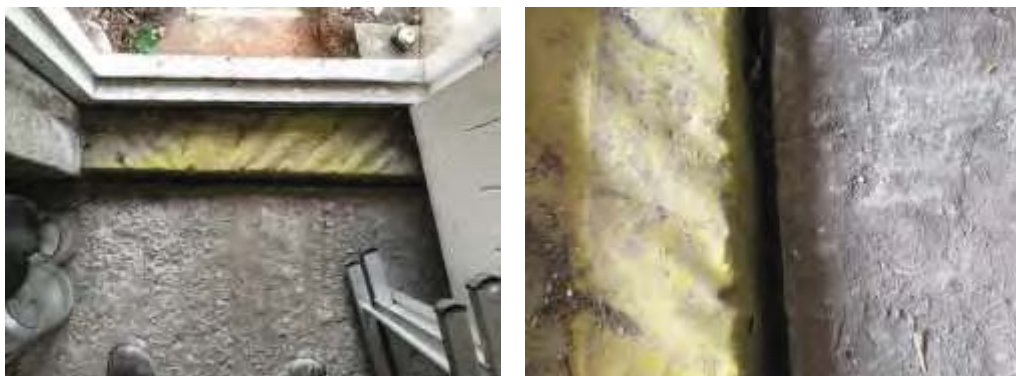
5.1.1.1. The ground-bearing floor slab of the extension has endured movement of approx. 15 to 20mm in the form of downward settlement in relation to the external blockwork of the extension. From discussions with the Owner it is apparent that the foundations of the original structure were underpinned approximately 12 months prior to the construction of the extension, which indicates ground bearing slab would be founded on unsuitable material at a higher level, which has led to the settlement under the weight of the structure over time. It is likely that the design of the foundations of the extension has accounted for potential subsidence or excessive settlement and are therefore likely to have been constructed to similar depths to those of the original structure post-underpinning. This has likely limited, although not entirely prevented, the settlement of its foundations.

5.1.1.2. However the ground floor slab of the extension, which is a structure independent from the external walls, appears to have settled under its own weight, thus suggesting that the shallow strata has upon which it bears has unsuitable bearing resistance characteristics.

Figure 4 - Slab movement

- The floor slab and foundations of the extension should be underpinned to prevent further settlement. The foundations may be underpinned by mass concrete pour, whilst resin injection techniques are available to underpin the floor slab and, in some cases, may raise the level of the floor to the original level. It is recommended to undertake intrusive ground investigation to determine the bearing characteristics of the ground strata, as well as the nature of the extension's foundations and the floor slab (if this information is not readily available). The services of a specialist contractor should be procured for the purpose of undertaking these works.

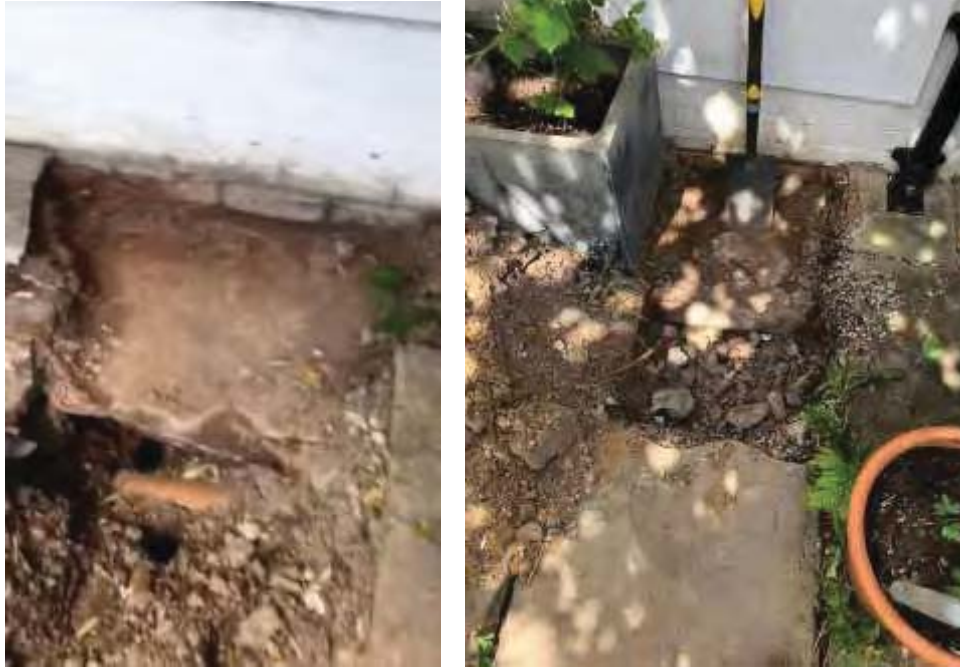
Visual inspection of exposed ground near to the building's footprint confirmed the ground to be of silty nature, which is susceptible to washout in periods of heavy rainfall and may therefore have contributed to any settlement issues.

*Figure 5 - Exposed Concrete Foundations*

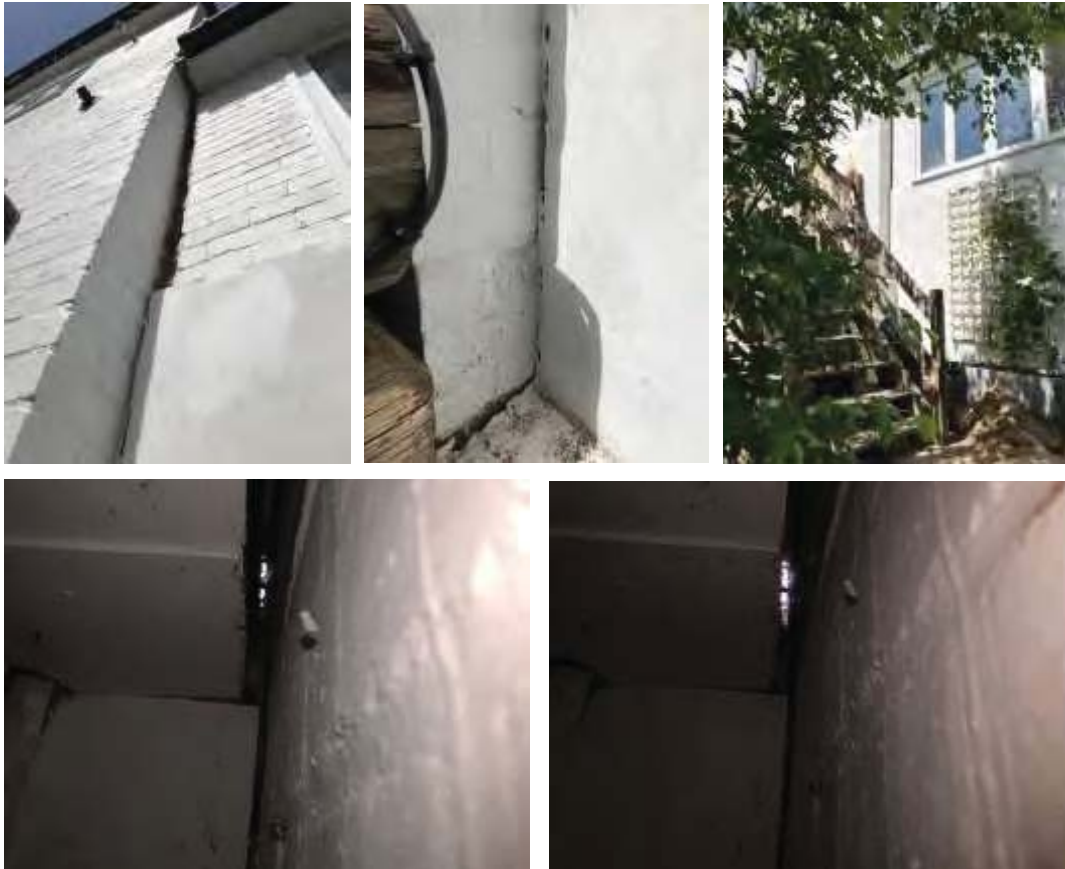
- 5.1.2.1. Significant gaps / cracking is evident along the interaction between the original structure and the extension of approximately 30mm and indicative of foundation settlement. Settlement of a new build tends to occur in the early years of its construction; this, combined with underpinning of the original structure, has led to differential settlement across the two structures. However, this issue is exaggerated by the fact that there appears to be no structural ties between the extension and the original structure; rather the extension has been constructed to abut the original structure only. The original structure therefore provides no resistance to counteract the extension's movement and the lack of restraint has allowed the extension to rotate from verticality.

*Figure 6 - Vertical gaps / cracking at extension interaction with historic structure*

6.2. It is noted that the existing foundation arrangement of the kitchen extension approved by the local Building Control during its construction does not conform to the minimum requirements within the Approved Document A of the Building Regulations 2010. The movement noted within the structure is considered as a direct result of the inadequate foundations.

- Remedial wall ties should be installed at regular intervals along the interaction between the extension and the original structure providing an effective movement plane between both buildings. The gap / cracking between both structures should then be filled with resin or grout until a continuous surface (both internally and externally) between both structures is formed. Similarly, the services of a specialist contractor should be procured for the purpose of undertaking these works.
