**REPORT**

**ALTHREY WOODHOUSE  
OVERTON ROAD  
BANGOR ON DEE  
LL13 0DA**

**M WASON & R J A PEARCE MRICS  
4 Lime Terrace  
Lime Street  
Coleham  
Shrewsbury  
SY3 7EE**

**Date of Inspection: 7<sup>th</sup> November 2019**

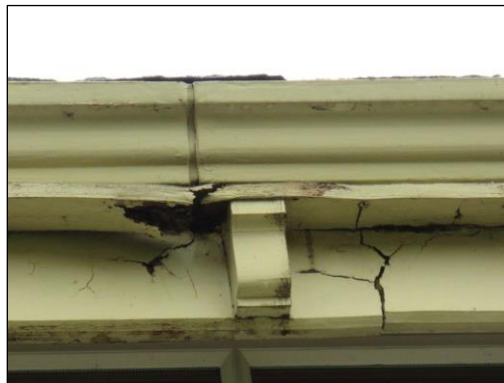
Rain water gutters and downpipes need replacing.

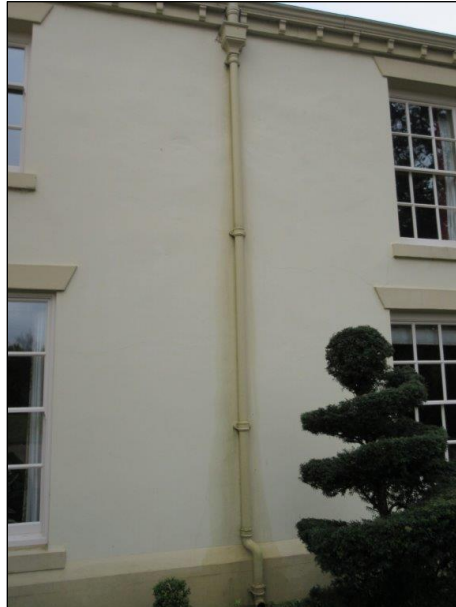
The downpipes are clearly incapable of dealing with the amount of rainwater discharging from the roof. This has caused damage to the external render which is cracking and losing its structural key.

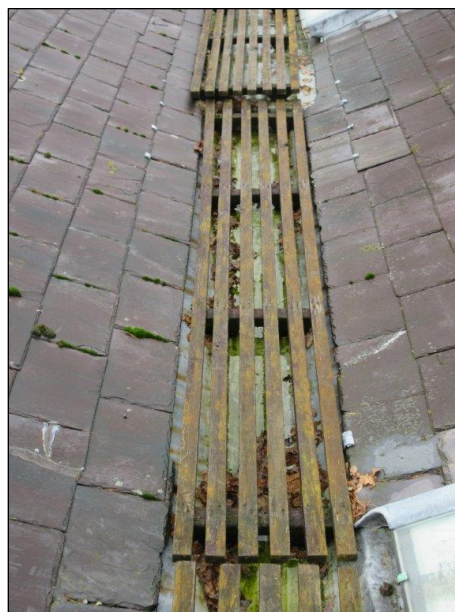
The valley gutter would of sufficient diameter to deal with the water discharge from the valley had it been correctly constructed.

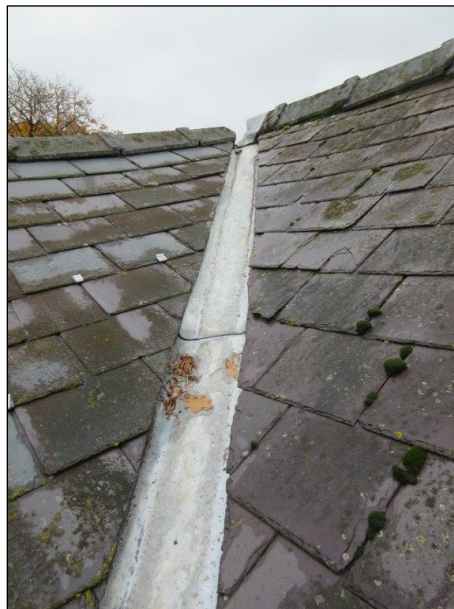
The pipe to which the central valley discharges has been leaking at the joints.

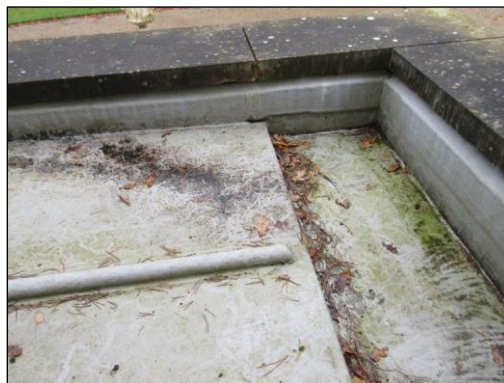
The ingress of water has caused the timbers below to rot.

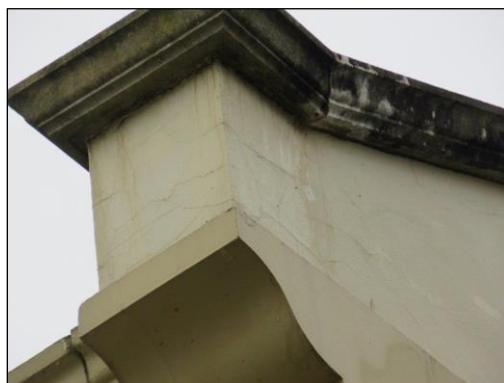
An injected retrofit damp-proof course has been applied to some of the external walls. The problem with this type of application is that the damp present to the walls above the level of the injected damp-proof course at the time of the application is now trapped within the fabric of the building.

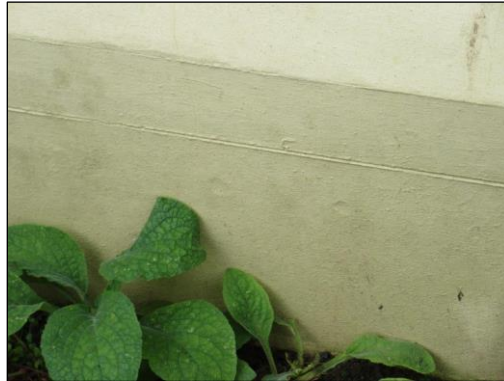
There are signs of minor structural cracking to the brickwork walls which have not been rendered caused by historic settlement.

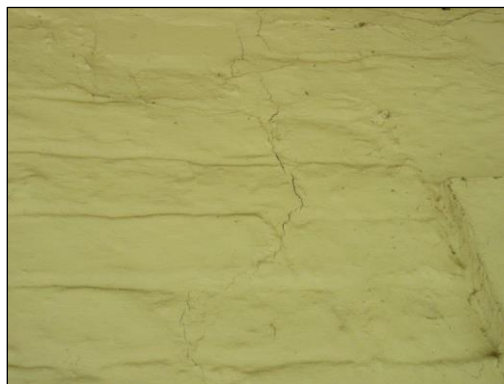
There is extensive cracking to the rendered elevations of the property, the render had blown and lost its key, it is beyond economic patch repair. All render will require hacking off and replacing.

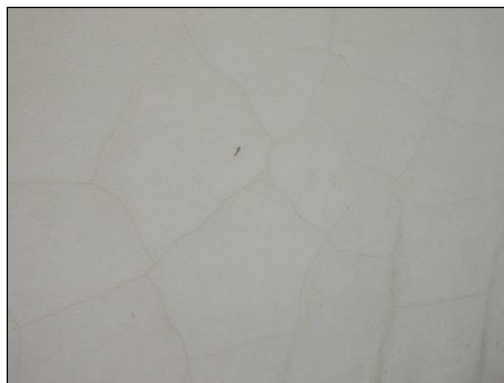
This is prevalent both the front and side elevations, the 19<sup>th</sup> century bricks used in construction will have been porous by today's standards leading to penetrating damp.

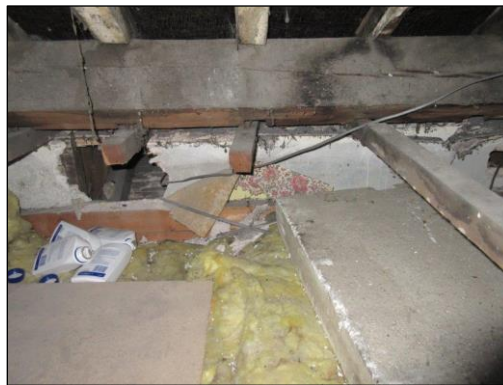
Rot has affected many of the roof timbers, some of the rafters have been replaced however there are several that have suffered from wet rot and there structural integrity will have been affected.

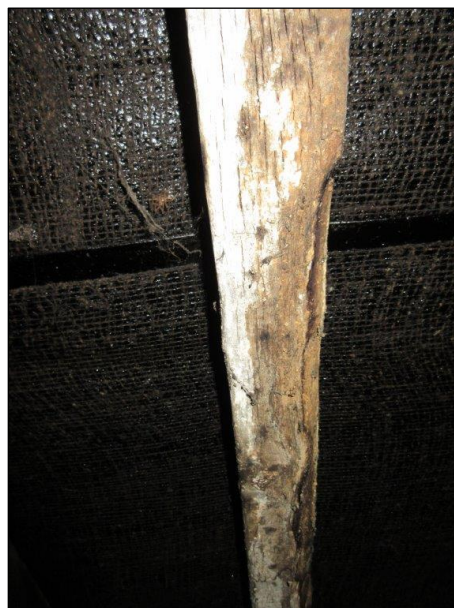
Similarly the ridge board has suffered with wet rot due to roof leaks.

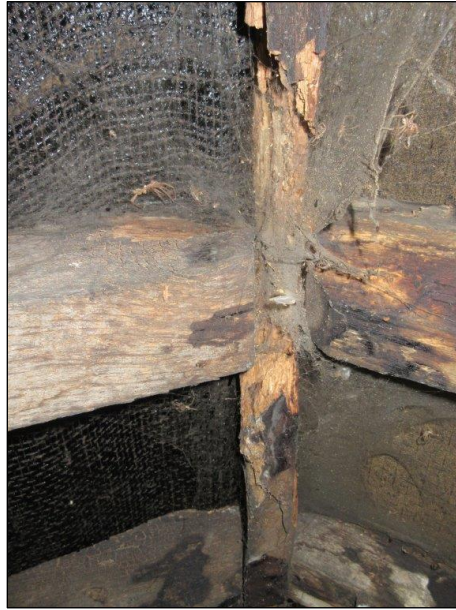
There is an infestation of wood boring beetle to the accessible roof space. Due to the give in the floorboards it is suspected that wood boring beetle is present and has damaged the boards although all floors were covered at the time of inspection.

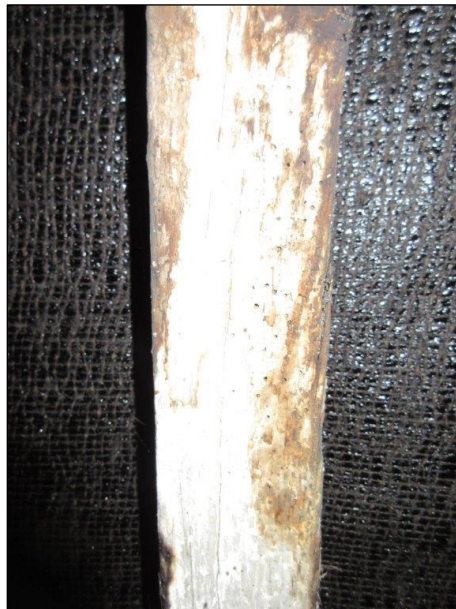
Timbers within the roof space which provides access to the roof are also suffering from wet rot.

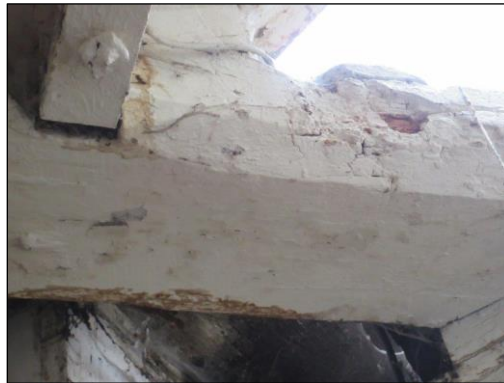
It appears the garage ceiling is constructed with asbestos sheeting. It is highly likely due to the age of the property that the presence of asbestos will be found elsewhere. It was not within the remit of this report to report or otherwise the presence of asbestos.

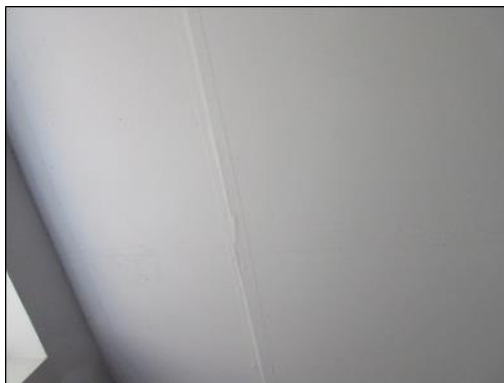
A section of the original lath and plaster ceiling has collapsed at first floor level, it is assumed this has been caused by a passed leak from the roof.

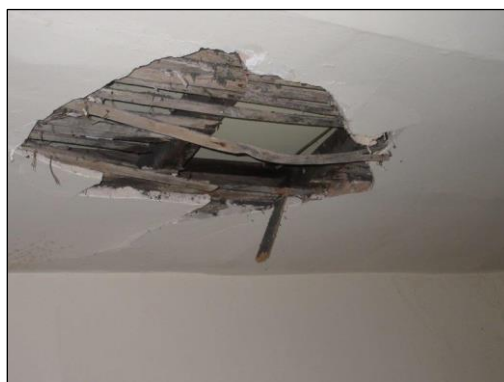
Damp is evident to first floor ceilings and walls where flashings have failed.

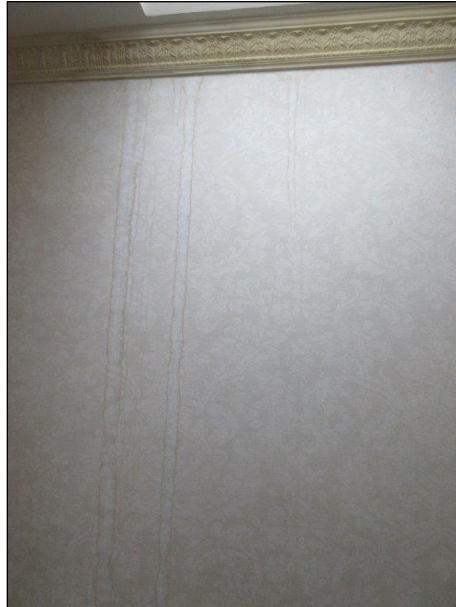
Additionally there are internal leaks from the valley gutter as previously mentioned, which will have affected the integrity of the structure.

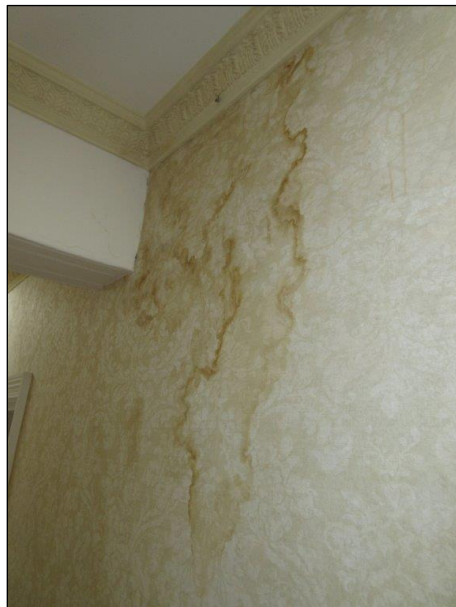
Even at ground level water ingress from the roof structure has badly affected decorations and plasterwork.

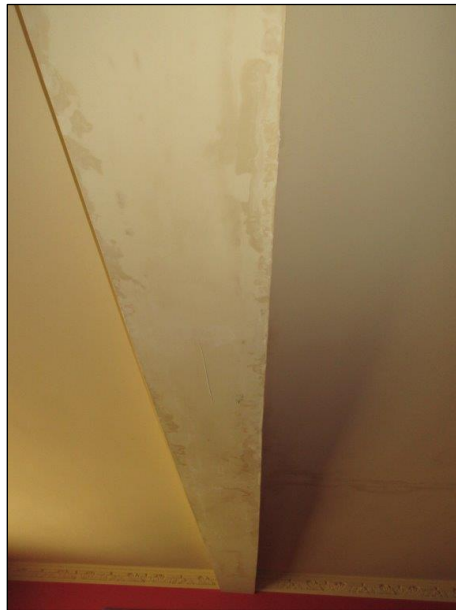
Mould can be seen on the surfaces of the plasterwork of boxed in beams which would suggest the structural elements have been affected by rot due to the ingress of water. This will be very disruptive to repair and potentially extremely costly.

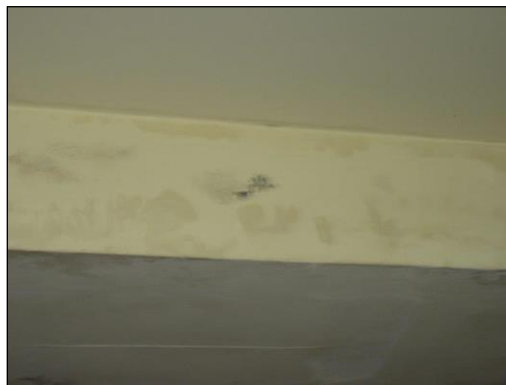
The ingress of water from either penetrating or rising damp and or roof and flashing leaks have affected virtually every room to the property.

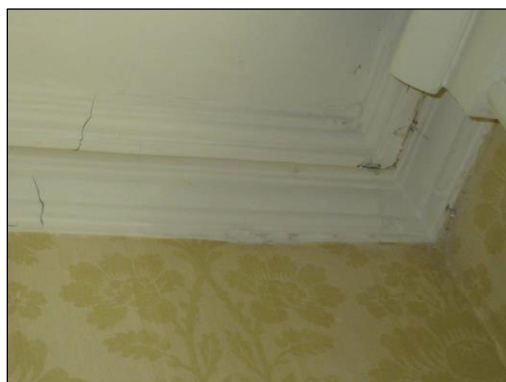
There are areas where plasterwork requires complete replacement, there is visible internal cracking from the structural movement.

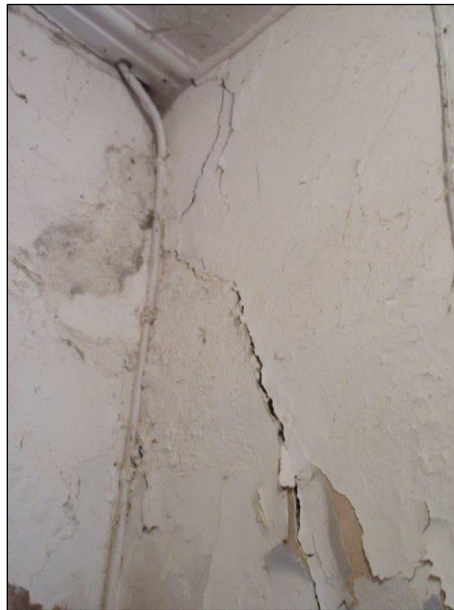
Penetrating damp is also present at ground floor level where water has breached the masonry via the cracking to the external render.

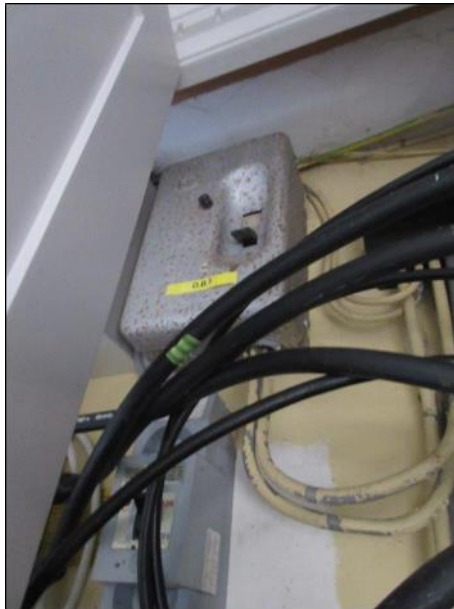
Fittings are dated and require replacement.

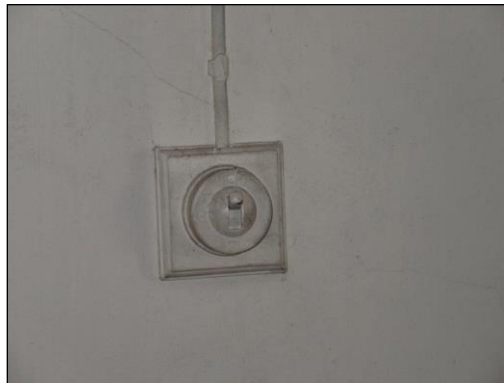
A light fitting to the ground floor has blown, this has likely been caused by the penetrating dampness within the wall affecting the wiring loops. This is a serious danger.
