CM/JMM/Y19201

28<sup>th</sup> October 2019

**Re: Bursham Hall, Garage Conversion to Dining Facility – Stage 2 Structural Report.**

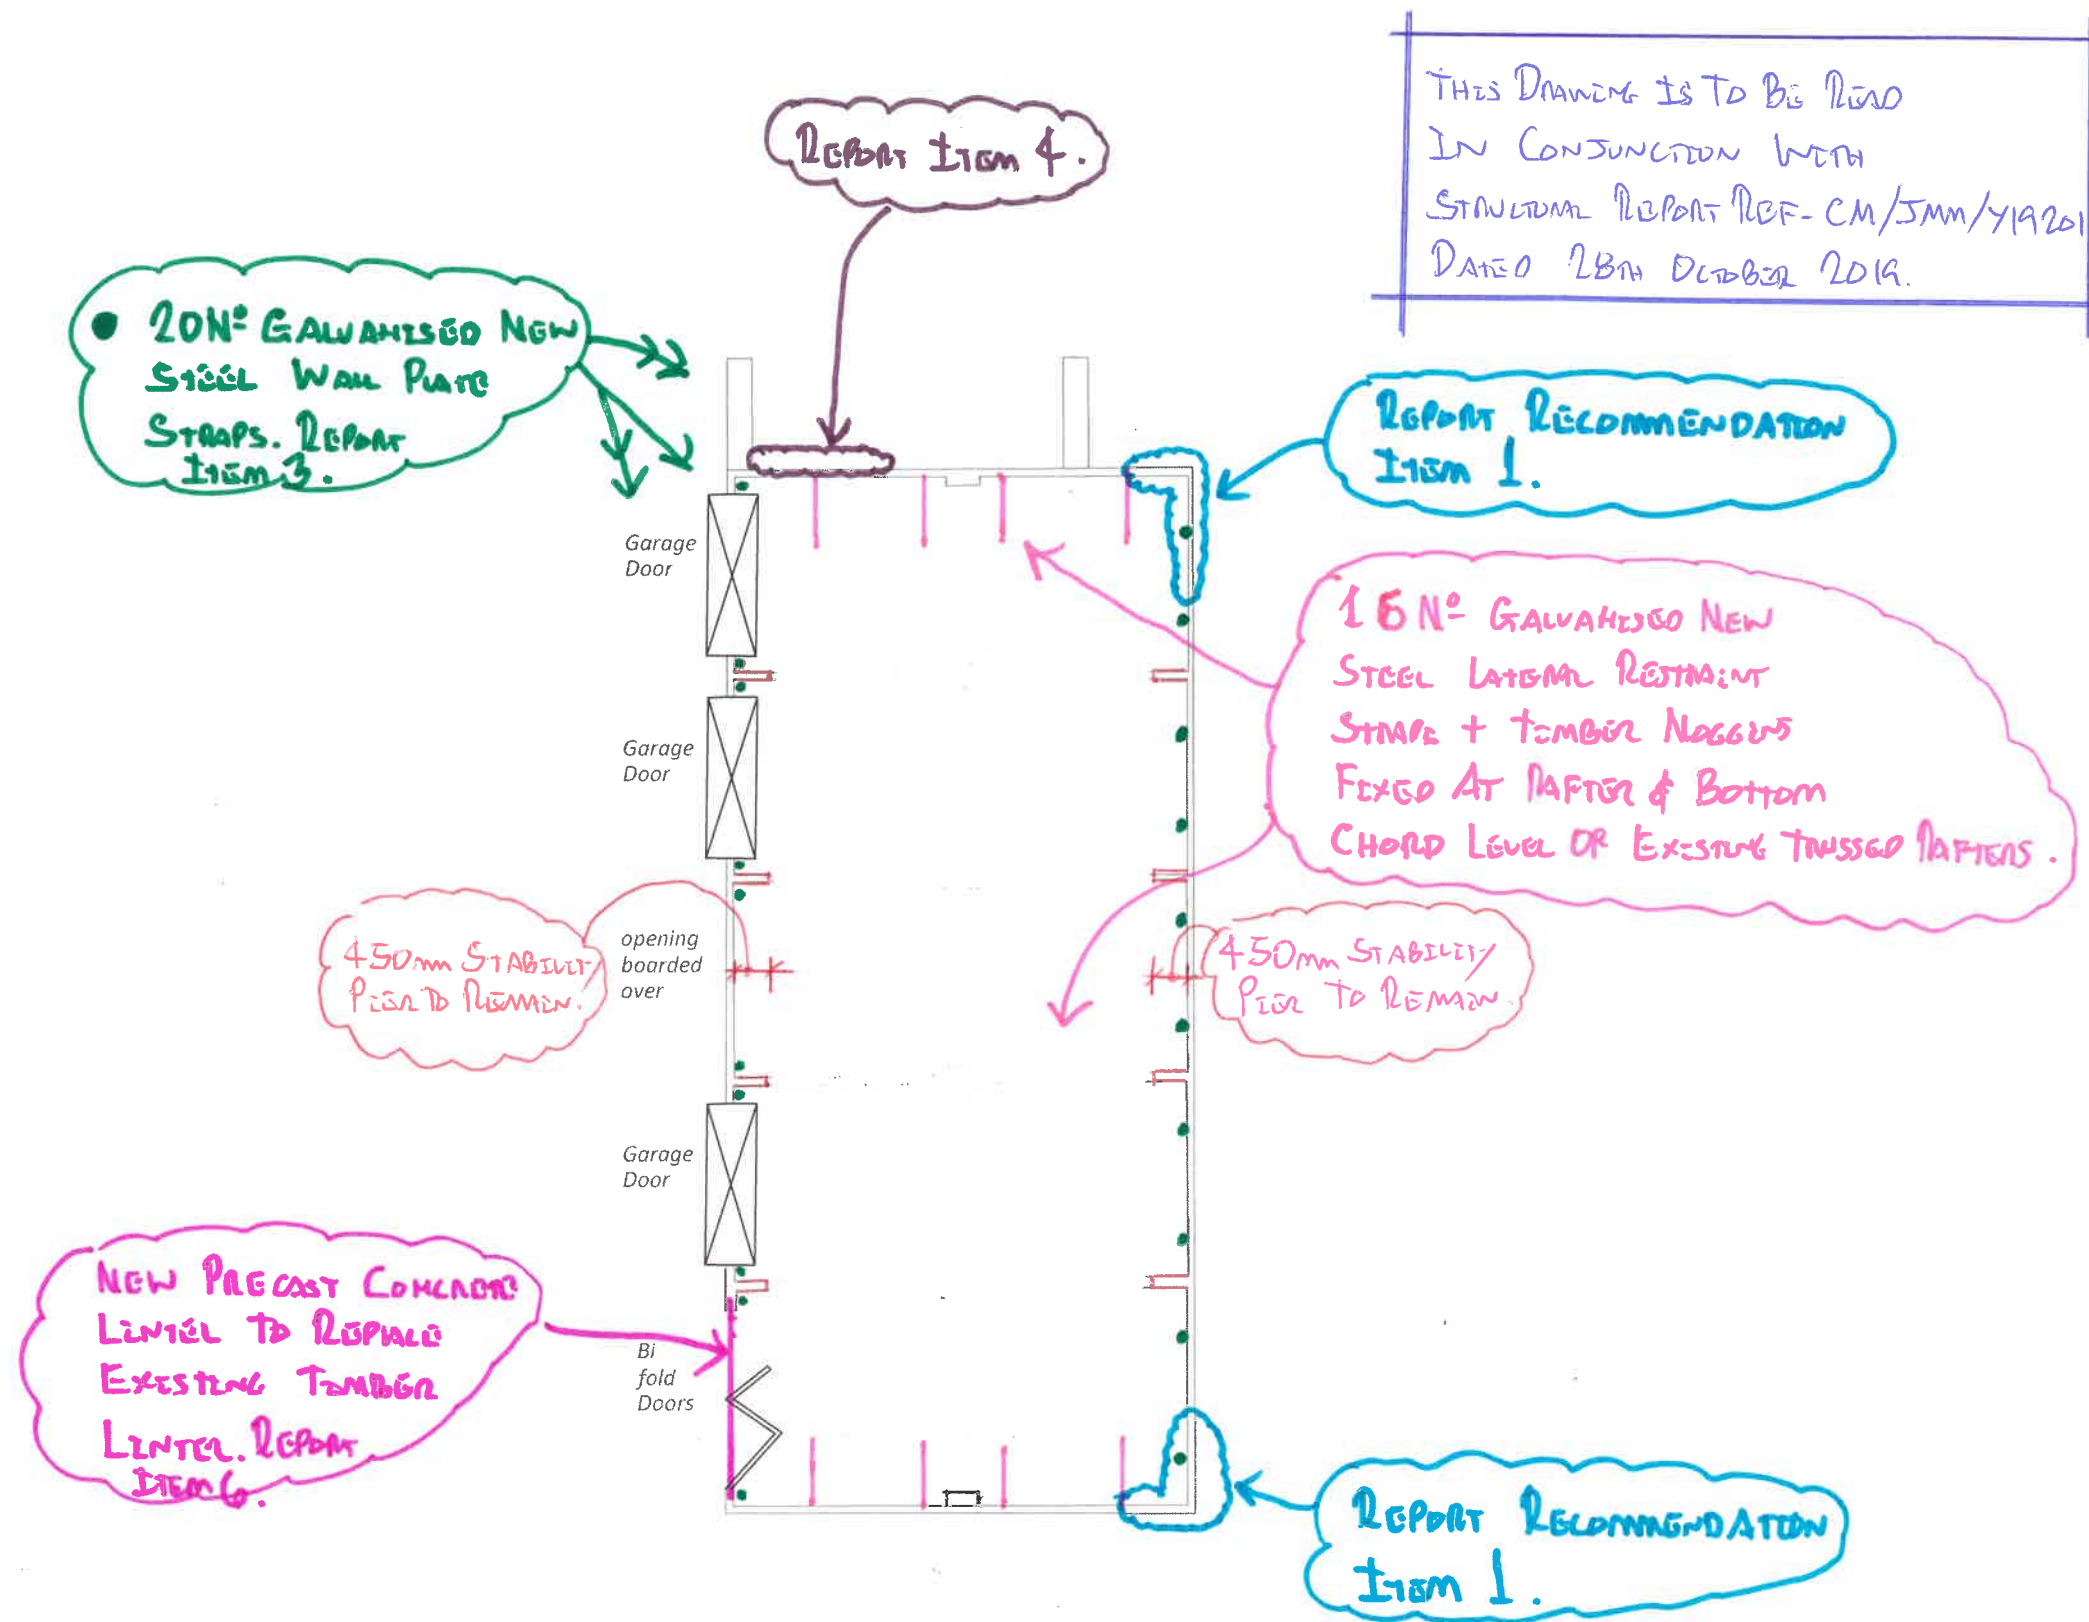
PREPARED BY - CHAS MARWARD  
F.G. MARWARD ASSOC LTD.  
DRAWING N° SK1.  
DATE - 29/10/19.

The internal inspection revealed signs of low level distortion and water ingress through the rear wall within the extreme left hand garage. The facing brickwork had clearly moved laterally at this location by a significant amount as a result of the root pressure from an external mature tree which was located within a few hundred millimetres from the rear corner of the building.

The existing timber wall plate to the front and rear elevation had not been adequately strapped down and was at risk of wind uplift.

The timber lintel to the folding sliding door to the extreme right hand garage was not considered to be structurally adequate to support the loading from the timber trussed rafters.

There were a number of mature trees located very close to the rear elevation. These trees were considered to be within influencing distance of the garage structure. There were signs of brickwork cracks within both rear corners of the external walls to the garage building which we consider are as a result of tree influence.

Inspection along the left hand gable wall revealed signs of salt attack to the facing bricks and mortar joints at low level. We suspect that road de-icing salts have been stored and stacked against this wall in the past, resulting in perished and re-cressed mortar joints along with minor damage to the brick faces.

STRUCTURAL COMMENTS / RECOMMENDATIONS  
FOLLOWING SITE SURVEY ON 16/10/19.

1. Carry out localised rebuilding works to the cracked and laterally distorted facing brickwork to the rear elevation and rear corner locations.
2. Arrange for removal of all mature trees adjacent to the rear elevation.

3. Install galvanised steel wall plate straps to the front and rear elevations.
4. Undertake repointing works and brick repairs to the left hand side elevation at low level where salt damage has occurred.

5. Reduce the external ground levels to the rear and side elevations to prevent ground water seepage through the external walls.
6. Replace the existing timber lintel to the extreme right hand garage door opening with a precast concrete lintel.

7. Replace, clear defective/blocked gutters.
8. Unblock existing surface water gullies at downspout locations.
9. Re-route rear downspouts to discharge in to existing front gullies.

10. Undertake repairs to all holes within the existing pitched roof.
