## AGENT'S HOUSE, BRYMBO

# PRELIMINARY BAT ROOST ASSESSMENT AND EMERGENCE SURVEY

Report Ref EE.672.LB

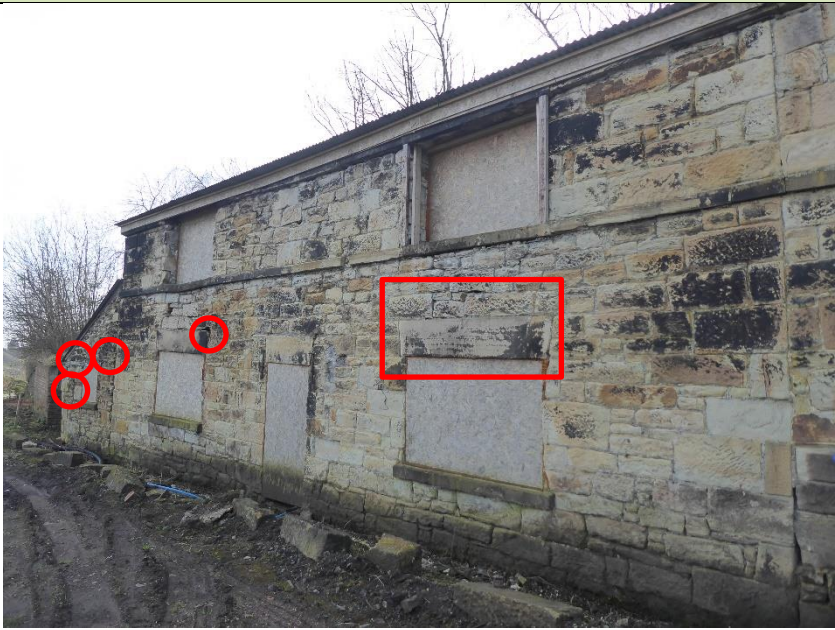
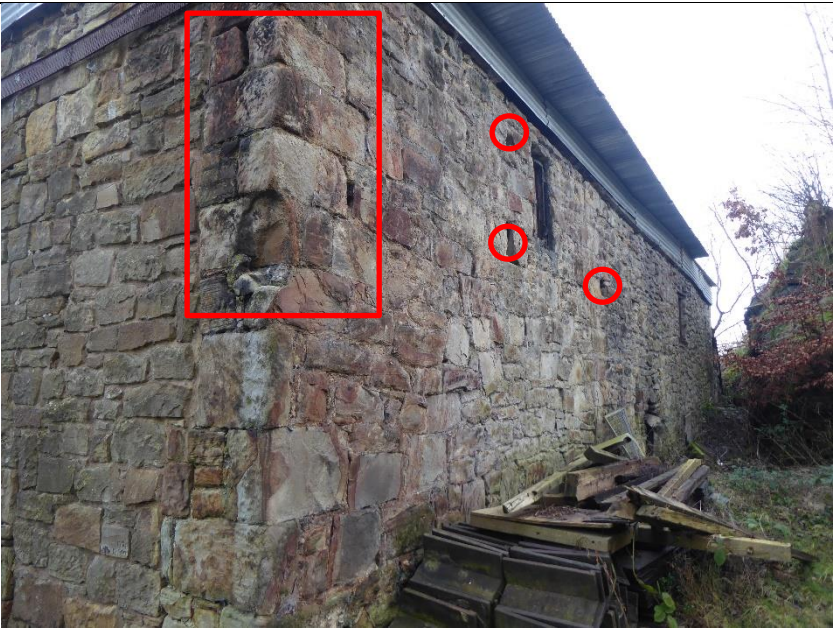
- 5.1.1 There were a number of deep cracks and crevices in the stone work, some of which were likely to have spanned the thickness of the wall and provided access into the cavity, but due to their position and/or height they could not all be inspected with an endoscope. There were large gaps underneath the corrugated metal fascias and above the boarding covering two of the windows.

| Description of Potential Roosting Features | Photo |
|---|---|
| Cracks and crevices in stonework | |

- 7.3 Deep cracks and crevices within the stone work provide some potential for roosting bats, particularly on the southern side of the building, which faced the woodland. The cavity between the stone walls and the chipboard would provide suitable roosting space for crevice dwelling bats. It is possible for bats to access this cavity between the external wall and internal chipboard walls from a small hole in the door, and it may also be possible for bats to access the cavity from under the fascias and crevices in the walls; however, it was not possible to confirm this during the PRA. Any spaces present under the corrugated metal roof and fascias are unlikely to be used by bats due to being subject to extreme temperature changes.

- 8.5 *Enhancements*
- Some crevices in the stonework should be retained, or created where possible, for crevice dwelling bats. Crevices will only be left where the natural crevice continues to a minimum depth of 10cm. The crevices should be 18-25mm x 50mm in size and this can be created by inserting a piece of timber of this size into the gap, tilting downwards for drainage. After pointing, the timber can then be removed creating roosting points. Crevices which provide roosting potential will be checked with an endoscope prior to sealing, or following an emergence/re-entry survey immediately prior to works.

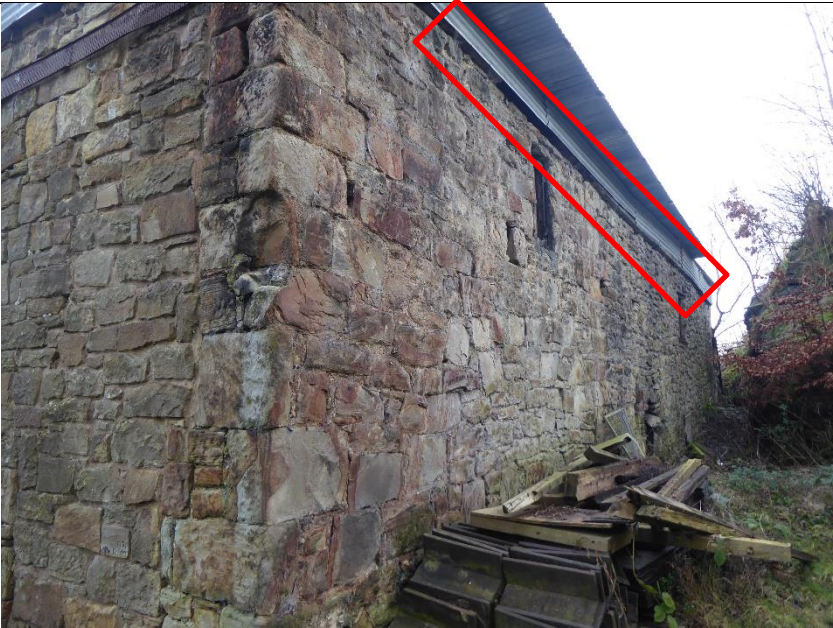
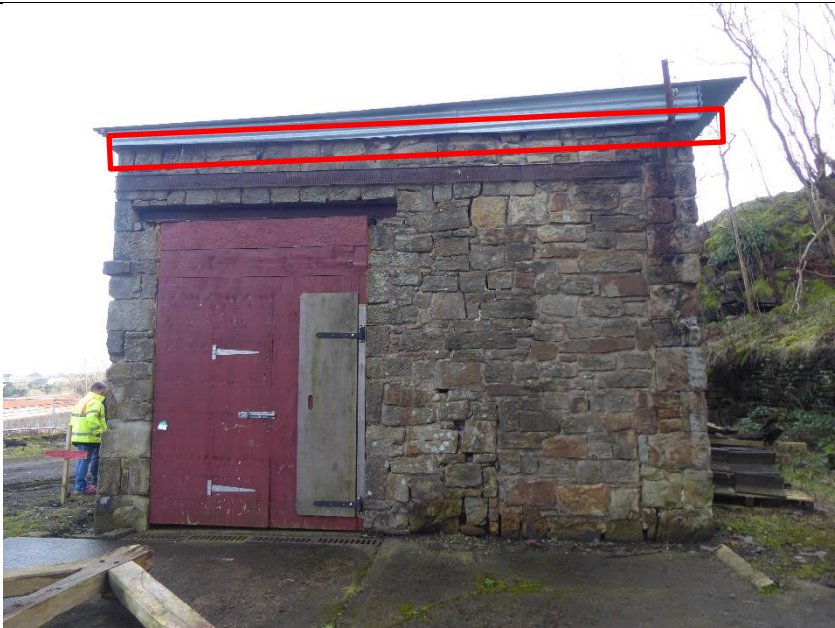
| Gaps under corrugated metal fascia | |

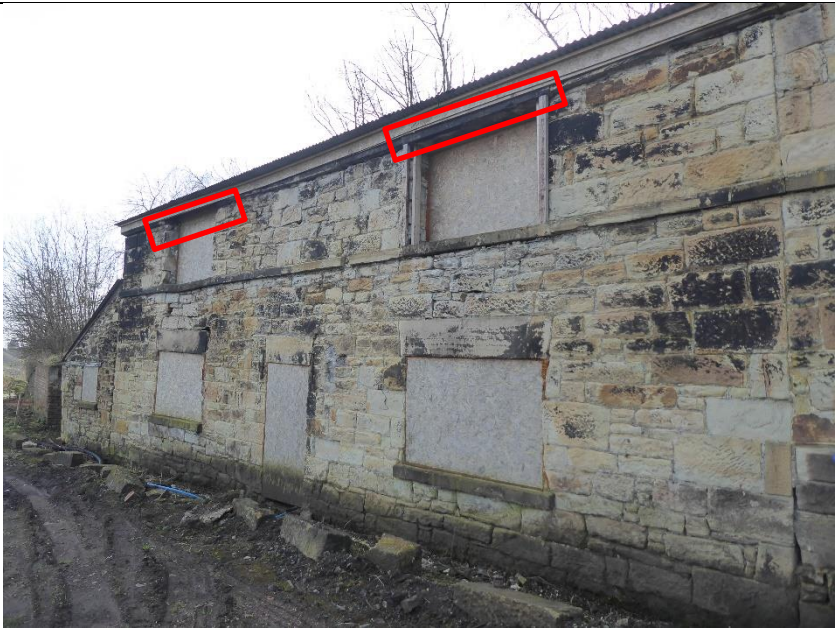
| Gaps above boarded windows | |

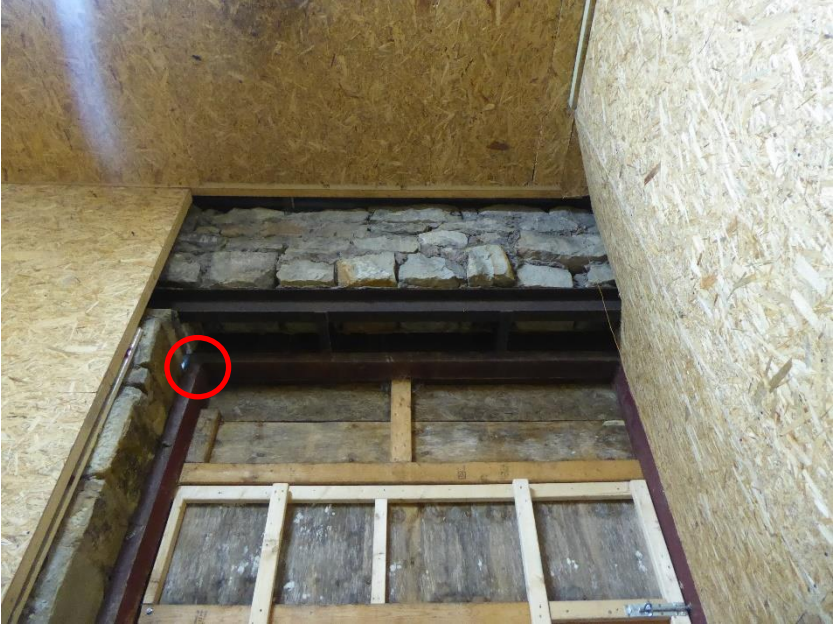
5.2.1 Internally the chipboard was well sealed, apart from the large doorway, which had a small gap at the top. From this doorway, the gap between the external wall and the chipboard was visible.

| <p>Gap above door</p> | |

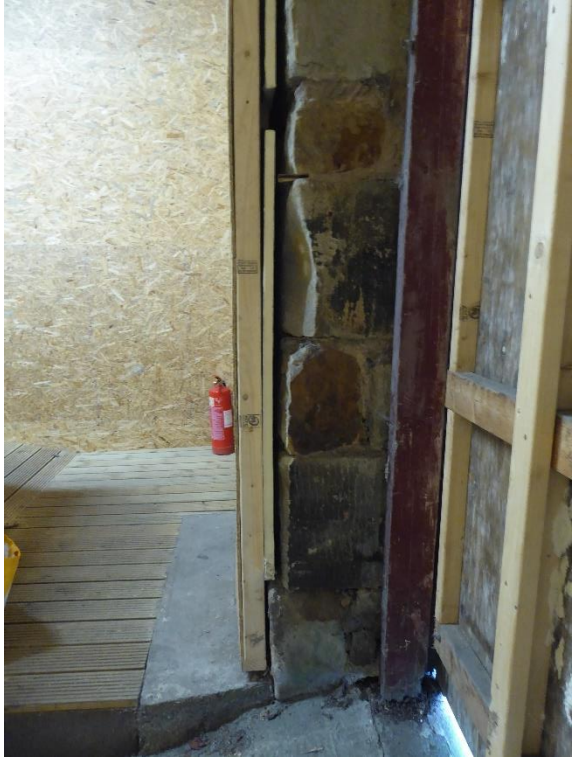
5.2.3 No signs of nesting birds were found within the building but during the survey there was, what sounded like, a bird that had become trapped in the cavity between the wall and the chipboard.

| <p>Cavity between the external wall and internal chipboard</p> | |

- 7.6 No signs of previous bird nests were seen during the survey; however there was a bird heard within the cavity between the walls and the chipboard during the survey so they are able to access this space, and there is potential for nesting birds within the crevices in the stone work and behind the fascias. Blue tits were also observed nesting in an external cavity.

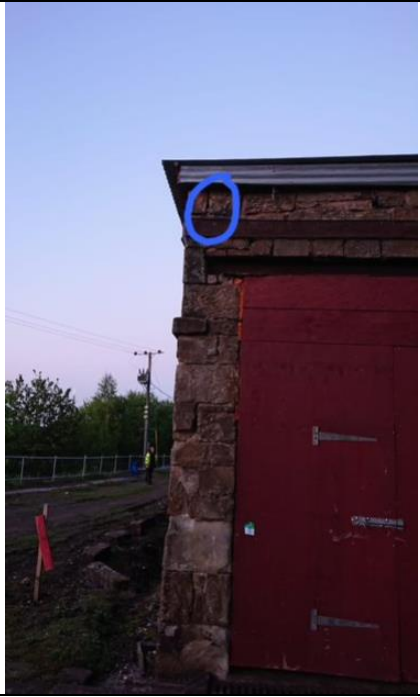
| Time | Species | Emergence (Y/N) | Comments | |
|---|---|---|---|---|
| 21:09 | Common pipistrelle | Y | Emerged from the north west corner of the building | |

- 7.5 The emergence survey confirmed that the building is being used by at least one common pipistrelle, however the bat emerged from an external crevice, as this can be retained, reasonable avoidance measures could be put in place rather than a licence required for this proposed work. Other crevices will also be identified, which can be retained for bats, and birds were possible.

- 8.1 From the results of the emergence survey, it can be determined that the Agents house is currently being used by one individual pipistrelle. This was observed emerging from an external crevice, which can be retained as part of the works.
