Conversion of Outbuilding,  
Beech Cottage, Gegin Lane,  
Minera, Wrexham

Structural Appraisal Report

July 2020

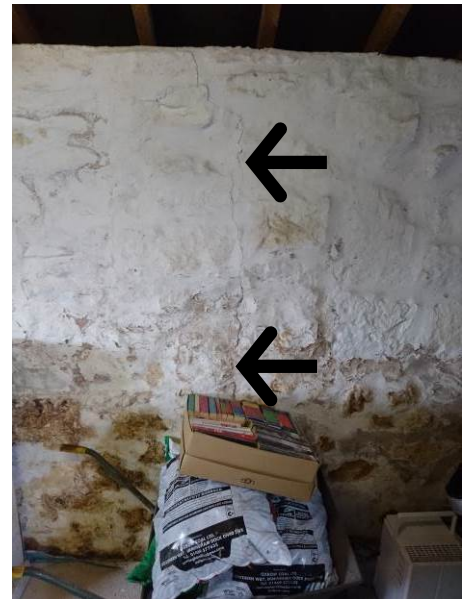
Peeling finishes were noted extending up the walls from floor level by up 1.0m. Coincident damp staining would be indicative of rising damp and damp penetration through walls supporting elevated ground levels. This type of defect is not untypical in rubble masonry walls. No staining was evident to the concrete floor which would indicate that the damp penetration is minor.

A vertical crack was noted extending for full height within the left hand side elevation. The crack was noted as up to 2mm wide and is coincident with cracking noted externally. The cracking would appear to be indicative of an infilled historic opening in the wall.

Damp staining at low level. Vertical crack to left hand side elevation.

- Insert a three stainless steel reinforcing bars at 450mm vertical centres across internal cracking to left hand side elevation. Bars should be installed within a 40mm deep saw cut at least 1.0m long. For details of materials and installation refer to attached Helifix data sheet.

- Install proprietary drainage layer extending full height to all internal faces of external walls to control damp penetration. Layer shall be secured to wall in accordance with manufacturer's recommendations.

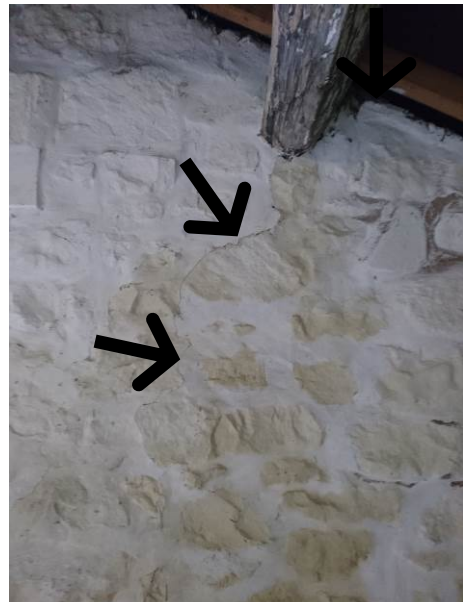
Cracking was noted extending down the front and rear elevations from the canted purlin bearings. The cracking was generally up to 2mm wide and is common in buildings of this age and type. The cracking is attributable to slight historic roof spread and stress concentrations and the inherent local weakness in the wall below the canted purlin.

The cracking is minor and is not indicative of movement of the outbuilding.

Cracking extending down from purlin bearing.

- Insert a single stainless steel reinforcing bar across internal cracking extending down from each purlin bearing. Bar should be installed within a 40mm deep saw cut at least 1.0m long. For details of materials and installation refer to attached Helifix data sheet.

- Repair cracking to external and internal elevations by raking out existing pointing to a minimum depth of 40mm. New pointing shall comprise a 1:1:6 lime:cement:sand mortar packed tight into joints and finished flush with the face of the walls.

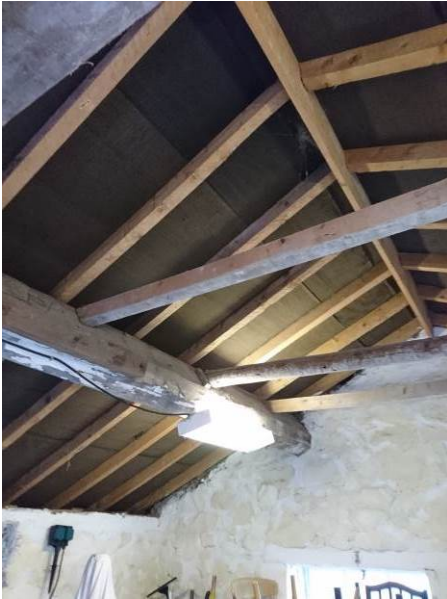
The roof over the outbuilding appears to be in generally good condition with no significant defects apparent. The rafters, slated finishes and felt membrane appear to be relatively recent replacements.

Typical view of roof.

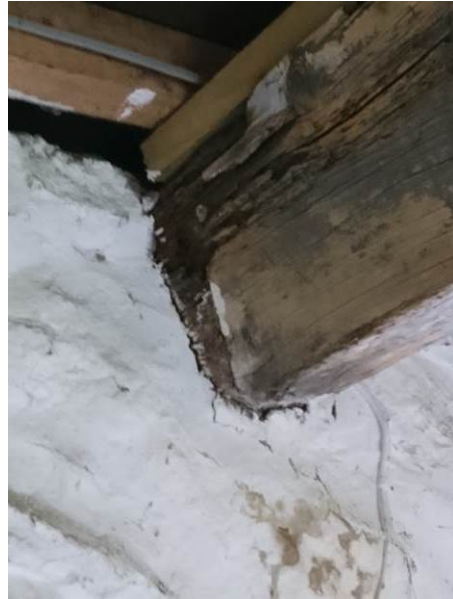
Slight worm infestation was noted to the purlins though no section losses were apparent. Damp penetration and slight rot were apparent at all of the purlin ends. No section losses were apparent and all of the timbers were noted as difficult to probe which would suggest that the defect is longstanding and may have been resolved by repairs to the roof in the recent past.

Slight rot at purlin end.

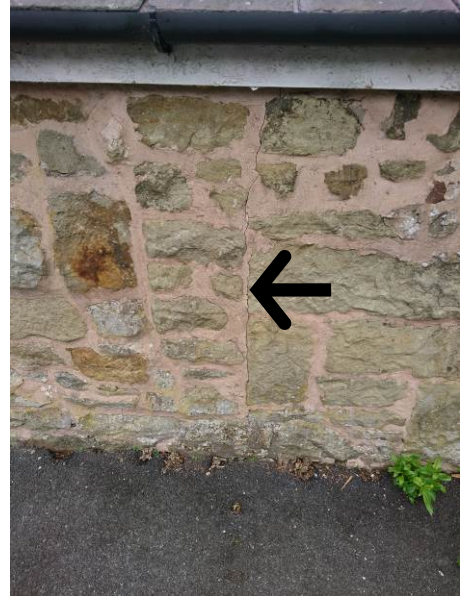
A vertical crack extending for full height was noted in the left hand side elevation. The cracking was noted as up to 2mm wide. The edges of the cracking were noted as slightly weathered suggestive of a fairly longstanding defect. The cracking is coincident with similar cracking noted internally. A change in masonry type across the defect would indicate the location of a historical infilled opening.

Vertical crack to left hand side elevation.

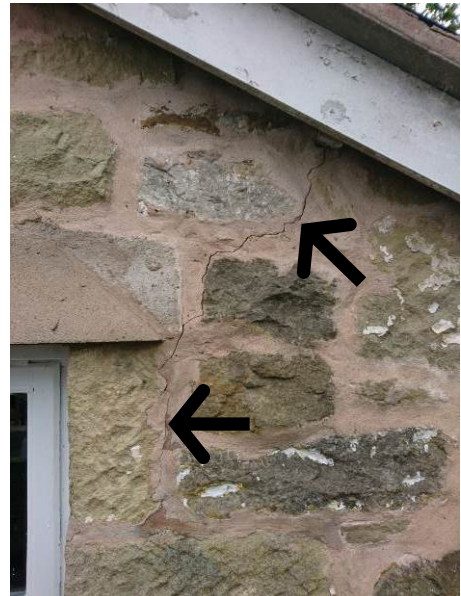
Diagonal cracking was noted to the right of the window opening on the rear elevation. The cracking is coincident with the cracking noted internally below the purlin bearing. The cracking was noted as up to 3mm wide. The edges of the cracking were noted as slightly weathered suggestive of a fairly longstanding defect.

Cracking adjacent to window on rear elevation.

As the defect reflects through the full thickness of the wall, it would be prudent to provide reinforcing bars across the cracking internally.
