Our Ref: 07673

**4 – 6 Regent Street, Wrexham**  
**Structural Inspection of Masonry Cracking**

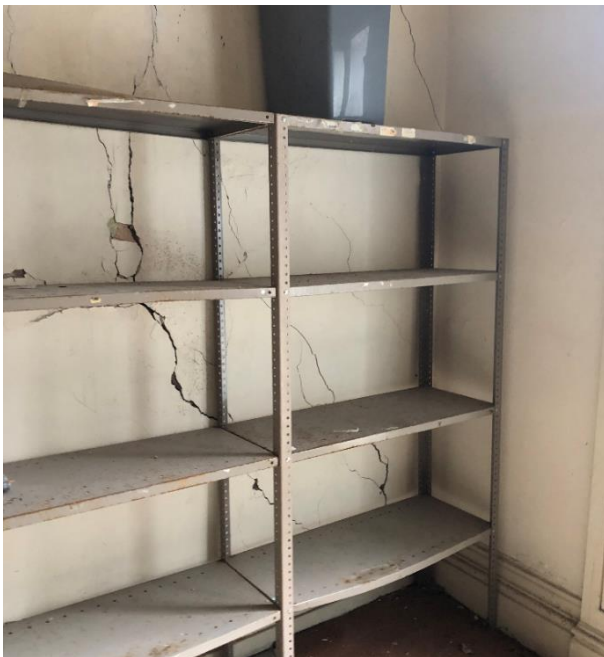
An inspection of the internal return walls at 1<sup>st</sup> and 2<sup>nd</sup> floors identified significant stepped cracking adjacent to the front elevation. The central chimney breast appeared to have settled significantly causing large structural movements and tapered cracking.

Fig 1: Settlement cracks to internal wall adjacent to front elevation

The front wall in its current condition cannot be considered as stable as the lateral restraint previously provided by the internal walls can no longer be relied upon. Remedial works to rectify the cracking will involve large sections of demolition and rebuild and appropriate temporary works will be required to maintain stability during the works. The fact that the settlement has occurred suggests that the support structure at ground floor is overloaded and consideration should be given to reducing the dead weight of masonry above or alternatively strengthening of the support structure and potential underpinning of the foundations. As an alternative, the heavy masonry structure above ground floor level could be demolished and replaced with a lighter weight form of construction however this and any other proposals would need to be discussed and agreed with the planning department and conservation officer.

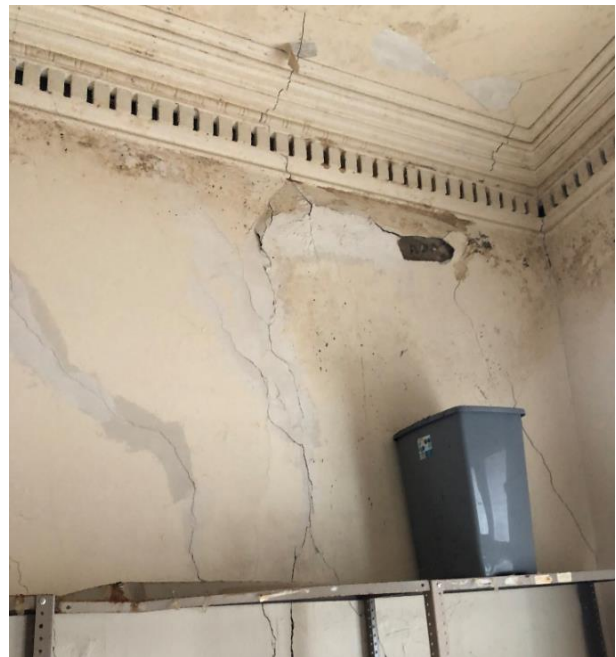
Fig 2: cracking extending full height to ceilings

On the basis of the defects observed during the survey, it appears that the masonry structure above ground floor level has suffered from significant structural movement resulting in severe cracking that extends the full height of the property. The form and location of cracking indicates that significant settlement has occurred and suggests that the steel support structure at ground floor level is overloaded, leading to excessive deflections and/or column and foundation settlement.

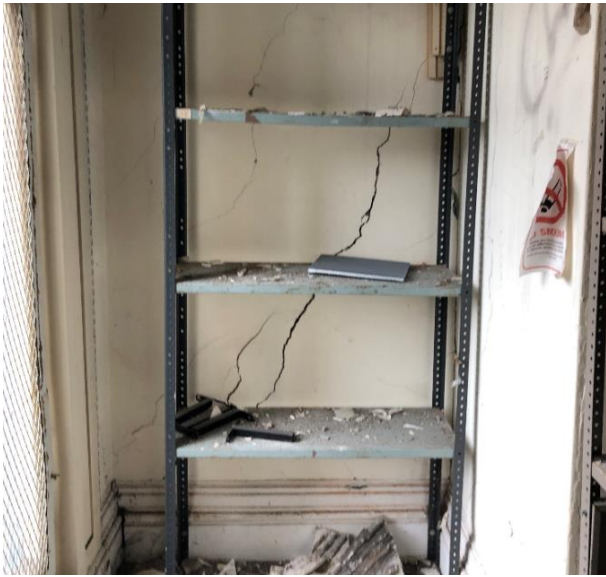
Fig 3: tapered cracking adjacent to front elevation – significant settlement of central portion of masonry leading to severe cracking to return walls

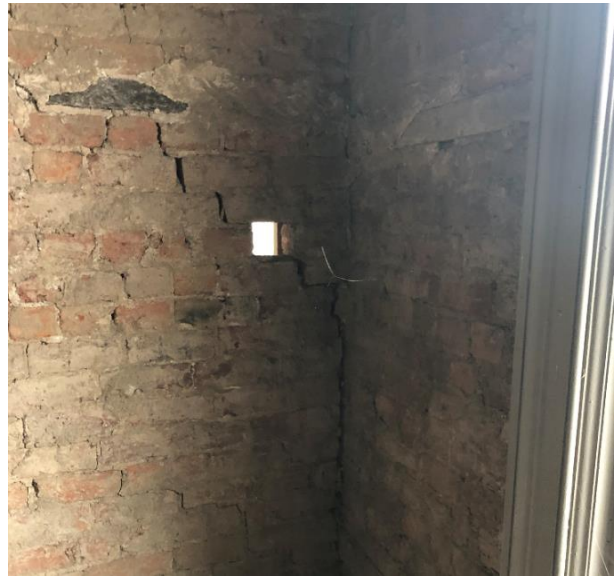
Fig 4: Stepped cracking and vertical crack along interface with front elevation suggesting restraint to front elevation has been severed

The fact that the cracking is located adjacent to the front elevation and in places runs vertically up the joint between the return walls and the front elevation, calls into question the lateral stability of the front wall. The cracks have severed the restraint provided by the internal walls and will no longer be providing full restraint to the front wall.

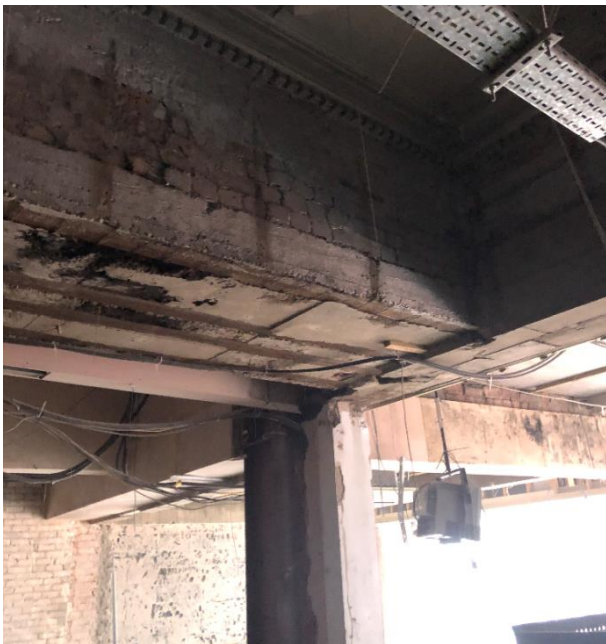
Fig 5: Support structure at ground floor level and significant weight of masonry above.

The support structure at ground floor ceiling level appears to be supporting a very large amount of weight and the fact that the chimney breast masonry has sunk suggests that the support structure is overloaded.

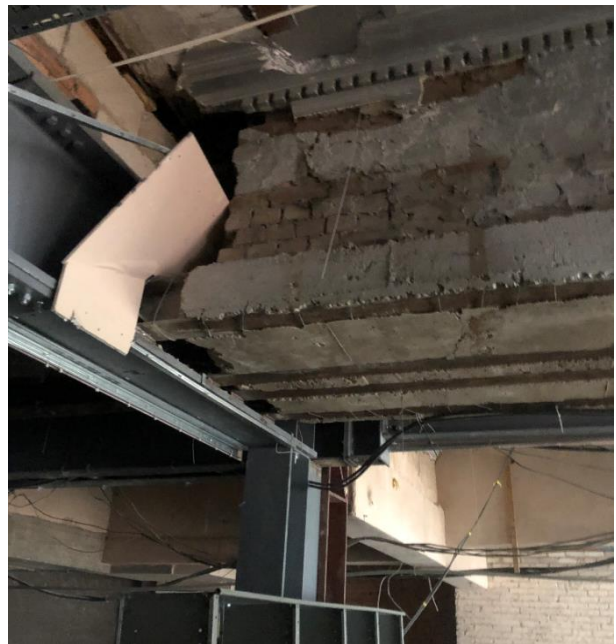
Fig 6: Chimney support at ground floor level and transfer structure to steel beams. Settlement cracking above suggests either excessive deflections in steel support structure and/or settlement of supporting columns
