# Conversion of Outbuilding, Cae Brynner Farm, Bowling Bank, Wrexham

## Structural Appraisal Report

September 2020

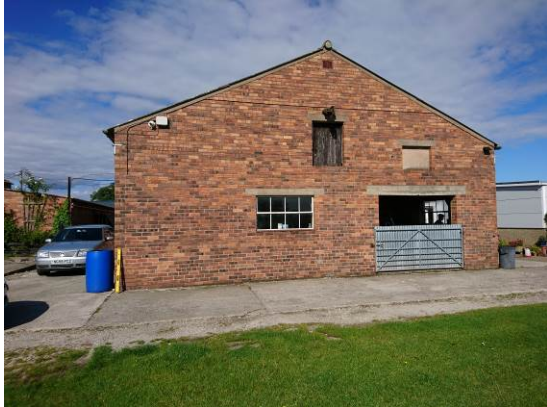
Photo 1 – Front Elevation.

The elevation comprises brickwork to full height with several window and door openings apparent with concrete lintels over (see Photo 1).

The overall condition of the elevation is considered to be fair.

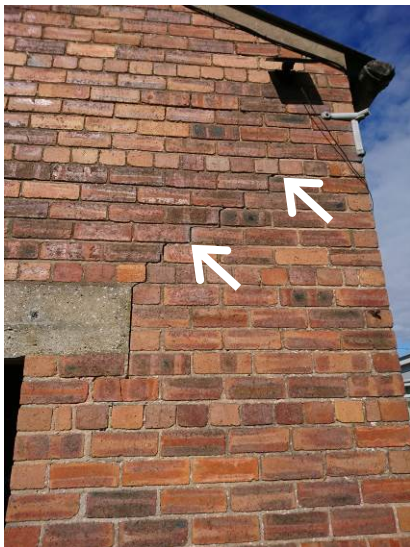
Cracking was apparent to the elevation in several locations. Diagonal bed joint cracking up to 5mm wide was noted extending from the ground floor door opening towards the right hand side elevation (see Photo 2). Cracking up to 2mm was noted extending down from both ends of the door lintel (see Photo 3). Hairline cracking was noted extending to roof level from the left hand side of the first floor door opening. A gap up to 5mm wide was noted to the left hand side of the ground floor window opening. The pattern of cracking is consistent with settlement at both ends of the elevation. The edges of the cracks were weathered which would indicate that the settlement is historic.

Photo 2 – Cracking to right of door opening.

- Replace existing lintels with new precast concrete units as required.
- Repair cracking to external walls by providing bed joint reinforcement (e.g. Helifix system) at four-course vertical centres. All works shall be carried out in strict accordance with the manufacturer's recommendations.

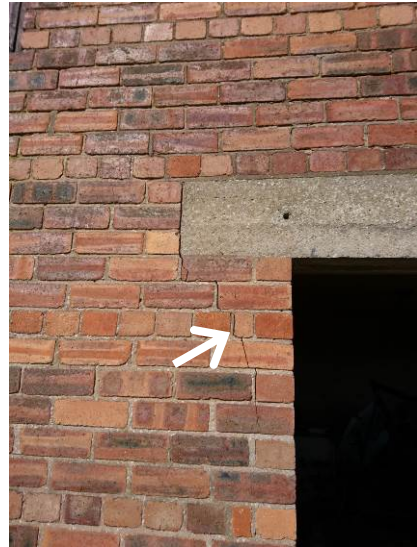
Photo 3 – Cracking below lintel.

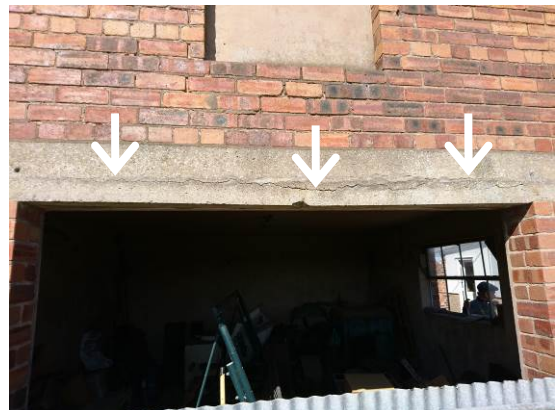
Deterioration is apparent to the concrete lintel over the ground floor door opening. A crack up to 5mm wide is apparent to the full length of the unit with a distinct sag along the soffit noted (see Photo 4). This type of defect is typically attributable to corrosion of embedded reinforcement which is common in buildings of this age.

Photo 4 – Cracking to concrete lintel.

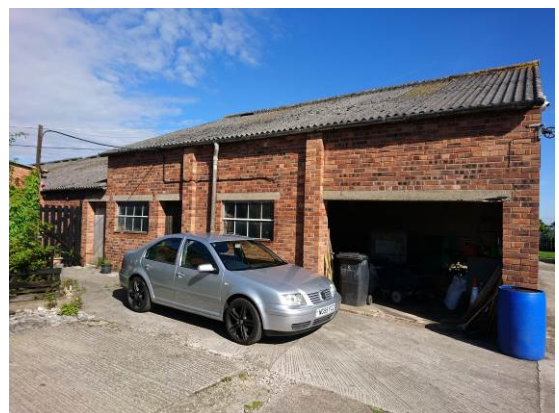
Photo 5 – Left Hand Side Elevation.

The elevation comprises brickwork to full height with several window and door openings apparent with concrete lintels over (see Photo 5). The roof over comprises asbestos cement sheeting.

The overall condition of the elevation is considered to be fair.

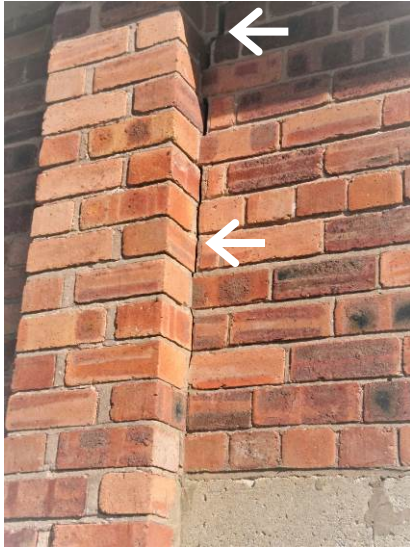
Cracking was apparent to the elevation in several locations. Vertical cracking was noted extending from the left hand end of the larger door lintel to eaves level (see Photo 6). The cracking was noted as up to 15mm wide at eaves level. The pattern of cracking is indicative of a significant settlement at the front elevation. Hairline cracking was noted extending up from the central window opening. The edges of the cracks were weathered which would indicate that the settlement is historic.

Photo 6 – Cracking extending from door opening.

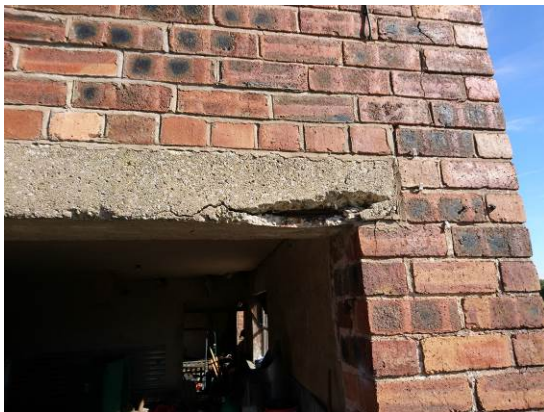
Deterioration is apparent to the concrete lintel over the large door opening. A large spall is apparent at the right hand bearing exposing severely corroded reinforcement within (see Photo 7). Minor spalling was also apparent along the soffit of this lintel and to the lintel over the smaller door opening.

Photo 7 – Spall to concrete lintel.

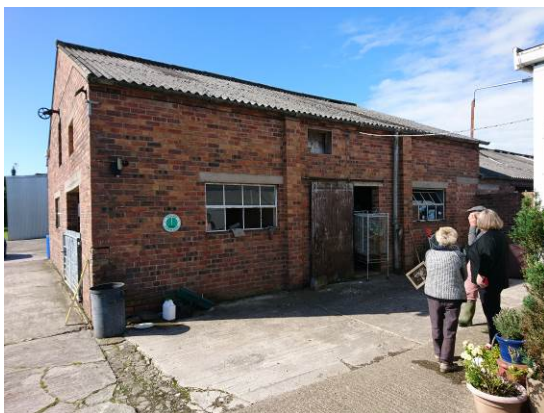
Photo 8 – Right Hand Side Elevation.

The elevation comprises brickwork to full height with several window and door openings apparent with concrete lintels over (see Photo 8). The roof over comprises asbestos cement sheeting.

The overall condition of the elevation is considered to be fair.

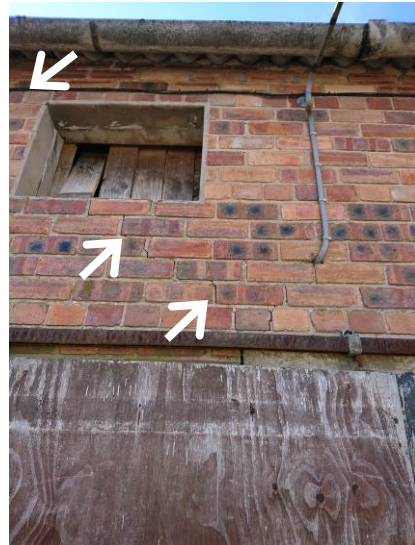
Cracking was apparent to the elevation in several locations. Diagonal bed joint cracking was noted extending from the left hand side of the door opening (see Photo 9). The cracking extends through the small opening above to eaves level. The cracking was noted as up to 4mm wide. Hairline cracking was noted at eaves level adjacent to the front elevation and would appear to be a continuation of the cracking noted to the front elevation. Horizontal cracking 1mm wide was apparent above the lintel over the left hand window opening. Hairline bed joint cracking was apparent extending from the right hand window opening towards an infilled door opening. The pattern of cracking is indicative of a settlement at the front elevation. The edges of the cracks were weathered which would indicate that the settlement is historic. A small area of loose brickwork was noted at the junction with the front elevation.

Photos 9 – Cracking above door opening.

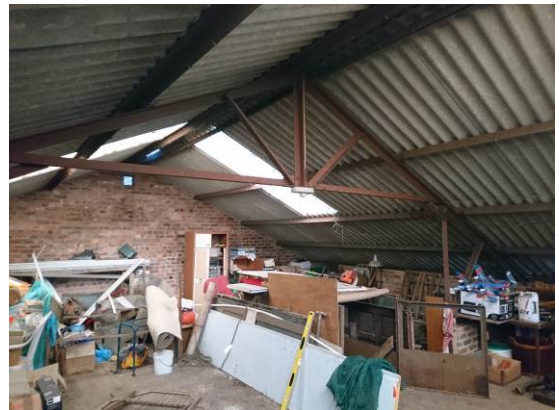
Photo 10 – View of Barn First Floor.

Barn First Floor occupies the entire first floor area. The room comprises bare brick external walls supporting a steel angle purlin and truss roof over. The floor comprises boarded finishes over timber joists (see Photo 10).

The overall condition of the room is considered to be fair.

- Remove existing roof construction and replace as necessary.
- Remove existing boarded finishes at first floor level. Obtain specialist inspection of timber joists and carry out treatments as required. Provide new floor decking glued and screwed to existing joists.

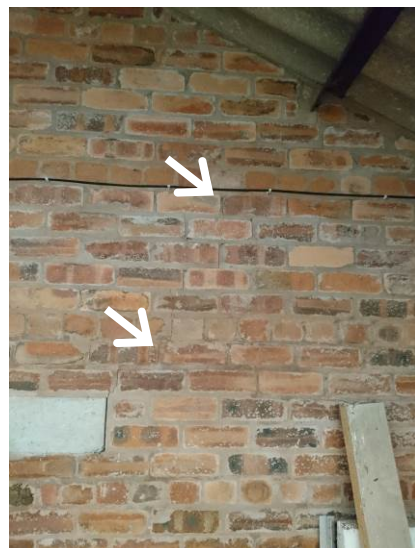
Cracking was apparent to the external walls in several locations. Diagonal bed joint cracking was apparent extending from the central opening on the front elevation towards the purlin (see Photo 11). The cracking was noted as up to 0.5mm wide. Cracking up to 18mm wide was apparent in the left hand side elevation near to the front elevation and extending to wall plate level (see Photo 12). Further cracking up to 3mm wide was apparent in the left hand side elevation towards the rear of the room. Cracking up to 3mm wide was apparent in the right hand side elevation towards the centre of the room (see Photo 13). The pattern of cracking is consistent with an historic settlement along the front elevation.

Photo 11 – Cracking to front elevation.

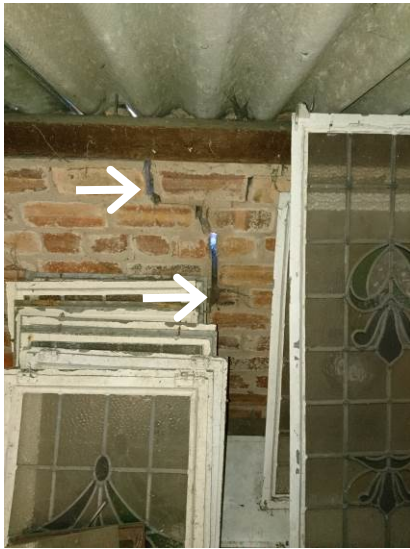
Photo 12 – cracking to left hand side elevation.

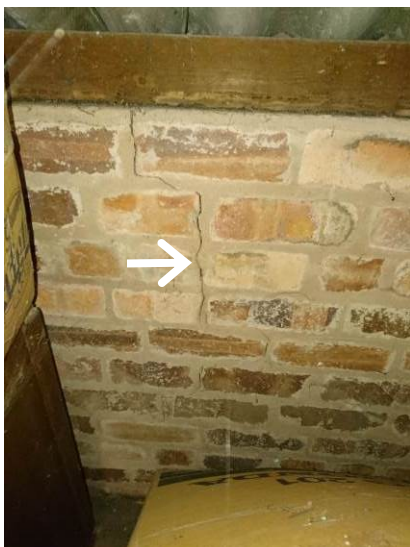
Photo 13 – cracking to right hand side elevation.

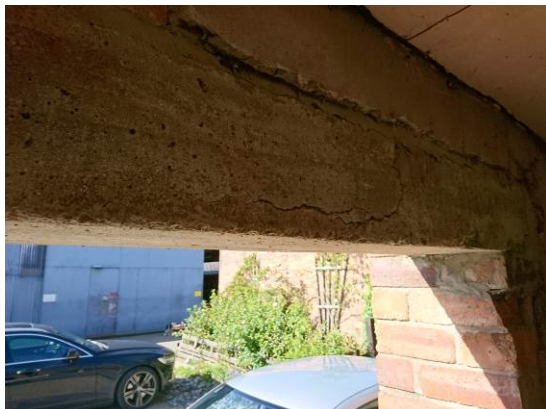
Minor cracking was apparent to rendered wall finishes throughout, probably resulting from long term shrinkage of finishes. The cracking is particularly prevalent around openings. Cracking 3-5mm wide was apparent to the concrete lintel over the door opening (see Photo 14). The cracking has resulted from corrosion of embedded reinforcement which is common in buildings of this age.

Photo 14 – cracking to door lintel.

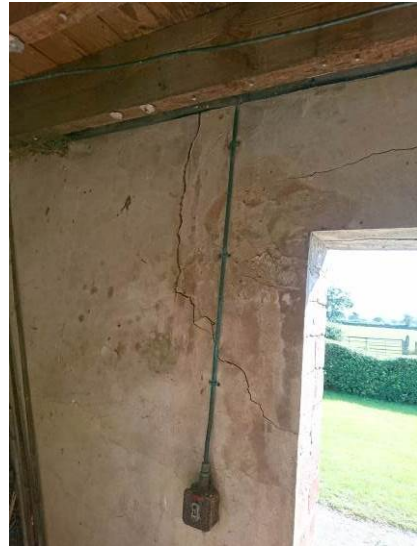
Minor cracking was apparent to rendered wall finishes throughout, probably resulting from long term shrinkage of finishes. Cracking 4-5mm wide was noted to the left of the door opening extending to first floor level (see Photo 15). The concrete lintel to the outer leaf over the door opening shows a significant sag at mid span resulting from corrosion of embedded reinforcement.

Photo 15 – Cracking to side of door opening.

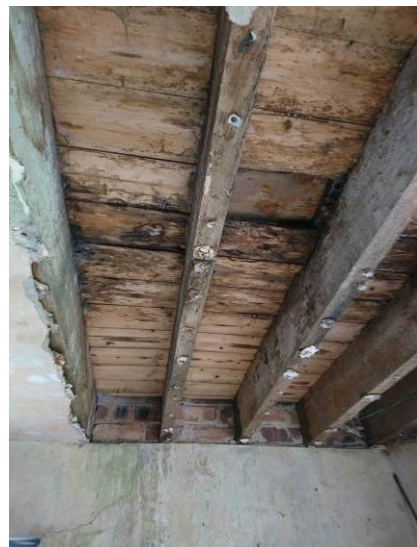
Photo 16 – View of floor over.

The floor over is hidden behind plasterboard finishes except for an area above the door opening on the front elevation which has collapsed. The collapse has resulted from weather penetration from above evidenced by staining to joists and boards locally (see Photo 16). Significant rot to boards was apparent locally. Minor worm infestation was noted though no section losses were apparent. Staining was also apparent to joist ends, though no significant rot was apparent.

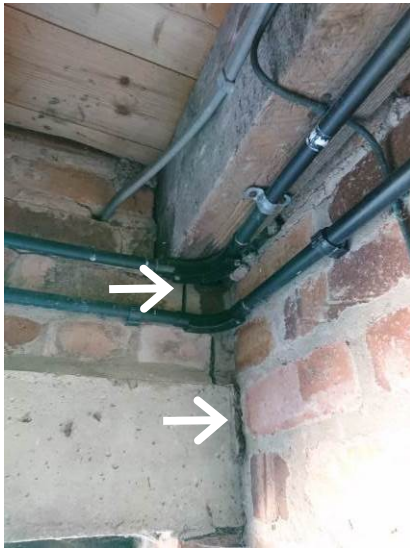
Cracking was apparent to the right hand side elevation. Bed joint cracking up to 6mm wide was noted extending to first floor level from the right hand side of the external door opening (see Photo 17). Cracking up to 1mm wide was noted extending to first floor level from the left of the window lintel. The pattern of cracking is consistent with a settlement at the gable elevation.

Photo 17 – Cracking to side of door opening.

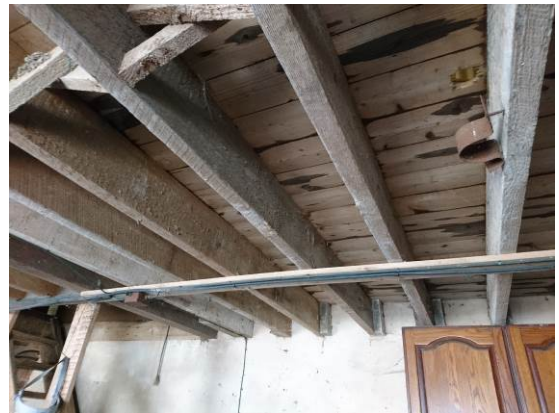
Photo 18 – General view of floor over.

The floor over is constructed from 50mm x 200mm solid joists at 350mm centres with boarded finishes over (see Photo 18). Minor worm infestation was noted though no section losses were apparent. Staining was apparent to isolated areas of the boarded finishes with localised section losses noted. Staining was also noted to several joist ends, though no significant rot was apparent.
