# **PRELIMINARY BAT ROOST ASSESSMENT**

## **ADDENDUM**

### **ALTHREY WOODHOUSE**

**Overton Road, Bangor-on-Dee LL13 0DA**

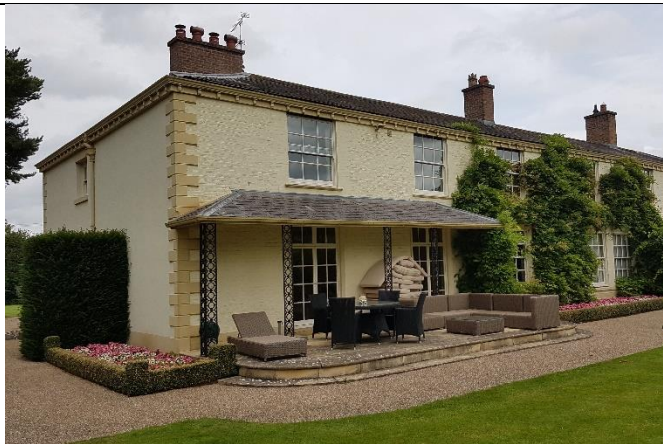
Southern elevation

The southern elevation supports extensive growth of *Wisteria sinensis*.

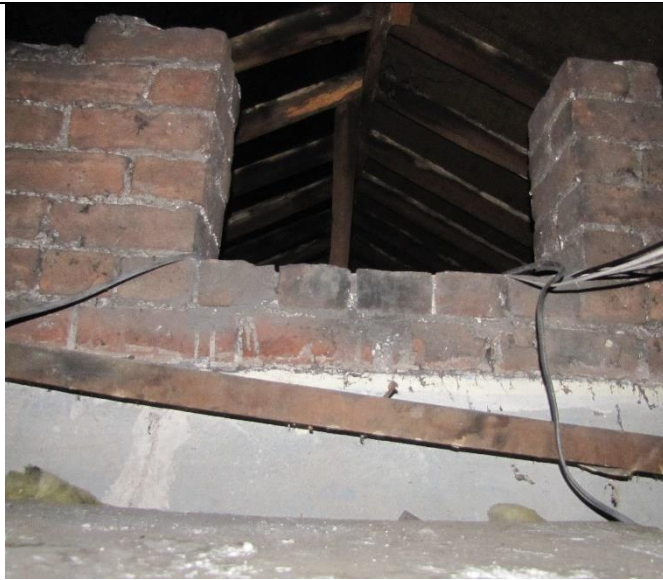
Southern loft

The internal loft spaces were accessed and examined for evidence of bats. All roofs have Type 1 bitumen lining and loft floors are insulated with rock wool. There is no evidence of access points into the loft spaces from the exterior. No bat droppings were observed.

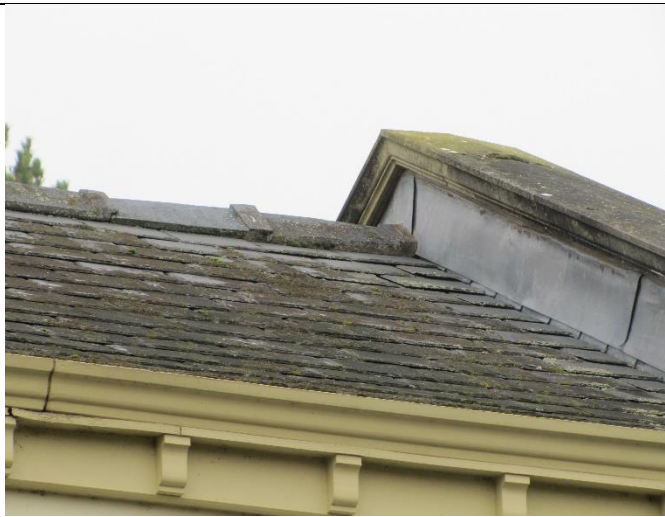
The roof structure is complex with three hipped roofs and a central valley. All roofs are slated and support clay ridge tiles on the main ridge with lead flashing over hipped ridges and around chimney stacks. Close inspection with binoculars of the roof from all elevations demonstrated that all slates, tiles and flashing are well-bedded with no apparent gaps. There are no slipped slates and no raised ridge tiles

Detail showing well-bedded slates and ridge tiles, design of eaves, gutter and parapet

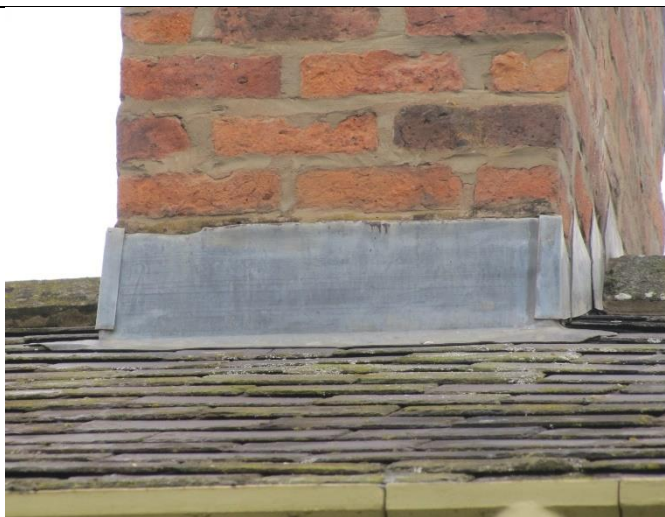
Lead flashing around chimneys

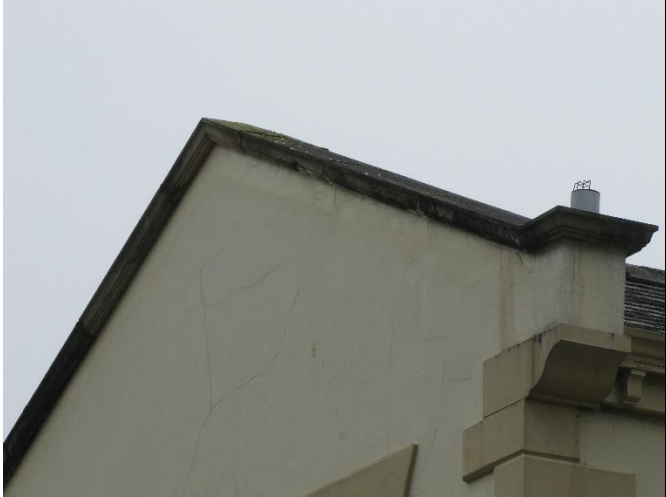
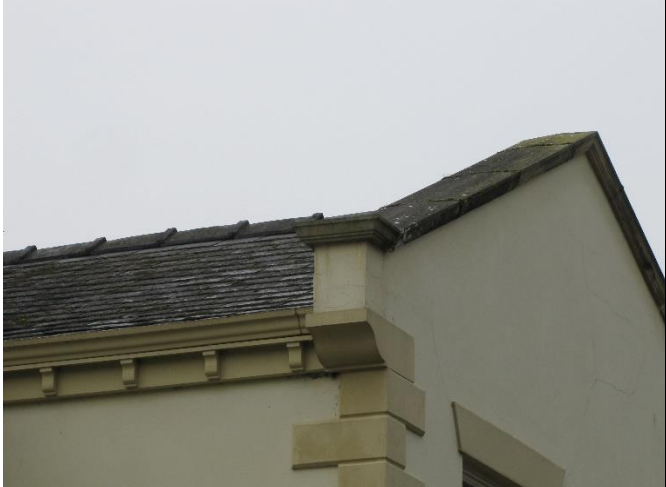
There are parapeted gable ends on two extended pavilions at the front of the house. The parapets are capped with stone coping.

| | <p>Parapet with stone capping, no crevices</p> |
| | <p>As above</p> |
