## AGENT'S HOUSE, BRYMBO

# PRELIMINARY BAT ROOST ASSESSMENT

Report Ref EE.672.LB

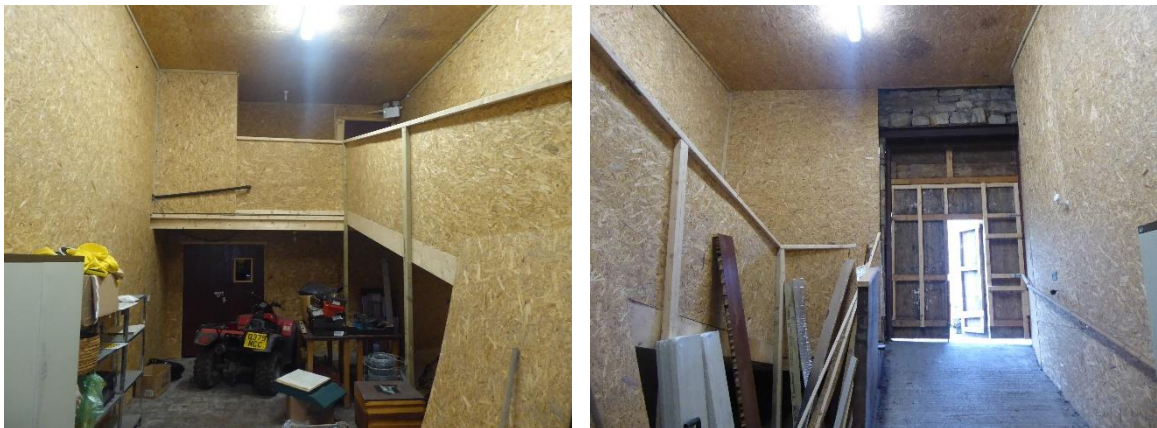
**PHOTO 4.3 & 4.4. WALLS LINED WITH CHIP BOARD TO CREATE A LARGE DOUBLE STOREY HEIGHT ROOM**

- 4.2.1 Internally, the walls and ceiling were lined with chipboard, creating a large double storey height room, which was used for storage (Photo 4.3 & Photo 4.4). This was accessed through the large wooden door on the western side of the building (Photo 4.4). Two rooms had been created on the eastern side of the building, one on the ground floor and another on the first floor, reached by a wooden ramp (Photo 4.5).

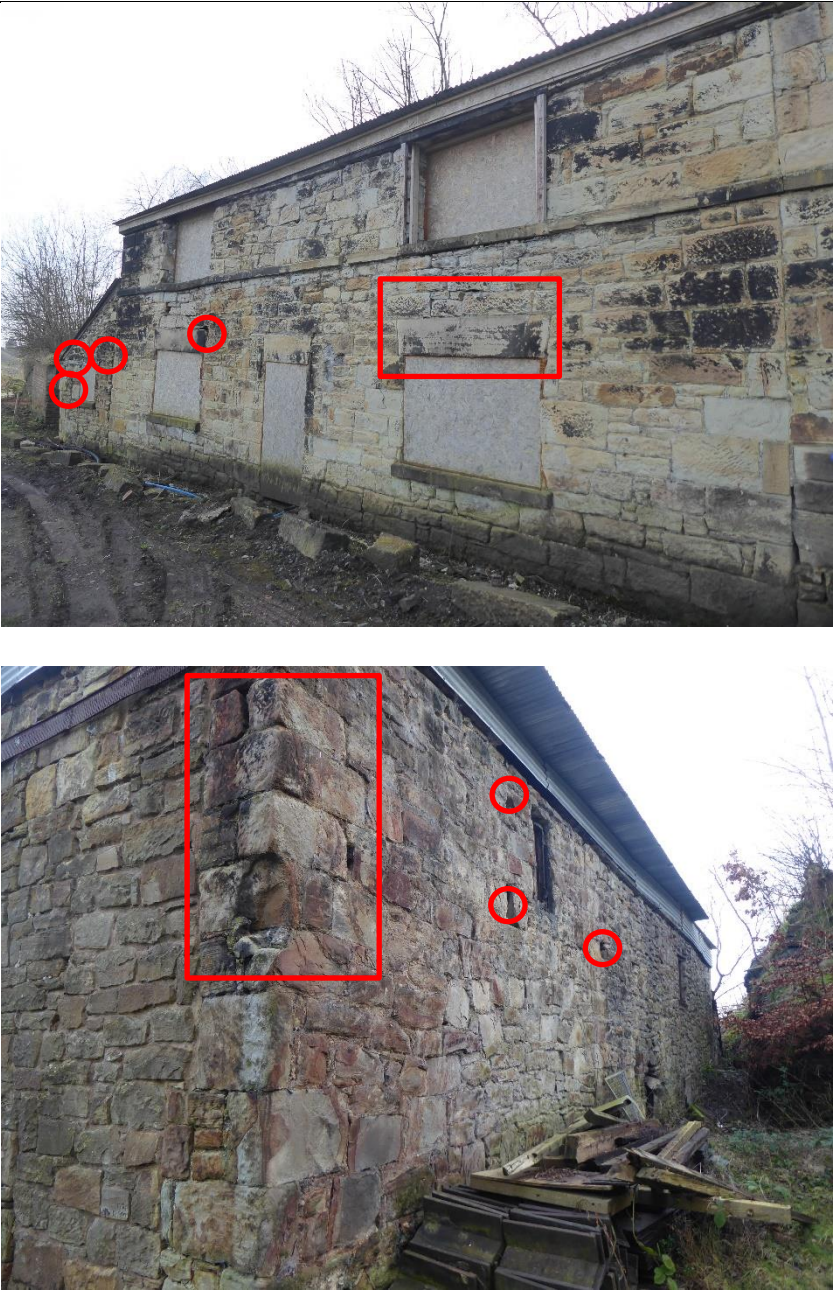
5.1.1 There were a number of deep cracks and crevices in the stone work, some of which were likely to have spanned the thickness of the wall and provided access into the cavity, but due to their position and/or height they could not all be inspected with an endoscope. There were large gaps underneath the corrugated metal fascias and above the boarding covering two of the windows.

| Description of Potential Roosting Features | Photo |
|---|---|
| Cracks and crevices in stonework | |

- 6.3 Deep cracks and crevices within the stone work provide some potential for roosting bats, particularly on the southern side of the building, which faced the woodland. The cavity between the stone walls and the chipboard would provide suitable roosting space for crevice dwelling bats. It is possible for bats to access this cavity between the external wall and internal chipboard walls from a small hole in the door, and it may also be possible for bats to access the cavity from under the fascias and crevices in the walls; however it was not possible to confirm this during the PRA. Any spaces present under the corrugated metal roof and fascias are unlikely to be used by bats due to being subject to extreme temperature changes.

- 7.1 In accordance with the Good Practise Guidelines (Collins, J., 2016), as the Agent's house was found to have moderate suitability for roosting bats, a minimum of two emergence surveys are required to assess if/how many/ what species of bats are using the building; these must be undertaken between May and August (inclusive).

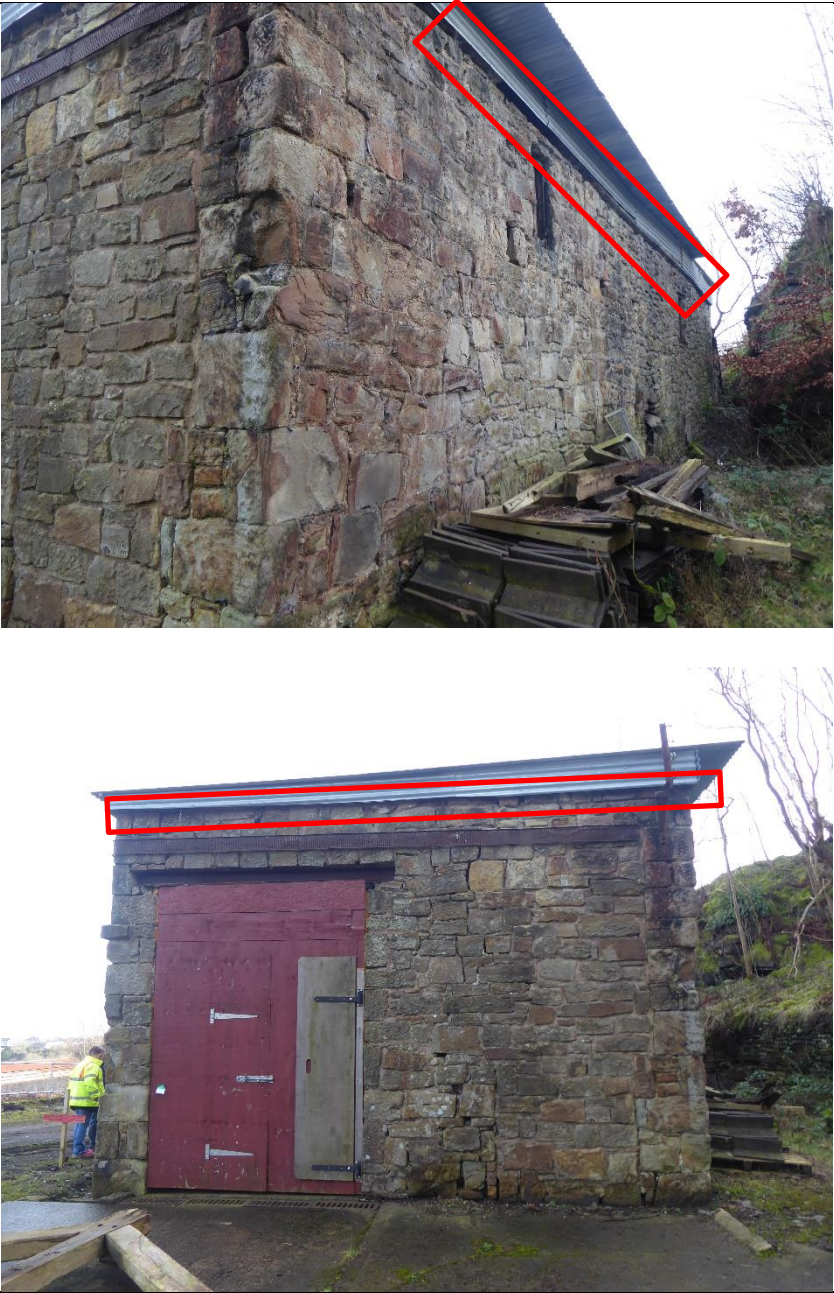
| <p>Gaps under<br/>corrugated<br/>metal fascia</p> | <p>The table contains two photographs of a stone building. The top photograph shows a close-up of the corner of the building, highlighting a gap under the corrugated metal fascia with a red box. The bottom photograph shows the front of the building with a red door, also highlighting a gap under the corrugated metal fascia with a red box. A person in a yellow high-visibility vest is visible in the background of the bottom photograph.</p> |

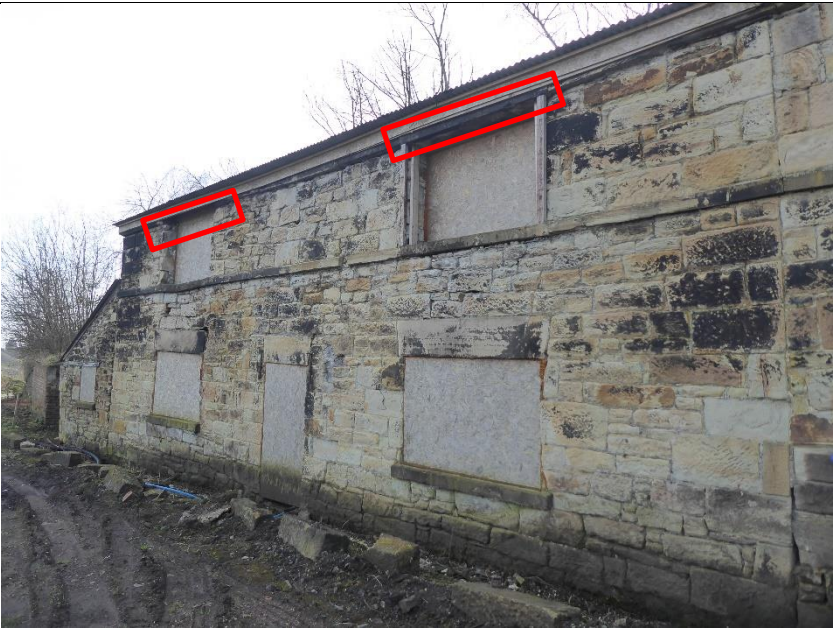
| <p>Gaps above boarded windows</p> | A photograph of the exterior of a stone building. The wall is made of rough-hewn stone blocks. There are several windows that have been boarded up with greyish material. Above two of these boarded windows, there are small gaps between the stone and the roofline, which are highlighted with red rectangles. The ground in front of the building is dirt and debris. |

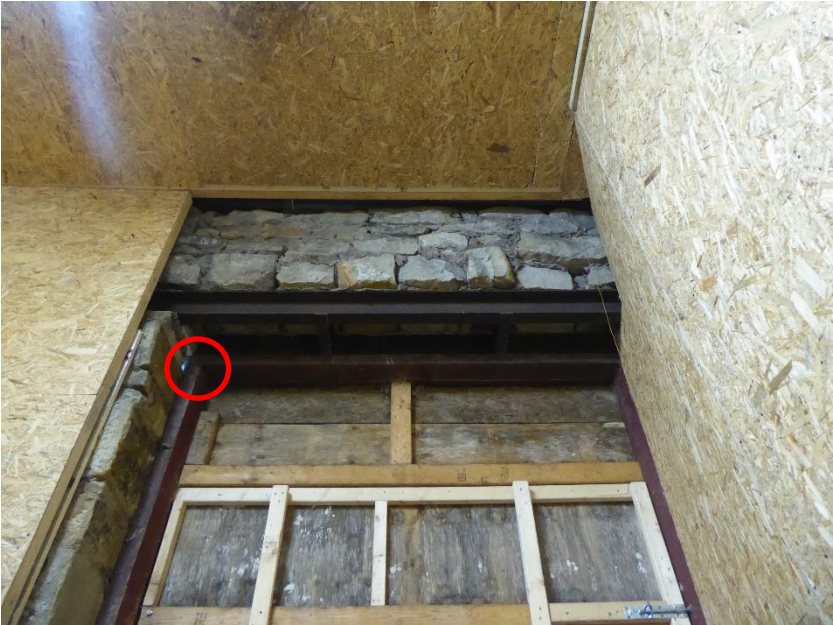
5.2.1 Internally the chipboard was well sealed, apart from the large doorway, which had a small gap at the top. From this doorway, the gap between the external wall and the chipboard was visible.

| <p>Gap above door</p> | A photograph taken from inside a room, looking up at a gap above a wooden door. The walls and ceiling are made of light-colored wood paneling. The door is made of dark wood with vertical slats. Above the door, there is a gap between the door frame and the stone wall above it. This gap is circled in red. The stone wall above the door is made of rough-hewn stone blocks. |
