# Conversion of Buildings at Plas Power Home Farm, Ruthin Road, Wrexham

## Structural Appraisal Report

July 2019

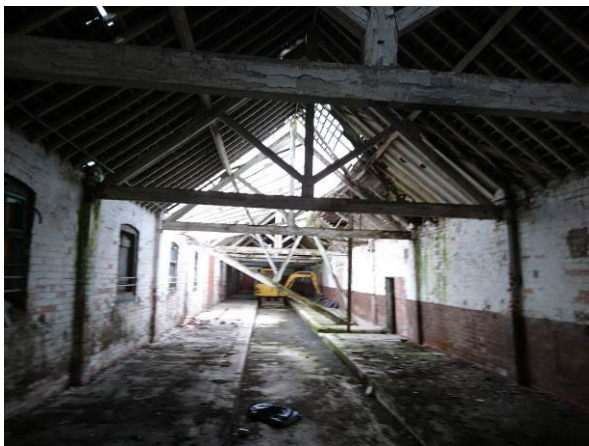
The traditional roof over the main part of the building has collapsed within a single bay near the middle of the roof. The partial collapse would appear to have been instigated by the collapse of a single truss supporting the roof. The end of the truss shows evidence of severe section losses as a result of rot caused by weather penetration over an extended period. The junction between the flat roof at the rear and the pitched roof appears poorly detailed allowing weather to penetrate. Similar defects are apparent to several of the remaining trusses supporting the roof which would raise concerns regarding the long term durability of the roof as a whole.

General view of roof over main part of building.

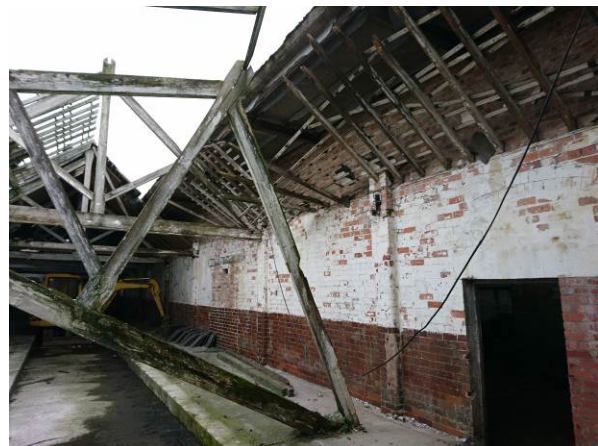
Collapsed truss supporting roof.

It is proposed to convert the main building into three self-contained dwellings arranged over two storeys. A significant part of the rear outrigger will be demolished to free up room for gardens and improve views at the rear. The conversion will require the replacement of the roof to the remaining property so that additional headroom can be provided for the upper storey. Therefore, none of the original elements will be retained, though some of the supporting steel beams may be re-used. The external and internal walls are of solid brick construction and are considered to be of adequate capacity to support the proposed conversion.

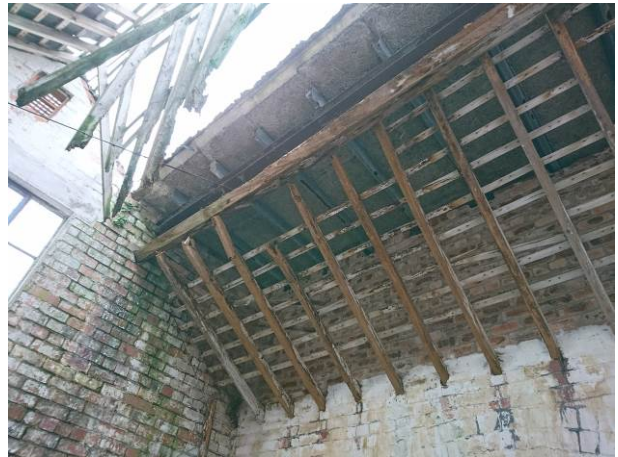
Further collapses are apparent to the roofs over the outriggers at the rear of the main building. Again this would appear to have resulted from weather penetration through a poorly detailed joint between the pitched and flat roofs.

Partial collapse of roof over outrigger.

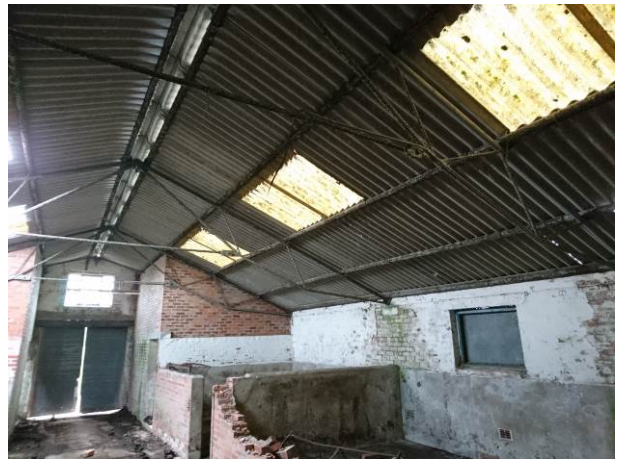
The roof over the cow shed outrigger to the rear is in fair condition with evidence of weather penetration through finishes apparent within and around the edges of the room. The roof comprises asbestos cement sheeting supported off tubular purlins and fabricated tubular trusses at regular centres.

Surface corrosion is apparent to tubular elements, though no significant section losses are apparent.

Roof over cow shed outrigger.

This section of the building will be demolished as part of the conversion scheme.

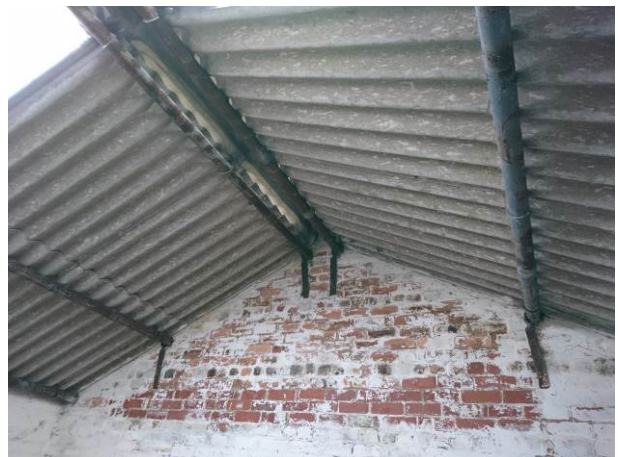
The roof over the adjacent store is in good condition with evidence of very minor weather penetration through finishes apparent around the edges of the room. The roof comprises asbestos cement sheeting supported off tubular purlins supported by load bearing walls.

Surface corrosion is apparent to tubular elements, though no significant section losses are apparent.

Typical construction of store roof.
