**Re: Burton Buildings- 26 and 30 Bridge Street, Wrexham LL13 7HP**  
**Cellar (Lower ground floor) and Overlying Floor (Ground floor)**

Further to our non-intrusive inspection at the above on the 2<sup>nd</sup> October 2109, please find the following-

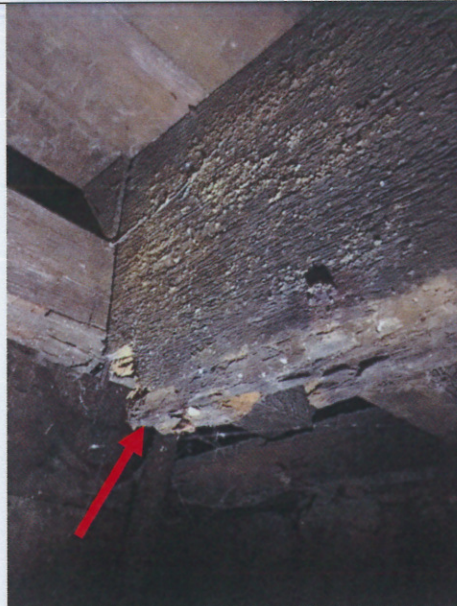
- c) Improvement works have been partially completed to the right-hand side ground and lower ground spaces.
3. **Observations and defects seen-**
  - a) Overlying floors- the floors are constructed from softwood joists with tongue and groove floorboards. Substantial timber decay to significant areas of the joists have occurred due to both beetle infestations and wet rot, this has resulted in the joists not being able to perform as intended and sporadically failed as a result of the decay. Localised areas of floorboarding has also succumbed to decay.  
Several repairs have been attempted in the distant past via the introduction of further timber being planted onto the existing joists, these have now failed.  
A probe was used to determine integrity of the joists; this identified soft and decayed timber to a proportion of the joists.

Fig 1- significant timber decay- joist

Replace timber joists and floorboards as required. The extent of decay does not warrant retention. Ensure joist gloves are used and all structural timber is pre-treated with preservative prior to installation.

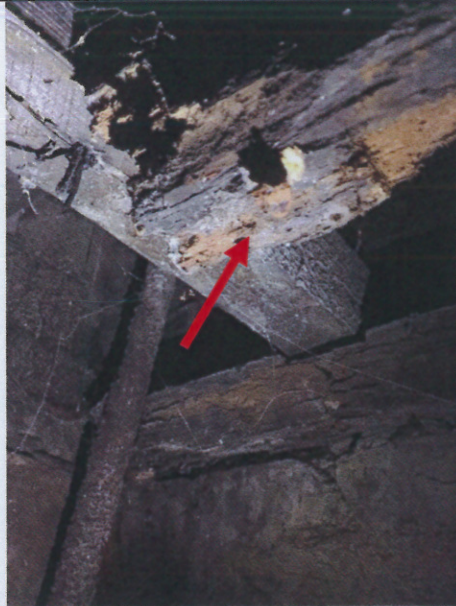
Fig 2- significant timber decay- joist

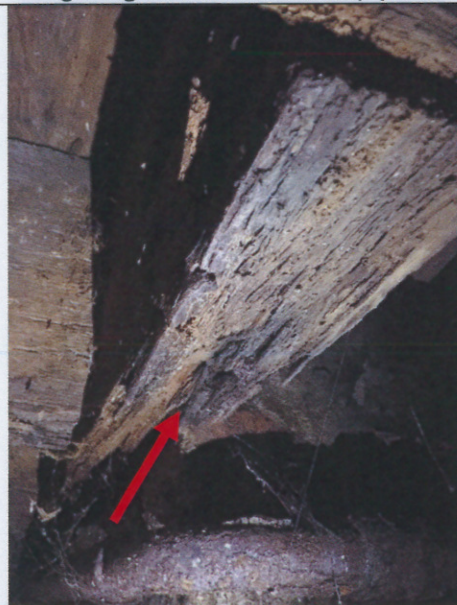
Fig 3- significant timber decay- joist

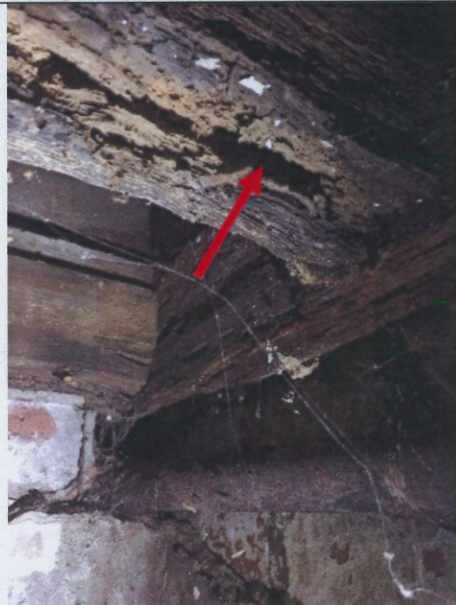
Fig 4- significant timber decay- joist

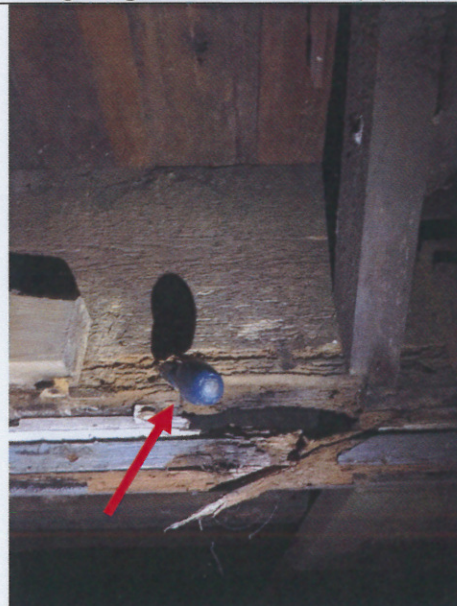
Fig 5- significant timber decay- joist-  
embedded probe

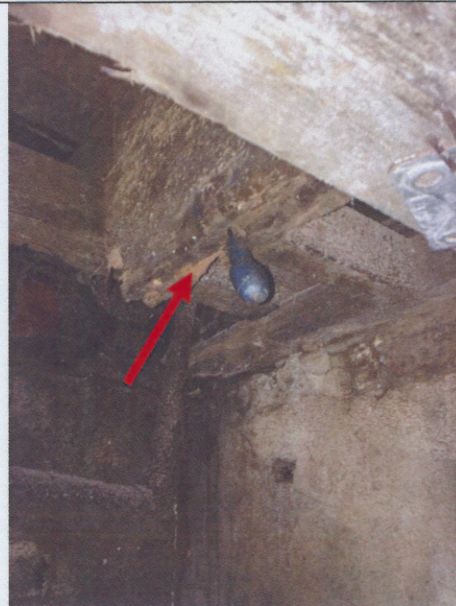
Fig 6- significant timber decay- joist-  
embedded probe

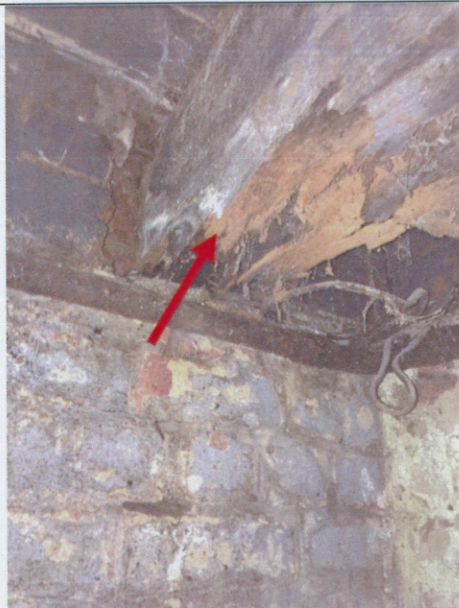
Fig 7- significant timber decay

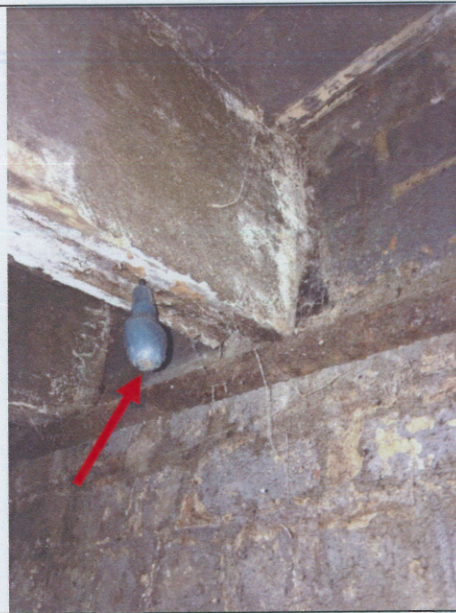
Fig 8- significant timber decay- joist-embedded probe

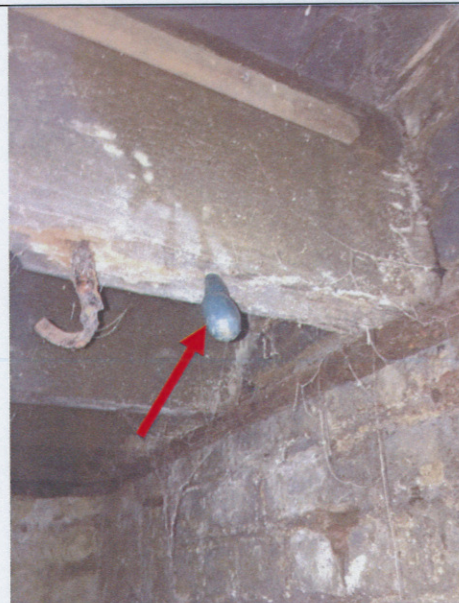
Fig 9- significant timber decay-embedded probe

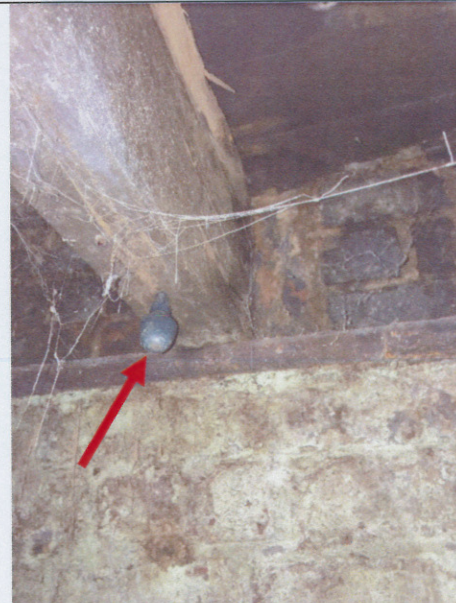
Fig 10- significant timber decay- joist-embedded probe

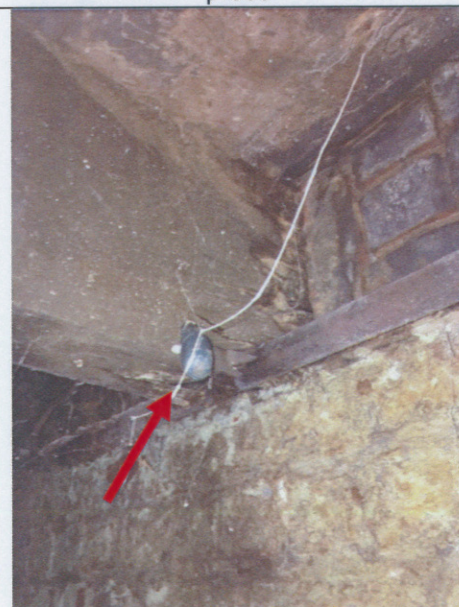
Fig 11- significant timber decay-embedded probe

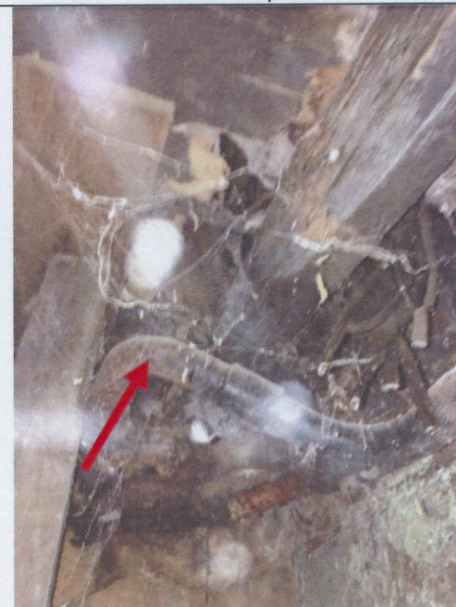
Fig 12- decayed floorboarding and joists

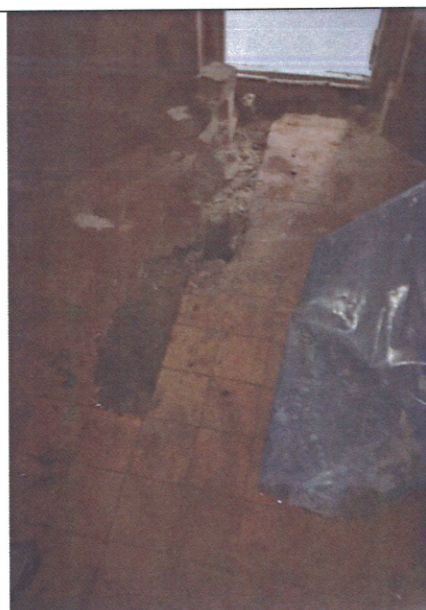
- c) Lower ground floors- are of solid construction tiled or cast in-situ concrete. Water ingress is occurring due to presumed ground water infiltration.

Fig 14- water ingress- tiled floor

Monitor water ingress following works to drainage.

Introduce either dry angle tiles or provide a cavity drained system if water infiltration cannot be sufficiently controlled.
