**Re: Burton Buildings- 30 Bridge Street, Wrexham LL13 7HP**  
**Walls (Ground floor) Paint to Cellar (Lower ground floor) and**

Further to our non-intrusive inspection at the above on the 27<sup>th</sup> February 2020, please find the following-

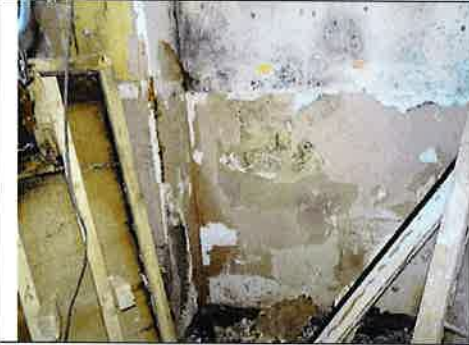
- c) Improvement works have been partially completed to the right-hand side ground and lower ground spaces.
- 3. Observations and defects seen-**
  - a) The main outer and internal walls have primarily been lined internally with plasterboard- two layers.

Fig 1- detached and degraded drylining

Remove all drylining and external cement-based render as necessary.

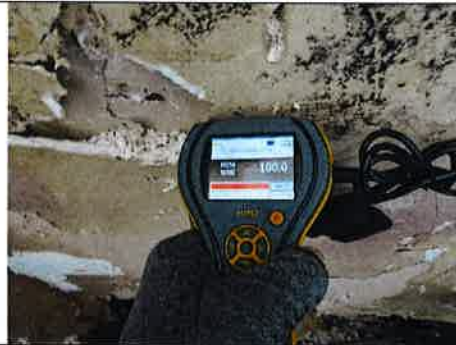
- b) The outside of the walls have either been pointed in a cement-based mortar or coated in a cement-based render.
  - c) Significant moisture ingress/damp identified to these areas- a moisture meter was used and this produced elevated readings.

Fig 2- elevated moisture meter readings

Monitor moisture content following removal of existing linings with a calibrated meter until reduced to a satisfactory level.

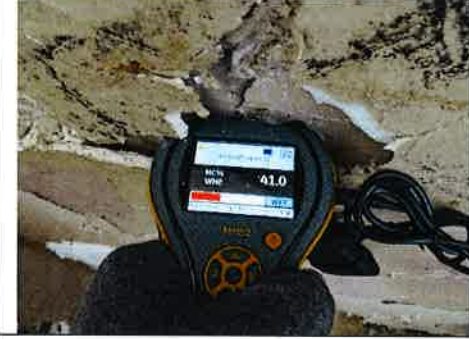
Fig 3- elevated moisture meter readings

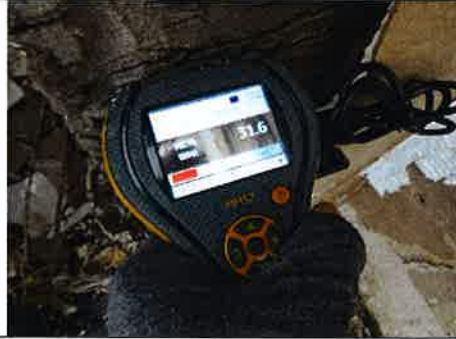
Fig 4- elevated moisture meter readings

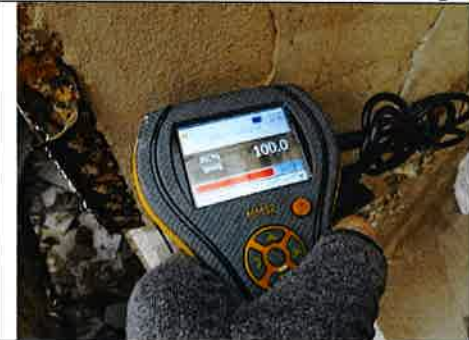
Fig 5- elevated moisture meter readings

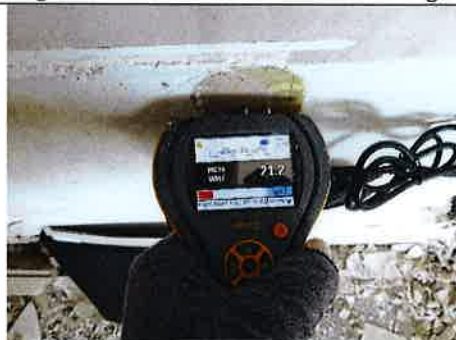
Fig 6- elevated moisture meter readings

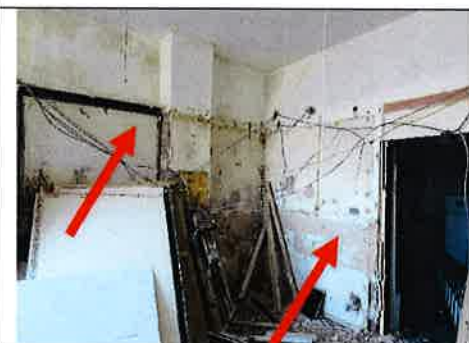
Fig 7- external and internal walls

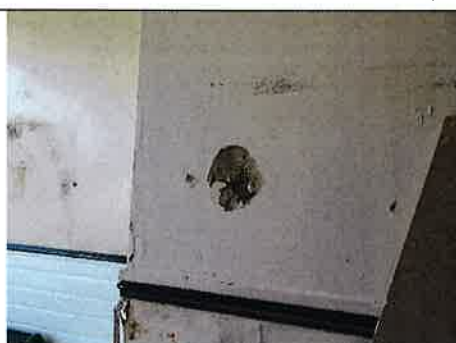
Fig 8- pier to external wall

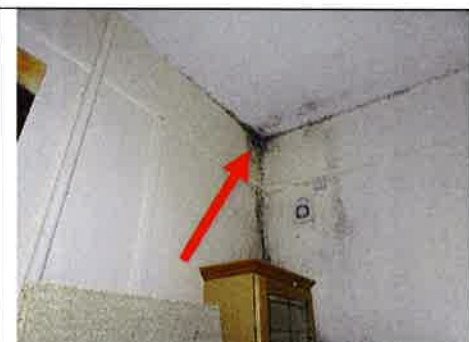
Fig 9- junction between walls

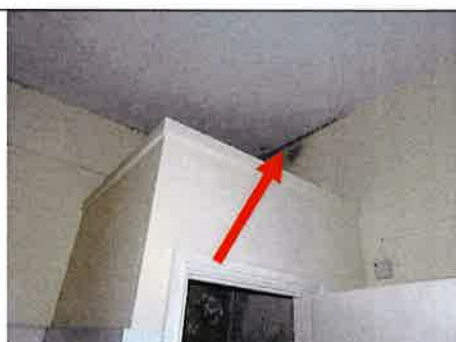
Fig 10- junction between walls

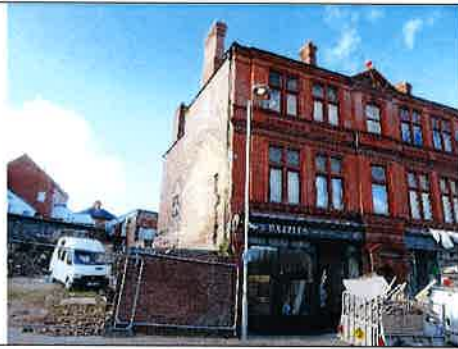
Fig 11- frontage and side

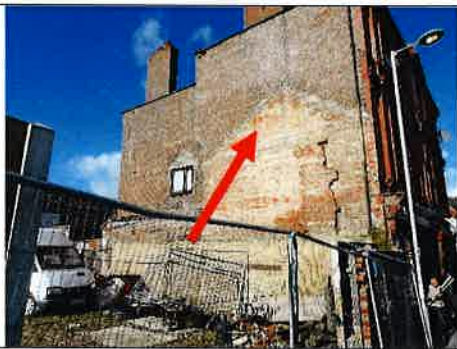
Fig 12- side denoting previous outline of building

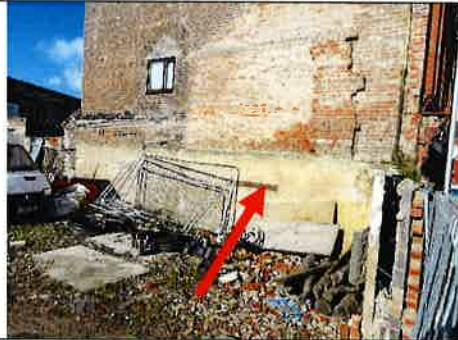
Fig 13- cement based render

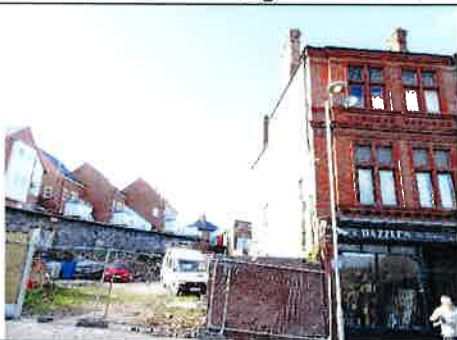
Fig 14- frontage and area to side
