# Arboricultural Report

## Safety and Condition Survey

**The Woodlands  
Worthenbury  
Wrexham  
LL13 0AW**

Date: 3<sup>rd</sup> April 2018

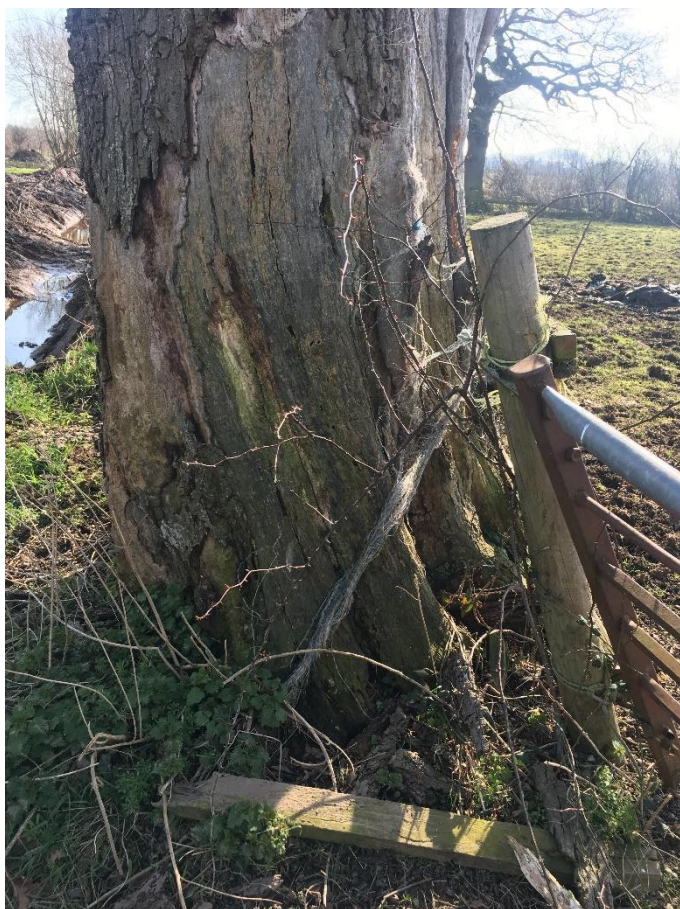
| Ref | Age | Species | Height (m) | Diameter at breast height DBH (mm) | Radial crown spread (m) | Condition | Observations | Recommendations | Priority |
|---|---|---|---|---|---|---|---|---|---|
| T1 | M | Oak | 15.8 | ~ 1000 | 8.5 | C/D | Extensive basal decay extending up to the scaffold union at circa 4m.<br>Extensive dieback (re-trenching) evident throughout the crown. | Reduce to a habitat stick of circa 6m in height using coronet cuts where practicable to maintain / create habitat potential for bats etc. | Moderate (6-12M) |

Photograph of T1 showing extensive decay

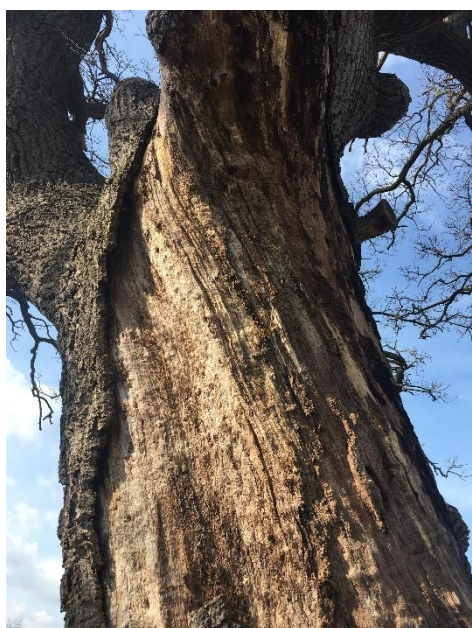
Photograph of decay to stem of T1

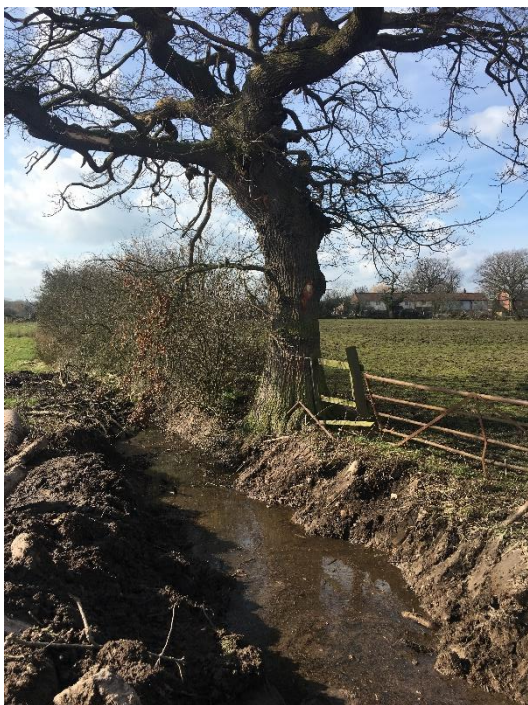
Photograph of T2

| Ref | Age | Species | Height (m) | Diameter at breast height DBH (mm) | Radial crown spread (m) | Condition | Observations | Recommendations | Priority |
|---|---|---|---|---|---|---|---|---|---|
| T2 | M | Oak | 12.0 | ~ 650 | 6.2 | C | Located on edge of ditch. Waterlogged. Moderate deadwood observed in crown. Multiple historic pruning wounds located around the scaffold union. Evidence of historic storm damage to crown. | Crown clean and deadwood. Crown lift to 3m (epicormic growth) | Low (12-18M) |

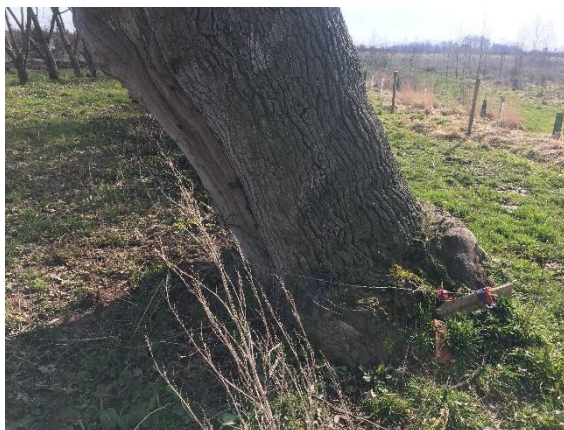
Photograph of T3

| Ref | Age | Species | Height (m) | Diameter at breast height DBH (mm) | Radial crown spread (m) | Condition | Observations | Recommendations | Priority |
|---|---|---|---|---|---|---|---|---|---|
| T3 | M | Oak | 11.1 | ~ 950 | 5.0 | D | Extreme basal and stem decay. Extensive dieback of crown. Lean of approximately 10°. Cavity to base. Appears to be hollow. | Reduce to a habitat stick of circa 5m in height using coronet cuts where practicable to maintain / create habitat potential for bats etc. | Moderate (6-12M) |

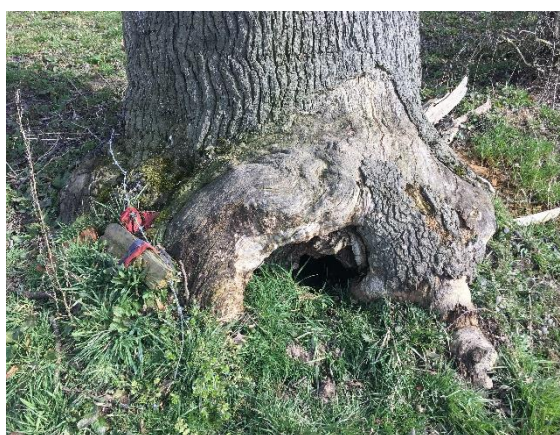
Photograph of T3 base

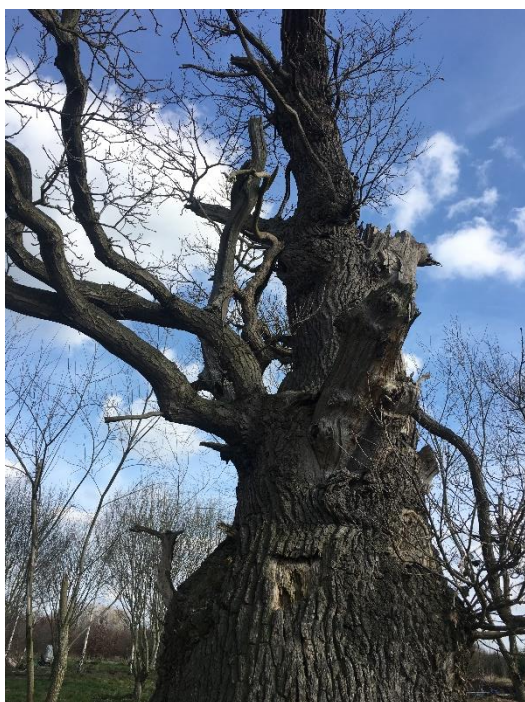
Photograph of T3 crown

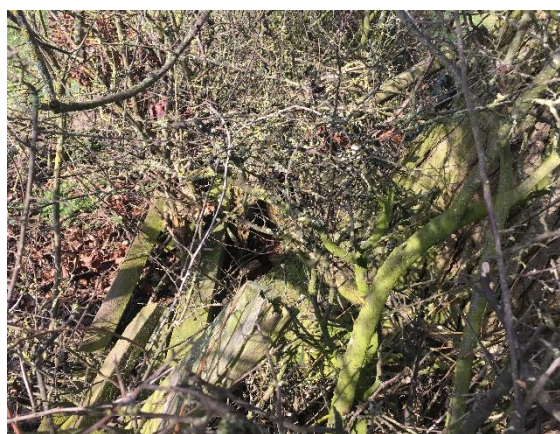
Photograph of T4 failure

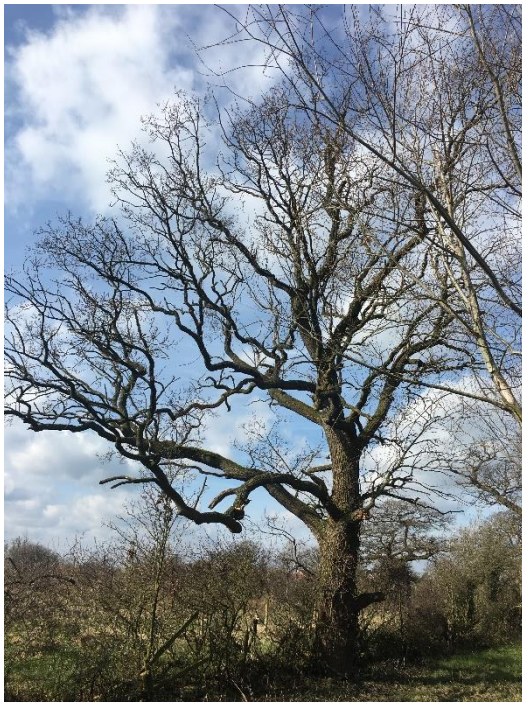
| Ref | Age | Species | Height (m) | Diameter at breast height DBH (mm) | Radial crown spread (m) | Condition | Observations | Recommendations | Priority |
|---|---|---|---|---|---|---|---|---|---|
| T4 | M | Oak | 17.3 | ~ 700 | 5.5 | C/D | Extensive dieback to crown (retrenching)<br>Ivy covered | Crown clean and deadwood.<br>Sever Ivy | Low (12-18M) |

Photograph of T4 crown

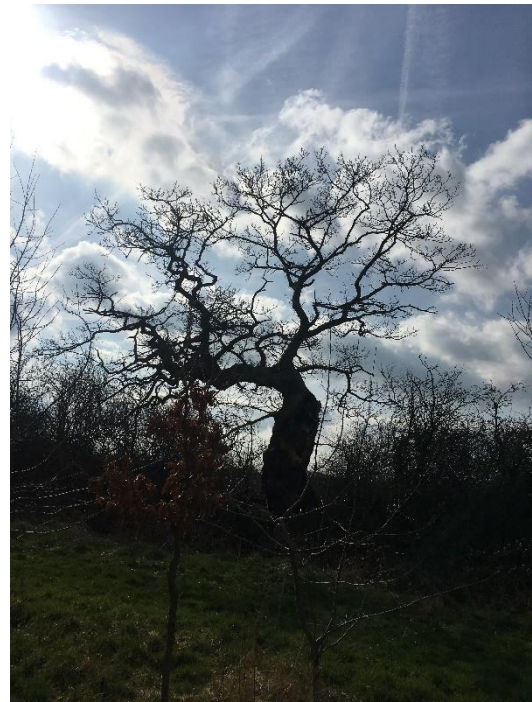
Photograph of T5

| Ref | Age | Species | Height (m) | Diameter at breast height DBH (mm) | Radial crown spread (m) | Condition | Observations | Recommendations | Priority |
|---|---|---|---|---|---|---|---|---|---|
| T5 | M | Oak | 10.0 | ~ 1000 | 5.0 | D | Located on edge of ditch. Significant historic failure. Canker. Cavity evident at 3-4m. Fungal fruiting bodies evident (Saprophytic). Clear structural cracking to stem indicating rotational stress failure. | Fell to ground level | Moderate (6-12M) |

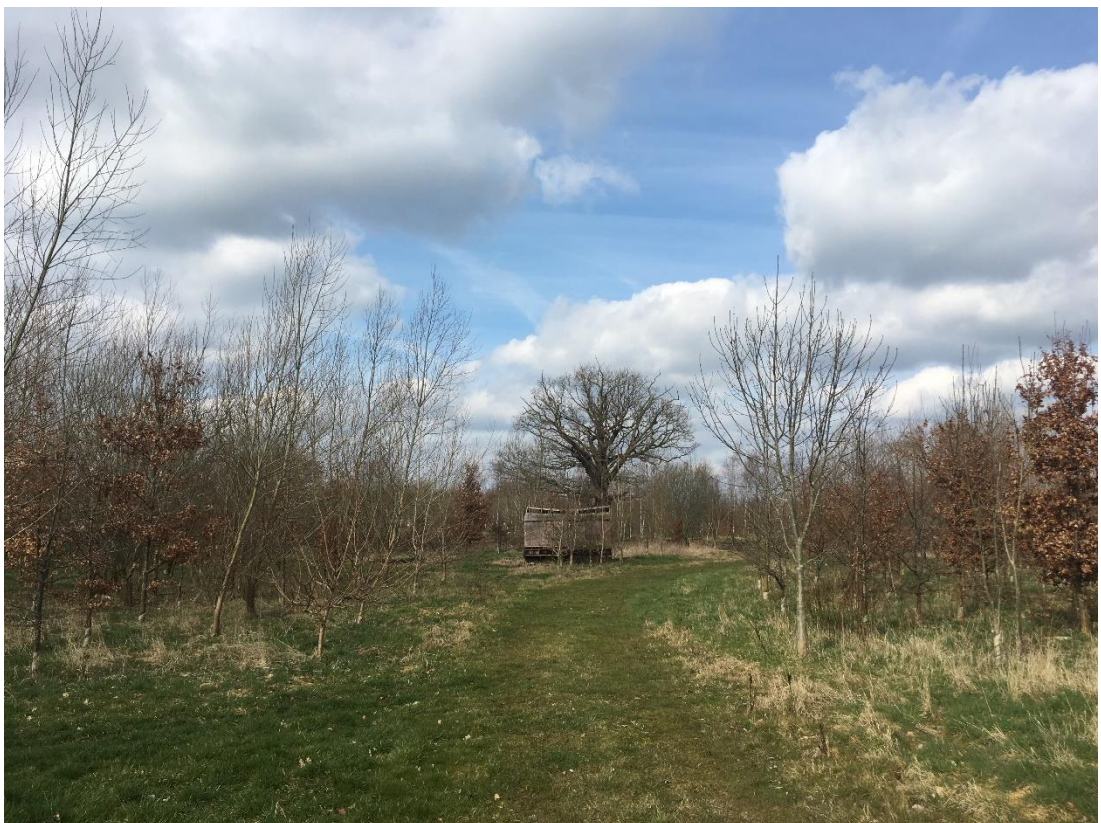
Photograph of T6

| Ref | Age | Species | Height (m) | Diameter at breast height DBH (mm) | Radial crown spread (m) | Condition | Observations | Recommendations | Priority |
|---|---|---|---|---|---|---|---|---|---|
| T6 | M | Oak | 20 | ≥ 1600 | ~ 10 | B | Some evidence of hollowing under buttress roots.<br>Evidence of historic storm damage.<br>Retrenching (significant deadwood in crown) | Crown clean | Low (12-18M) |

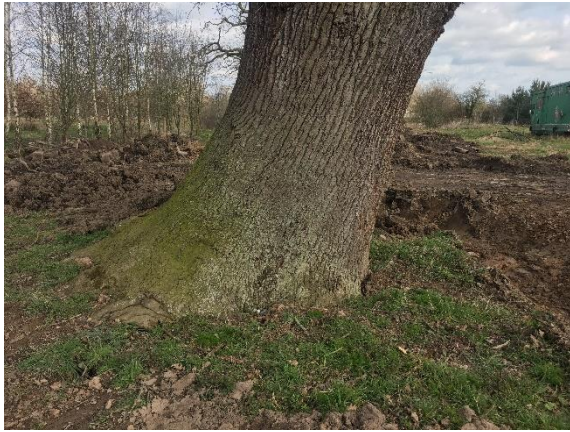
Photograph of T6 base

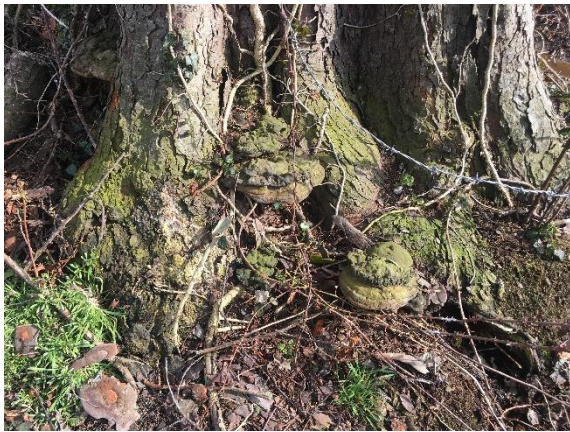
Photograph of T7 Ganoderma

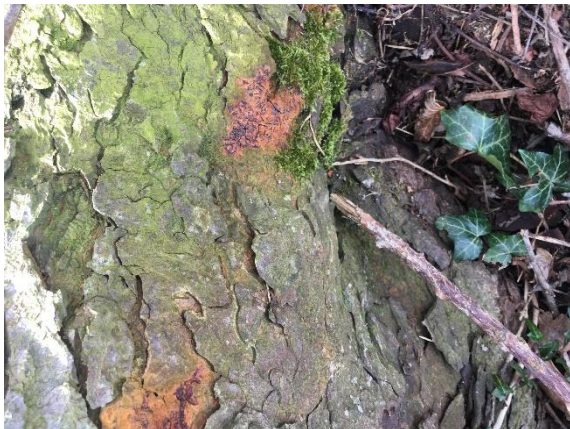
Photograph of T7 Bleeding Canker

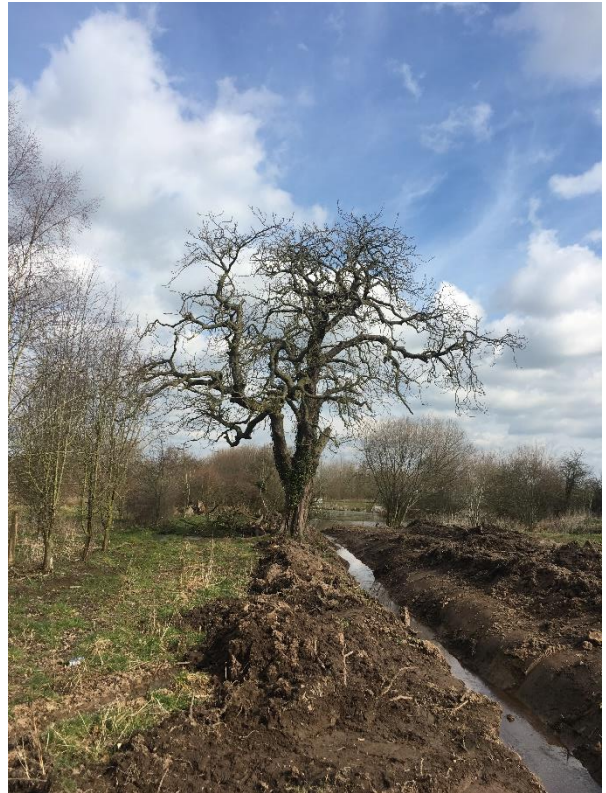
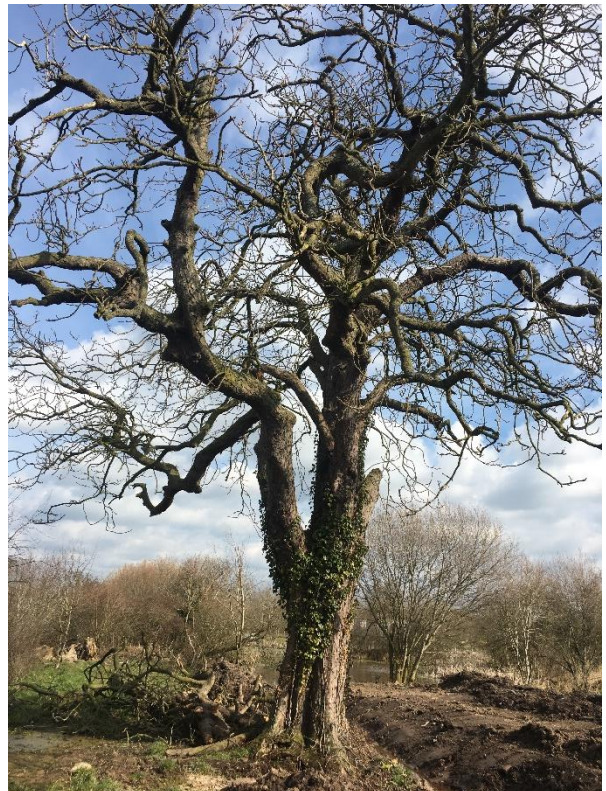
Photograph of T7

| Ref | Age | Species | Height (m) | Diameter at breast height DBH (mm) | Radial crown spread (m) | Condition | Observations | Recommendations | Priority |
|---|---|---|---|---|---|---|---|---|---|
| T7 | M | Horse Chestnut | 15 | ~ 700 | 5-6 | D | Waterlogged. Poor extension growth. Sparse crown. Evidence of significant historic failure. Hollow under root plate. Extensive (and historic) Ganoderma fruiting bodies. Evidence of bleeding canker. In decline (mortality spiral). | Fell to ground level | High (0-6M) |

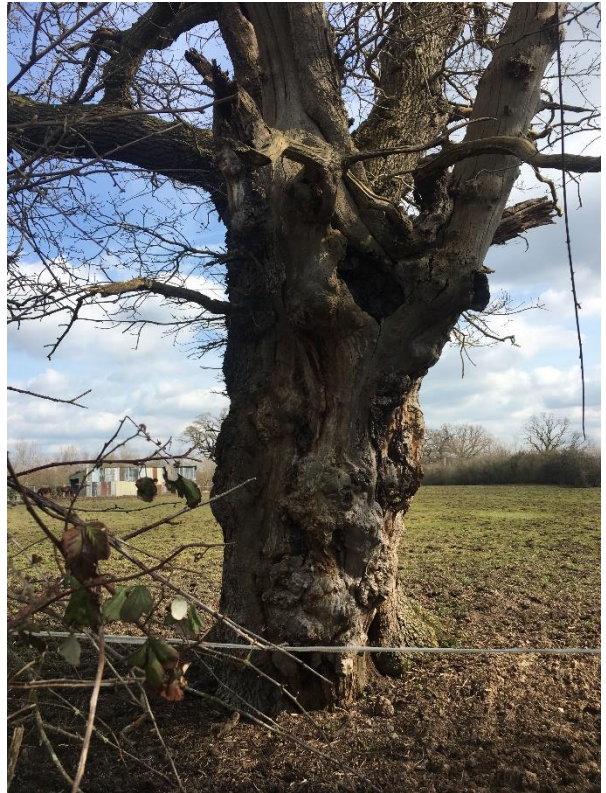
Photograph of T8

| Ref | Age | Species | Height (m) | Diameter at breast height DBH (mm) | Radial crown spread (m) | Condition | Observations | Recommendations | Priority |
|---|---|---|---|---|---|---|---|---|---|
| T8 | M | Oak | ~ 11 | ~ 700 | 5.5 | C/D | Roadside tree. High target value. Evidence of historic failure. Extensive dieback. Bark necrosis evident in crown. Ivy covered. | Reduce to a habitat stick of circa 6m in height using coronet cuts where practicable to maintain / create habitat potential for bats etc. | High (0-6M) |

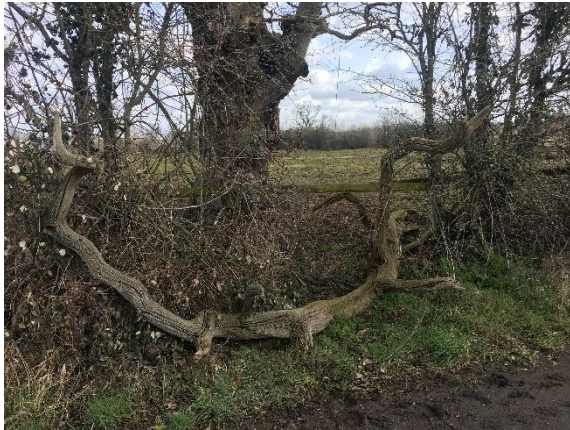
Photograph of T8 historic failure

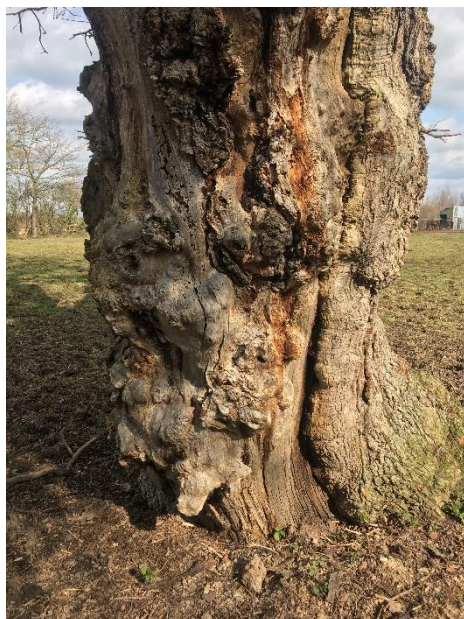
Photograph of T8 stem

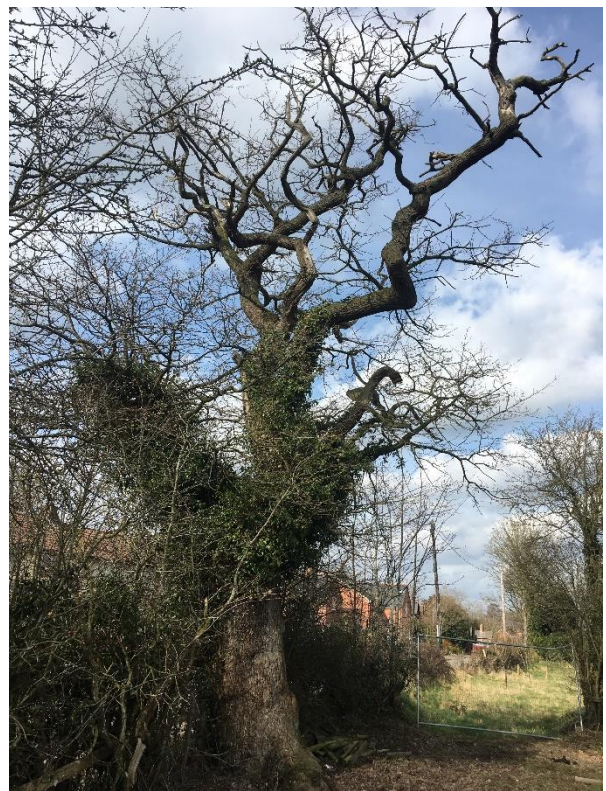
Photograph of T9

| Ref | Age | Species | Height (m) | Diameter at breast height DBH (mm) | Radial crown spread (m) | Condition | Observations | Recommendations | Priority |
|---|---|---|---|---|---|---|---|---|---|
| T9 | M | Oak | ~ 11 | ~ 1000 | 5.5 | C/D | Extensive decay. Hollow. Significant historic failure over road. Decay evident to stem / base and scaffold. | Reduce to a habitat stick of circa 4-5m in height using coronet cuts where practicable to maintain / create habitat potential for bats etc. | High (0-6M) |
