## RSA Designer Response

### ROAD SAFETY AUDIT STAGE 1/2

| <b>Project Title</b> | Llay S278 |

# **STRAIGHT MILE, GRESFORD ROAD AND CROWN CROSSROADS, LLAY PROPOSED SECTION 278 HIGHWAY WORKS**

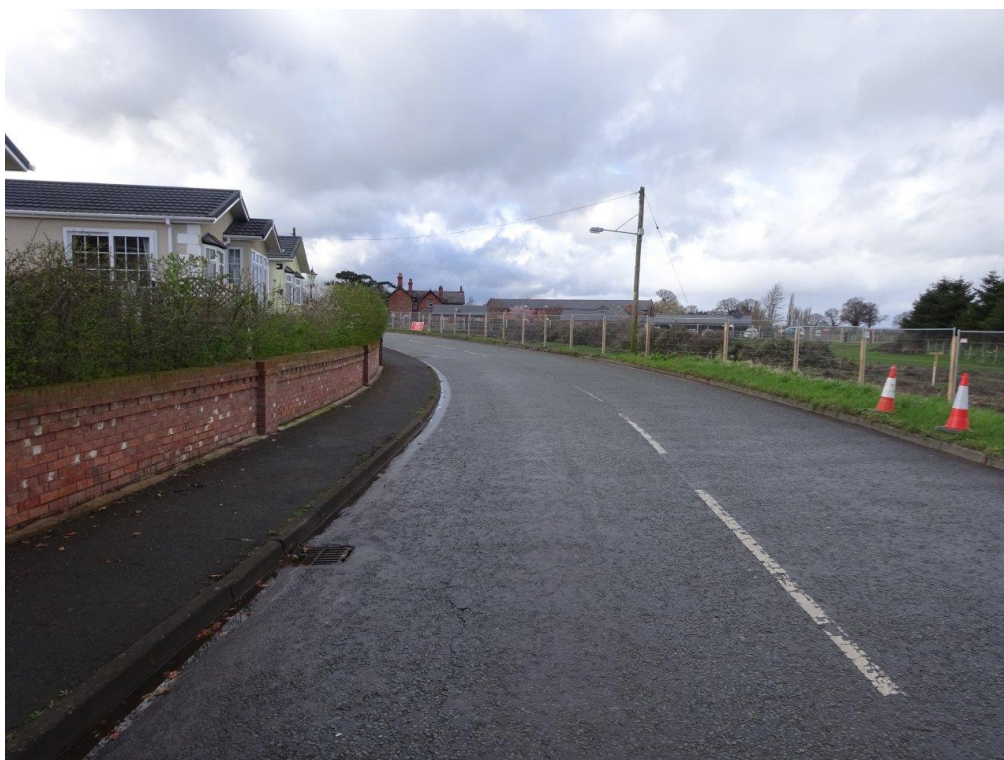
It was observed during the site visit that the intervisibility between north-westbound drivers approaching the Puffin crossing and pedestrians crossing from the south-western footway appears to be reduced due to the left-hand bend on the approach to the proposed Puffin crossing. This may increase the risk of collisions between these pedestrians and vehicles travelling north-west. (Photo 13.1 & 13.2)

13.1 Gresford Road Puffin – Reduced north-westbound visibility

| Problem Identified (Paragraph No) | Problem Accepted (YES/NO) | Recommendation Accepted (YES/NO/PART) | Response/Action (describe) |
|---|---|---|---|
| <p>7.1.1 Location: North-westbound approach to proposed Puffin crossing</p> <p>Problem</p> <p>Summary: Reduced intervisibility between approaching drivers and pedestrians crossing from south-western footway</p> <p>It was observed during the site visit that the intervisibility between north-westbound drivers approaching the Puffin crossing and pedestrians crossing from the south-western footway appears to be reduced due to the left-hand bend on the approach to the proposed Puffin crossing. This may increase the risk of collisions between these pedestrians and vehicles travelling north-west. (Photo 13.1 &amp; 13.2)</p> <p>Recommendation</p> | Y | P | <p>The location for the Puffin crossing was selected to be as close as practicable to future pedestrian desire lines whilst trying to accommodate the existing constraints imposed by junction locations.</p> <p>From a point 1m from the road centre line to a point offset 0.5m from kerb face at the centre of the south-west crossing, direct intervisibility is slightly substandard at 40m.</p> <p>However, the design has included for a primary signal on the north-east crossing that north-westbound drivers have visibility of way in excess of 43m. This accompanied with advanced warning signage of new road layout/signalised crossing will mitigate the risk of collisions.</p> <p>Drawing to include intervisibility splay(s).</p> |

The intervisibility should be checked and amendments made to the layout if appropriate intervisibility cannot be provided at this location.

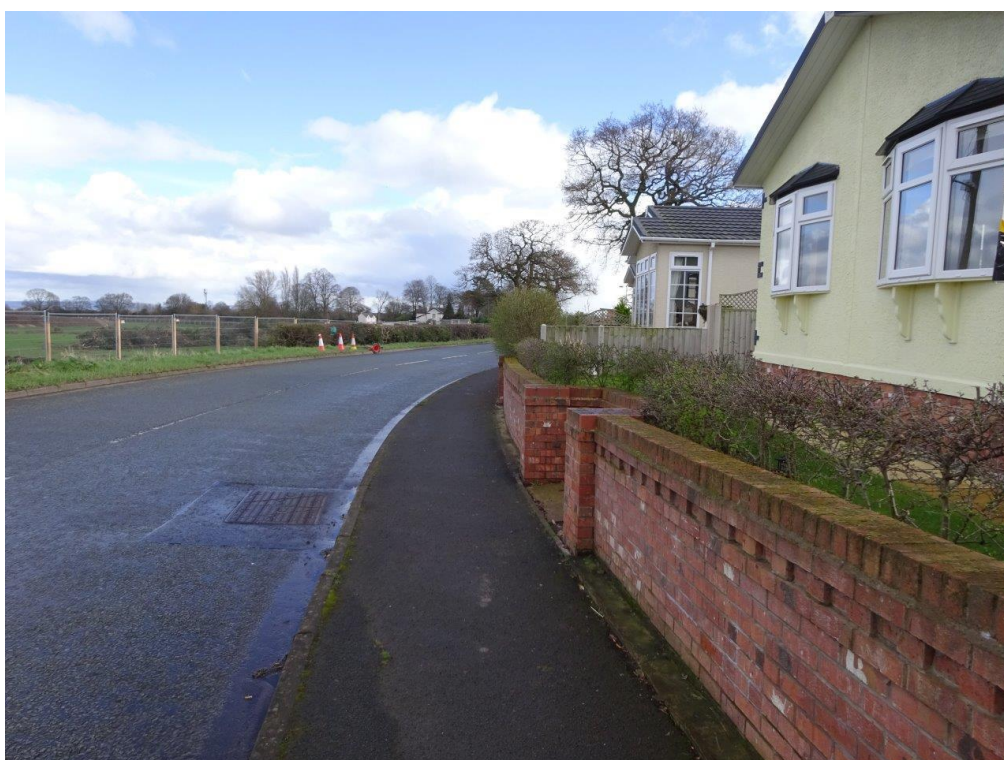
13.2 Gresford Road Puffin – Reduced visibility from southwestern footway

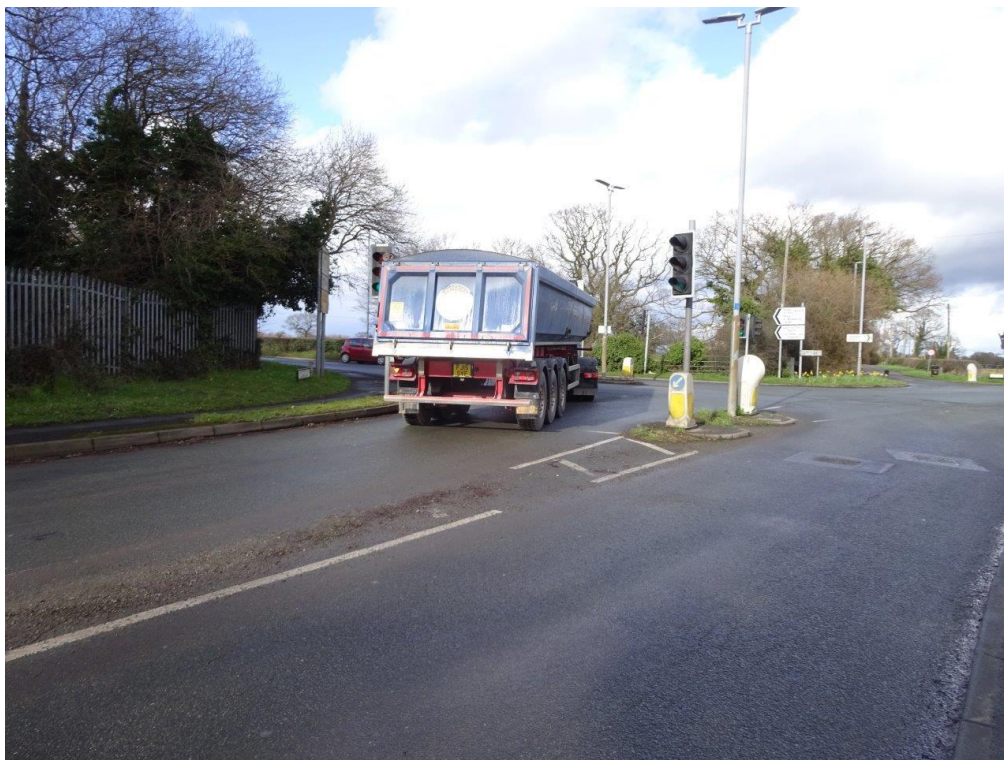
| Problem Identified (Paragraph No) | Problem Accepted (YES/NO) | Recommendation Accepted (YES/NO) | Action (describe) |
|---|---|---|---|
| <p>9.3.2 Location: Llay Road approach to traffic signal junction</p> <p>Problem</p> <p>Summary: Narrow lane width may result in side-swipe type collisions</p> <p>The drawings show two lanes are to be provided on the Llay Road approach to the proposed traffic signal junction, however the carriageway width at this location does not appear wide enough for two lanes. Vehicles attempting to enter the junction in two lanes may overhang into the adjacent lane increasing the risk of side-swipe type collisions. (Photo 13.3)</p> <p>Recommendation</p> <p>The carriageway should be widened to provide adequate width for two lanes on the Llay Road approach to the junction.</p> | Y | Y | <p>Staging to be reviewed.</p> <p>Design to be amended.</p> |

13.3 Crown Crossroads – Narrow carriageway on Llay Road approach

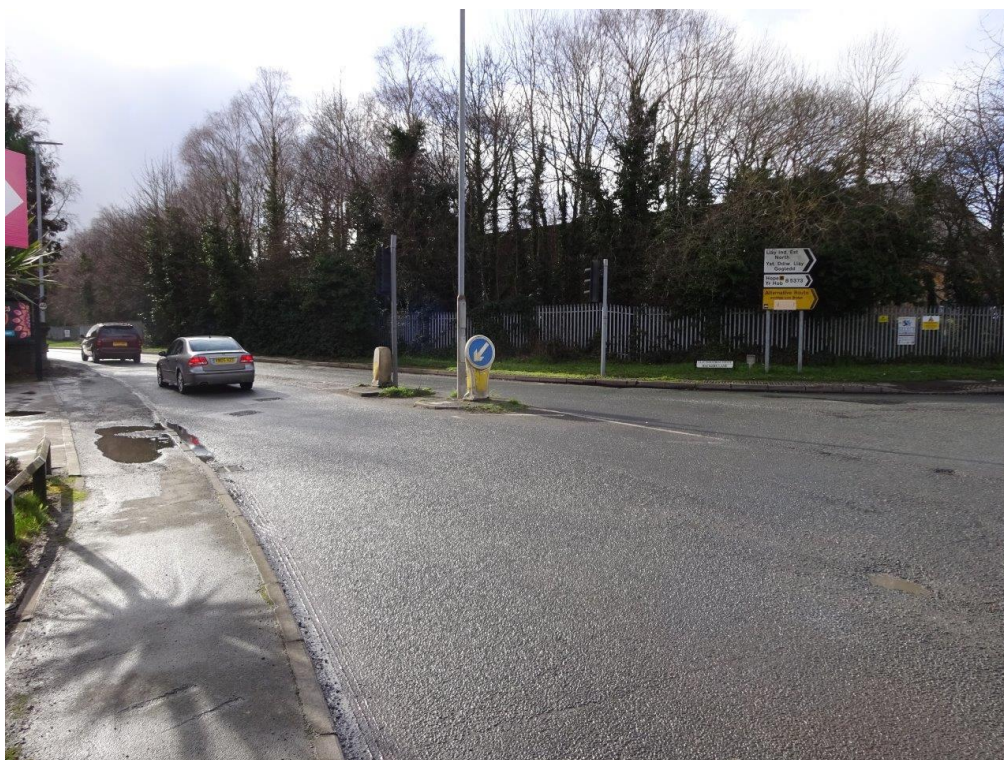
It was observed during the site visit that there is a lack of facilities for pedestrians throughout the traffic signal junction. It is unclear how the adjacent development will tie-into the junction with regards to pedestrian movement. If there is an increase in pedestrian demand throughout the junction, the lack of appropriate facilities may increase the risk of collisions between pedestrians crossing at the junction and vehicles travelling through the junction. (Photos 13.4 & 13.5)

13.4 Crown Crossroads – Lack of pedestrian facilities

| Problem Identified (Paragraph No) | Problem Accepted (YES/NO) | Recommendation Accepted (YES/NO) | Action (describe) |
|---|---|---|---|
| <p>9.4.1 Location: Throughout the traffic signal junction</p> <p>Problem</p> <p>Summary: Lack of facilities for pedestrians</p> <p>It was observed during the site visit that there is a lack of facilities for pedestrians throughout the traffic signal junction. It is unclear how the adjacent development will tie-into the junction with regards to pedestrian movement. If there is an increase in pedestrian demand throughout the junction, the lack of appropriate facilities may increase</p> | Y | P | <p>This is acknowledged as an existing problem but there is limited scope within the adopted highway boundary to improve fully.</p> <p>It is proposed that uncontrolled crossings will be provided across Straight Mile (east of the lane widening), Gresford Road (south of signal stop line) and Llay Road (either at splitter island or west of signal stop line). This will enable pedestrians to access all routes within the limitations of the junction geometry.</p> <p>Design to be amended.</p> |

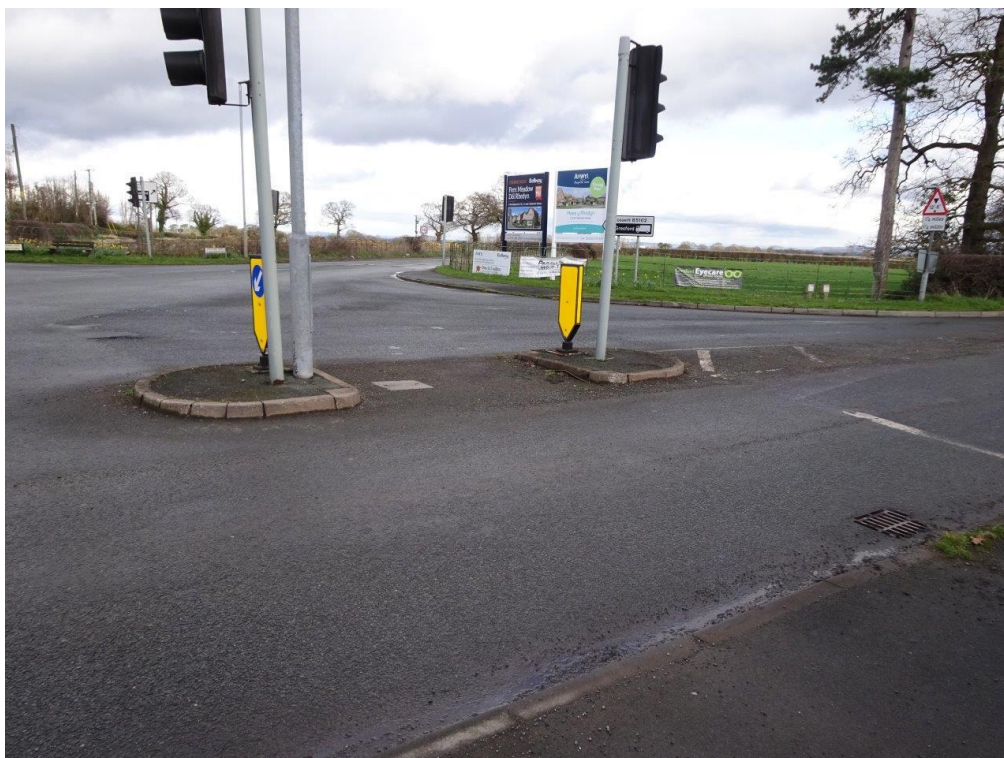
13.5 Crown Crossroads – Lack of pedestrian facilities
