**Road Safety Audit  
Stage 1**

**Proposed Development  
Lidl Store  
Bodhyfryd Wrexham**

**JHB/LPSWRSA1/Rev1**

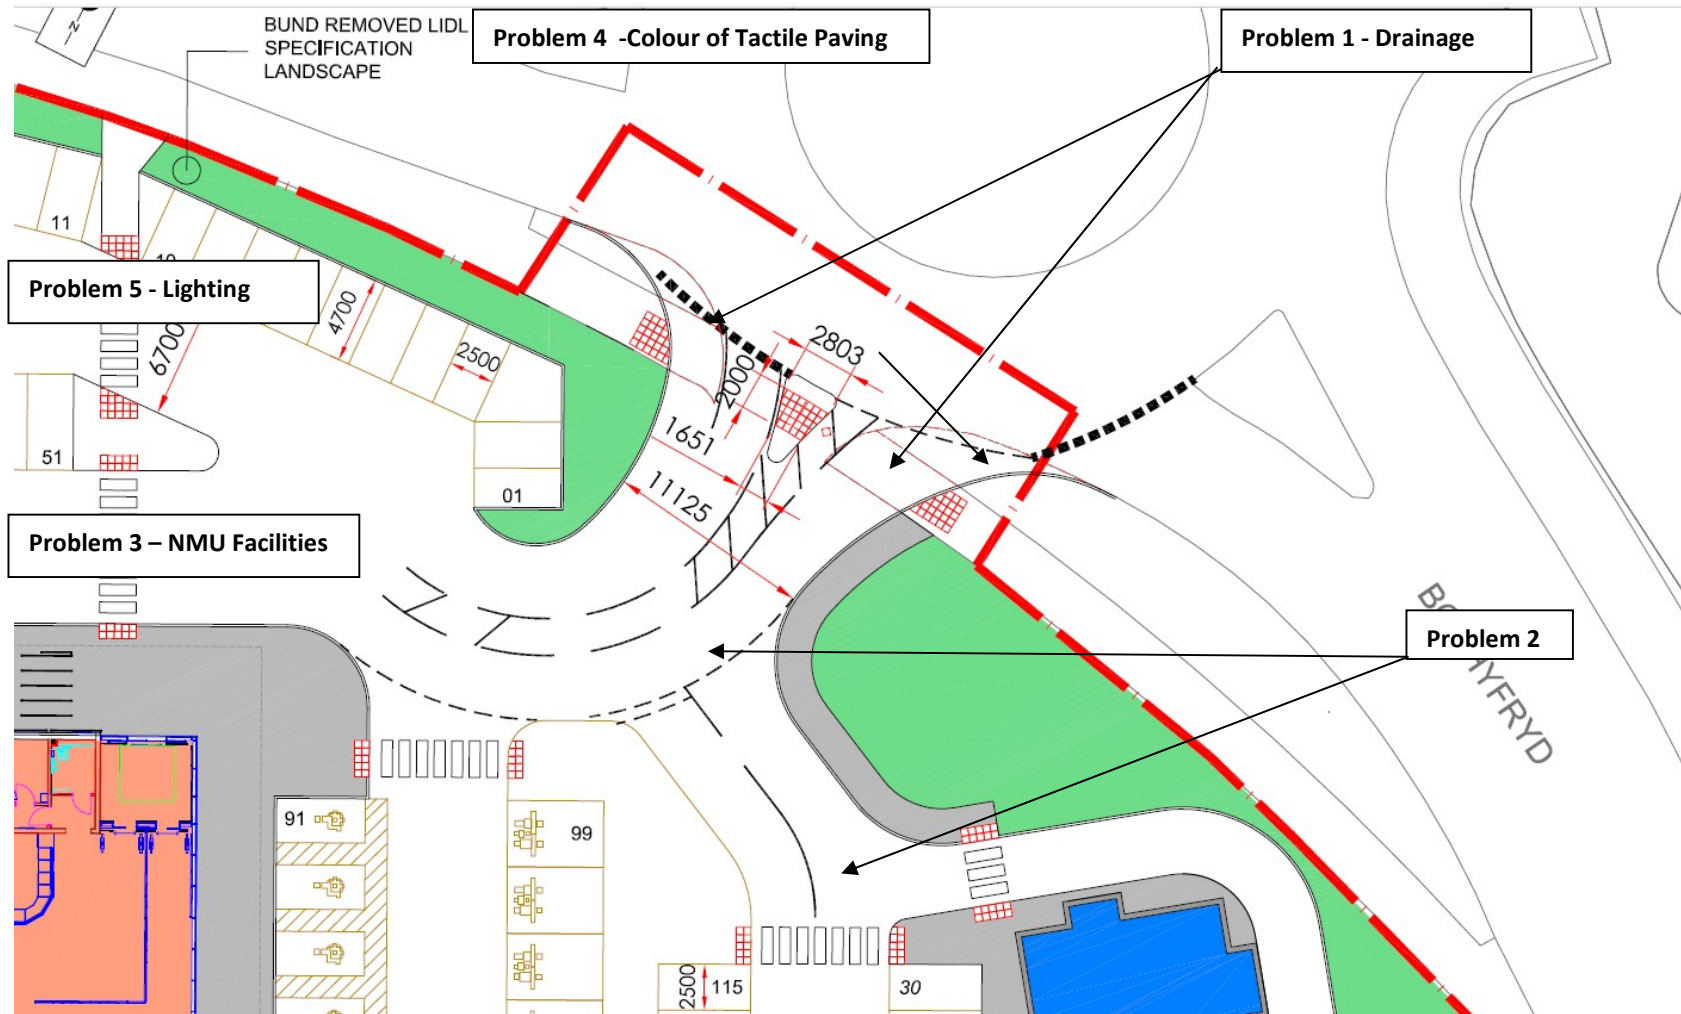
### Drawings: Problem Location Plan

**Location:** New road layout and site access junction.

**Summary:** Inappropriate drainage may lead to ponding water resulting in resulting in loss of control type collisions.

The drawing shows that the current access from the roundabout will be widened to accommodate vehicles associated with the proposed development. Ponding water can result in an increased risk of loss of control type collisions and at certain times of year and standing water will freeze resulting in sheets of ice. Vehicles manoeuvring in the turning could lose control resulting in an increased risk of collisions.

**Location:** Drive through.

**Summary:** Vehicles queuing for drive through may block the main access resulting in an increased risk of shunt type collisions.

From the drawing provided it is difficult to fully determine how many vehicles can queue at the drive through before blocking back of the main access from the roundabout will occur, a rough estimate of between six and seven vehicles could queue before blocking back becomes an issue.

However, should queues exceed the capacity of the drive through then vehicles could block the main access resulting in an increased risk of shunt type collisions.

**Location:** Roundabout.

**Summary:** Inappropriate NMU facilities could lead to NMU/vehicle collisions and an increased risk of slips/trips and falls.

Examination of the drawings show that details of gradients and kerb up stands have not been provided.

If inappropriate facilities are provided, then there is an increased risk of NMU/vehicle collisions as well as slips/trips and falls.

**Summary:** Inappropriate NMU facilities could lead to NMU/vehicle collisions and confusion to partially sighted NMUs.

The drawing shows red tactile in locations where new uncontrolled crossings are to be provided, in situations where uncontrolled crossings are provided "Buff" tactile paving should be used as standard.

If inappropriate facilities are provided, then there is an increased risk of partially sighted NMUs becoming confused resulting in an increased risk of NMU/vehicle collisions.

**Location:** Throughout the site.

**Summary:** Inappropriate levels of lighting can lead to an increased collision risk.

The drawings provided do not clearly show if alterations to the existing street lighting are proposed. The scheme will include localised changes with carriageway widening and it is also anticipated that the development will increase both the night time usage and the number of vehicles/NMUs using the proposed road network once the development is constructed. This may result in the new access and NMU crossing points being in shadow leading to possible conflicts during the hours of darkness.

**RECOMMENDATION:** Provide appropriate drainage at all locations where changes to the road layout and new carriageway are proposed.

**RECOMMENDATION:** Consider moving the collection point to a position that allows additional storage for the drive through and provides a minimum of 40m storage. Also consider altering the road markings where appropriate.

**RECOMMENDATION:** Ensure that appropriate dropped crossing points are provide in accordance with *Guidance on the Use of Tactile Paving Surfaces [DfT]*.

**RECOMMENDATION:** Ensure that appropriate tactile paving is provide in accordance with *Guidance on the Use of Tactile Paving Surfaces [DfT]*.

**RECOMMENDATION:** Ensure that suitable lighting provision is provided.
