## **STRUCTURAL APPRAISAL**

### **THE DYMOCK ARMS PENLEY**

**SEPTEMBER 14, 2019**

## **THE DYMOCK ARMS UPDATED REPORT SEPTEMBER 2019**

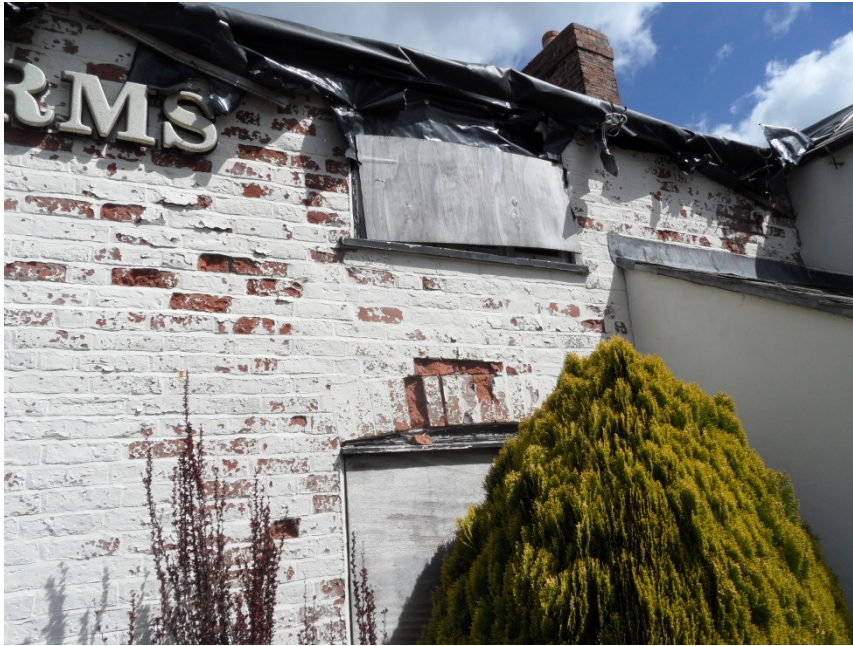
- 3.2 To this left hand entrance this has a distinct lean forward. There are signs of recent movement and relaxation occurring.
- 3.3 To the left of this is a mono pitch tiled roof portion. With further tiles have broken away than originally viewed to the roof. In addition a horizontal crack as appeared to the right hand side eaves level running across the front elevation of the entrance doorway.

- 3.4 To the section to the left hand side of this is perforated by windows at ground and first floor.
- 3.5 Immediately to the left of this is of painted masonry with extensive shaling occurring to the masonry. Above the window at ground floor level to the arched soldier course lintel it is noted as being most pronounced at the key stone position with failure and disturbance observed brickwork noted to the same.

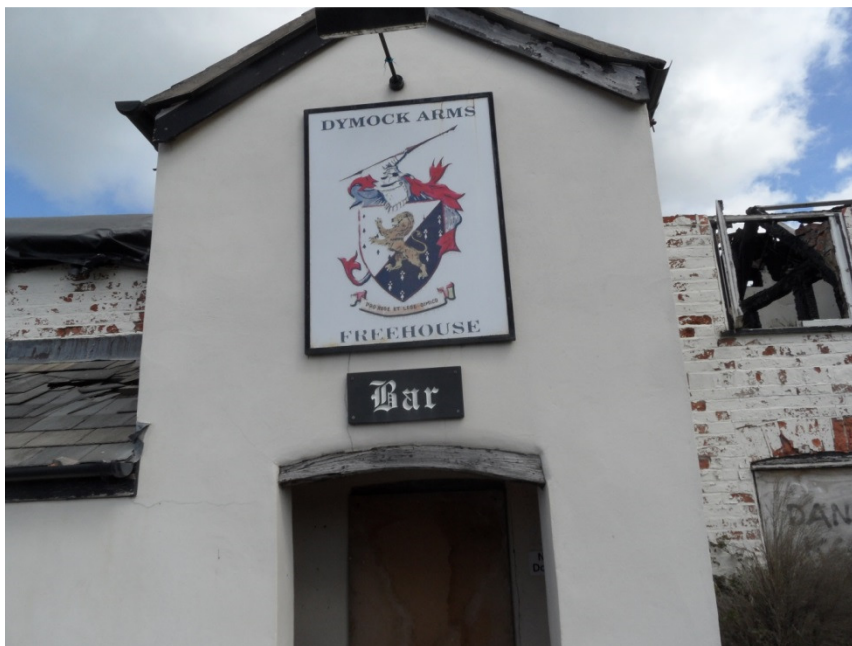
- 3.6 The entrance doorway is rendered throughout. Apart from the horizontal crack a vertical crack as also developed behind the signage affixed to this elevation.

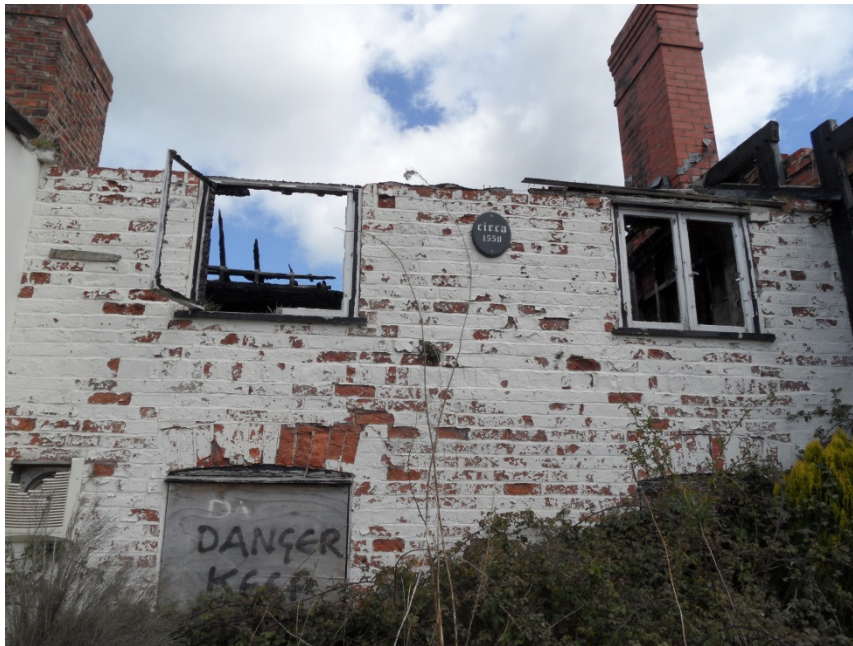
- 3.7 The middle section is perforated by two windows at ground floor with a vent aperture to the left hand side. Two windows perforate the elevation at first floor level. Again this elevation is of painted masonry and there are signs of shalled brickwork. The windows at ground floor level have solidier course lintels above their heads. Some cracking is noted emanating from the same. With the masonry to the right hand side noted as being shalled to the left hand

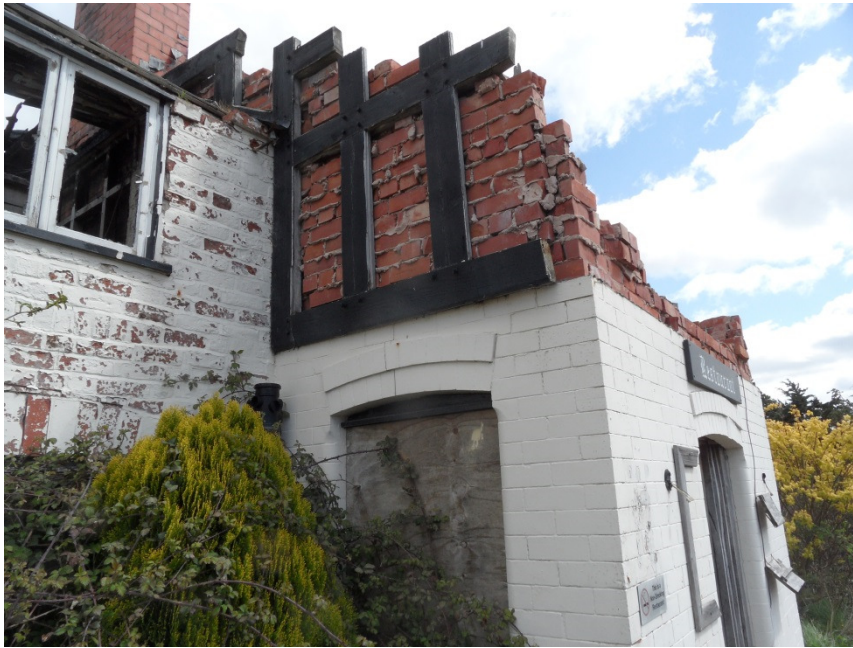
- 3.8 To the two windows at first floor level the roof is no longer in place above their heads. The date plate is situated between these windows. Some relaxation of the masonry was observed around the window to the right hand side.
- 3.9 To the restaurant entrance portion this has painted masonry at ground floor level with the first floor masonry having been removed to the front elevation. The First floor masonry and timber framework has been racked back to the flank walls. To the soldier course arch above the entrance doorway part of the brick has dropped and there is a crack noted just the right of centre of this construction. A vertical crack as also developed springing from the centre of the arched lintel to the window on the left hand return elevation.

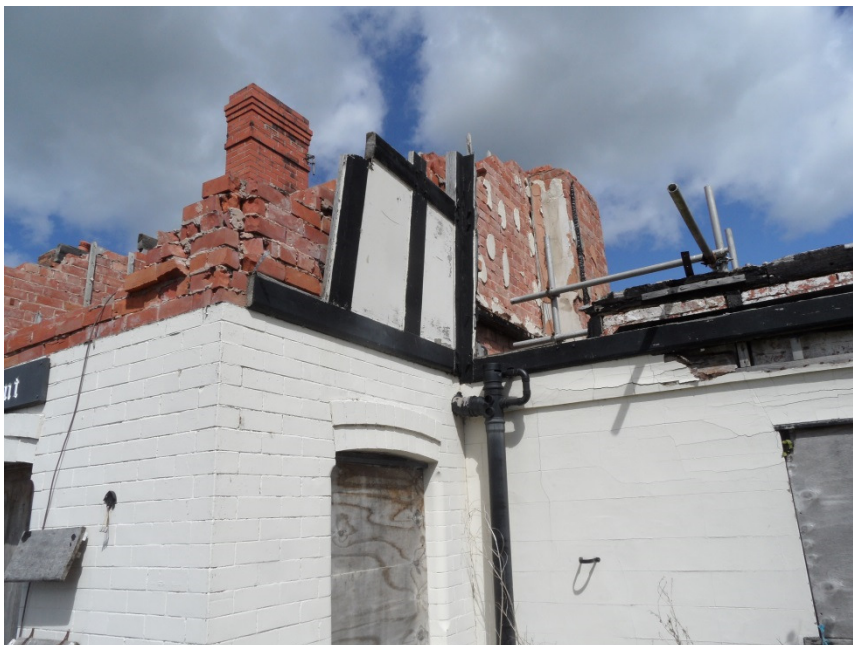
3.12 Extensive cracking is noted to the render throughout to this portion of the property with indications that the substrate is suffering from disturbance.

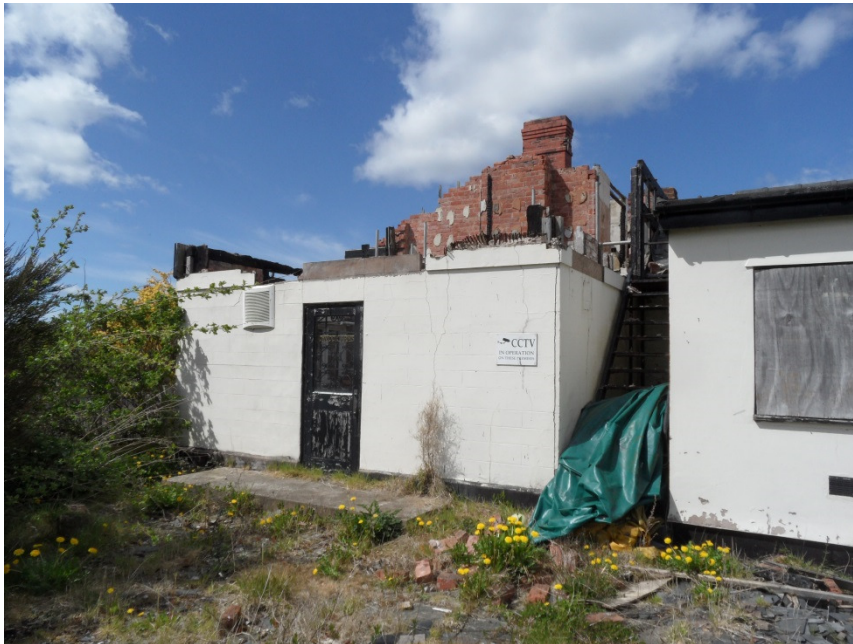
- 4.1 Again this comprises of three distinct portions. The two thirds to the left hand side stand proud of the other portion set towards the rear.
- 4.2 To the left hand side is a metal stairway set centrally with rendered walls to the left and right hand side.

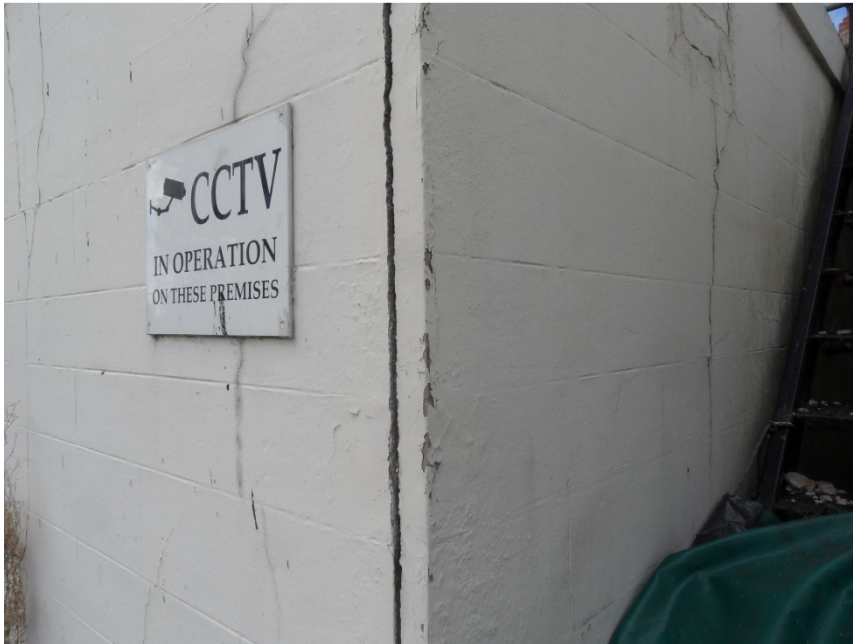
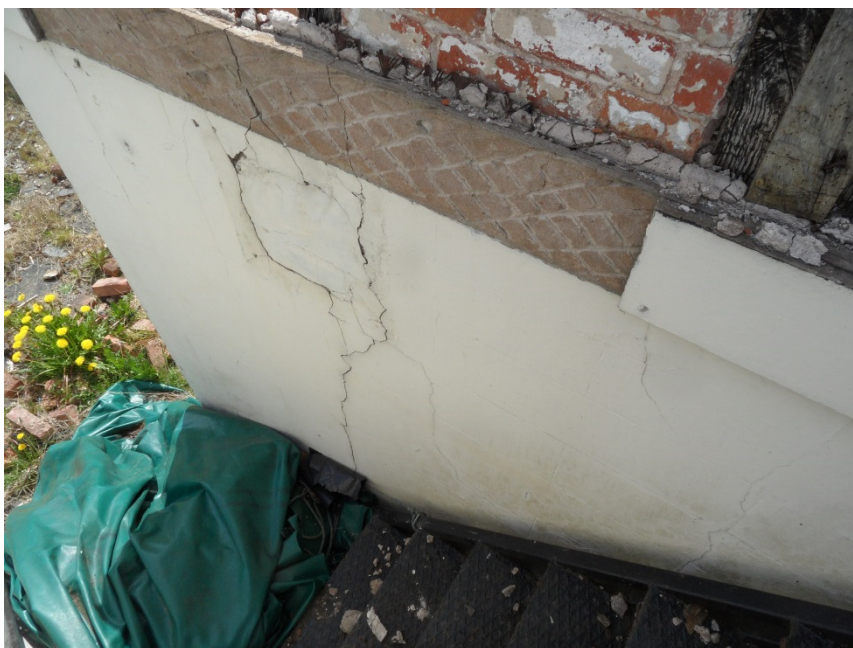
- 4.3 The portion to the left hand side has had the first floor removed and is perforated by a single doorway at ground floor level set centrally. Extensive vertical cracking as developed with a vertical crack having formed at the corner since this was since viewed. At the position of this crack displacement of the structure is occurring. The disturbance continues around the corner.

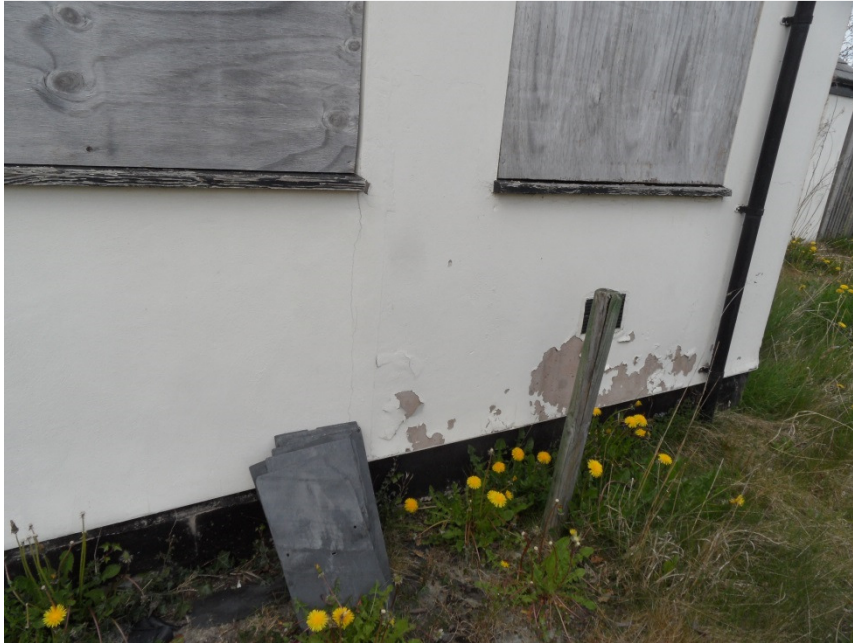
- 4.4 That to the right hand side is a felt covered flat roof single storey extension.
- 4.5 Rainwater goods exist at eaves level discharging into a rainwater pipe situated to the right hand side.
- 4.6 This is perforated by three windows set at equal distance. Vertical cracking is noted to the render to this portion of the property. Cracking has developed to the left hand return to this elevation

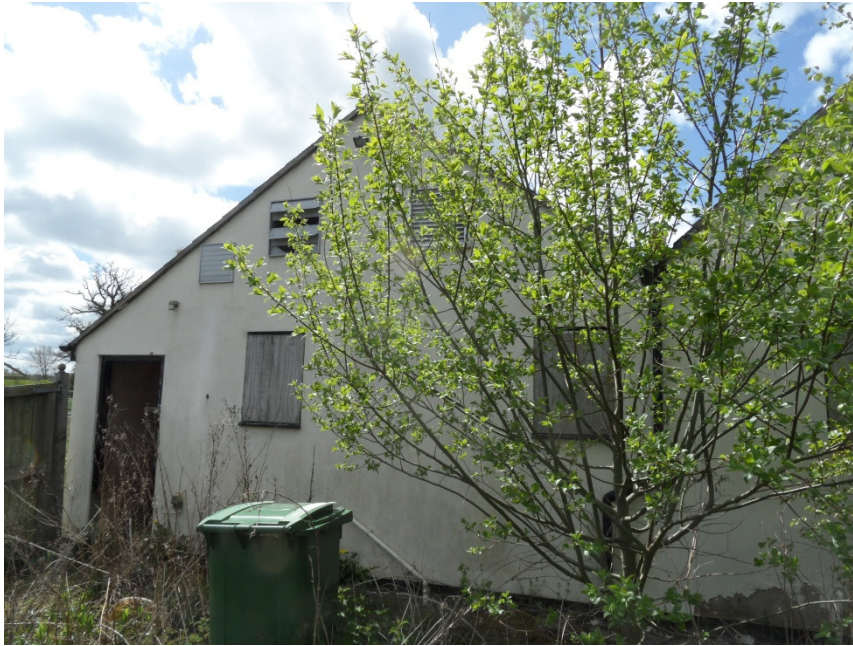
- 6.2 Rainwater goods are situated at eaves level discharging into a rainwater pipe situated between the two windows.
- 6.3 To the left hand side the elevation as two gables and is of single storey construction with a doorway situated at the left hand corner. Diagonal cracking was observed radiating from the left hand head of this door.

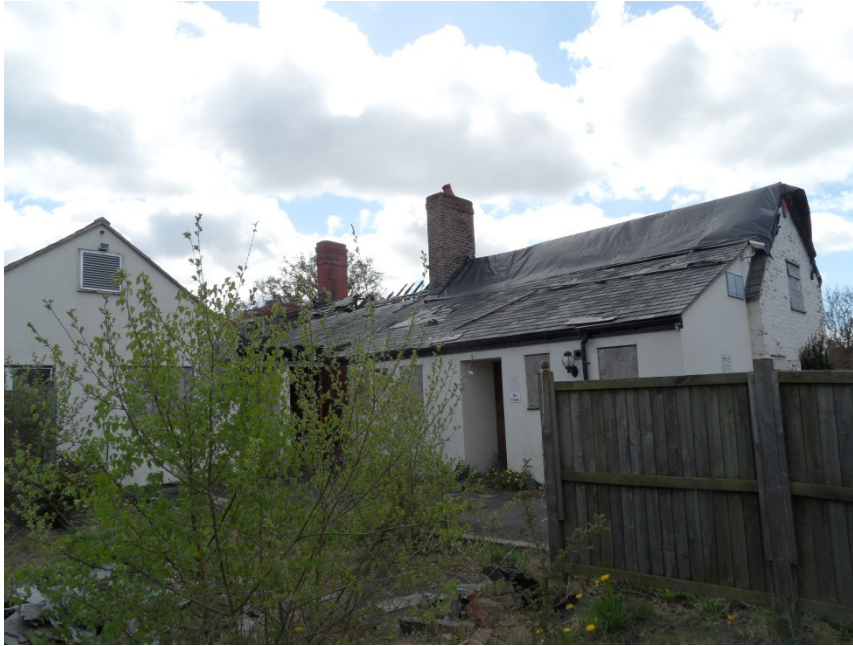
- 6.4 The remainder is perforated by three windows with a rainwater pipe being situated centrally which collects the discharge from the valley gutter. There is a vertical crack to the right of this rainwater pipe as there is below the window to the right hand side. Various vent apertures are noted to the left hand side below the verge position. To the right hand side a flue is in position with the elevation being perforated by various pipework.
- 6.5 The rest of the elevation is set back to the original structure and is a monopitched addition. It is rendered and perforated by various openings.

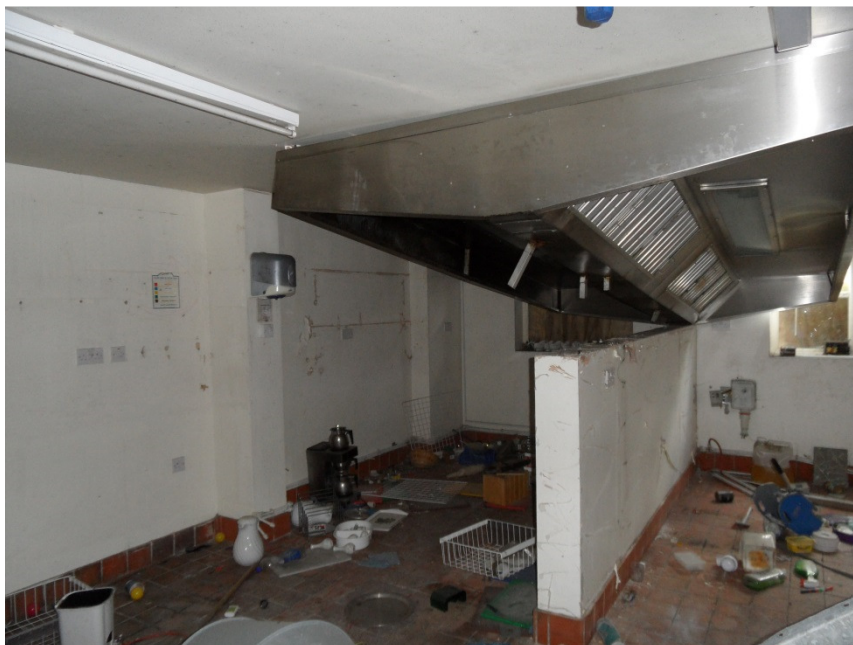
- 11.1 The kitchen has a quarry tiled floor with painted plasterwork to the walls and ceilings.
- 11.2 Some undulation to the floor is noted within here. Above the head of the doorway at the left hand side an area of the plasterwork has broken away with the beams to the walls also being missing.
- 11.3 An area of the ceiling has collapsed around the loft hatchway. The extract canopy which hung from the ceiling as partially collapsed since last viewed.

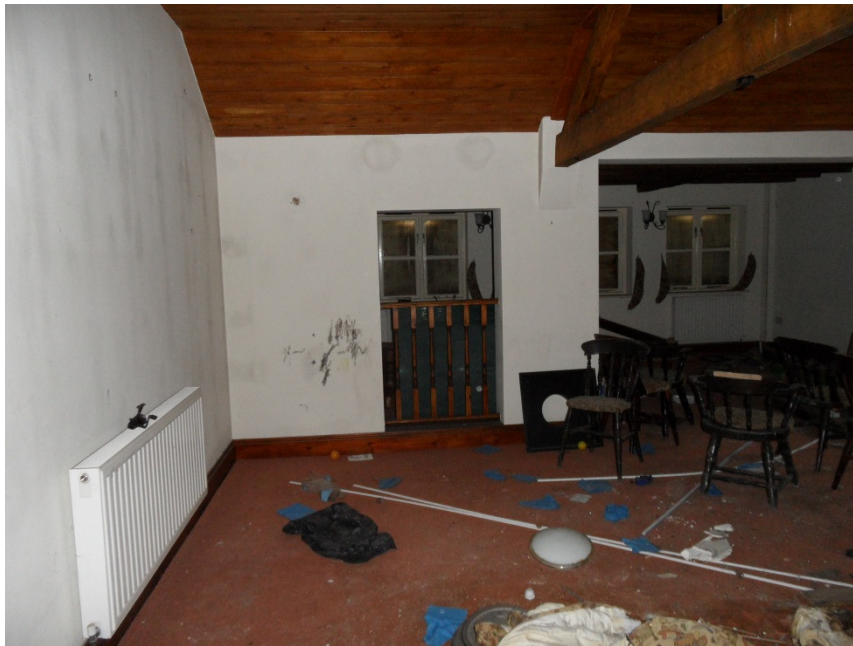
- 12.2 There has been extensive mould growth to the walls and damp penetration occurring was observed throughout this section

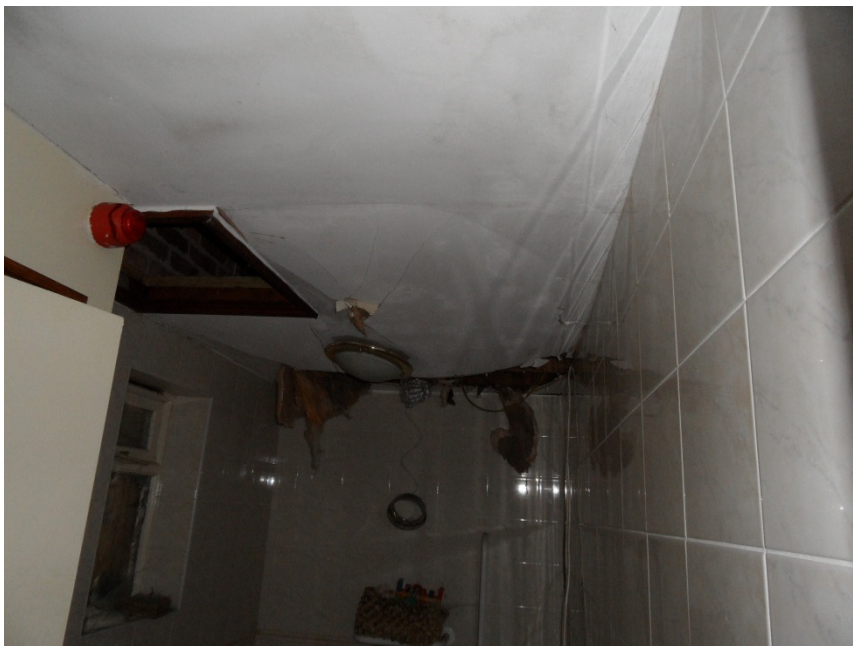
- 16.1 This is in a similar condition to the gents.
- 16.2 A large portion of the ceiling at the far end has is collapsing within here.

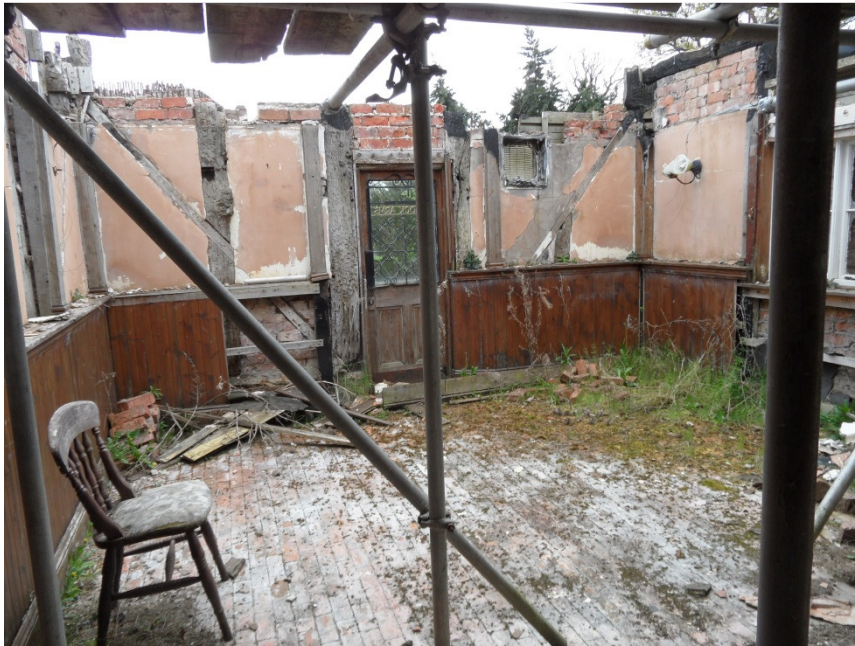
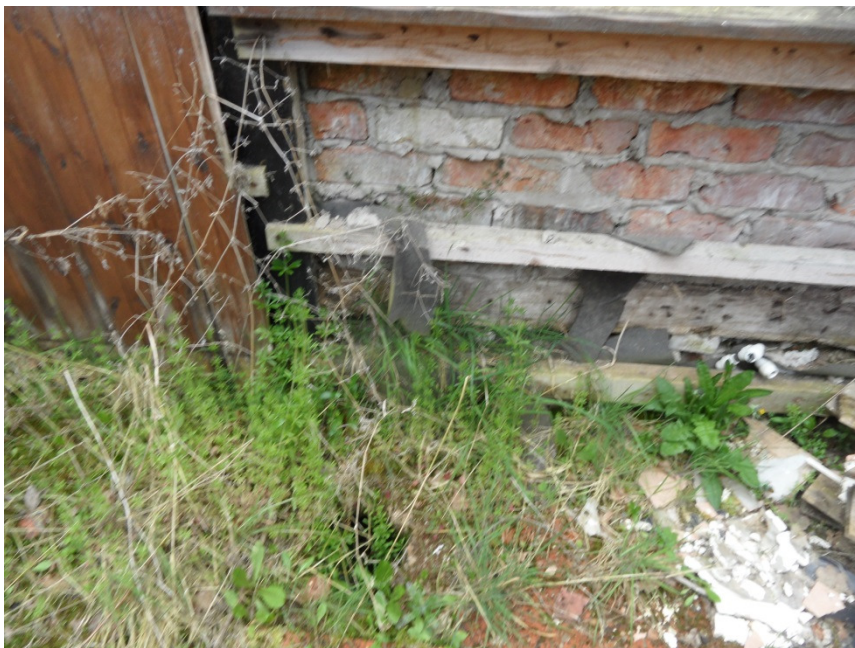
- 17.1 This is divided in two with the restaurant area being situated to the right hand side as viewed from the external entrance doorway. Within this area the ground floor is of timber. Extensive vegetation growth was noted to the area against the gable wall.

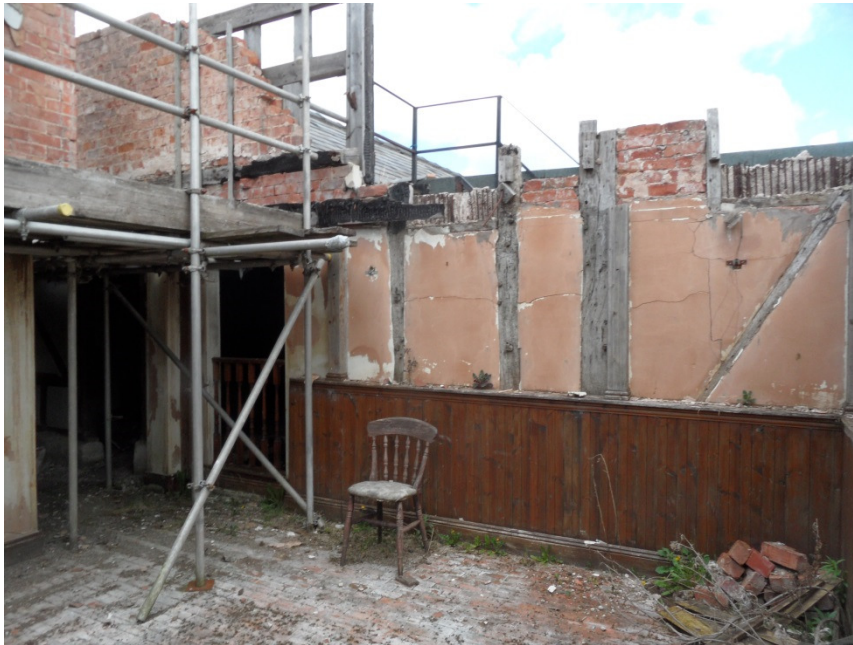
- 17.4 Cracking and disturbance was observed to the external walls mirroring that noted externally.

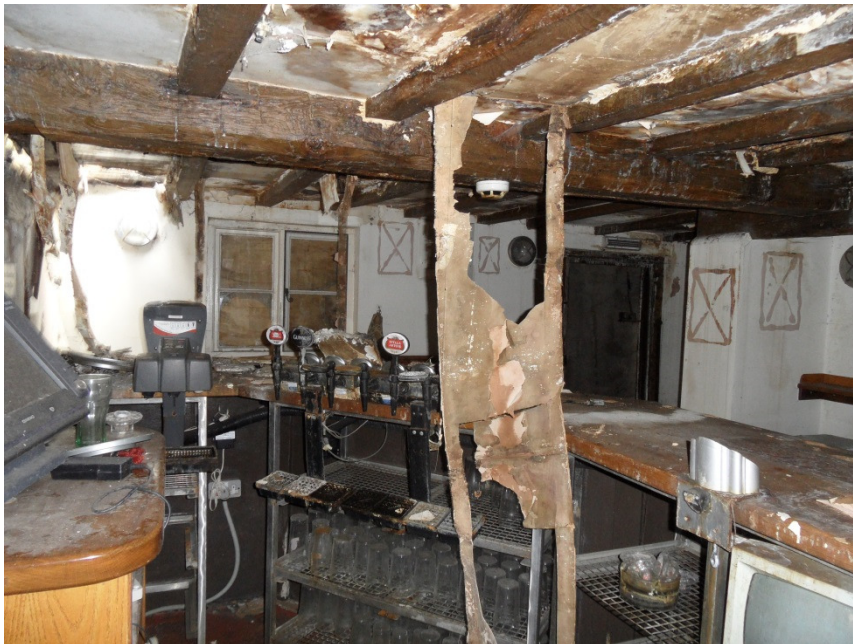
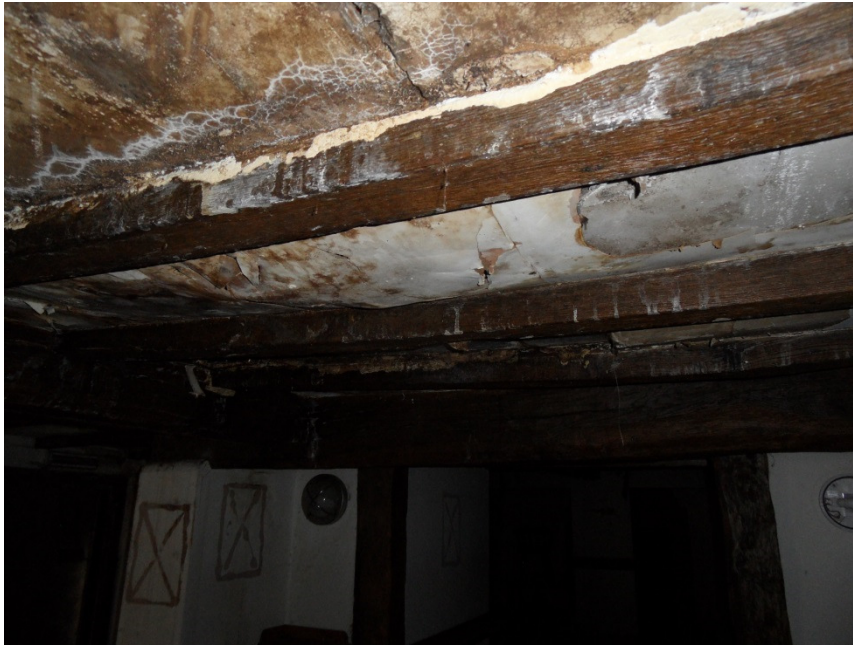
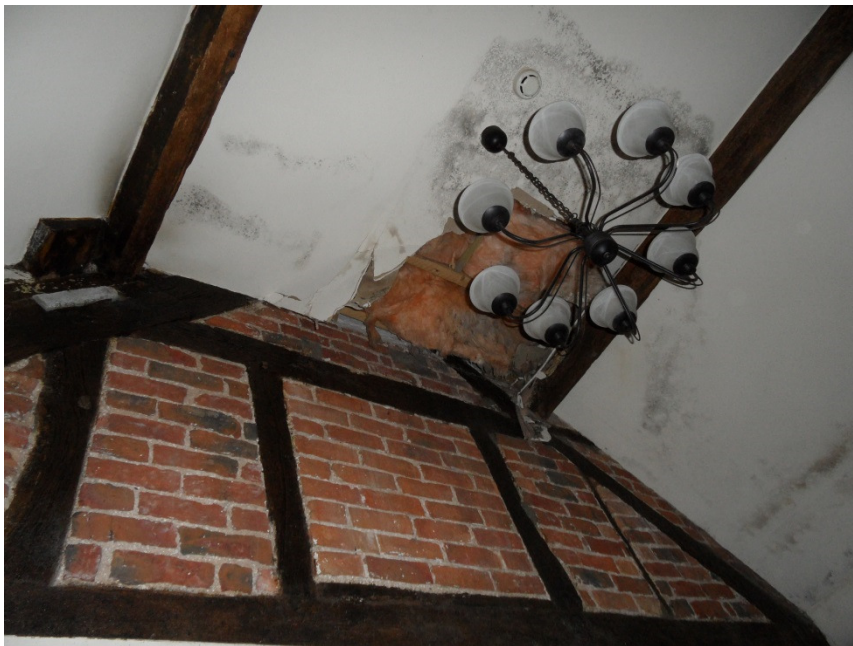
- 20.1 This again is split into three sections with that nearest the bar the main section in the middle and a snug around the fireplace at the gable end.
- 20.2 The floor within here is of quarry tile on slab on solid. The walls are painted plasterwork as is the ceiling.
- 20.3 Extensive damp ingress was noted to all external surfaces with localised collapse of the ceiling happening.

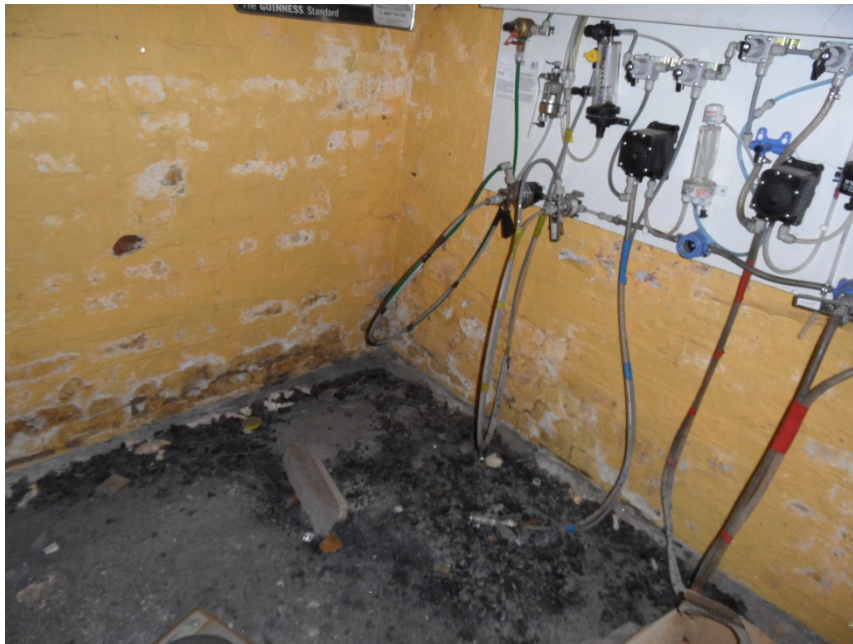
- 23.1 This is accessed off the lounge bar area via concrete steps which have tiles on them.
- 23.2 Within the cellar this has a painted concrete floor with painted masonry walls. There is painted plasterwork to the underside of the ceiling.
- 23.3 Again the timber supports are visible within here. Damp is noted to the basement walls within this portion of the property.

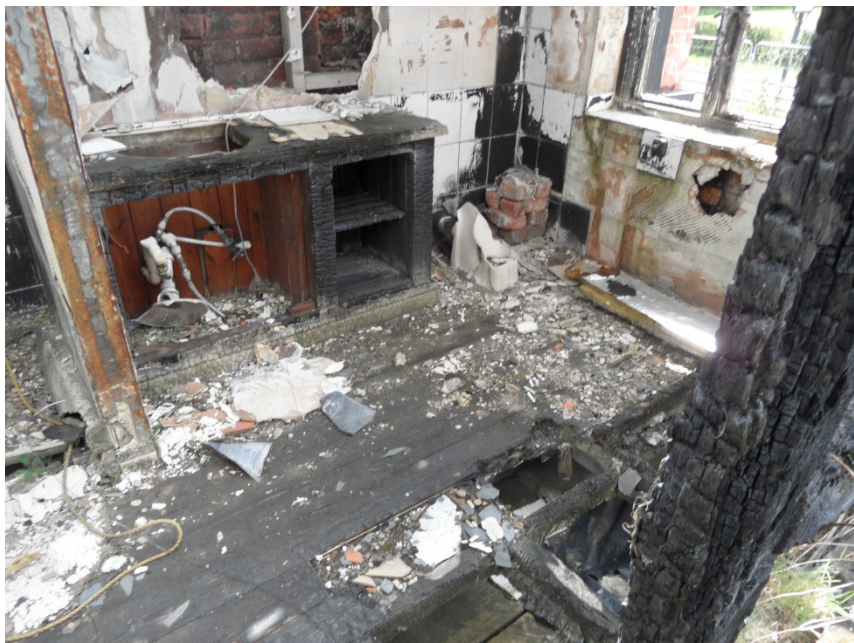
27.1 Some relaxation of the structure was observed in this part of the property.

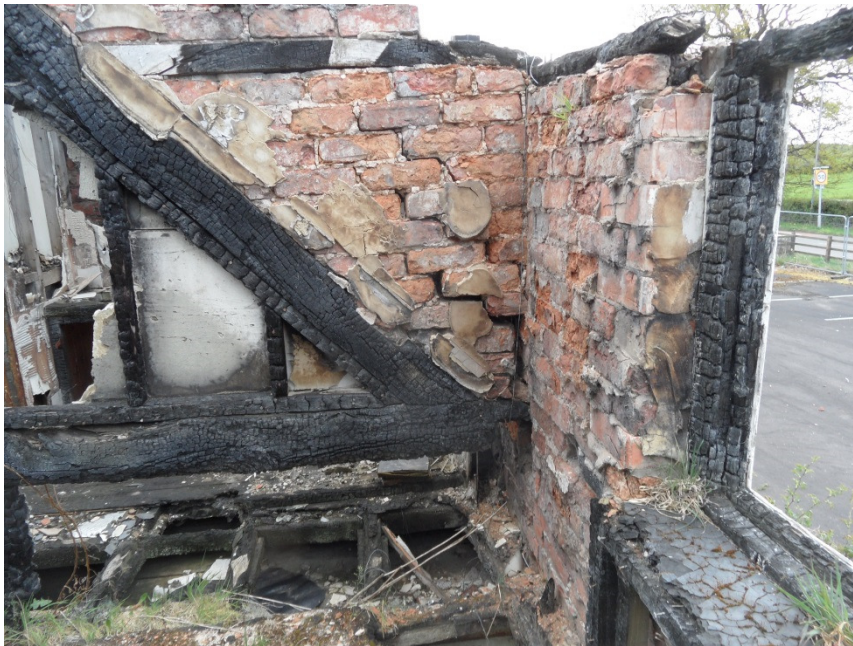
- 28.1 This has a chipboard floor which has been laid over suspended timber construction. Part of this has collapsed particularly against the front east elevation. The majority of the boarding has been removed exposing the timber studding behind in the main this has been charred away.
- 28.2 To the division wall between this room and the bathroom adjacent the front elevation diagonally cracking and movement is developing to the masonry. This is allowing the front wall to bow outward

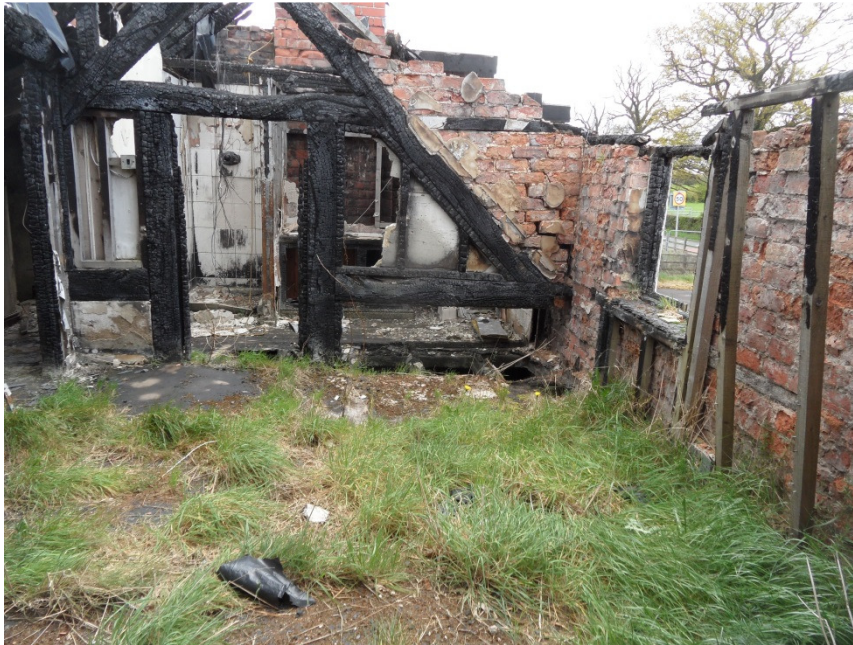
- 28.3 Again the roof structure has been removed in this area. Extensive vegetation growth is occurring to the first floor with localised collapse of the same

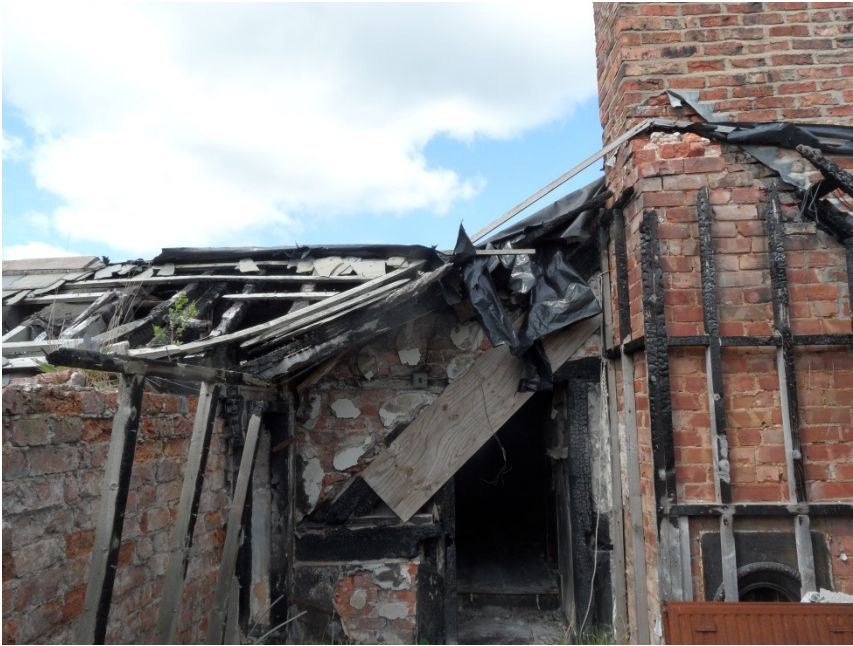
- 28.4 Some of the timber framing is detaching itself from the masonry.
- 28.5 A portion of the roof as collapsed above the entrance doorway into the bedroom with the roof area adjacent disturbed with vegetation growth occurring.

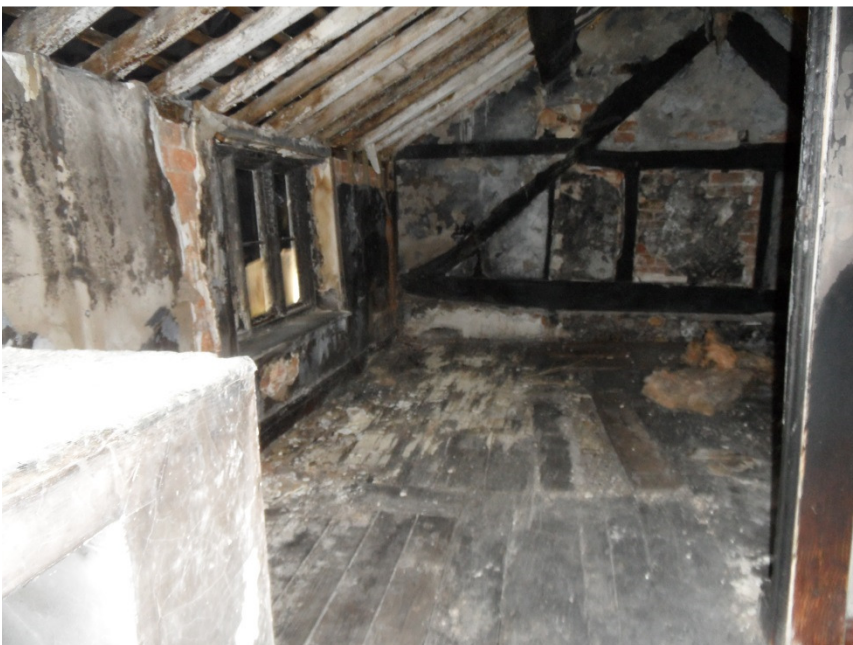
29.1 It would appear within here that the front elevation wall is deflecting outwards at eaves level.
