Wrexham Magistrates & County Court  
Chester Street  
Wrexham  
Clywd LL13 8XN

Underground  
CCTV Survey

| DRAWING No: 12055 UG_CCTV | REV: 0 |

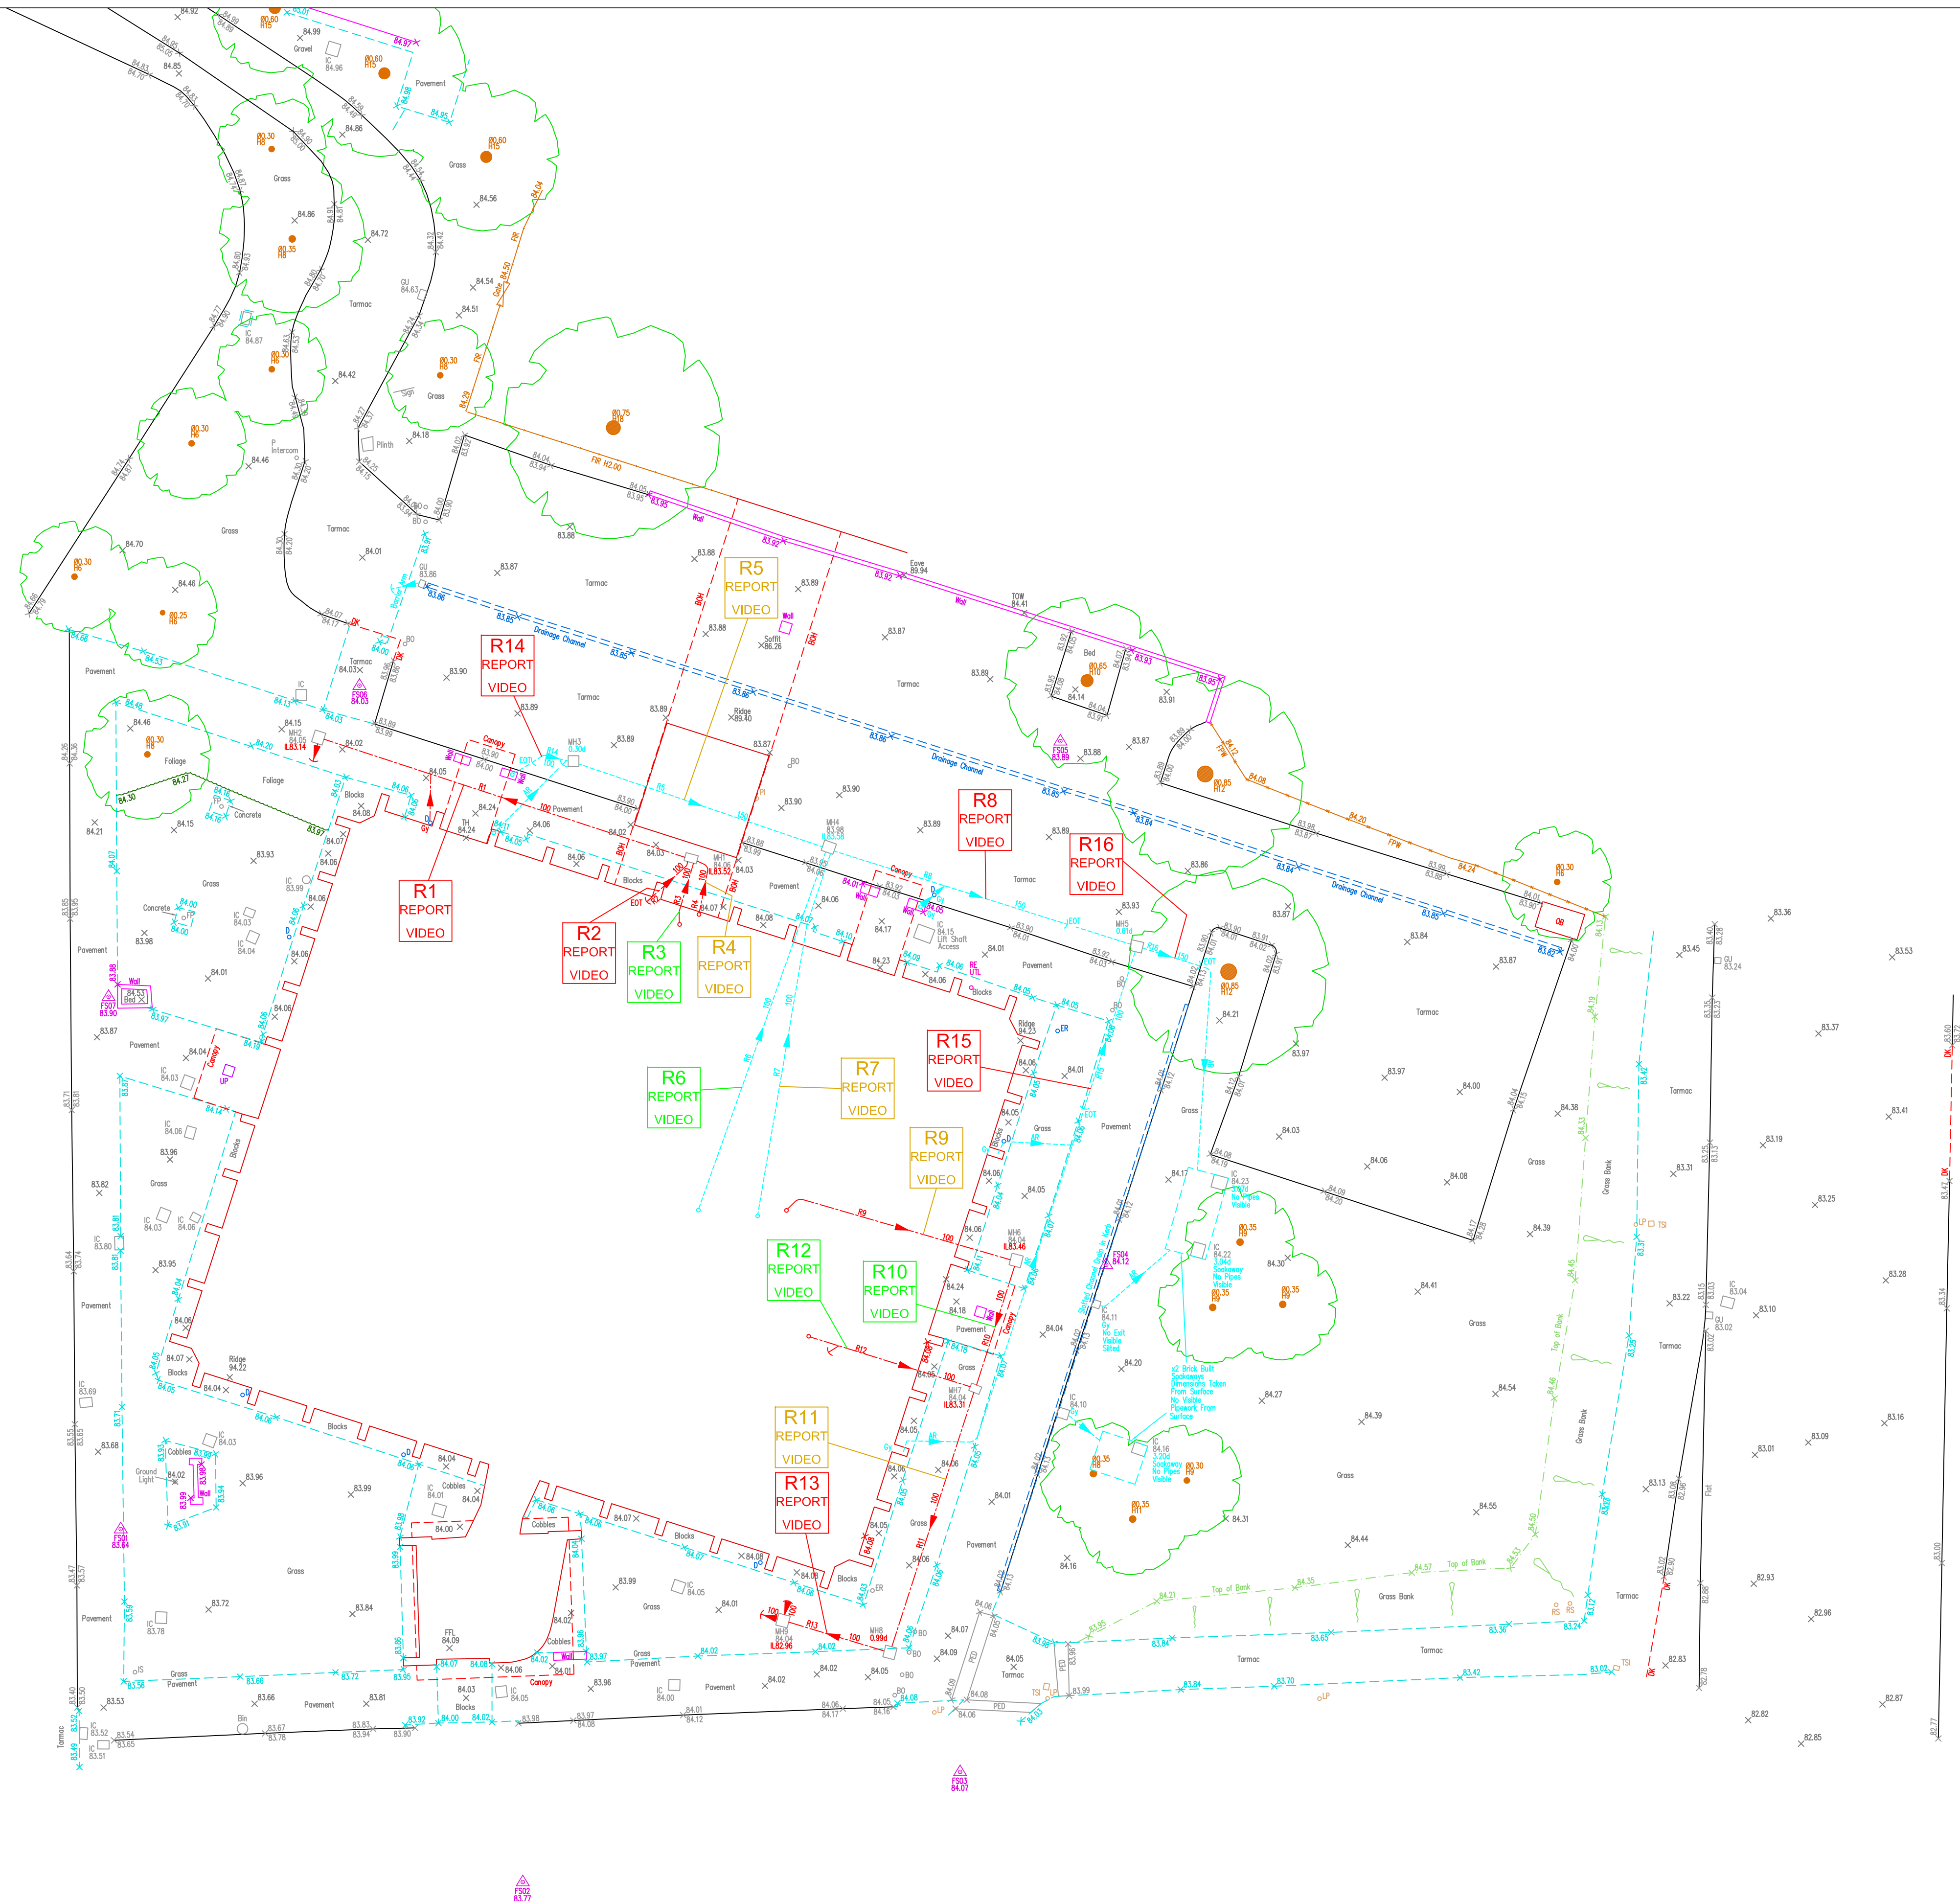
Root cutting required to clear Surface Water Sewer  
However, height restrictions will prevent access to car park area.  
Surface Water Sewer is heavily blocked with silt and root ingress.  
Drainage pipework was found to have been laid shallow beneath the car park surface leaving pipework at risk of damage.  
Routes of pipework have been assumed where condition has prevented the pipework being surveyed.  
MH5 - see photos  
Large root masses were removed from chamber and downstream.  
Further root masses remain in pipework.  
Surface Water assumed to soakaway.
