5th June 2019

Ref: K0871/pw

**WILLIAMS FARM: WREXHAM INDUSTRIAL ESTATE:  
REVIEW OF DRAINAGE MEASURES**

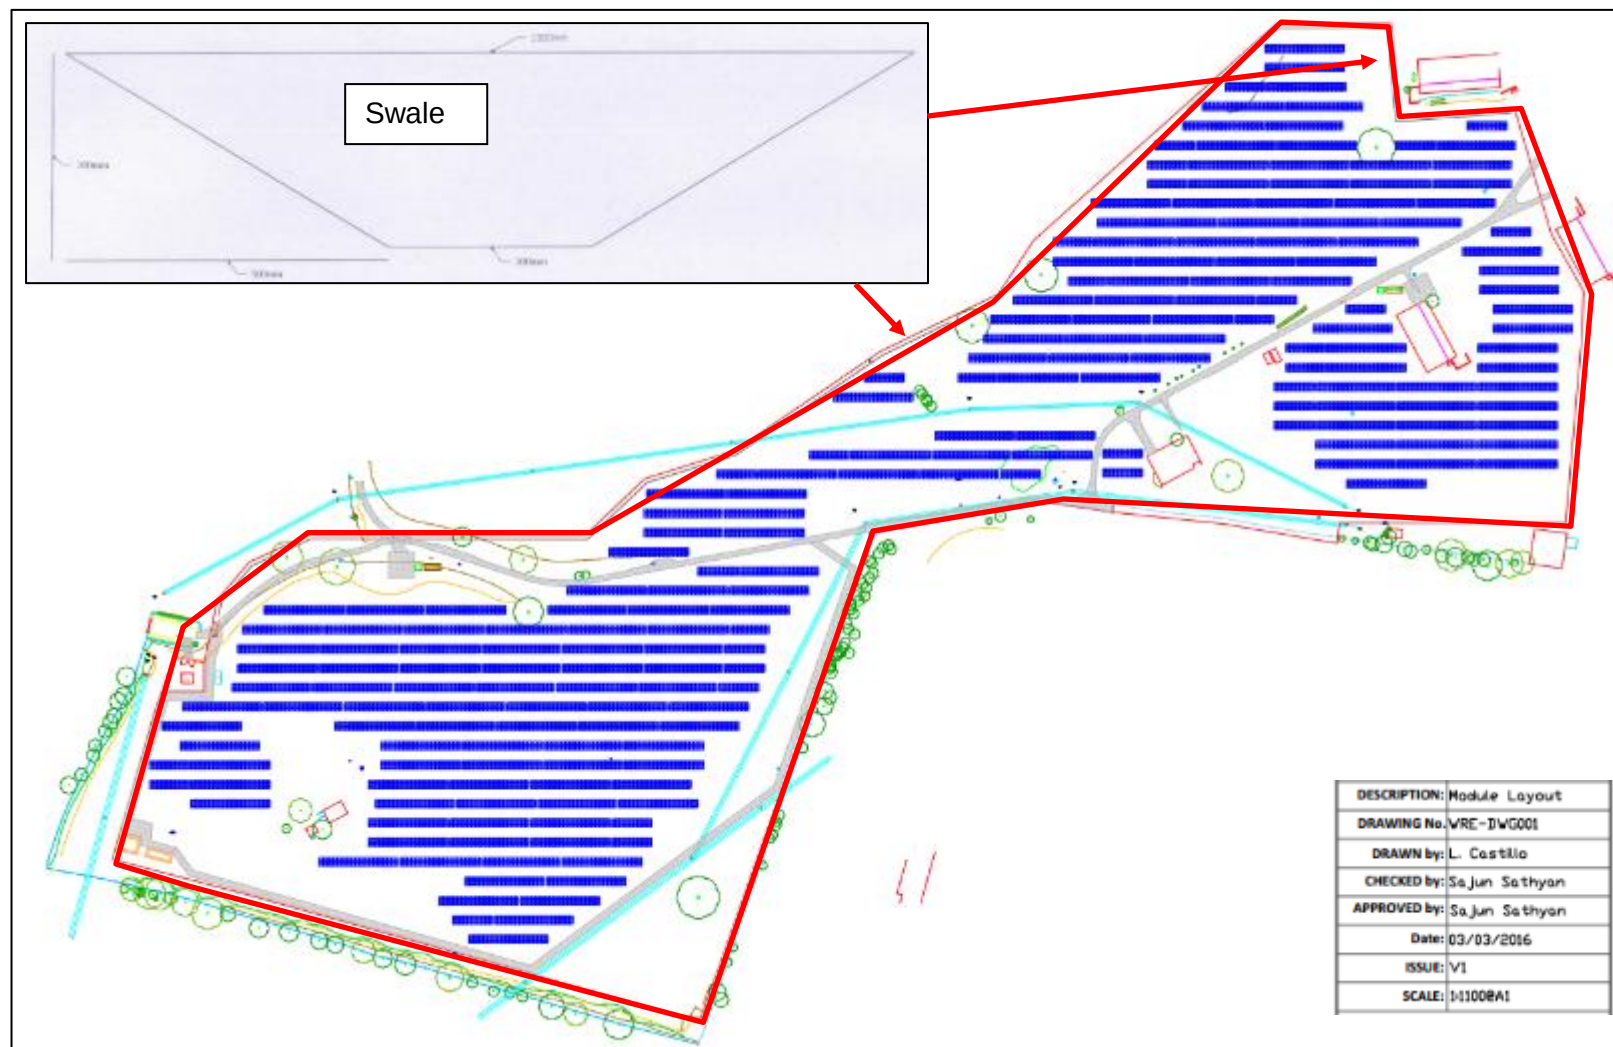
Figure 2: Proposed drainage measures as per the SWMP

The drawing shows a series of swales along part of the Site boundary. Their combined length is given as 600 m in the report with nominal dimensions shown on the inset to Figure 2 and comprising bottom width of 300 mm, top width of 1300 mm and depth of 300 mm.

The basis for the sizing of swales is not clear from the Report. The swales provide 144 m<sup>3</sup> of storage which is greater than a calculated volumetric requirement of around 130 m<sup>3</sup>.

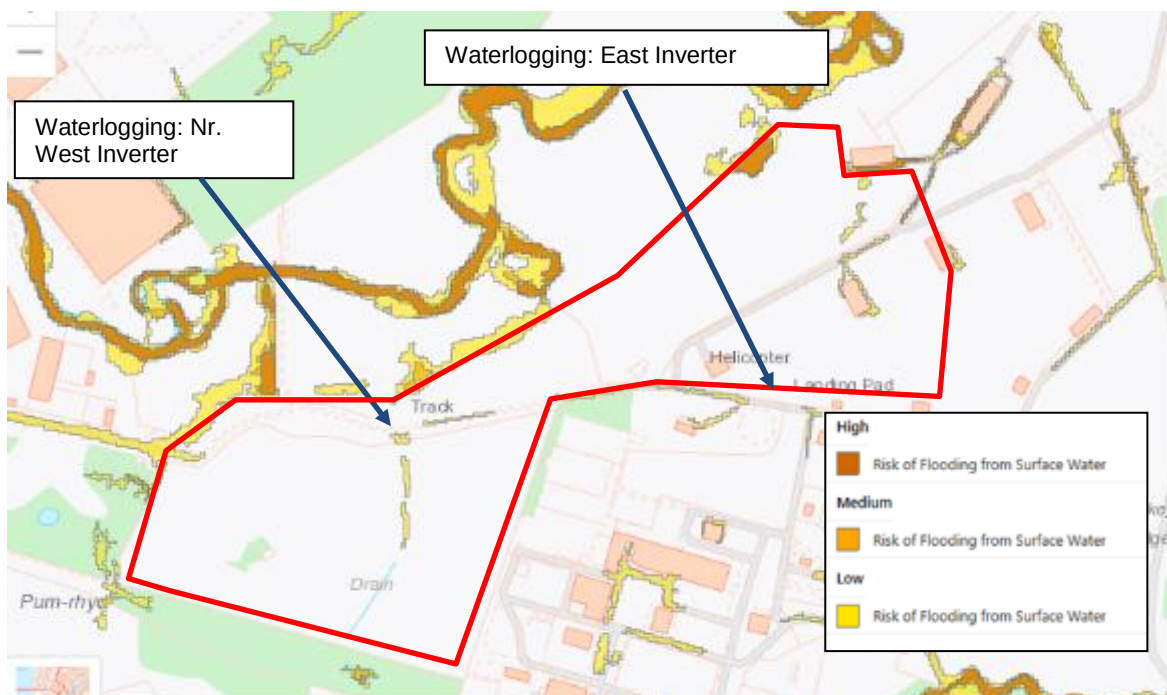
**Figure 4: Surface Water Flood Risk (NRW Web Site) with locations of waterlogging**

Extracts from the NRW (Natural Resources Wales) Web Site are given in Figure 3 for Fluvial Flood Risk and Figure 4 for Surface Water Flood Risk. This shows that the Site lies almost entirely within Fluvial Flood Zone 1, with an annual exceedance probability (AEP) of flooding of lower than 0.1% (very low category). There is minor encroachment into flood zones along the north western boundary, but this is of no practical consequence. The majority of the Site is at very low risk of surface water flooding being unshaded in Figure 4. The exception is a small area on the north western margin where there is a high risk.

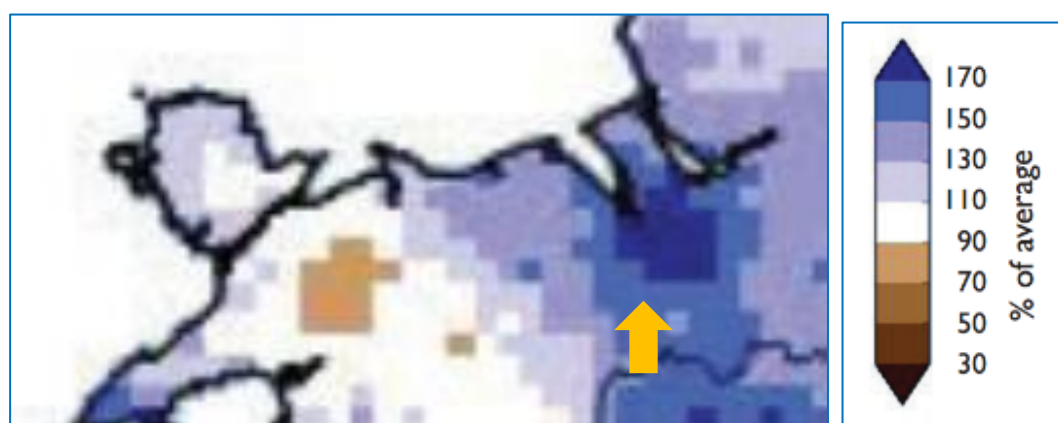
**Figure 6: Rainfall for March & April 2018**

The Site Visit took place on 9<sup>th</sup> May 2018. The visit took place during dry conditions, but it was noted that the previous months had been wet, the CEH Monthly Bulletin showed that March and April had received between 150 and 170% of the long term average for that period (Figure 6). The site visit was thus taking place at a particularly useful time for observing any drainage problems.

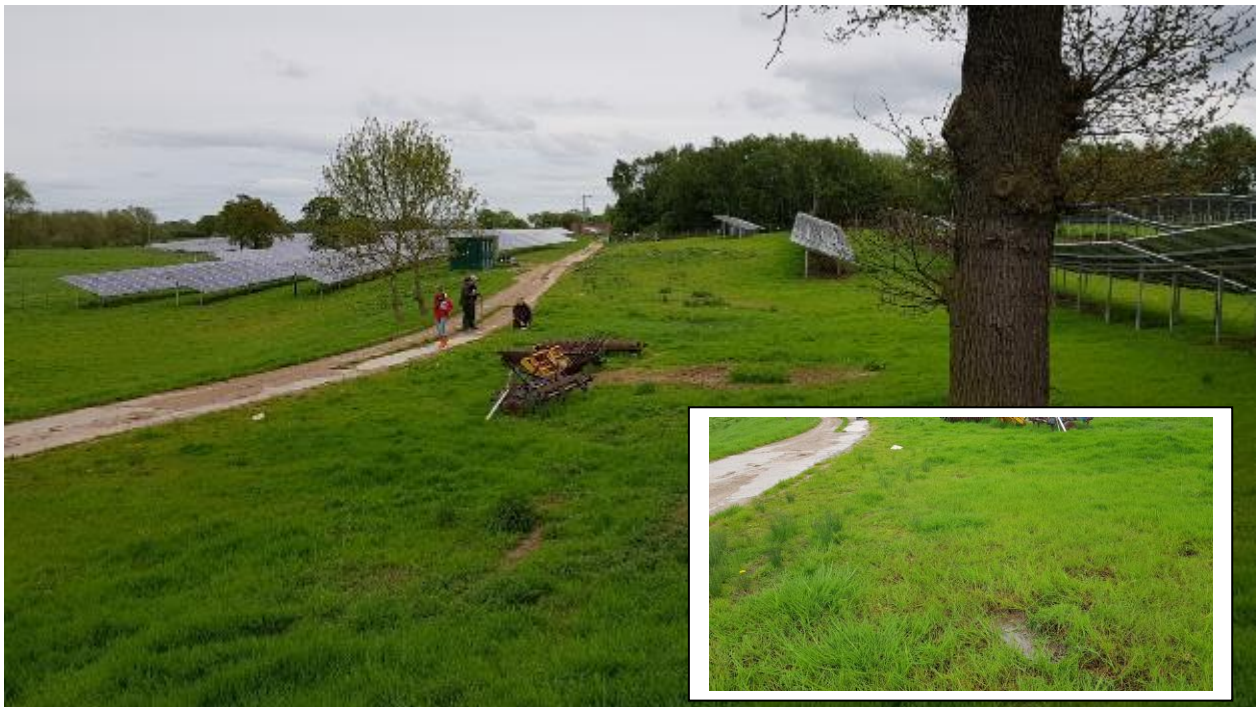
**Figure 7: Area of waterlogging near the west Inverter set (#1)**

The first of these is shown in Figure 7 where the topography converges on a shallow depression, just south of the access road that was wet at the time of the visit. The dry sediment on the road surface showed that at times, this area did spill to the north, but it was not doing so at the time of the visit. The land that feeds to this wet area was investigated and is shown in Figure 8. It also seems to suffer from intermittent waterlogging, likely due to soil texture and the shallow slope and the presence of a blue-line (marked as a drain) on Figure 4.

*Inset shows water at surface*

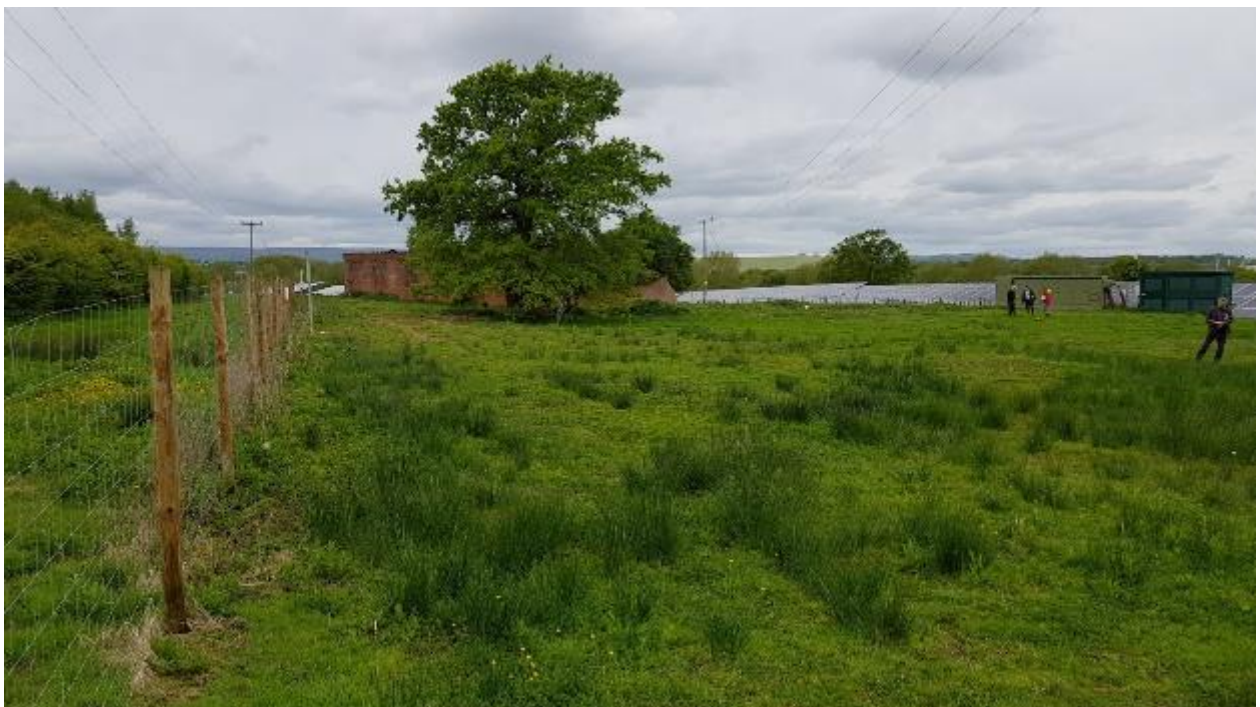
**Figure 9: Area of waterlogging resulting from runoff onto the Site – south of Inverter set #2**

The second area of pronounced waterlogging was also on the southern boundary and south of the East inverter set. This is shown in Figure 9 and results from water entering the Site from the south. It appeared as if road surfaces were draining informally onto the William's Farm site. This is therefore an "inherited" drainage problem for which there seems little that can be done currently to avert it. It is posing no practical problems for the operation of the Site.

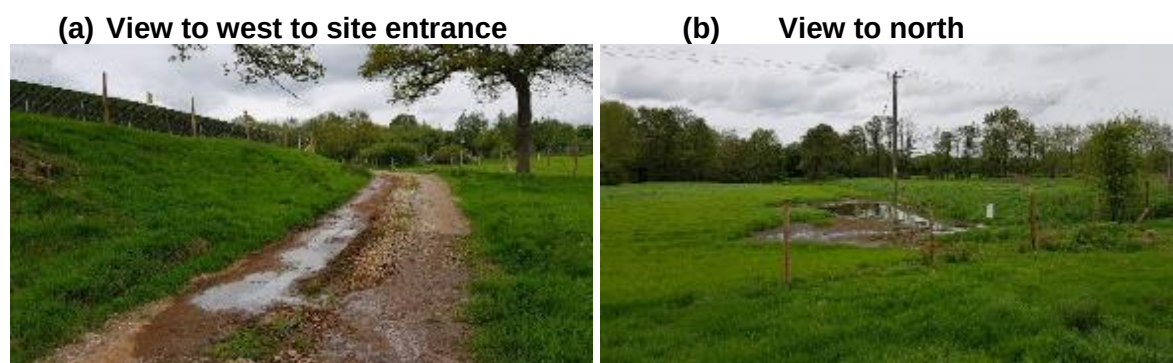
**Figure 10: Ephemeral Spring (May 2018)**

An ephemeral spring was also noted during the May 2018 visit. It is understood that this is dry for much of the year, but that its recent activity owed much to the above average rainfall leading up to the visit (Figure 10). It is an historic feature and its activity is not related to the solar farm. The spring was not active during the April 2019 visit (Figure 11).

Note that the water that is visible in Figure 10b is outside the red line boundary. This accumulation can be seen on the NRW Surface Water Flood Map (Figure 4) where there is a “high” risk.

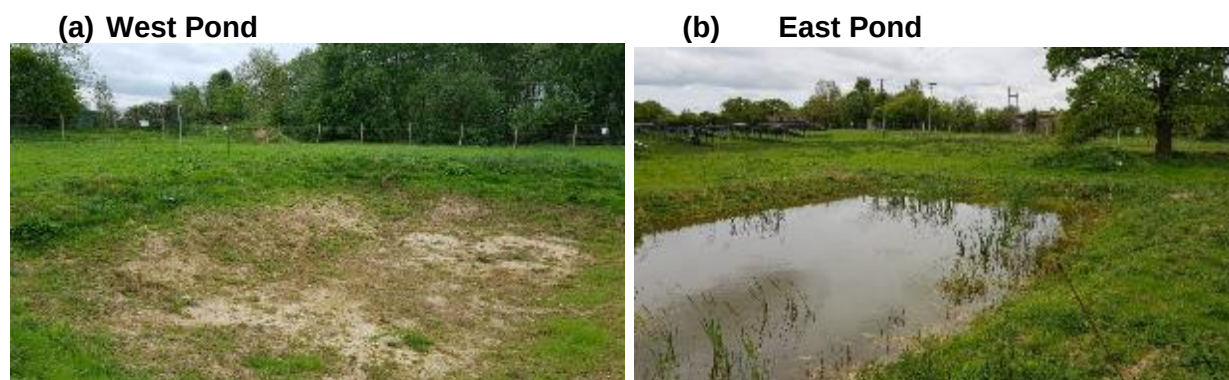
**Figure 12: Newt ponds**

Two newt ponds had been constructed – one in each of the principal fields. The photos in Figure 12 show how the west pond was dry; this was hardly surprising given that there was no catchment draining to it and the texture of the bed was found to be silty/sandy and unlikely to hold water. The east pond was holding water, reflecting both a reasonable inflow and an ability to hold water.

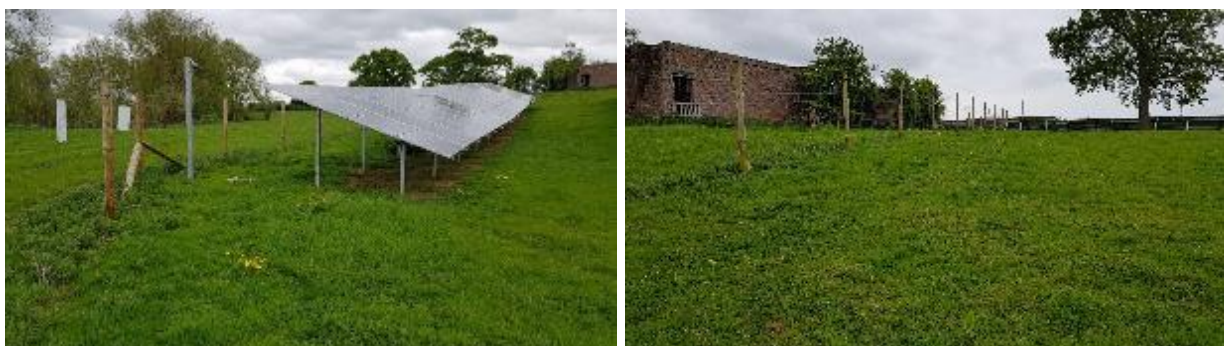
**Figure 14: Part of Section AB**

Section AB is on the northern margin of the Site. The SWMP had proposed a swale in this Section. However, the photos in Figure 14 show that there would be virtually no runoff over the Site boundary due to the topography. **No swale is thus warranted in this Section.**

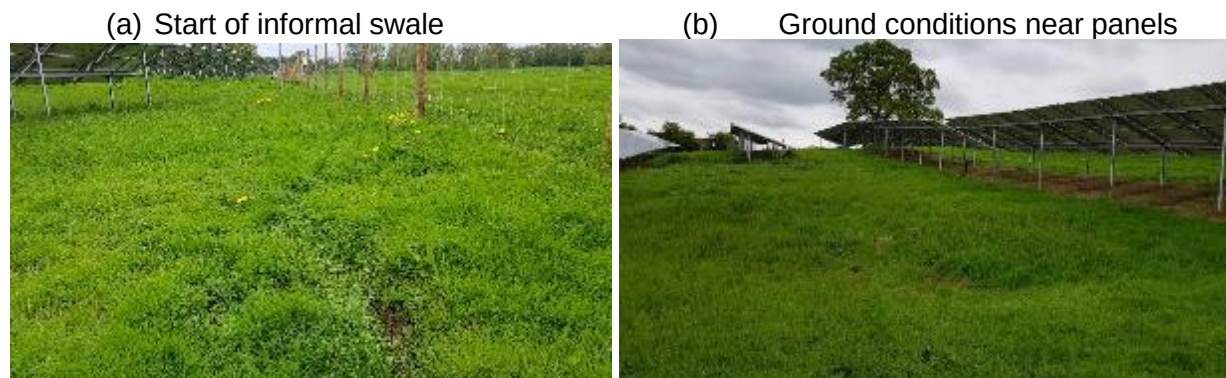
**Figure 15: Part of Section BC**

The SWMP proposed a swale for a short part of the Section BC. In practice, an informal swale exists along the entire length of BC (Figure 15a). It has a width of around 1 m and depth of up to

0.25 m. There was no indication of any waterlogging along its length. Similarly, there was no indication of excess runoff from the panels, even on the relatively steep slopes as shown in Figure 15b.

It was concluded that the informal swale, as constructed, provided a suitable buffer for any runoff that may drain from this part of the Site during an extreme storm. **No additional measures are required for this Section.**

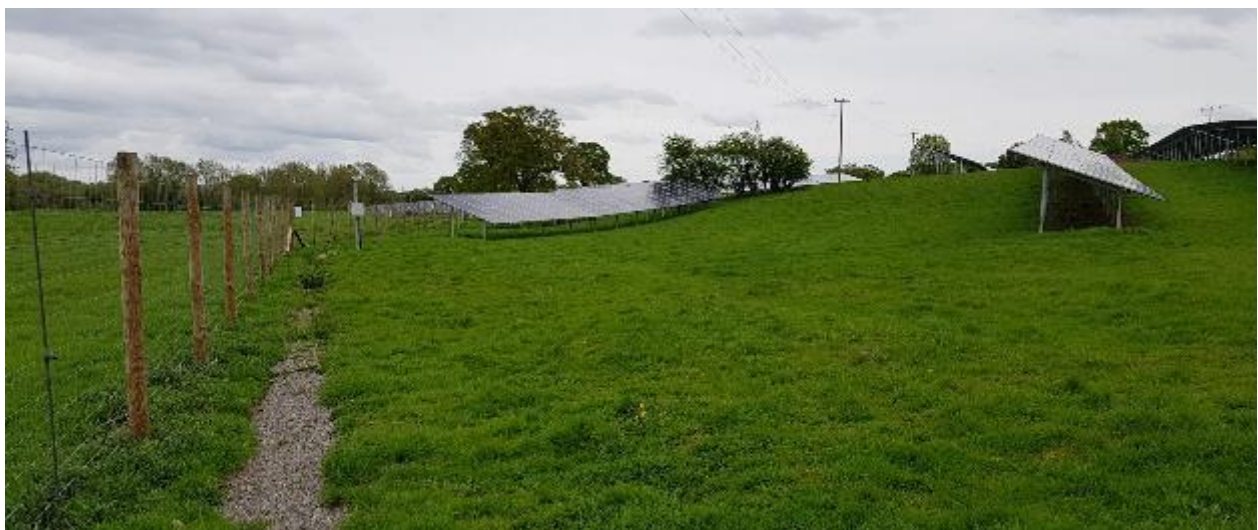
**Figure 16: Part of Section CD**

A swale was proposed in Section CD in the SWMP. Whilst a formal swale has not been constructed, there exists a gravel-filled cable trench (Figure 16). The width of the gravel varies from about 0.5 to 0.8 m, as measured in April 2019. Excavation of the gravel showed that it was to a depth of around 0.4 m (Figure 17). Since the gravel is coarse and angular, it provides a suitable medium that would provide both storage and some opportunity for infiltration, albeit at a slow rate.

It was concluded that the existing measures in the Section CD are adequate and would provide a suitable buffer for any excess runoff from this part of the Site. **No additional measures are required for this Section.**

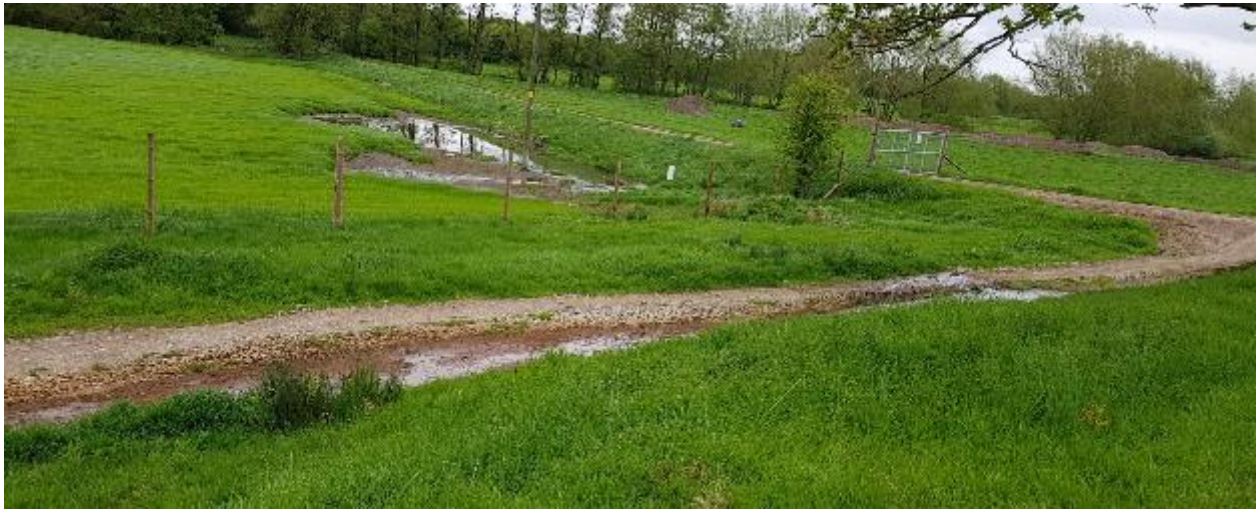
**Figure 18: Informal pond (May 2018)**

The SWMP proposed a standard swale in this Section. However, none has been constructed. In practice, the need for a swale is difficult to justify, given the fact that the road (Figure 10) would intercept any excess flow prior to discharge to an informal pond that exists on the western side of a track that leads north, across the flood plain (Figure 18). The pond was dry in April 2019 which is most unusual for the time of year.

**It is concluded that no drainage measures are required in Section DE.**
