## OUTBUILDINGS AT HOSELEY HOUSE, MARFORD

### PRELIMINARY BAT ROOST ASSESSMENT AND EMERGENCE SURVEYS

Report Ref EE.454.LB

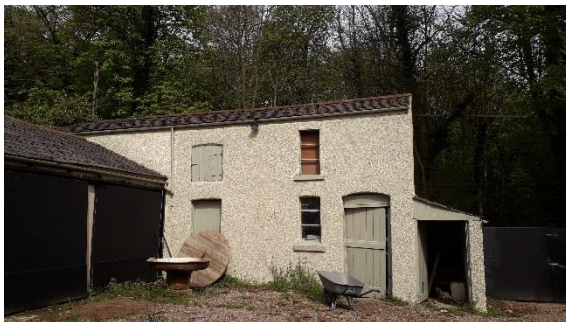
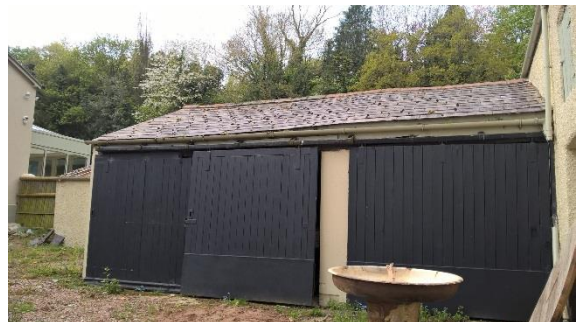
- 4.1.1 The outbuildings comprised a main two storey section with the roof line running east to west (Photo 4.1) and perpendicular to this was a single storey garage section with the roof line running in a north south direction (Photo 4.2). There was also a small lean-to on the eastern gable of the main section and also a small mono-pitched building on the southern gable of the garage section, which had no roof (Photo 4.3).

**PHOTOS 4.1 & 4.2 MAIN TWO STOREY SECTION AND ADJOINED GARAGE SECTION.**

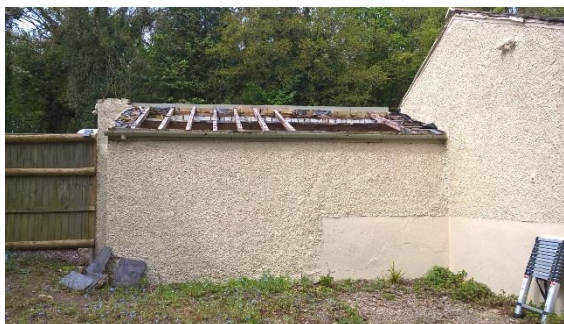
**PHOTOS 4.3 MONO-PITCHED BUILDING ON THE SOUTHERN SIDE OF THE GARAGE**

5.1.2 The mono-pitched adjacent to the southern end of the garage was in a poor condition with no roof and there were large cracks in the brickwork.

5.2.4 The brick walls of the mono-pitched section had large cracks in them creating a number of gaps.

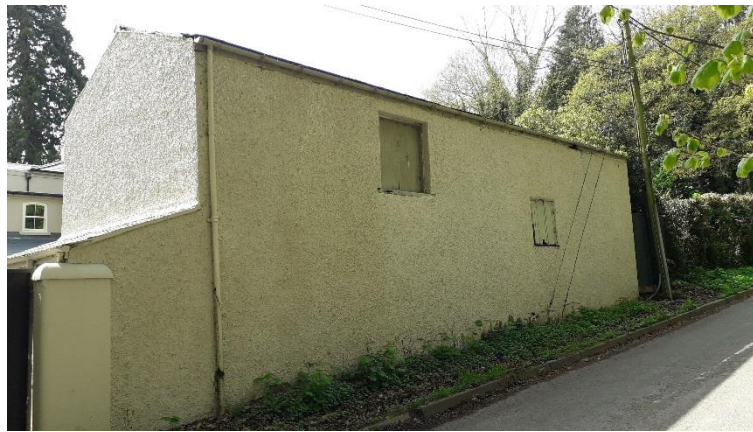
- 4.1.3 The northern side of the main building backed directly onto Park Lane, with a large area of broad-leaved woodland beyond (Photo 4.4).

**PHOTO 4.4. NORTH SIDE OF THE MAIN SECTION ADJACENT TO PARK LANE.**

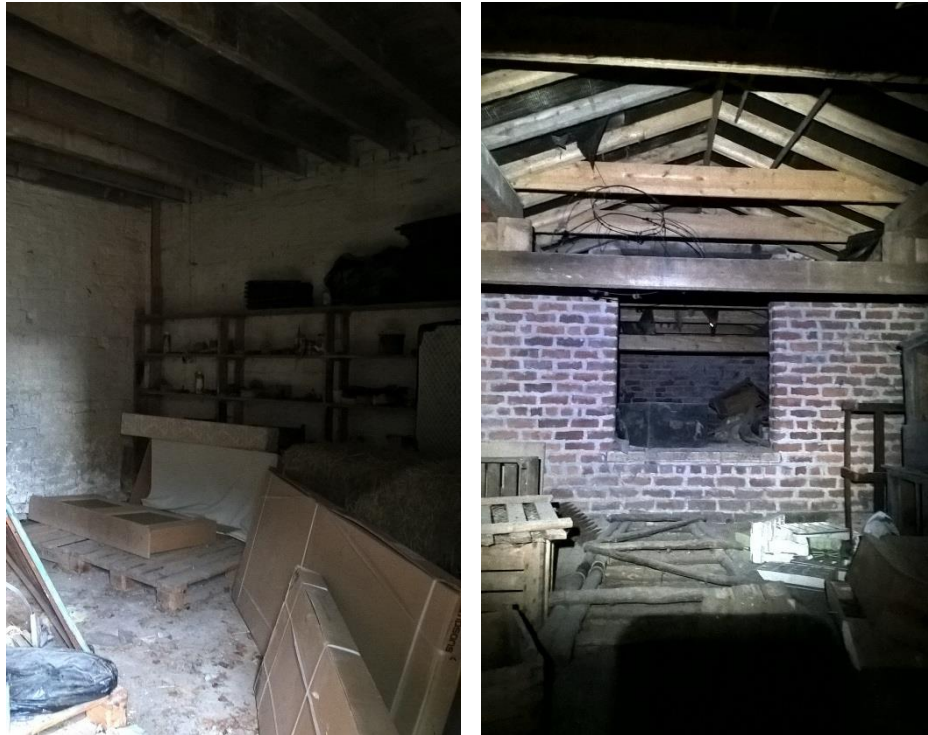
- 4.2.1 The ground floor of the main building comprised one large room (approx. two thirds of the ground floor) on the eastern side, accessed through an external doorway and a smaller room to the west, accessed through the garage (Photo 4.5). The walls were bare painted brick and the ceiling joists were exposed. Both rooms were in use for storage. The first floor had an open roof with a height of approx. 2.5m (Photo 4.6). The roof timbers were exposed and the roof lined with bitumen felt. There was an internal wall, which corresponded with the ground floor dividing wall, however there was a large opening allowing for free movement between the two rooms.

*PHOTO 4.5 & 4.6. GROUND FLOOR AND FIRST FLOOR OF THE MAIN BUILDING.*

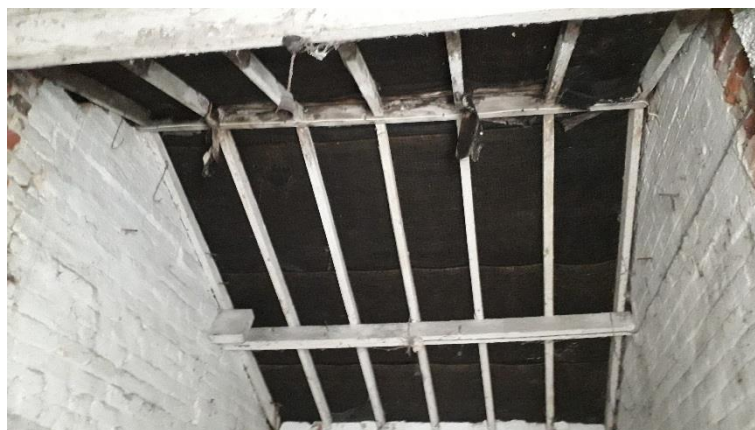
- 4.2.2 The garage section was split into two sections with the entrances comprising large sliding wooden doors. Internally both rooms were open to the roof with exposed timbers and were lined with bitumen felt (Photo 4.7). Both sections were used for storage and the southernmost section had plastic sheeting hanging from the joists covering approx. two thirds of the room.

*PHOTO 4.7. ONE OF THE TWO GARAGE ROOMS.*

5.2.3 There was a large gap along the top of the sliding garage doors, which led directly into the garage spaces. There was a large crevice in the internal brick work of the garage and also gaps where the gable end rafters met the walls. The bitumen was in a poor condition, however there were no obvious light gaps from the slates.

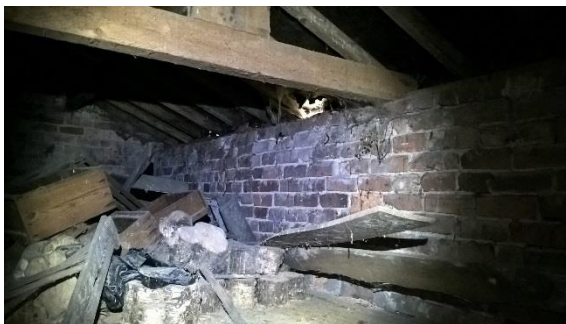
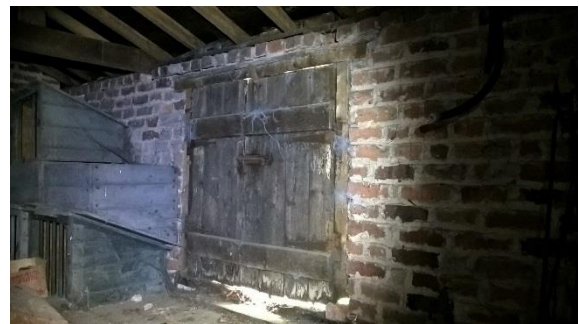
5.2.2 There was access from the ground floor up to the first floor through the open loft hatch and there were also a number of small areas of the ceiling, which were missing creating further access. On the first floor, there were a number of large gaps at the eaves, particularly on the northern side (Photo 5.1). The boarded hatches on both the northern and southern sides had gaps around the sides (Photo 5.2). The bitumen felt was in poor condition, however no light was visible between the slates above.

**PHOTO 5.1 & 5.2. GAPS AT EAVES AND AROUND BOARDING**

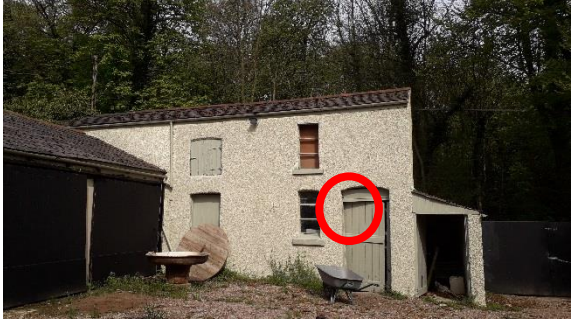
| No. | Time | Species | Location |
|---|---|---|---|
| 9 | 21:36, 21:45, 21:46, 21:49, 21:59, 22:02, 22:03(x2) & 22:07 | Brown long-eared | <p><b>PHOTO 6.1. LOCATION OF BLE EMERGENCE. *PLEASE NOTE AT THE TIME OF THE SURVEY, THE DOOR HAD COME OFF ITS HINGES AND SO THE DOORWAY WAS OPEN</b></p> |

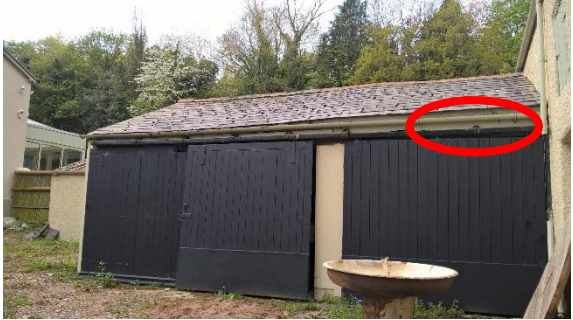
| No. | Time | Species | Location |
|---|---|---|---|
| 1 | 21:54 | Brown long-eared | <p><b>PHOTO 6.2. LOCATION OF BLE EMERGENCE FROM GAP ABOVE GARAGE DOOR</b></p> |

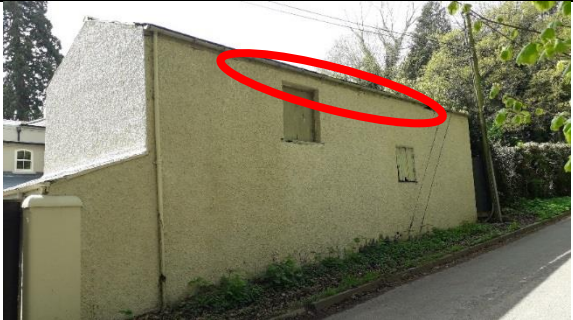
| No. | Time | Species | Location |
|---|---|---|---|
| 3 | 21:34, 21:47 & 21:57 | Brown long-eared | <p><b>PHOTO 6.3. LOCATION OF BLE EMERGENCE FROM THE EAVES ON THE NORTHERN SIDE OF THE BUILDING</b></p> |

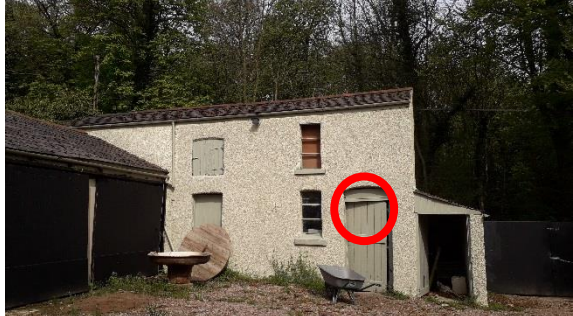
| No. | Time | Species | Location |
|---|---|---|---|
| 12 | 21:59, 22:04, 22:07, 22:11, 22:19, 22:20, 22:22, 22:24, 22:26, 22:28, 22:31 & 22:36 | Brown long-eared | <p><b>PHOTO 6.3. LOCATION OF BLE EMERGENCE.</b><br/>*PLEASE NOTE AT THE TIME OF THE SURVEY, THE DOOR HAD COME OFF ITS HINGES AND SO THE DOORWAY WAS OPEN</p> |

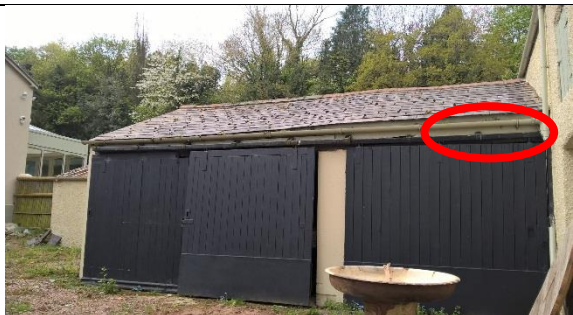
| No. | Time | Species | Location |
|---|---|---|---|
| 1 | 22:15 | Brown long-eared | <p><b>PHOTO 6.4. LOCATION OF BLE EMERGENCE FROM GAP ABOVE GARAGE DOOR</b></p> |
