REF: 1970/GLA/Plot 1 & 3/RepLet/mjs

9<sup>th</sup> August 2017

## **RE: GRANGO LANE PONCIAU: PLOTS 1 & 3: SHALLOW MINING ASSESSMENT**

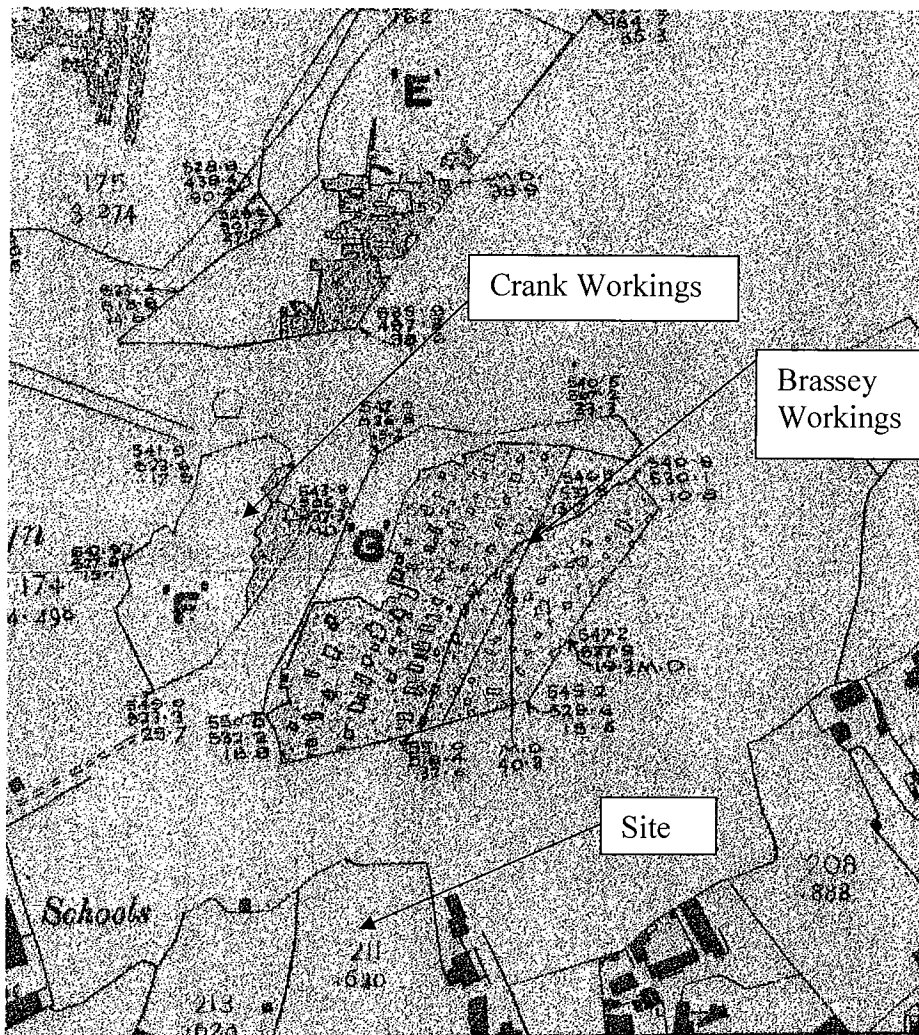
Plan NW 38

In addition, mine plan NW 38 held in GSL archives was inspected. This shows the opencast workings immediately north of the site, and immediately south of the Ty-Gwyn fault. This shows workings in the Top and Bottom Brassey seams and Crank seam, which would put the Brassey

seam outcropping immediately west of the site. It was proved to have been extensively worked with the top and bottom seams being some 3' thick (0.91m) and the underlying Crank seam being 1.807' thick (0.51) A section of this plan is presented below.

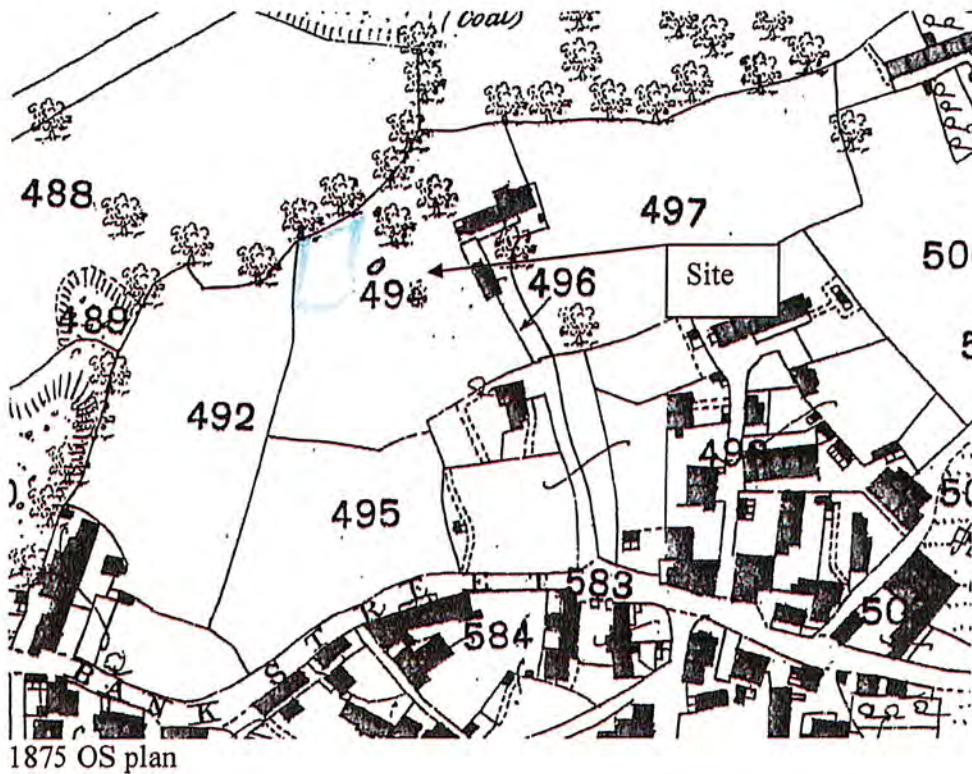
The 1875 OS plan held in GSL archives is reproduced below and fails to record any mining activity in the vicinity of the site.

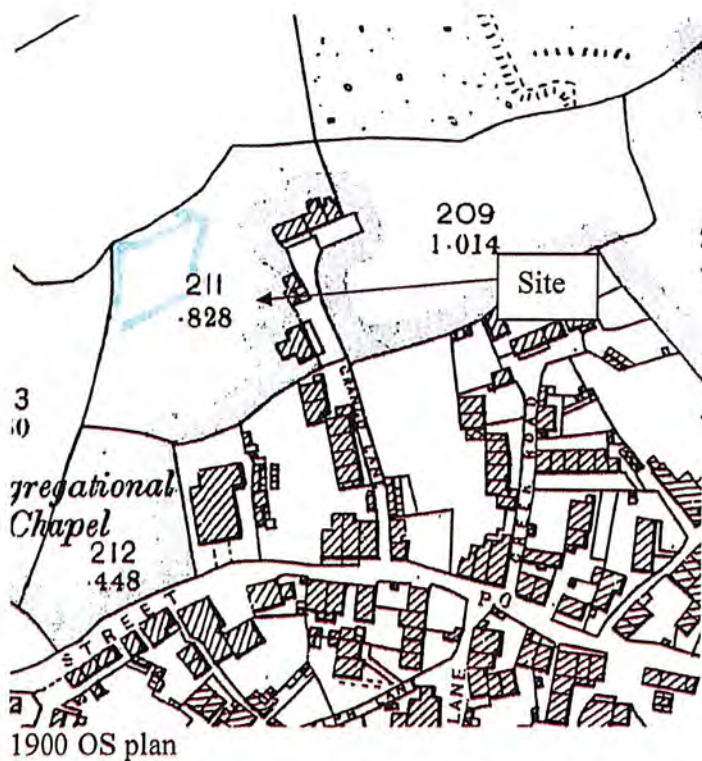
The 1900 OS plan, which was the recorded source for shaft 529, failed to record any evidence of the mine shafts within the site boundary.

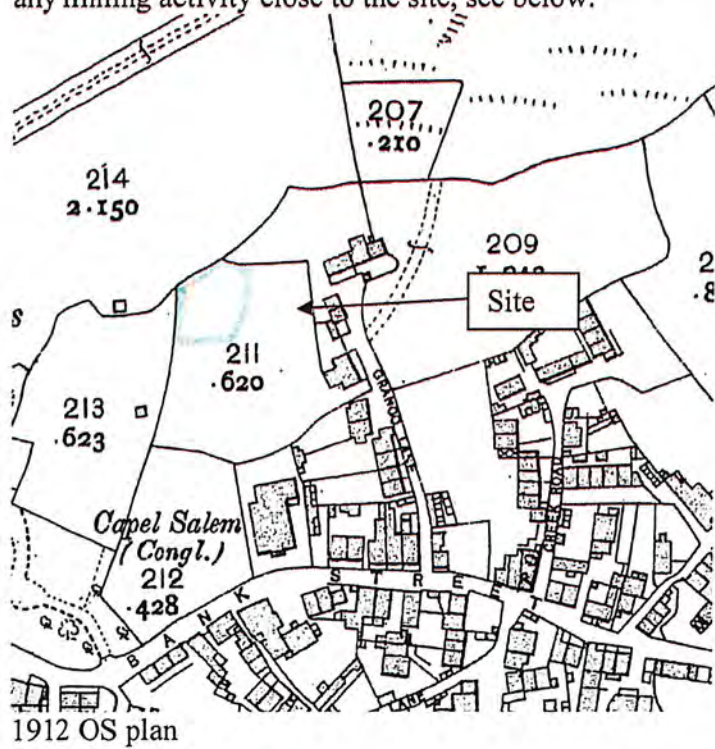
In addition, the later 1912 OS plan was checked and this also failed to record any shafts on site or any mining activity close to the site, see below:

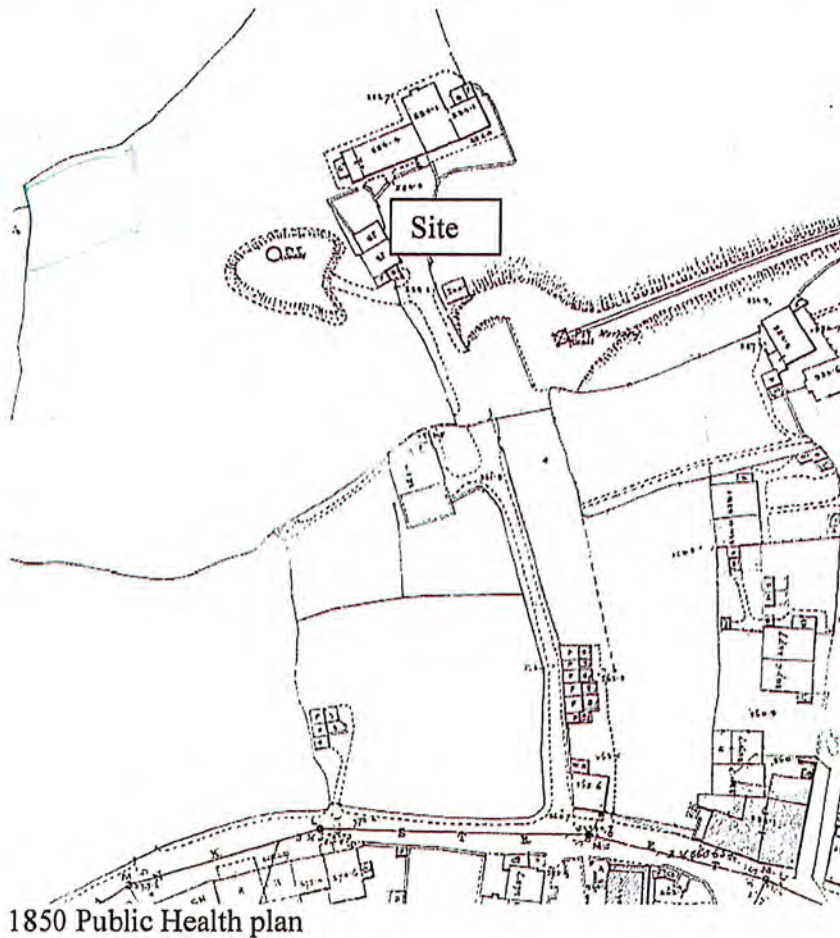
However, GSL also hold the 1850 Public Health plans for this area at a scale of 1:500. Examination of these plans revealed two mine shafts on site, see below. The positions of both of these have been plotted using common features between this plan and the later OS plans. The position of shaft 060 was in the same location as plotted from the Coal Authority information. However, shaft 529, which was reported to have been plotted from the 1900 OS plan was found to be in a different position, which is also shown on Figure 1. These pits had become dis used between the 1850 and 1875 OS plans. This plan also failed to reveal any surface evidence of any older shafts.

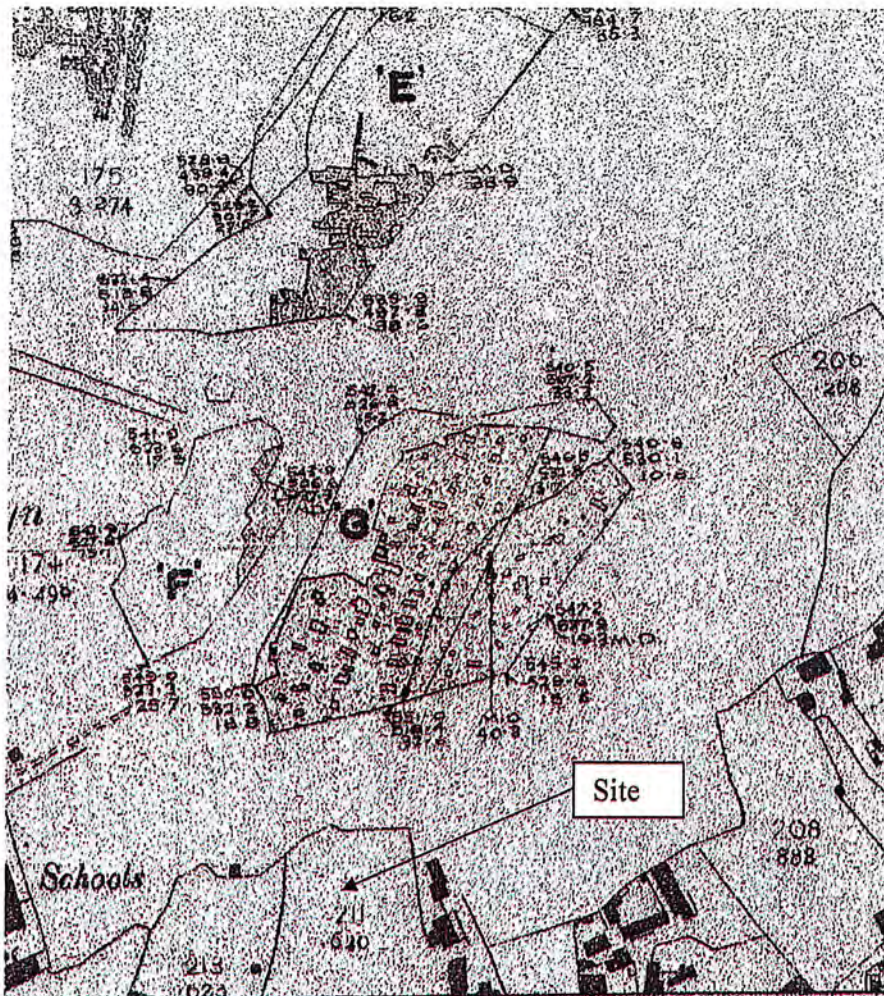
Plan NW 38

In addition, Mine plan NW 38 held in GSL archives was inspected. This shows the opencast workings immediately north of the site, and immediately south of the fault. This shows workings in the Top Brassey and Crank seams, which would put the Top Brassey seam outcropping immediately west of the site. It was proved to have been extensively worked and some 3' thick (0.91m). A section of this plan is presented below.

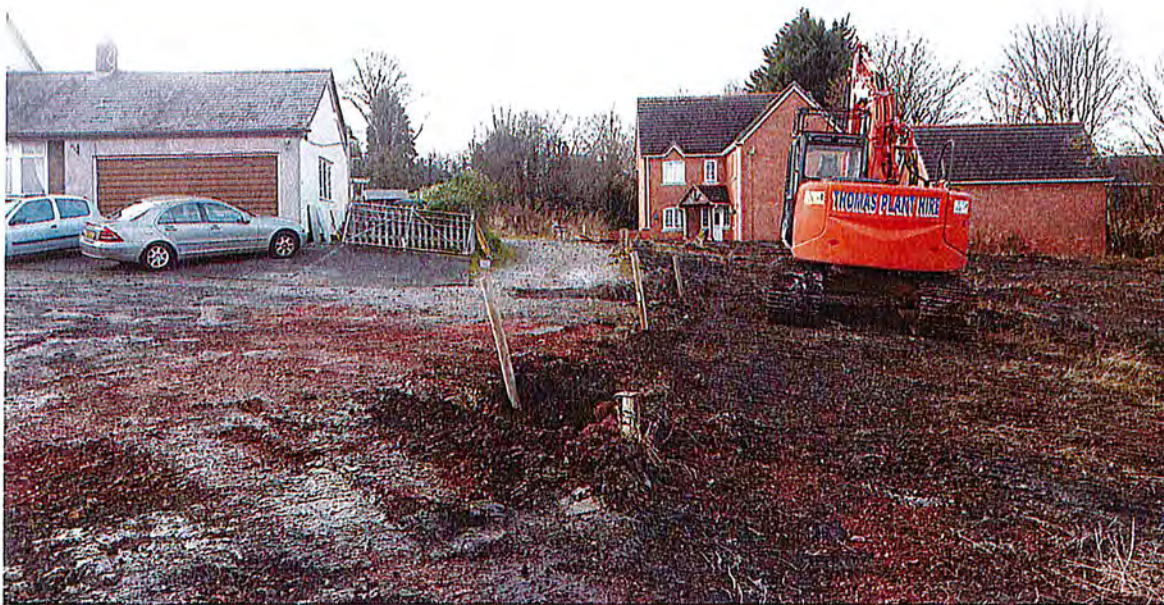
Photograph 5 Line of gas and water main looking west (posts)

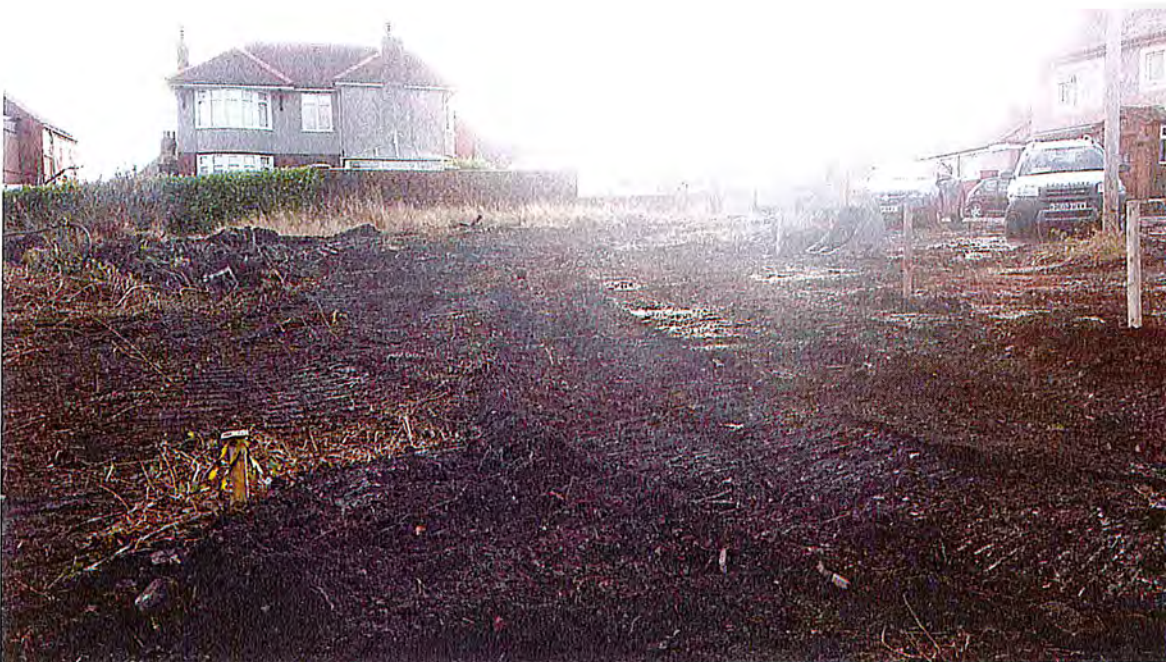
Photograph 6 Line of gas and water main looking east (posts)

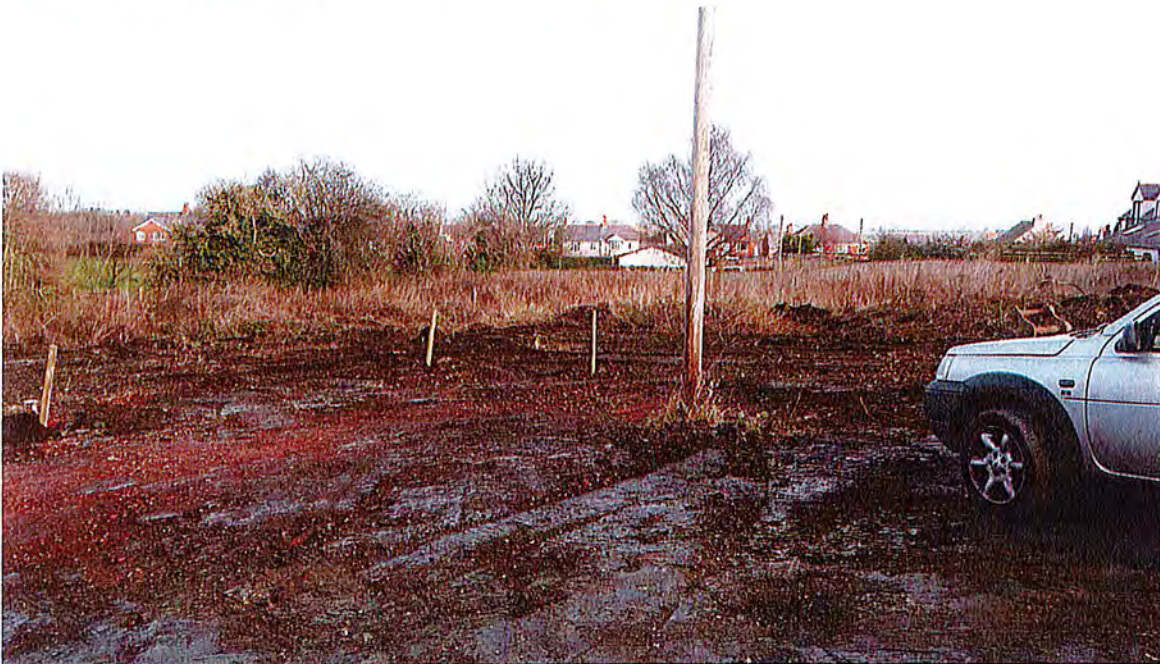
Photograph 7 Gas main and overhead lines

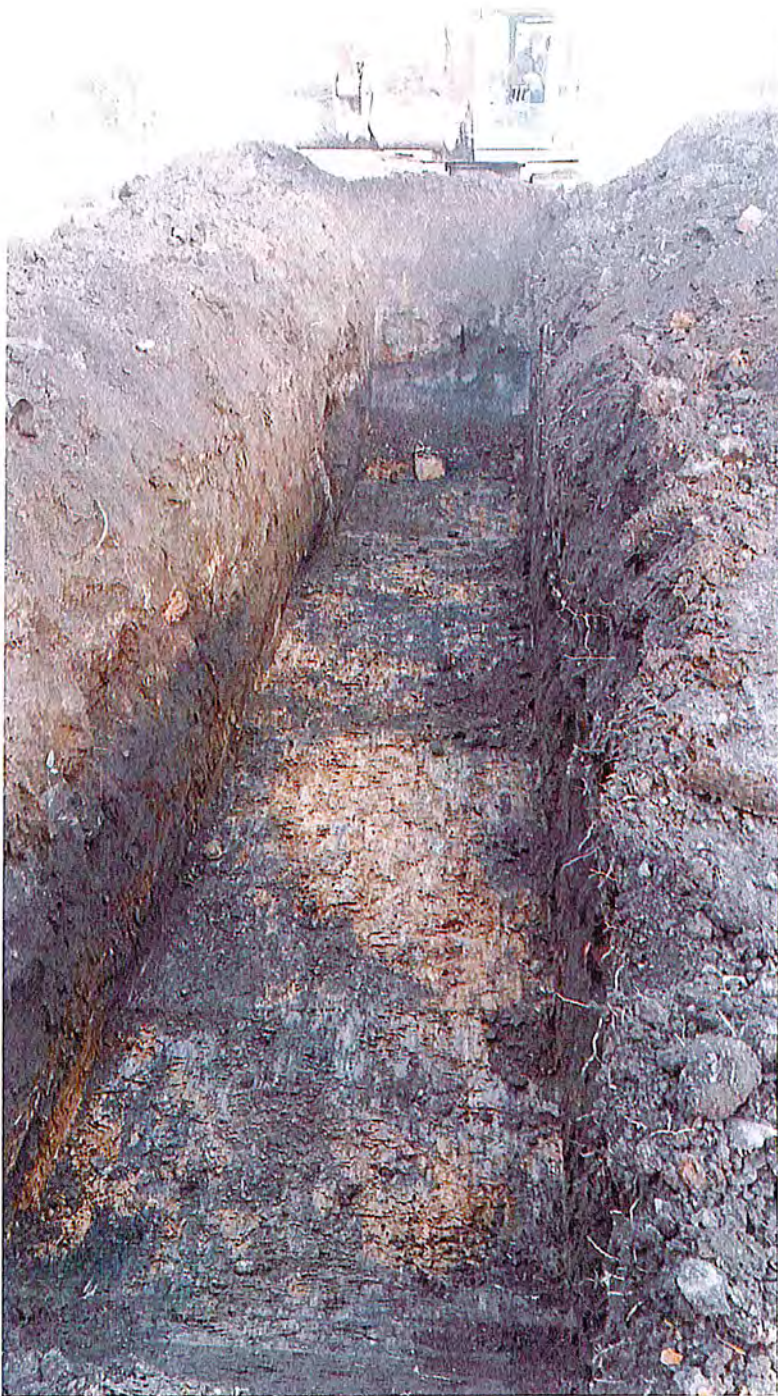
Photograph 13 typical Excavation

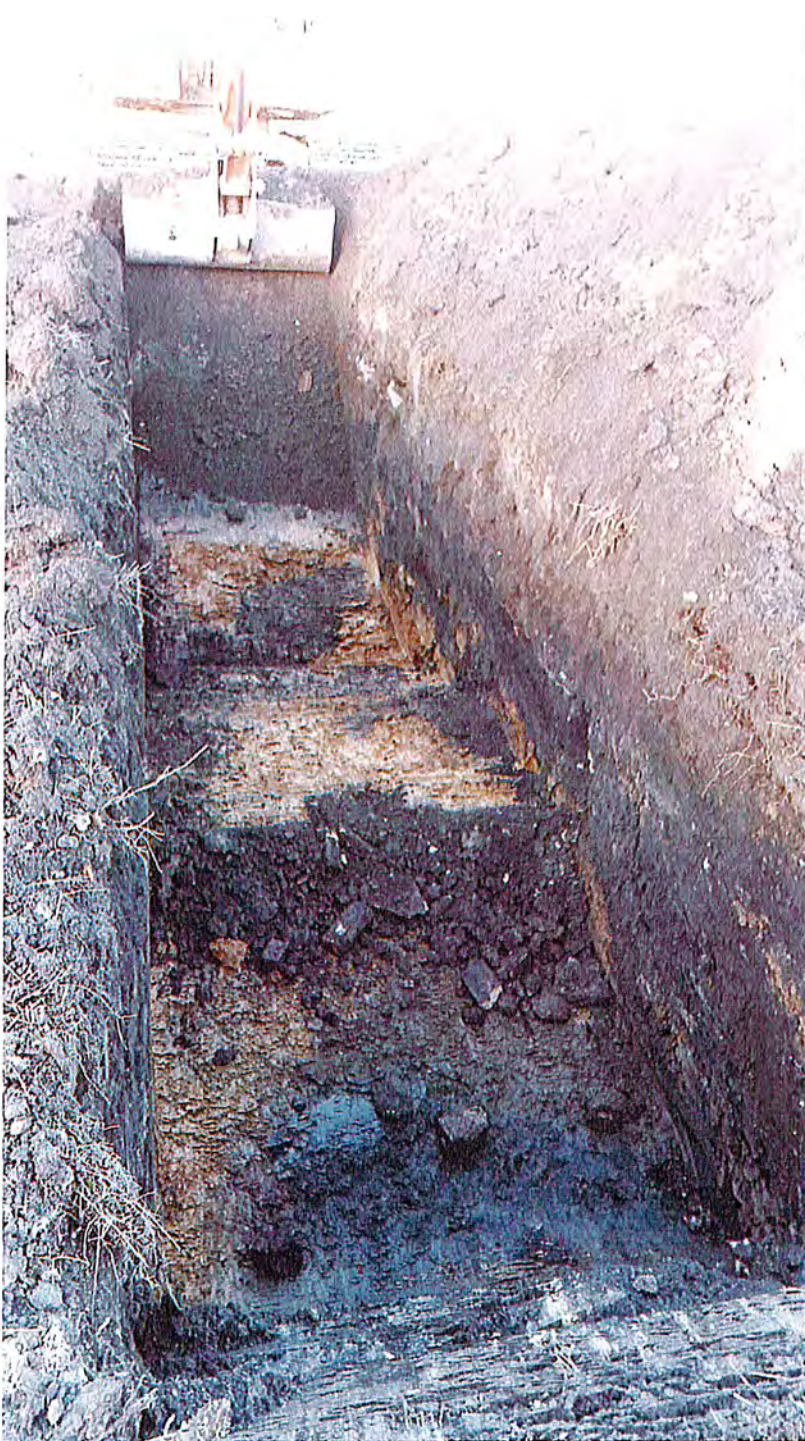
Photograph 14 Typical excavation
