## SALEM CHAPEL

# BAT INSPECTION AND EMERGENCE SURVEY

## UPDATED NOVEMBER 2018

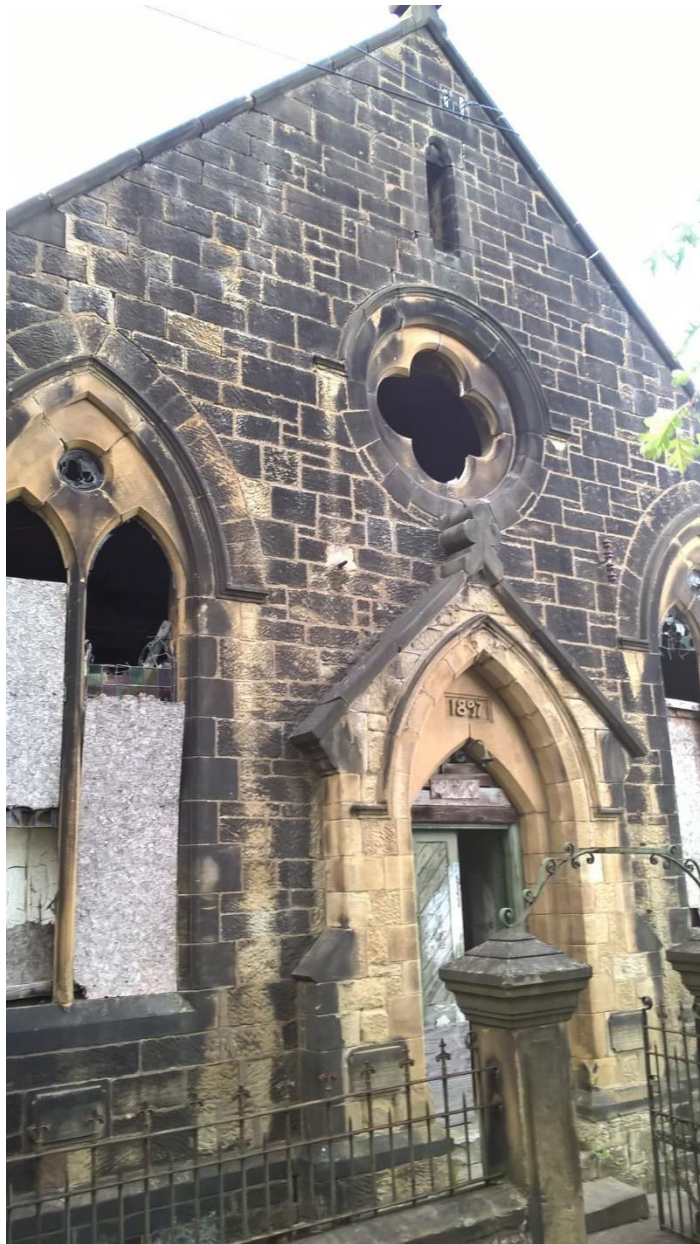
The Chapel was built in 1897, and many of the windows are partially boarded up but with large areas where there is no boarding as can be seen on the south of the building in figure 3. The south side has the most potential features for use by bats on the chapel, there is a “slit” near the apex of the building, directly below this there is a clover shape window which is missing all the glass and is not boarded up. Below this there are windows on either side, with large sections unboarded.

Figure 3 – south side of the chapel

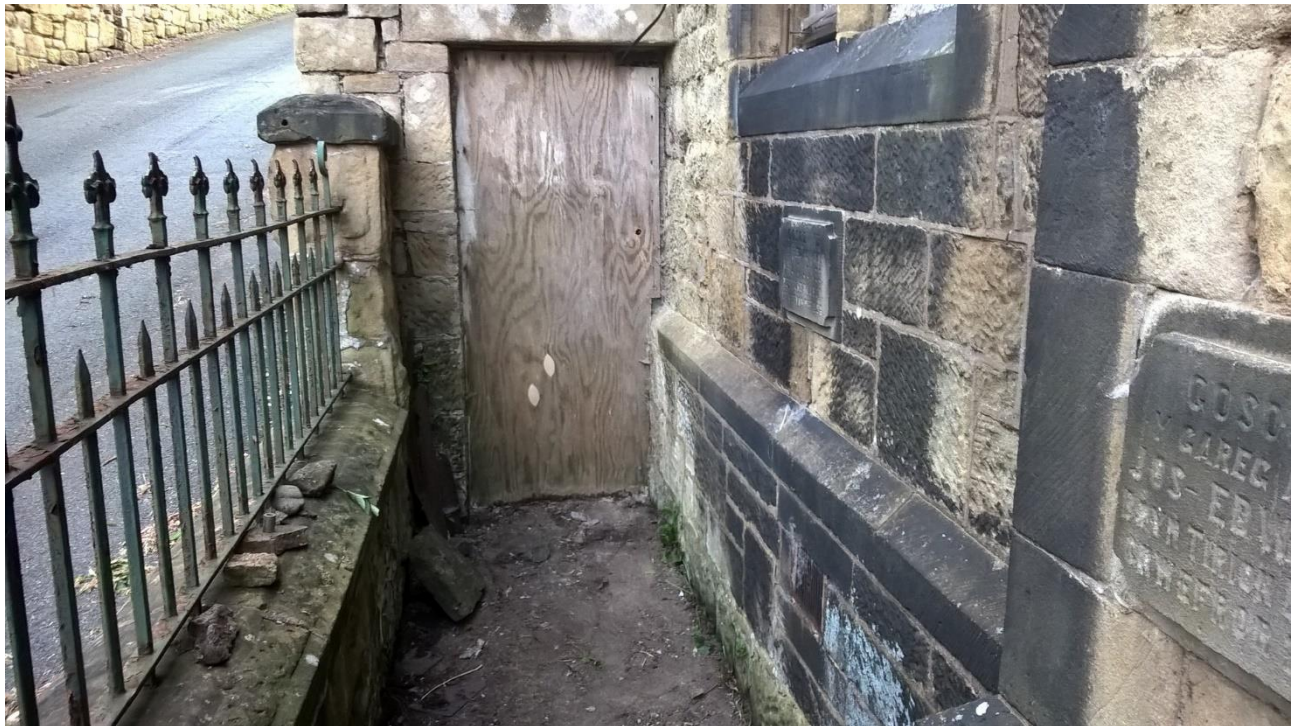
On the south side there is a door to the west which is boarded up which provides access into the basement below the house. There are large cracks in the stone work surrounding the door (figure 4). ***During the 2017 surveys this door is now unboarded and allows access into the basement of the house.***

**Figure 4 – door to the west of the main entrance**

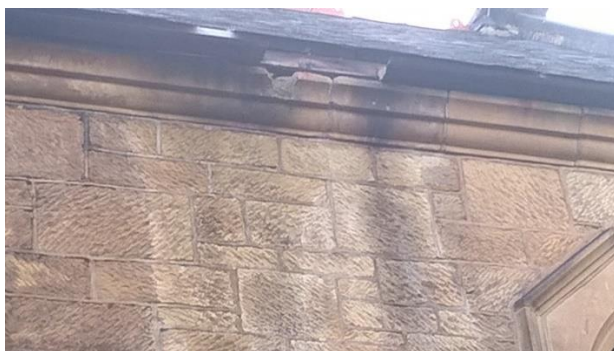
On the east side there are some large cracks present in the stone work above the window and also in the decorative stonework below the eaves. There was also loose stone work below the gutter and barge boards exposed where the gutter was missing (figure 5).

**Figures 5 – loose stone where barge board is missing**

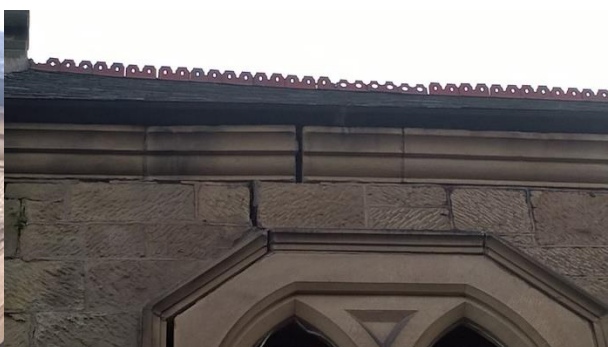
**Figures 6 – large gaps between stonework**

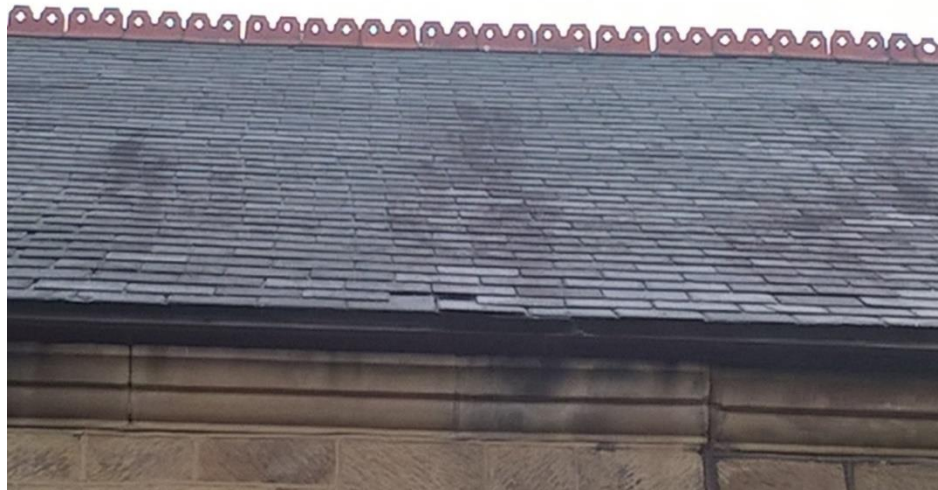
The roof itself was generally in good condition, a few ridge tiles had been replaced so were of a different design, which on first look appeared to be missing. A few slates were missing, but overall there were not many gaps present (figure 7).

**Figure 7 – The roof from the east side**

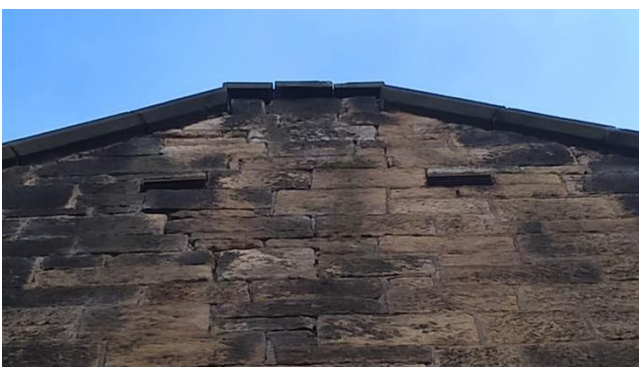
There were some gaps in the stone work around the north chimney and also some loose stone work underneath the chimney (figure 8). Two vents were present on the northern aspect, however these holes are very small and would not be big enough to be used by bats (figure 9).

**Figure 8 – gaps in stone work**

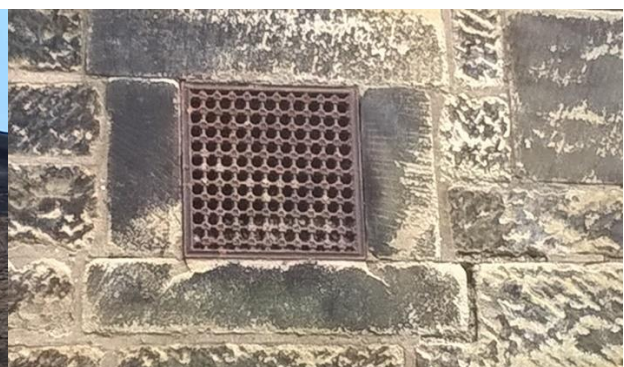
**Figure 9 – vents present on the northern side of the building**

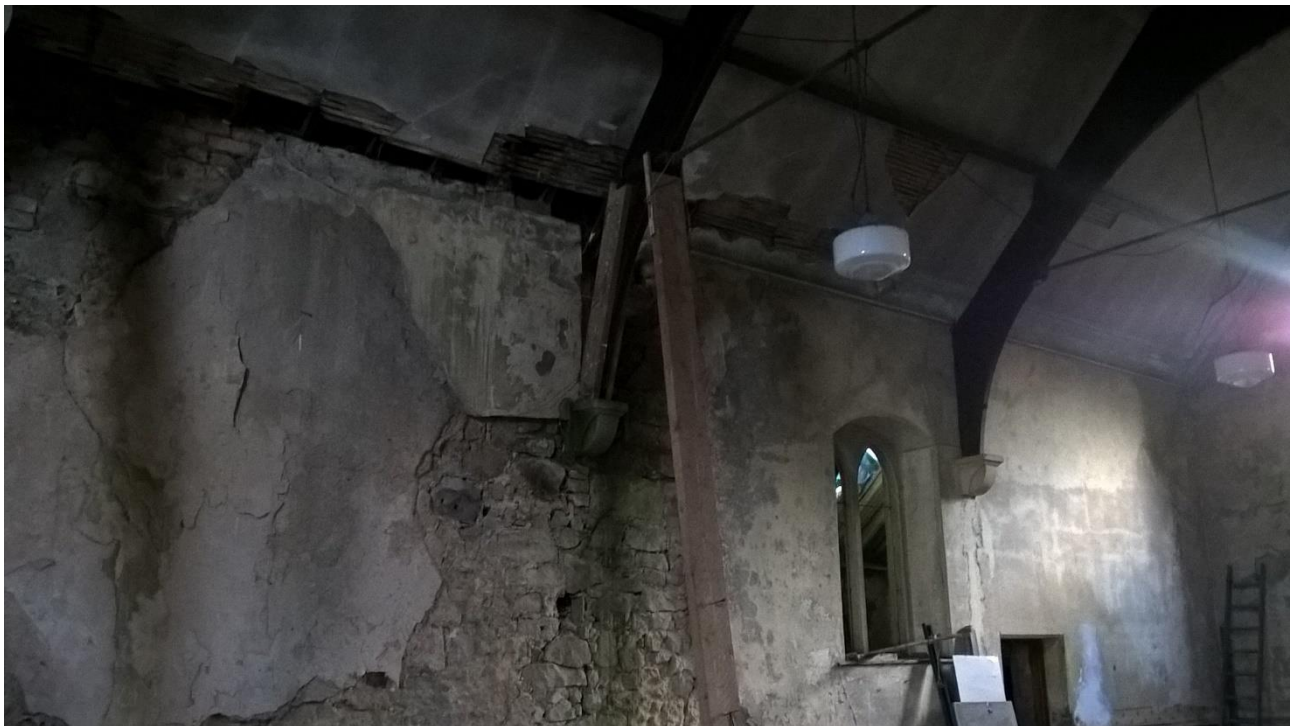
In some sections of the chapel, plaster had fallen off or been removed especially on the west wall, exposing the stone work (figure 10), providing roosting opportunities both behind the plaster abut also in the gaps in the stone work. The east wall was in much better condition with plaster remaining.

Figure 10 – illustrating the condition of the plaster on the western wall, also the window to the right which leads into the lean-to

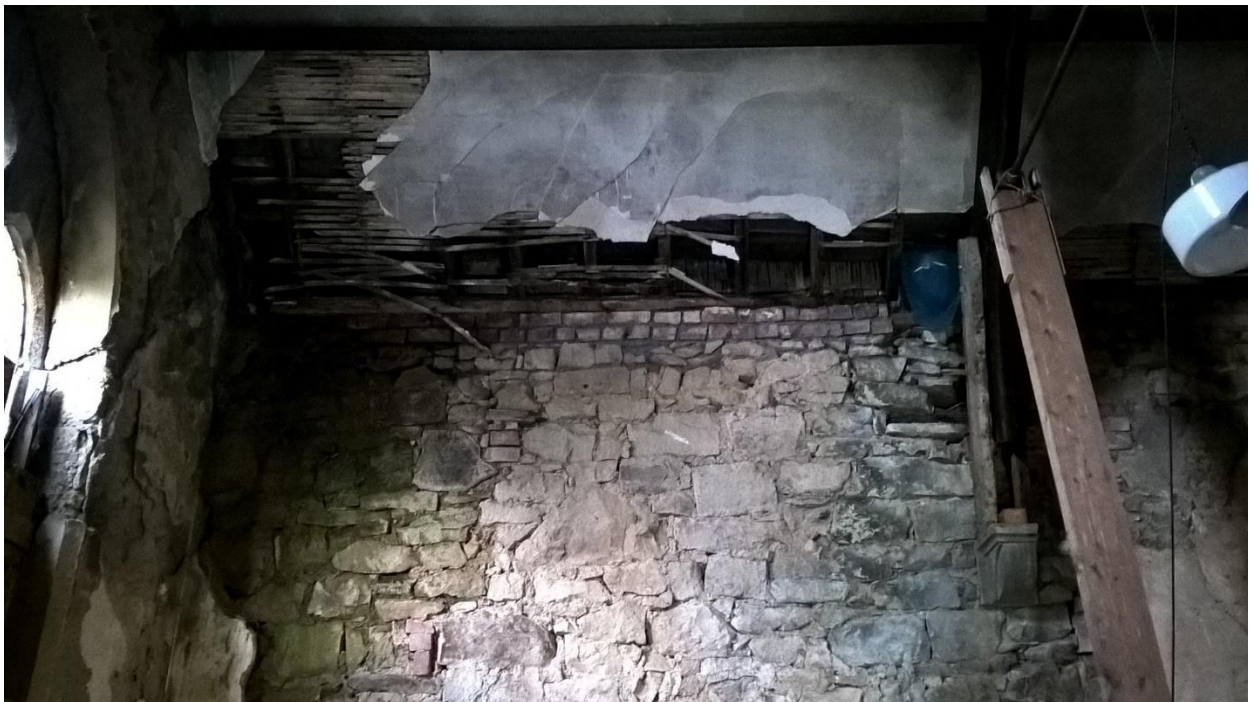
The main chapel ceiling is constructed of lathe and plaster as can be seen in figure 11.

**Figure 11 – Lathe and plaster construction of the ceiling**

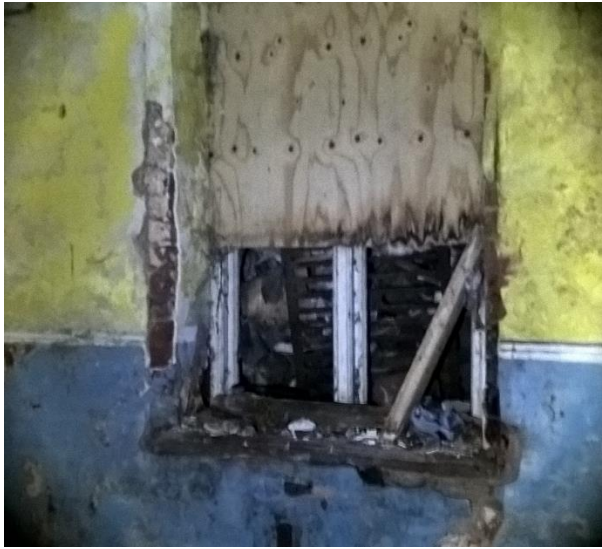
The window to the North was half boarded up and appeared to have been blocked with rubble (figure 12).

**Figure 12 – Window to the north of the basement**

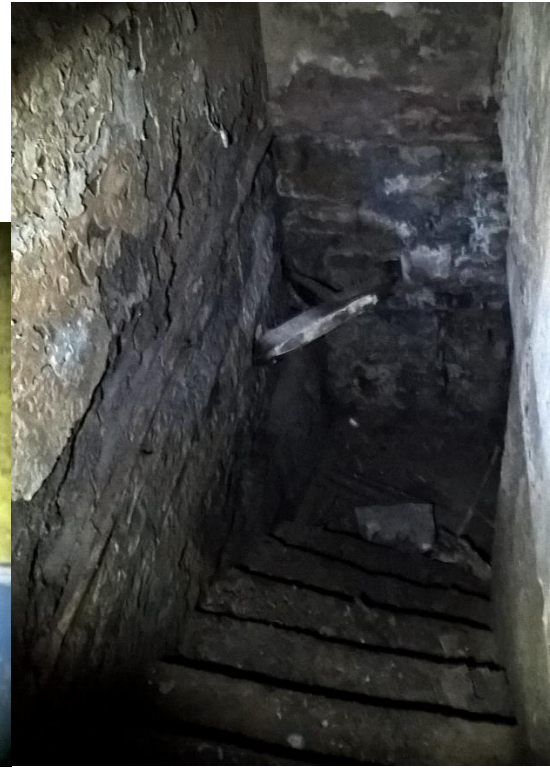
**Figure 13 – Stairs to the coal store/heating room**

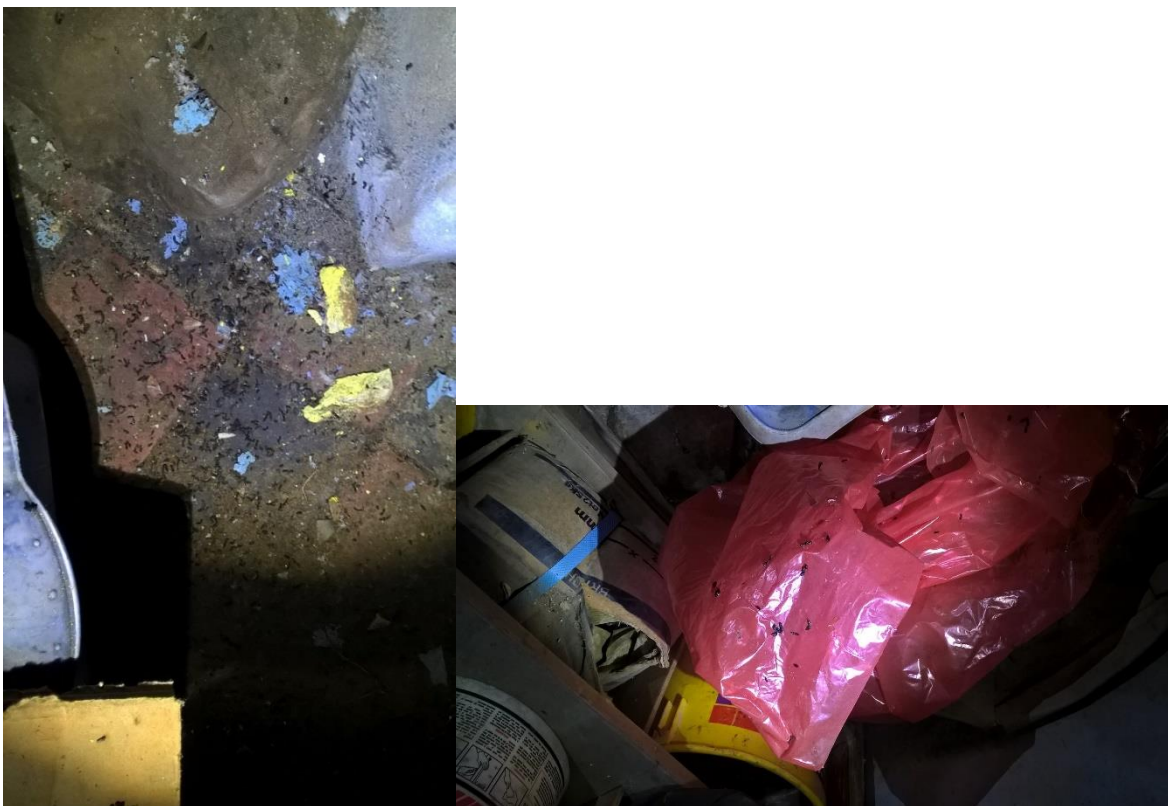
In the basement of the house many more droppings were found on the floor, these appeared to be Lesser horseshoe droppings. A Lesser horseshoe bat was then discovered in the porch area of the basement (figure 4), which was hanging up, this then flew into the corridor, there was a high concentration of bat droppings in this porch area. Two bats were observed flying whilst we were in the basement. One was later seen hanging up above the stairs to the coal bunker area and another underneath the pulpit. Figure 1 illustrates the layout of the Chapel. The pink lines illustrate the windows and door as described above.

Figures 14 and 15 – droppings in section a (see figure 16)
