## Structural Report

### Existing Out Buildings

The Oak Tree Inn  
45 – 47 Ruabon Road  
Wrexham  
LL13 7PL

Tel: 0151 334 3606  
Ref: 219199  
Date: June 2019

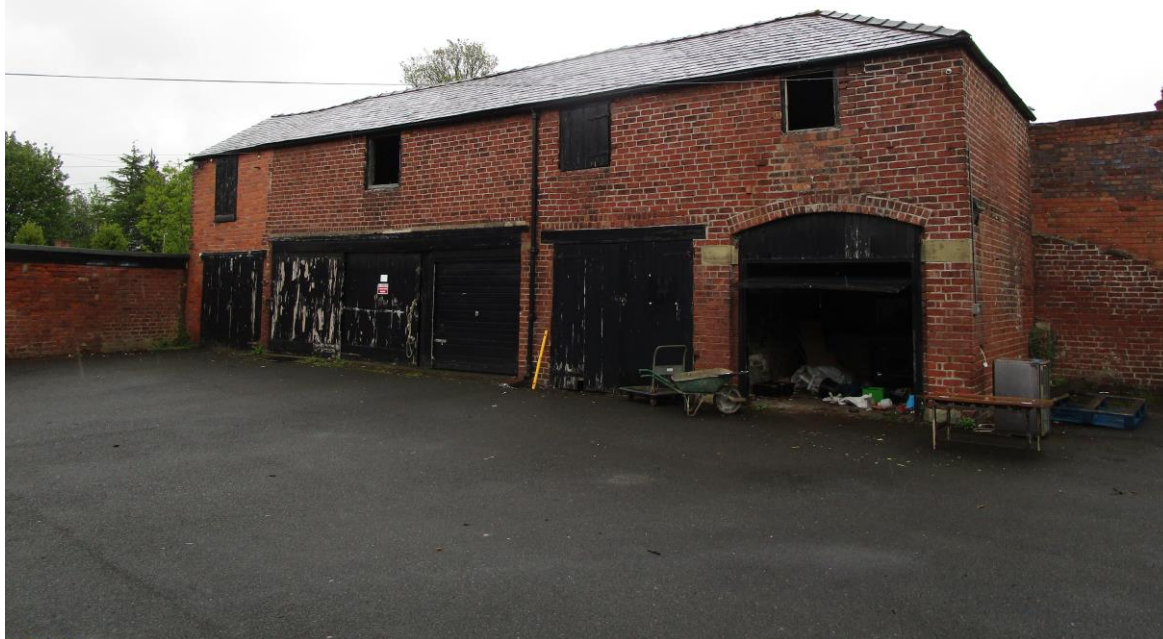
1. An inspection was made to the front elevation of the former stable building and this was found to contain four dominant openings, the three openings to the left of the elevation having timber lintels providing support to the brick elevation above and the far right-hand opening having a shallow brick arch over the opening.
2. It was noted that the brickwork above the far left-hand opening had been rebuilt in the past as it consists of newer clay commons. This was found to be poorly block bonded into the original clay brickwork to the left-hand gable corner and to the remainder of the front elevation to the right-hand side.

Photograph 1 – front elevation of former stable block

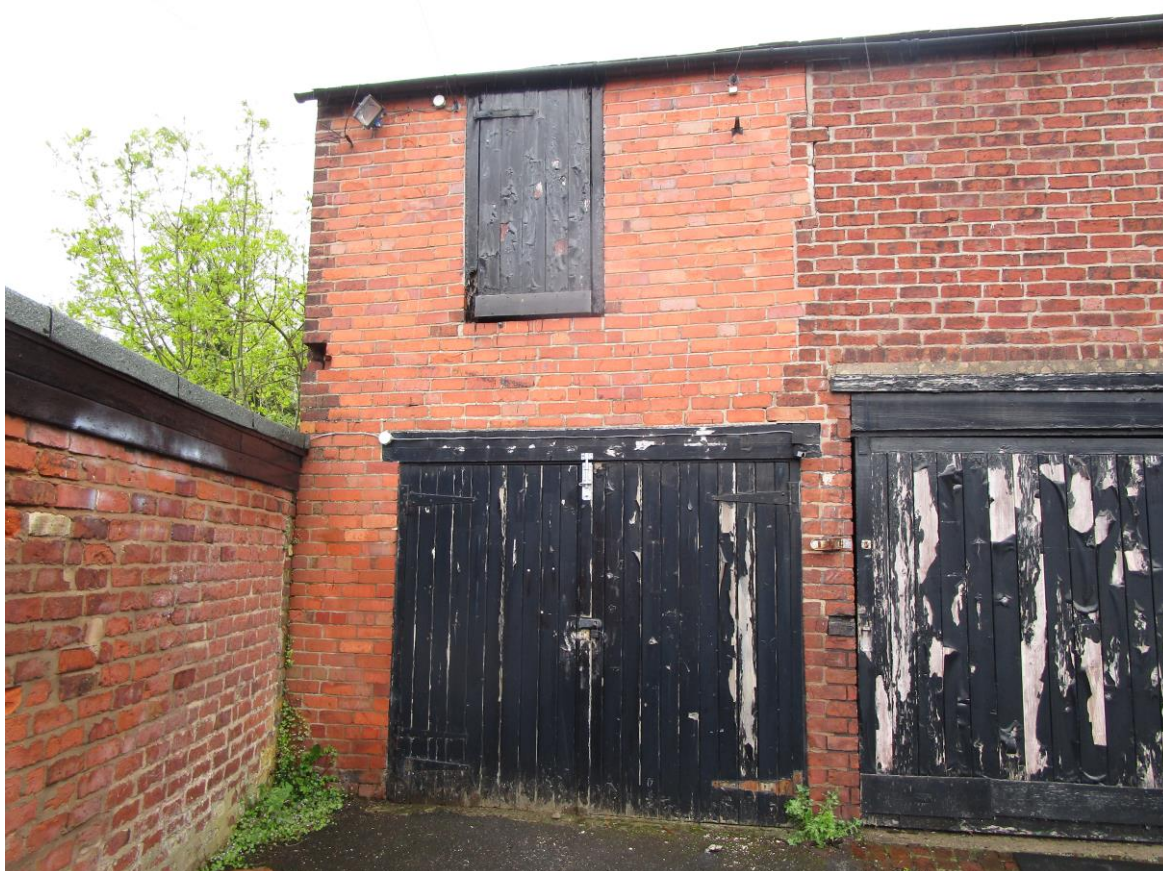
Photograph 2 – showing poorly rebuilt left-hand section of front elevation

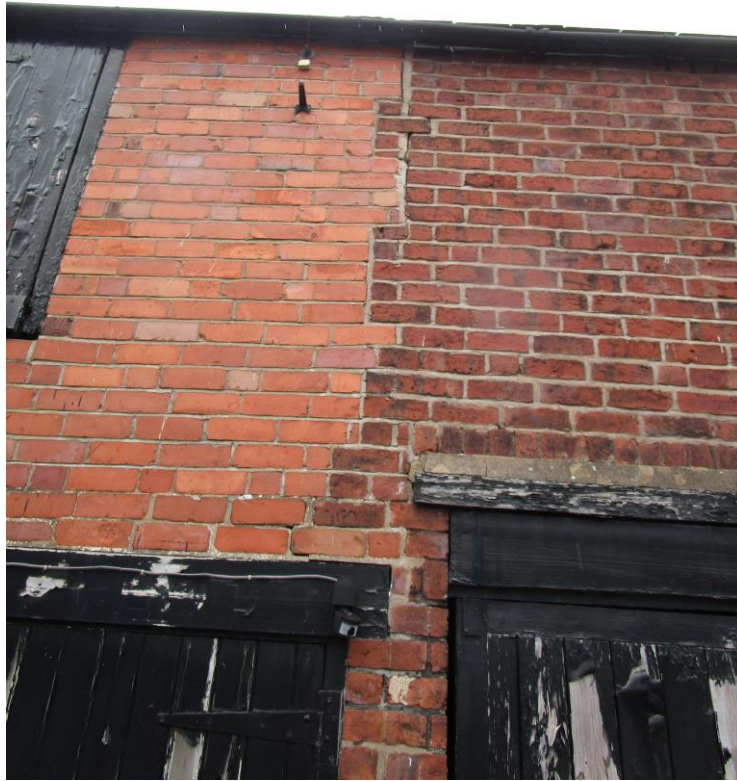
Photograph 3 – showing separation at junction of rebuilt brickwork

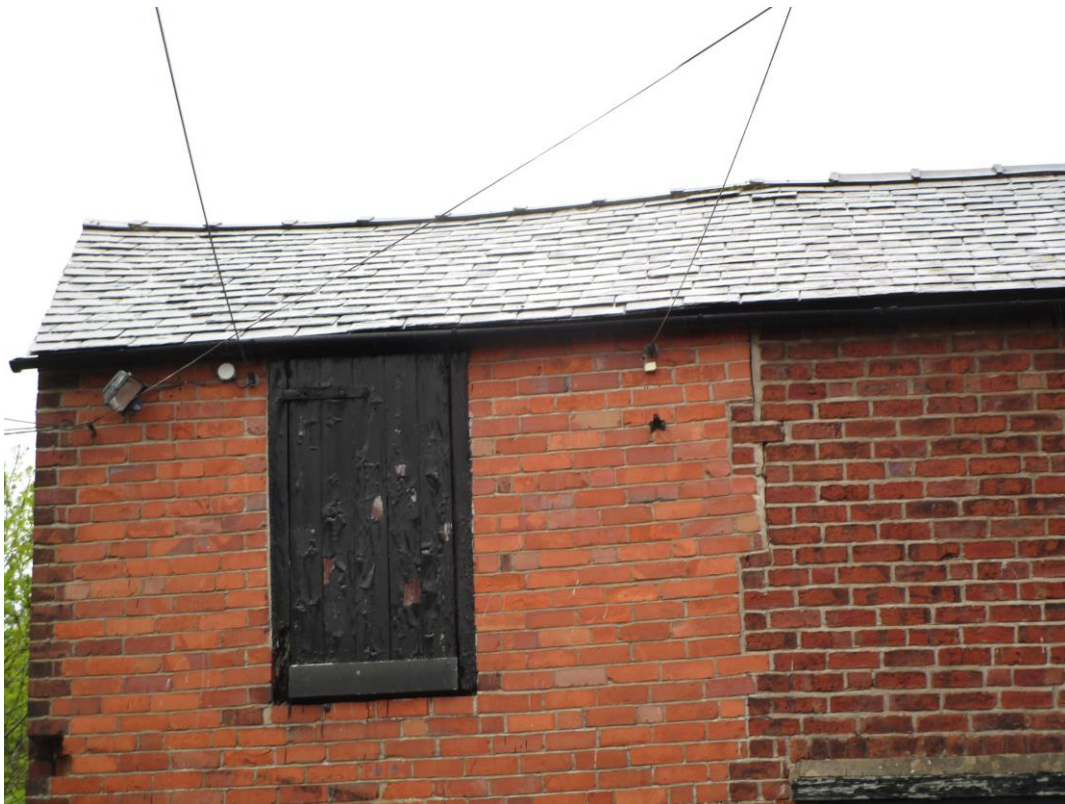
7. The roof displays significant deflection and therefore it would appear that it currently has significant structural inadequacies.
8. The right-hand elevation was found to be free from any significant distortion or evidence of any active structural movement.

Photograph 4 – showing deflection to roof and separation within brickwork

The roof to the former stable building appears to be in poor structural condition and would require stripping, strengthening and refurbishment.

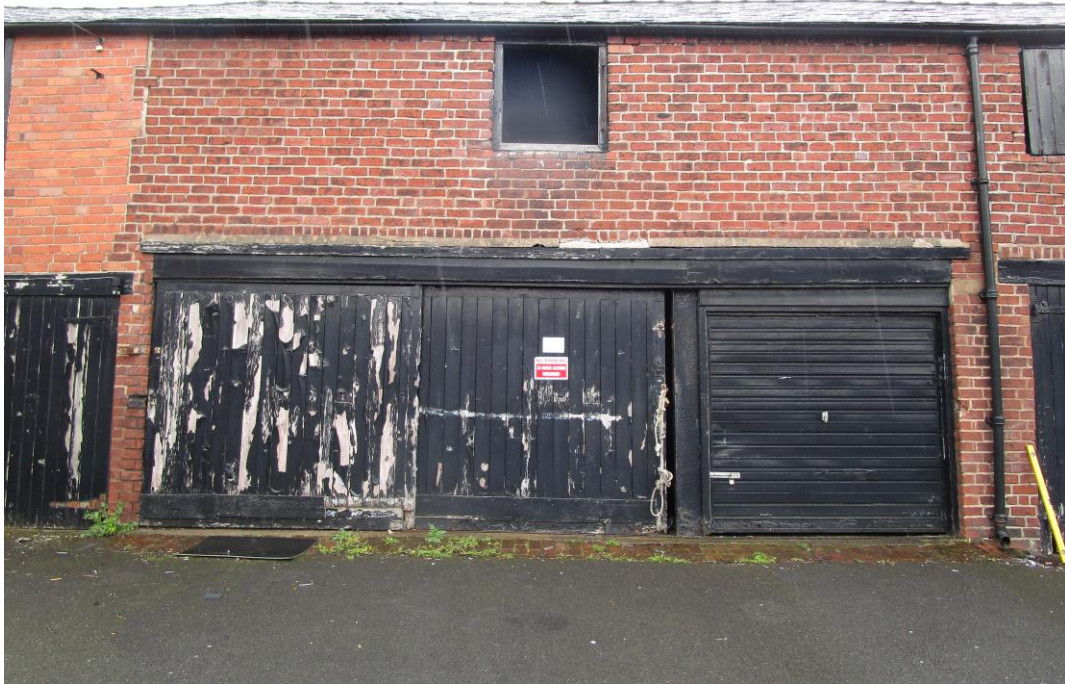
3. The second opening from the left-hand side of the building was found to consist of a large span timber lintel provided with an intermediate steel column. This is not of original construction, as it is likely that this large opening would have consisted originally of two openings.

6. Similarly the timber lintel to the wider structural opening is considered also in need of replacement. We would advise that the foundation provided to the current column arrangement is likely to be inadequate. The column provided appears not to be adequately restrained laterally.

Photograph 5 – showing dominant opening to front elevation with non-original supporting column

The front elevation of the stable building is inadequate in construction to comply with the requirements of The Building Regulations in terms of lateral stability. It would be necessary to incorporate structural steel 'goal post' stability frames. Alternatively, it will be necessary to provide buttressing to the front left and right hand corners of a minimum of 665mm and provide a nett width of brickwork within the width of the elevation of at least one third of the width of the original elevation. The retention of the existing openings in their current form is NOT considered structurally acceptable.

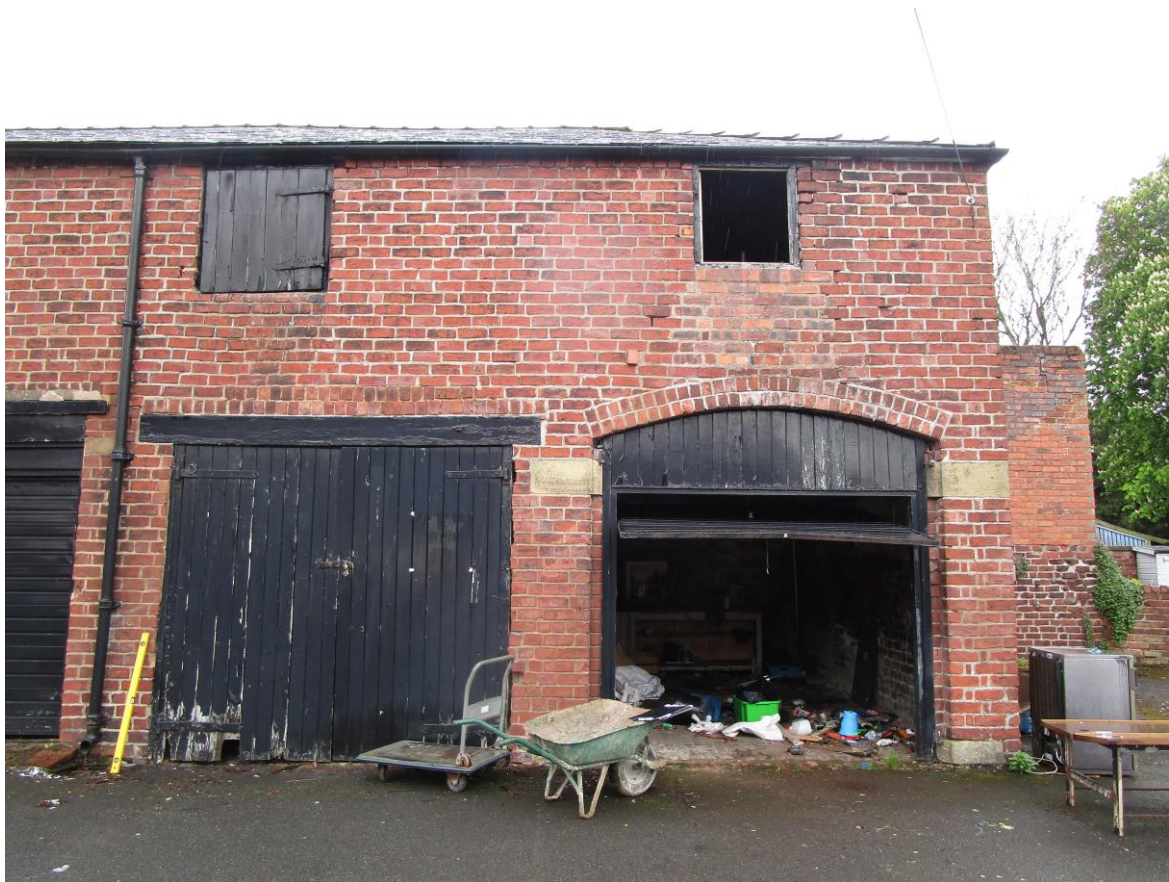
4. The right-hand opening provided with the only brick arch was found to have suffered some degree of structural movement. We noted past repointing of mortar joints above the crown of the arch and open mortar joints in the vicinity of the opening to the first floor level.

Photograph 6 – showing brick arch to right-hand opening

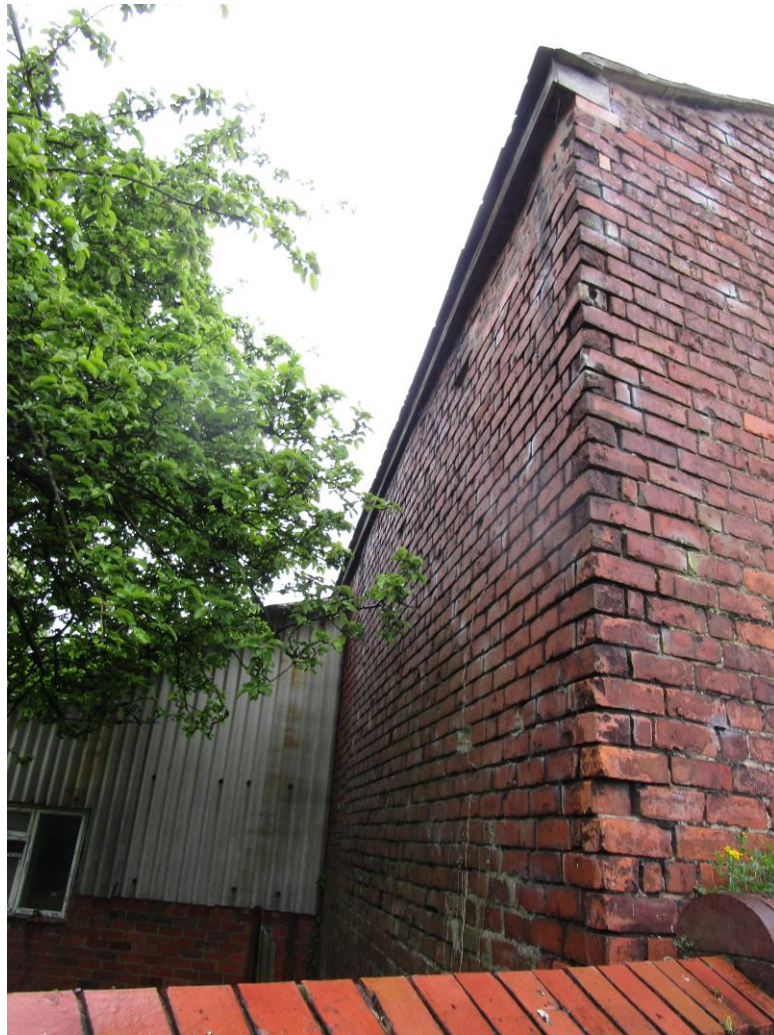
9. The left-hand elevation was not accessible. However, from our observations made from the driveway to the adjacent left-hand property, we noted that brickwork has suffered weathering as mortar joints are worn and in need of repointing with spalled bricks requiring cutting out and replacing.

10. The rear elevation of the stable building could not be accessed but from our observations made from the adjoining driveway it was noted that a corrugated steel building is built up the the rear elevation.

Photograph 7 – showing weathered brickwork to rear left-hand corner and attached outbuilding to rear elevation

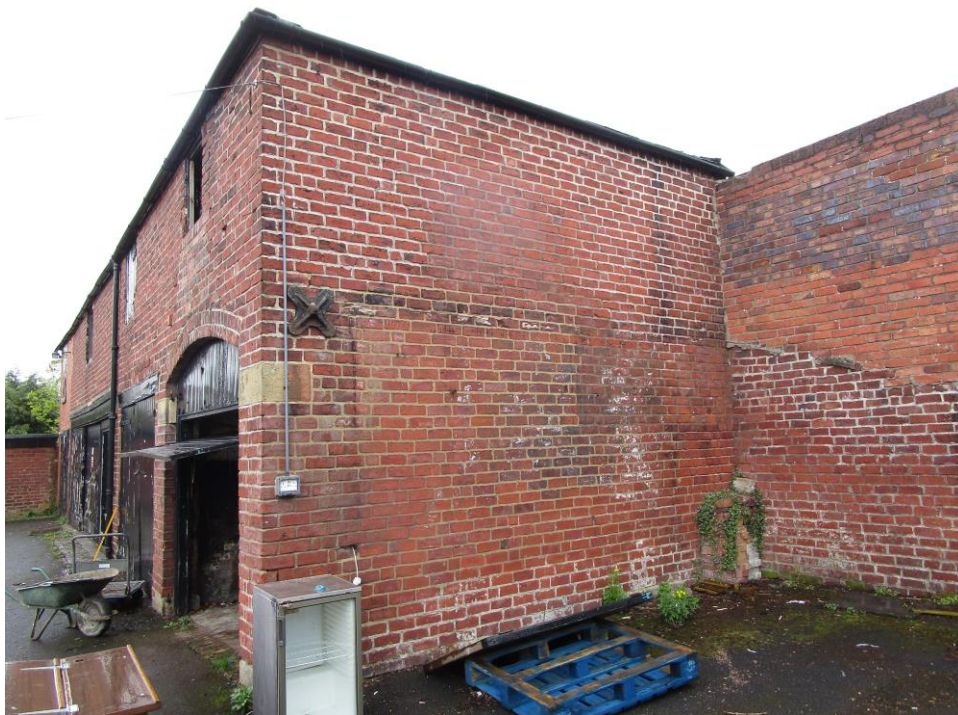
Photograph 8 – showing right-hand elevation

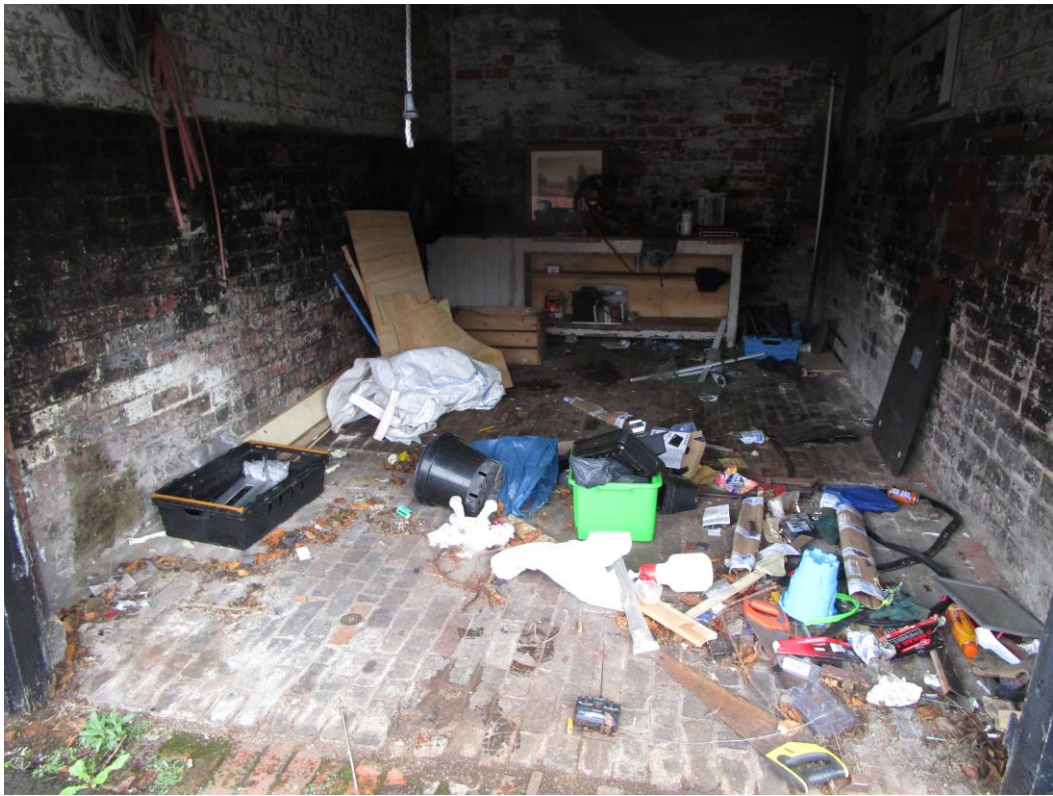
1. Access to the inside of the building was made were it was available at the time of our inspection.
2. We noted that internal ground levels are similar to the external levels. Therefore, excavation of the existing floor to allow the construction of an insulated floor construction may have an adverse affect upon the existing foundations as these are likely to be of shallow construction.

Photograph 9 – showing right-hand stable with paved flooring lacking damp resistance

It is likely that the former stable building will require to be fully underpinned to allow for the construction of an insulated ground construction and to achieve the required floor to ceiling heights.

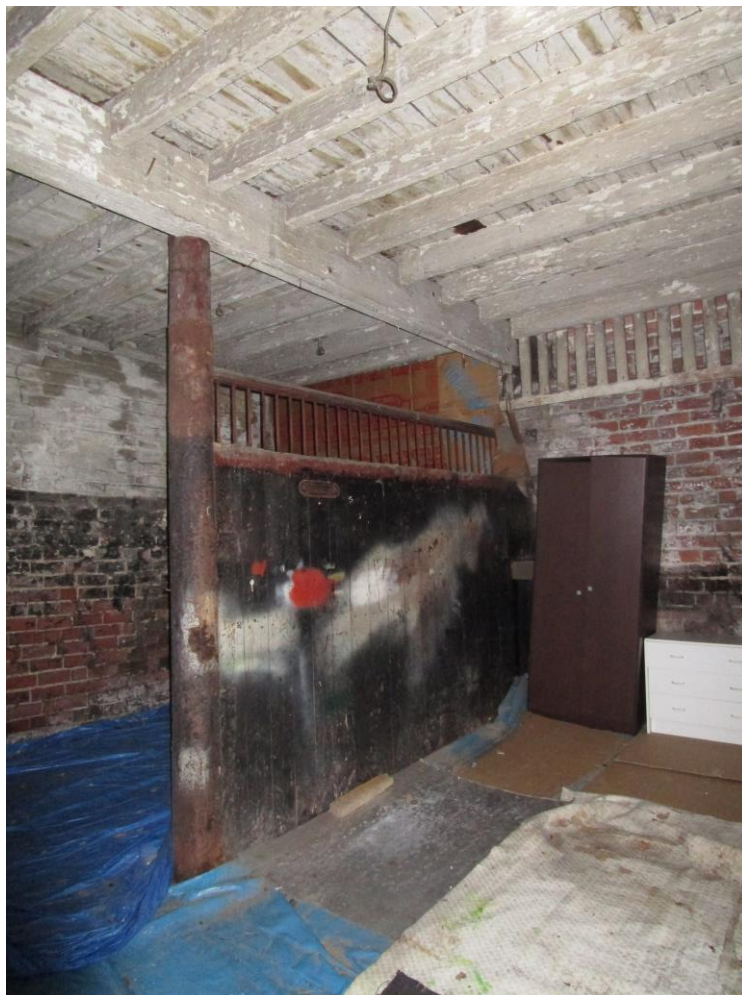
3. The support to and the actual first floor construction appear to be in need of substantial up grading to comply with current Building Regulations to provide adequate support for domestic floor loading and partition walls.

Photograph 10 – showing poor structural arrangement to first floor construction

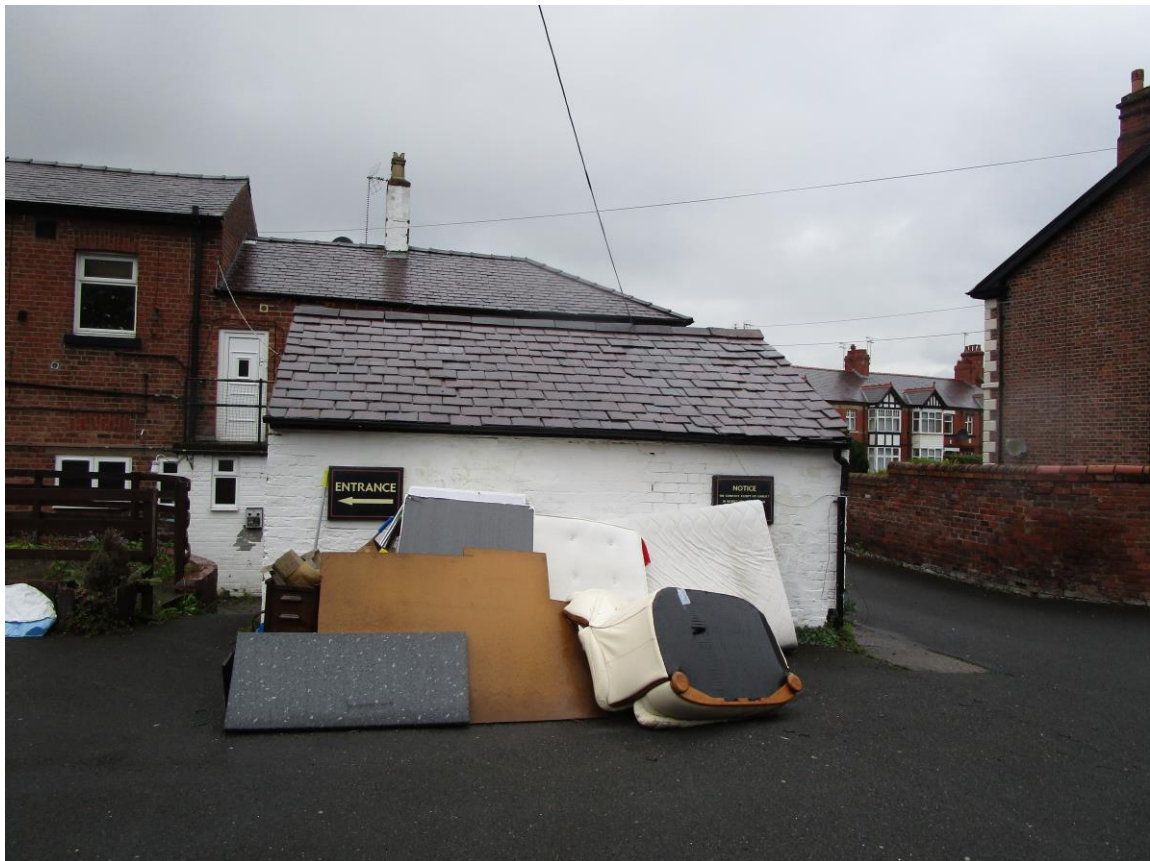
Photograph 11 – detached out building adjacent to public house

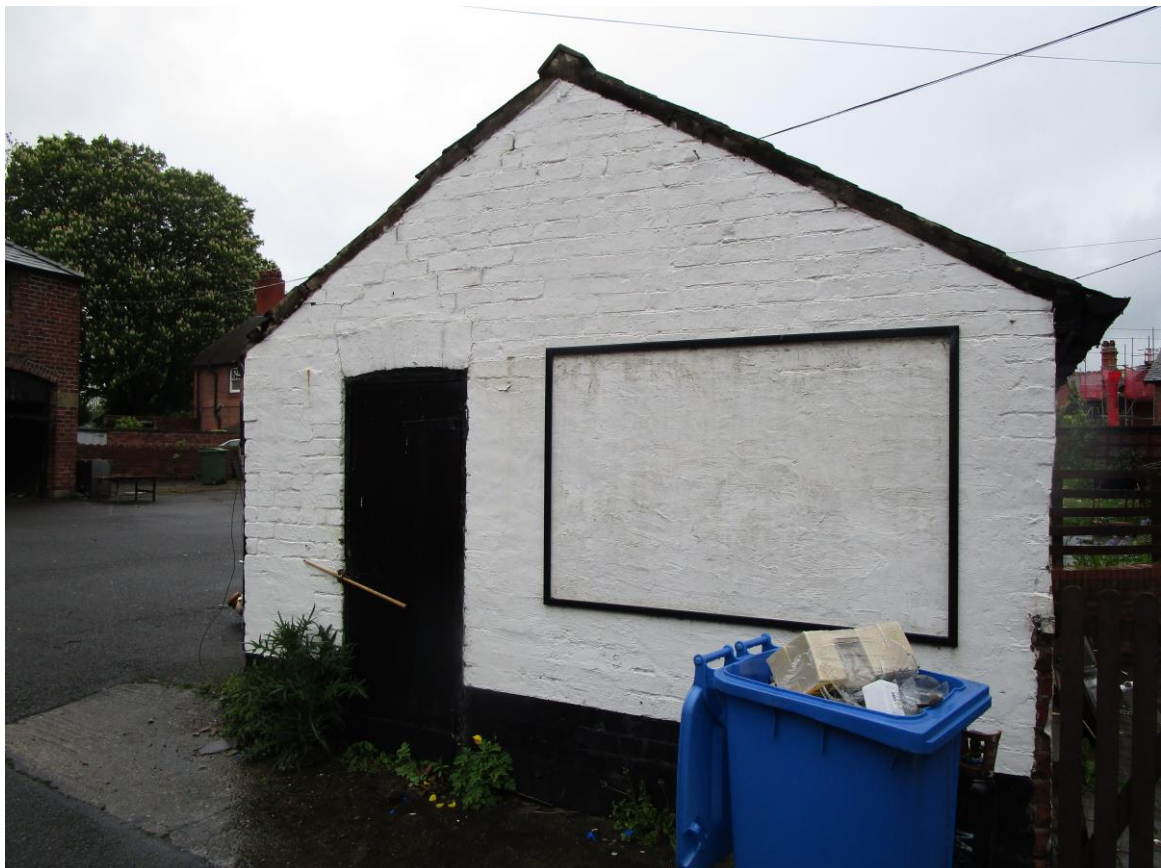
Photograph 12 – detached out building showing minor cracking above the arch to side door

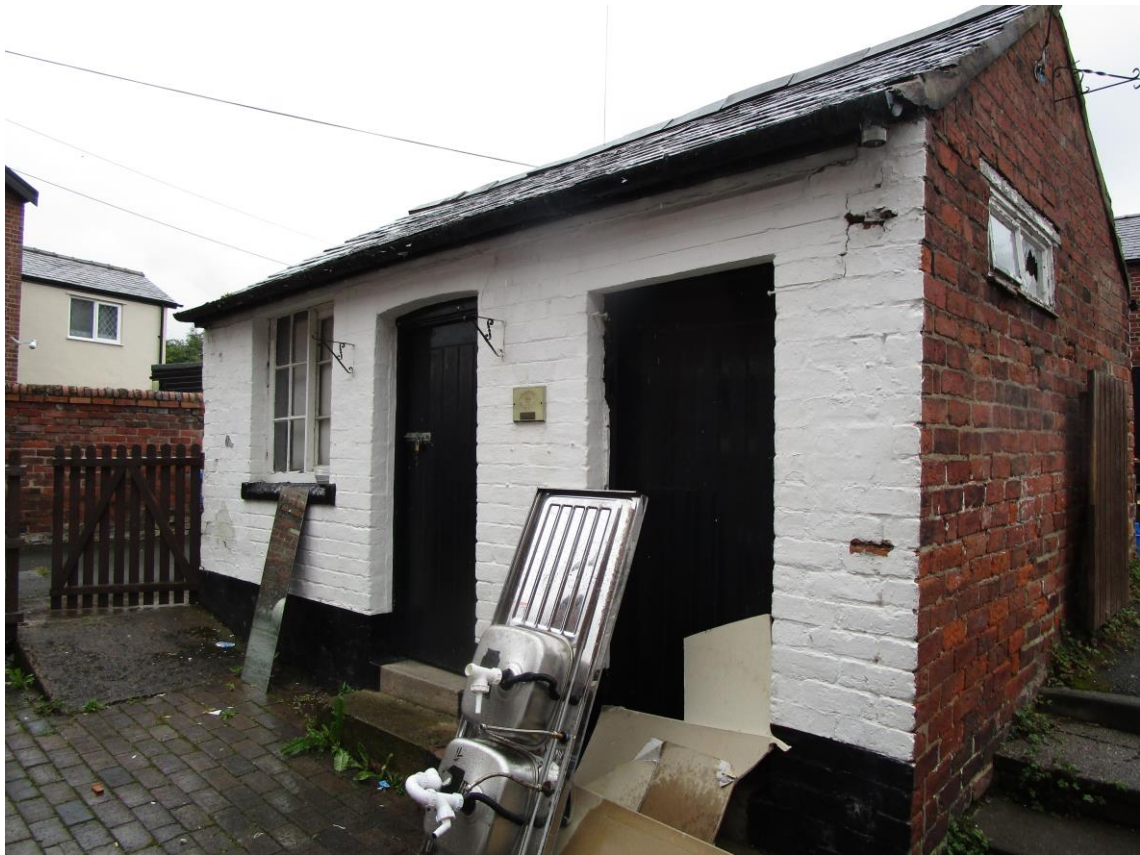
11. A single storey out building closer to the public house exists and has a pitched slated roof. The external elevations were found to display some outward tilting which was generally within acceptable structural limits. However, we did not some localised cracking and some areas of brickwork was found to be in poor condition. A timber lintel to the right-hand side wall was found to be in poor condition.

Photograph 13 – showing elevation to out building nearest to public house with cracking evident to top right of right-hand door

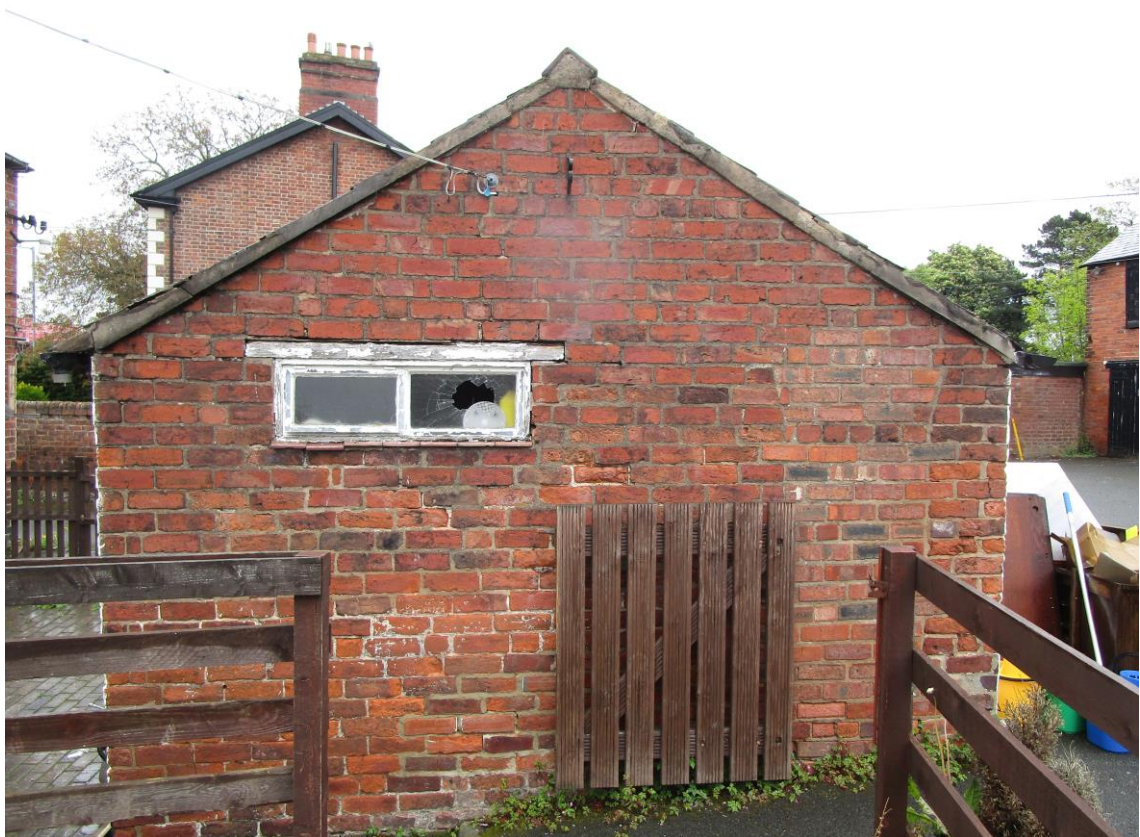
Photograph 14 – showing side wall of out building with brickwork above window inadequately supported and generally in poor condition
