# Tree Monitoring Report

**Tree Monitoring Report For  
Car Park Construction Works Adjacent to Trees  
At  
Erddig Hall, Wrexham LL13 0YT  
Report no 1**

**The National Trust**

January 2019 ref 2973

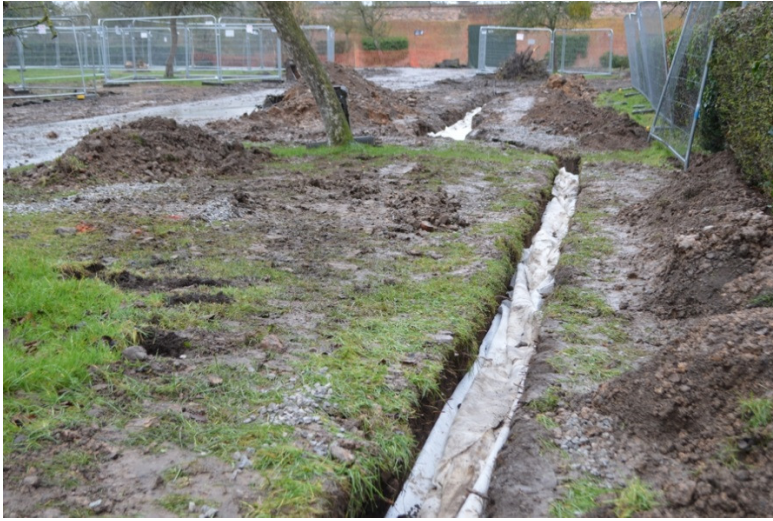
Within the RPA there were 2 no tree roots with a diameter of 10-15 mm exposed within the drainage trench. There were also minor tree roots with a diameter of less than 5mm. (photos nos1 and 2)

These roots can be classified as within the accepted tolerances to root damage. No major tree roots were uncovered. Existing topsoil was of good quality and consisted of silty loam with average stone content.

**Photo 1. T114 drainage trench**

- Prune off damaged roots under 50 mm diameter with a sharp hand tool.to the exposed roots within the excavated drainage trenches
- Restore temporarily removed protective fencing.
- Backfill drainage trenches as soon as practicable with a suitable non limestone material. Drainage runs within soft landscape to be backfilled with subsoil and topsoil taken from onsite stock piles.
- If tree roots are encountered during excavation protect them with damp hessian during the construction works. Remove hessian prior to backfilling.

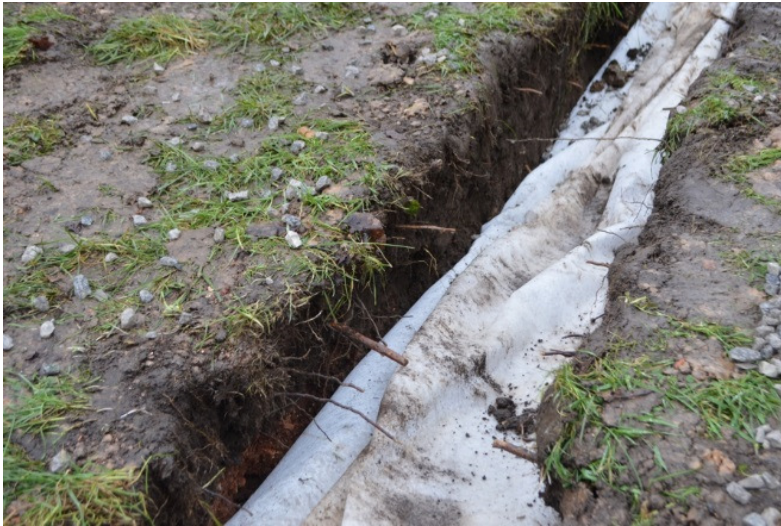
**Photo 2. Small exposed roots to T114**

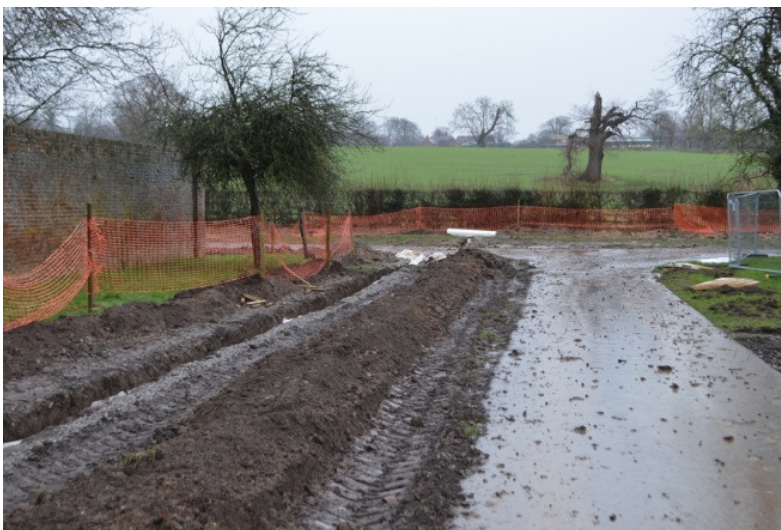
Within the RPA there were no tree roots with a diameter of 10-15 mm or greater exposed within the drainage trench. There were minor tree roots exposed with a diameter of less than 5mm. (photo no 3)

These roots can be classified as within the accepted tolerances to root damage. No major tree roots were uncovered. Existing topsoil was of good quality and consisted of silty loam with average stone content.

**Photo 3. T13 drainage trench**

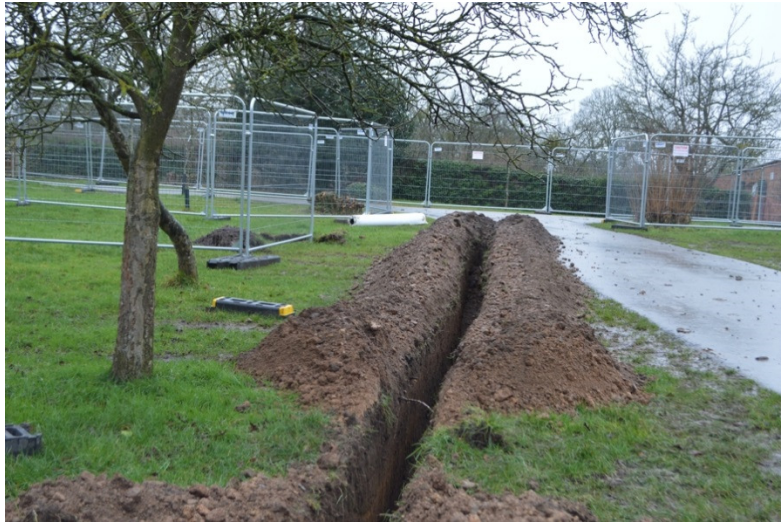
Within the RPA there were no tree roots with a diameter of 10-15 mm exposed within the drainage trench. There were minor tree roots with a diameter of less than 5mm. (photo no 4)

These roots can be classified as within the accepted tolerances to root damage. No major tree roots were uncovered. Existing topsoil was of good quality and consisted of silty loam with average stone content.

**Photo 4. T28 drainage trench**

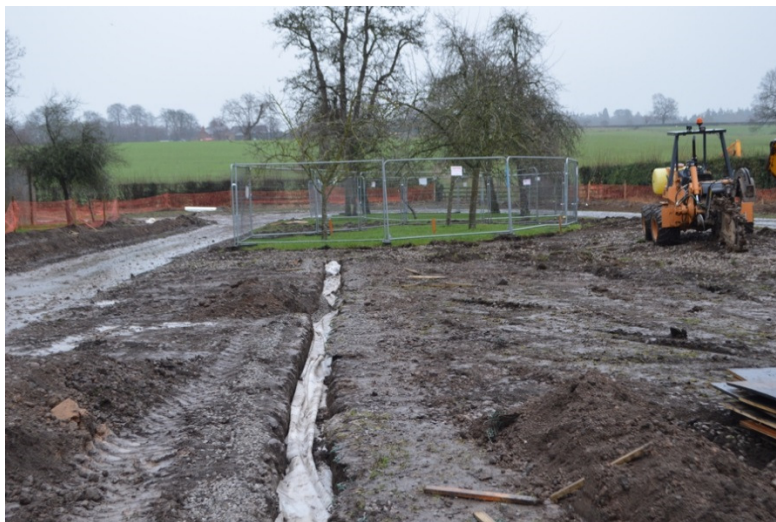
Within the RPA there was 1 no tree roots with a diameter of 10-15 mm exposed within the drainage trench. There were also minor tree roots with a diameter of less than 5mm. (photo no 5)

These roots can be classified as within the accepted tolerances to root damage. No major tree roots were uncovered. Existing topsoil was of good quality and consisted of silty loam with average stone content.

**Photo 5. T56 drainage trench**

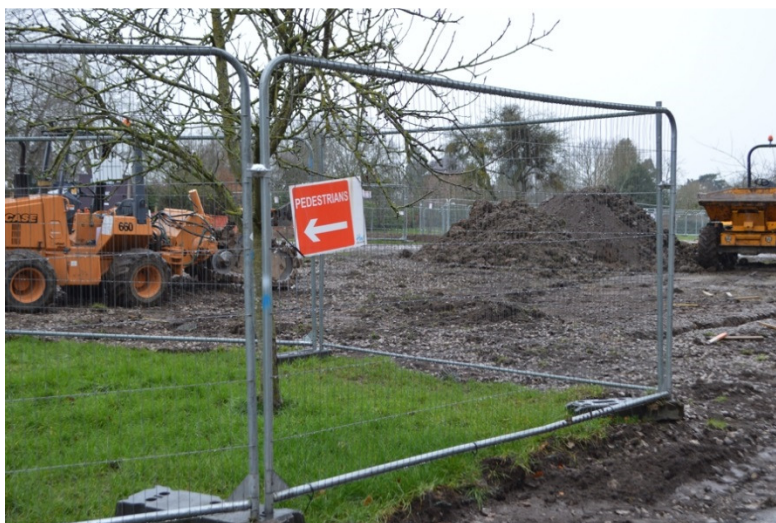
An inspection of all the tree protection was carried out and it is confirmed that there is no damage to the root systems, stems or tree canopies and all retained trees are in good condition. The current condition of the protective fencing is recorded in photos 6-12 inclusive.

**Photo 6. T98-T101 tree protection**

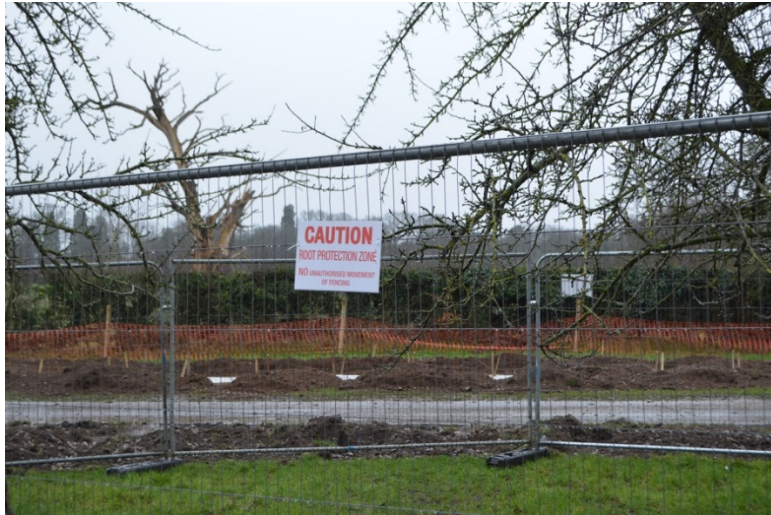
**Photo 7. T98 tree protection**

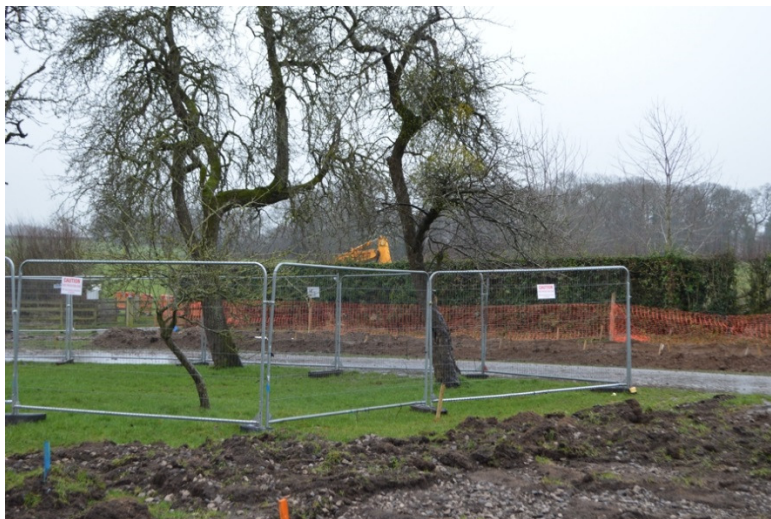
**Photo 8. T98-T101 tree protection**

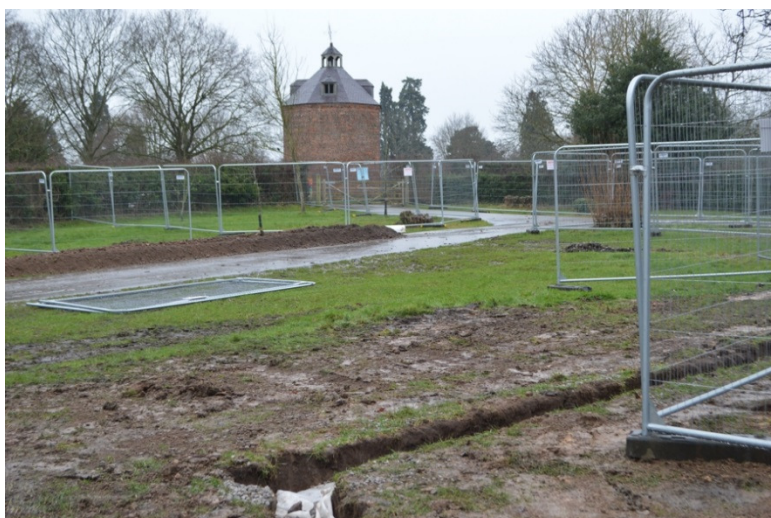
**Photo 9. T56-T64 tree protection**

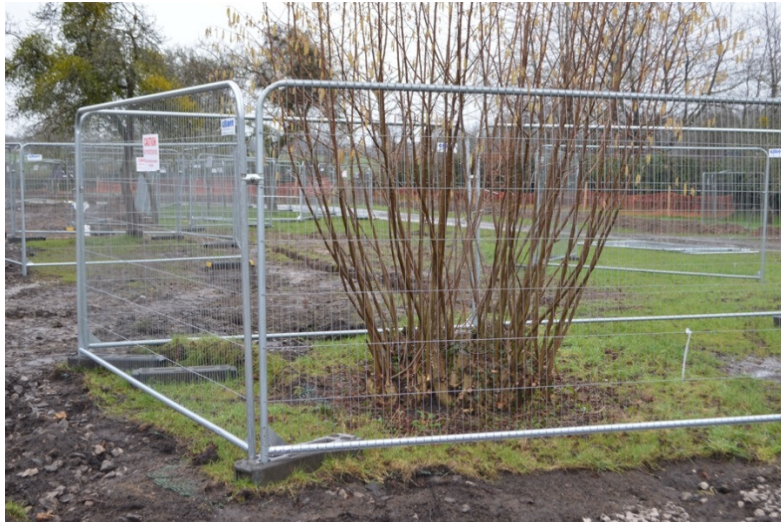
**Photo 10. T78 tree protection**

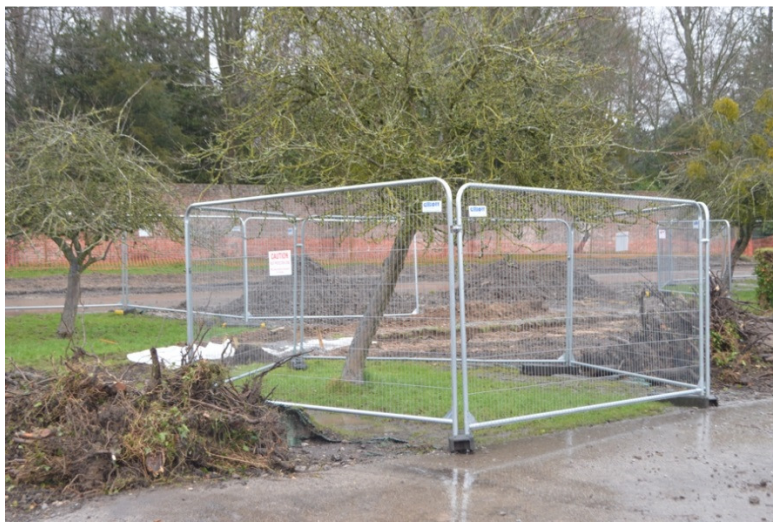
**Photo 11. T111 tree protection**

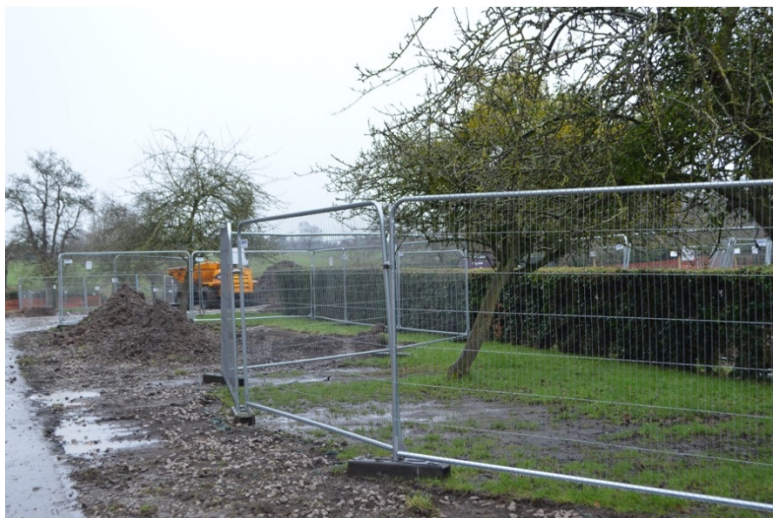
**Photo 12. T05 tree protection**
