REF: 1909/GLA/RepLet/mjs

John Hughes Lloyd  
Ellbay Properties Ltd  
8 Grango Lane  
Ponciau  
Wrexham LL14 1ER

2<sup>nd</sup> March 2017

## **RE: GRANGO LANE PONCIAU: SHAFT SEARCH**

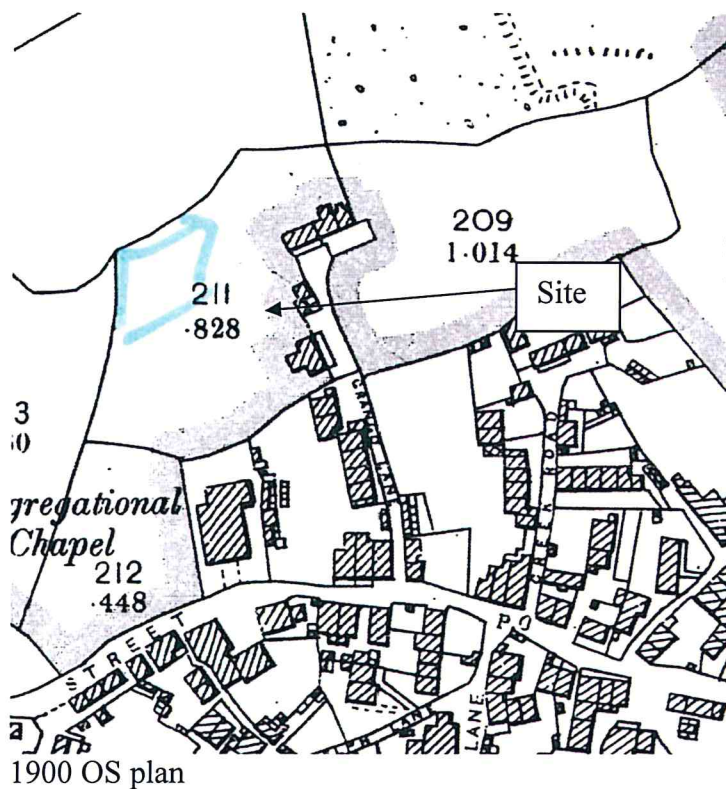
The 1900 OS plan, which was the recorded source for shaft 529, failed to record any evidence of the mine shafts within the site boundary.

Based on the evidence from the desk study the actual presence of this shaft must be questioned. The source for this shaft was the 1900 OS plan, whereby the location should have been able to have been plotted with an accuracy of several metres. However, a copy of this plan was obtained and it failed to prove the presence of this shaft. It is therefore considered likely that the shaft recorded on the 1850 Public Health plan actually exists and shaft 529 may actually have been a miss plot of this shaft location. Its revised location is presented on Figure 1.

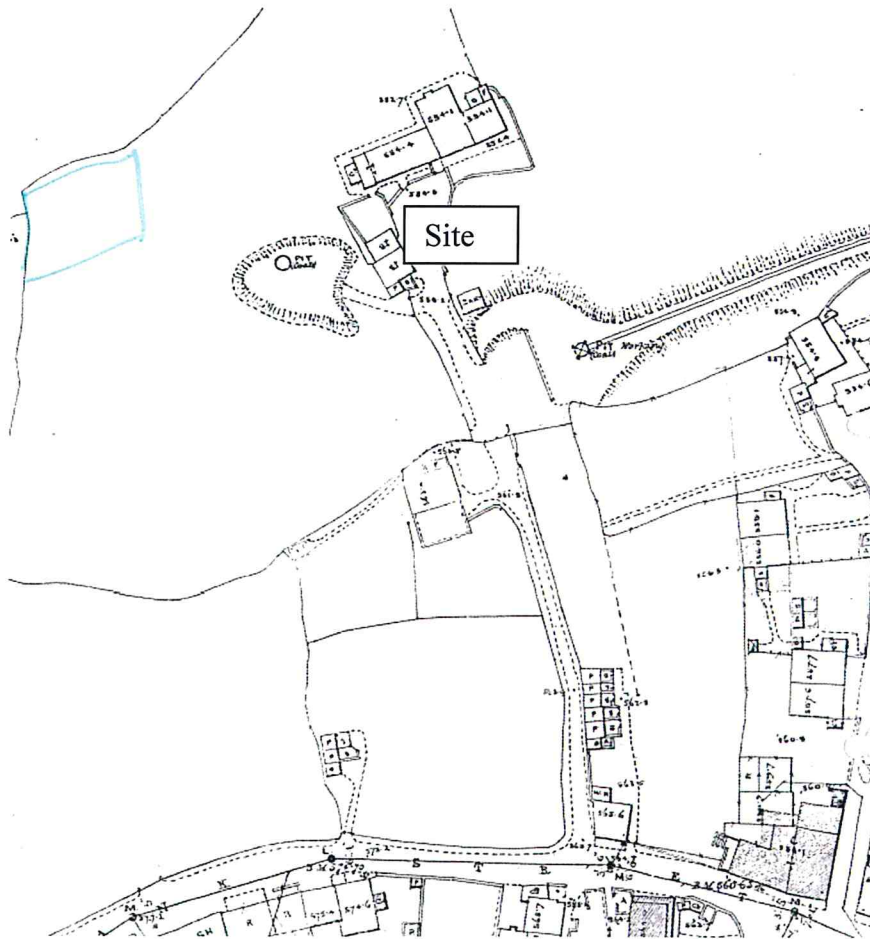
However, GSL also hold the 1850 Public Health plans for this area at a scale of 1:500. Examination of these plans revealed two mine shafts on site, see below. The positions of both of these have been plotted using common features between this plan and the later OS plans. The position of shaft 060 was in the same location as plotted from the Coal Authority information. However, shaft 529, which was reported to have been plotted from the 1900 OS plan was found to be in a different position, which is also shown on Figure 1. These pits had become dis used between the 1850 and 1875 OS plans. This plan also failed to reveal any surface evidence of any older shafts.

However, for shaft 060, while the source information is dubious, the 1850 Public Health plan confirmed the presence of this shaft. The plotted location for this shaft from both the Coal Authority and GSL plotting were within 1m of each other and were approximately 2m north of the gas and water main. The search for the shaft extended from the service location northwards beneath Plots 1 and 2. These failed to encounter any evidence of a shaft. The excavation was also extended to ensure the shaft did not present a risk to Plots 1 and 2 (Area C).

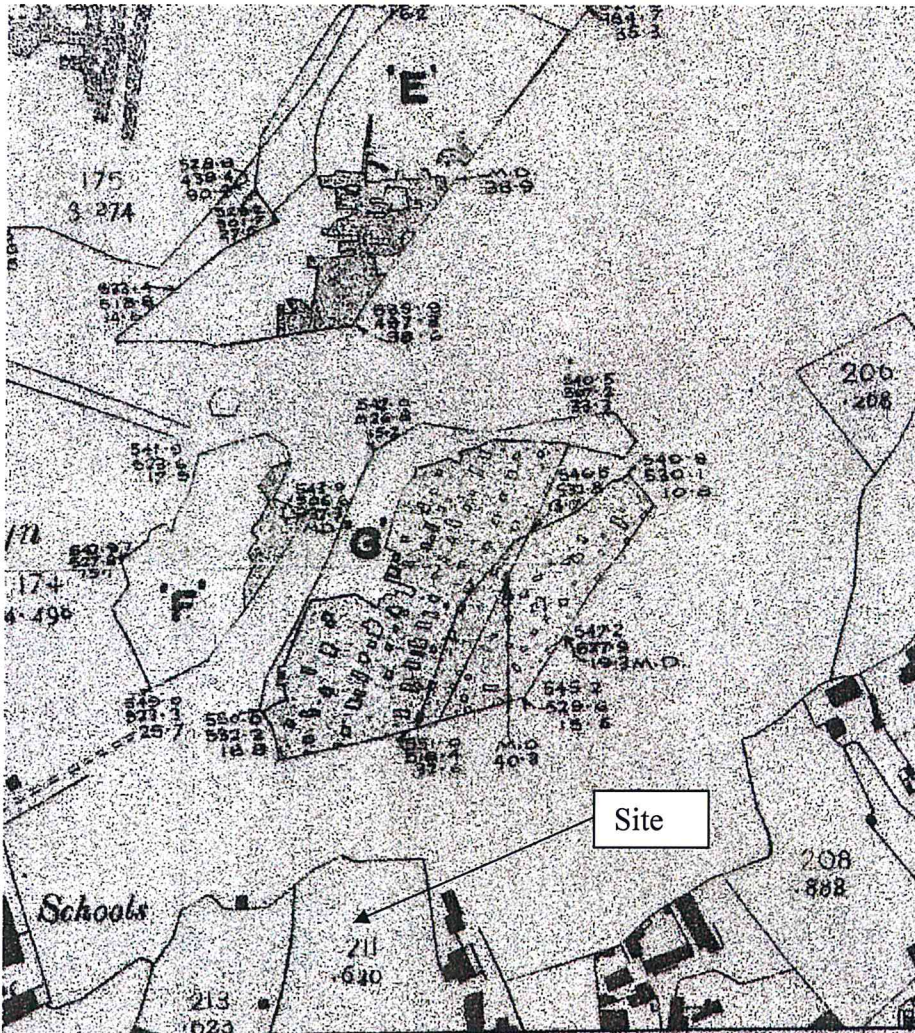
Plan NW 38

In addition, Mine plan NW 38 held in GSL archives was inspected. This shows the opencast workings immediately north of the site, and immediately south of the fault. This shows workings in the Top Brassey and Crank seams, which would put the Top Brassey seam outcropping immediately west of the site. It was proved to have been extensively worked and some 3' thick (0.91m). A section of this plan is presented below.

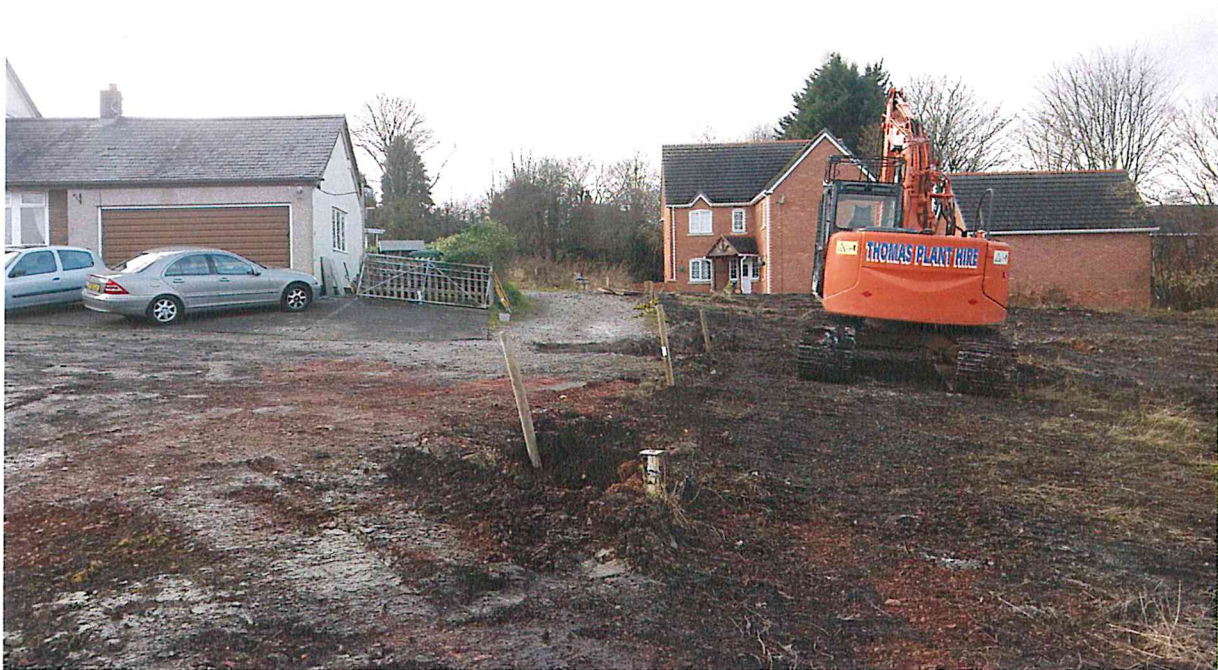
Photograph 5 Line of gas and water main looking west (posts)

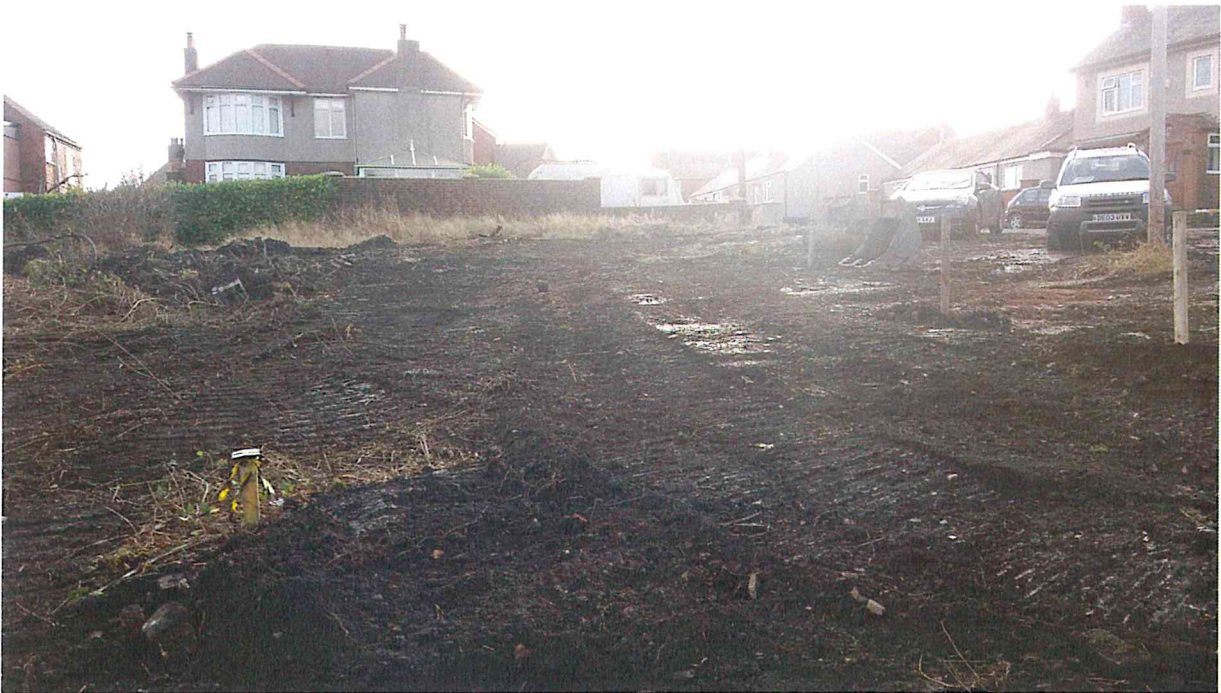
Photograph 6 Line of gas and water main looking east (posts)

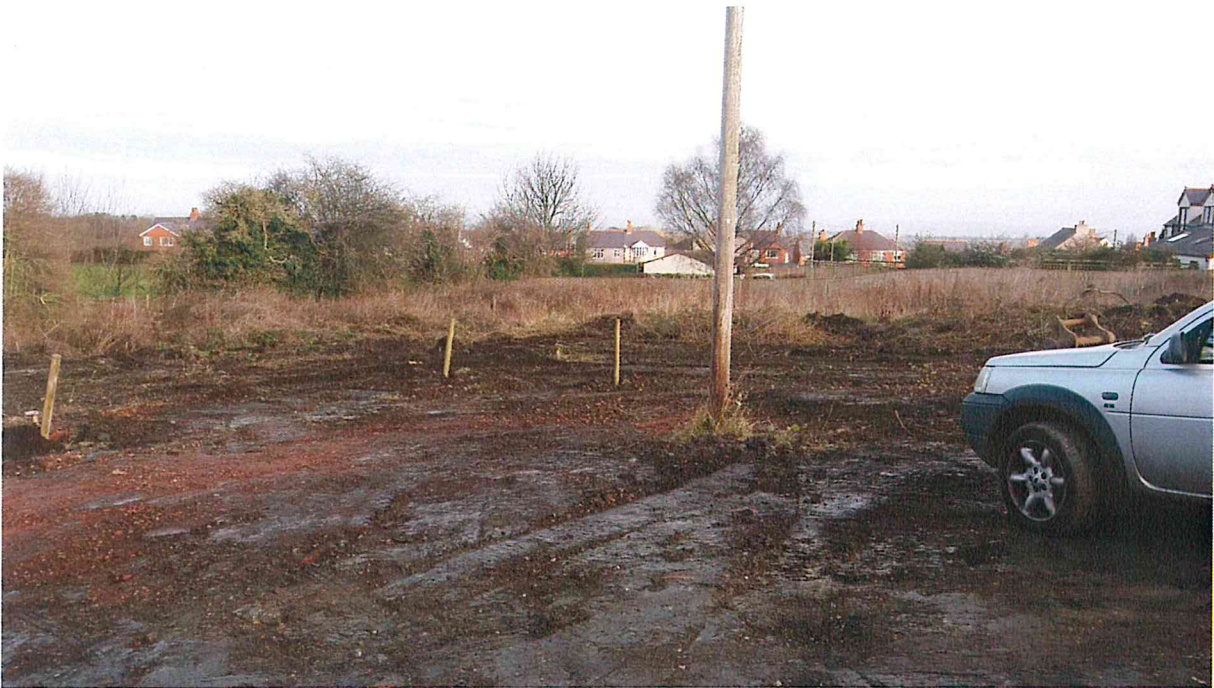
Photograph 7 Gas main and overhead lines

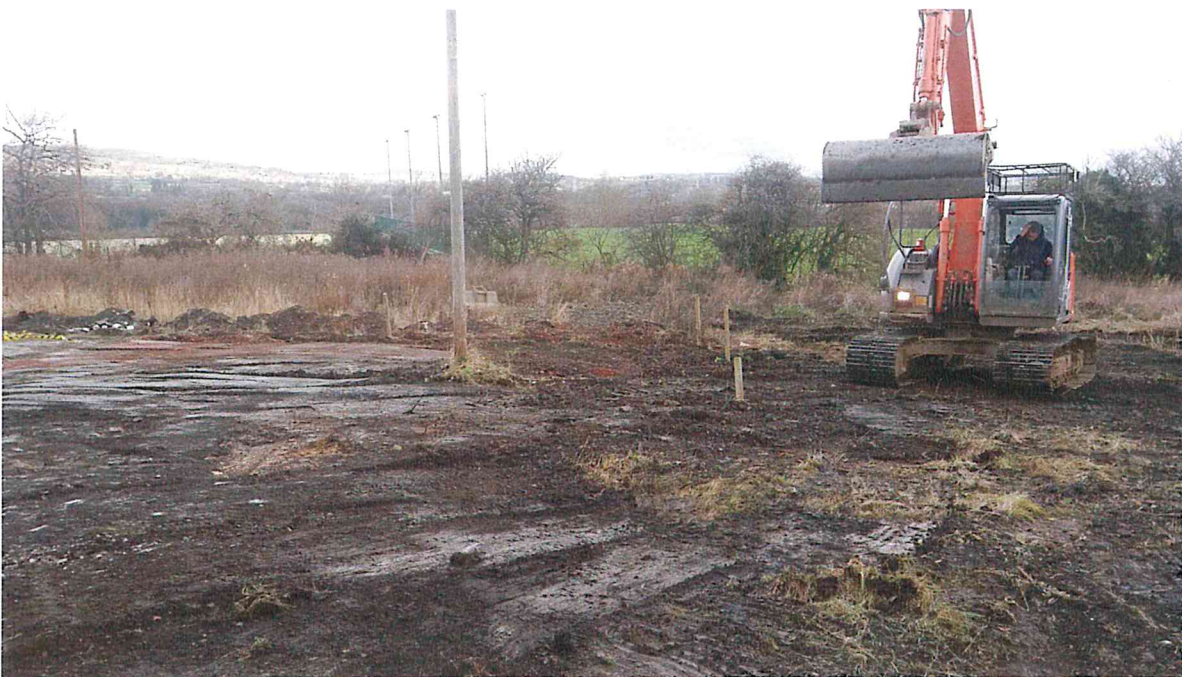
Photograph 9 Overhead and line of gas main

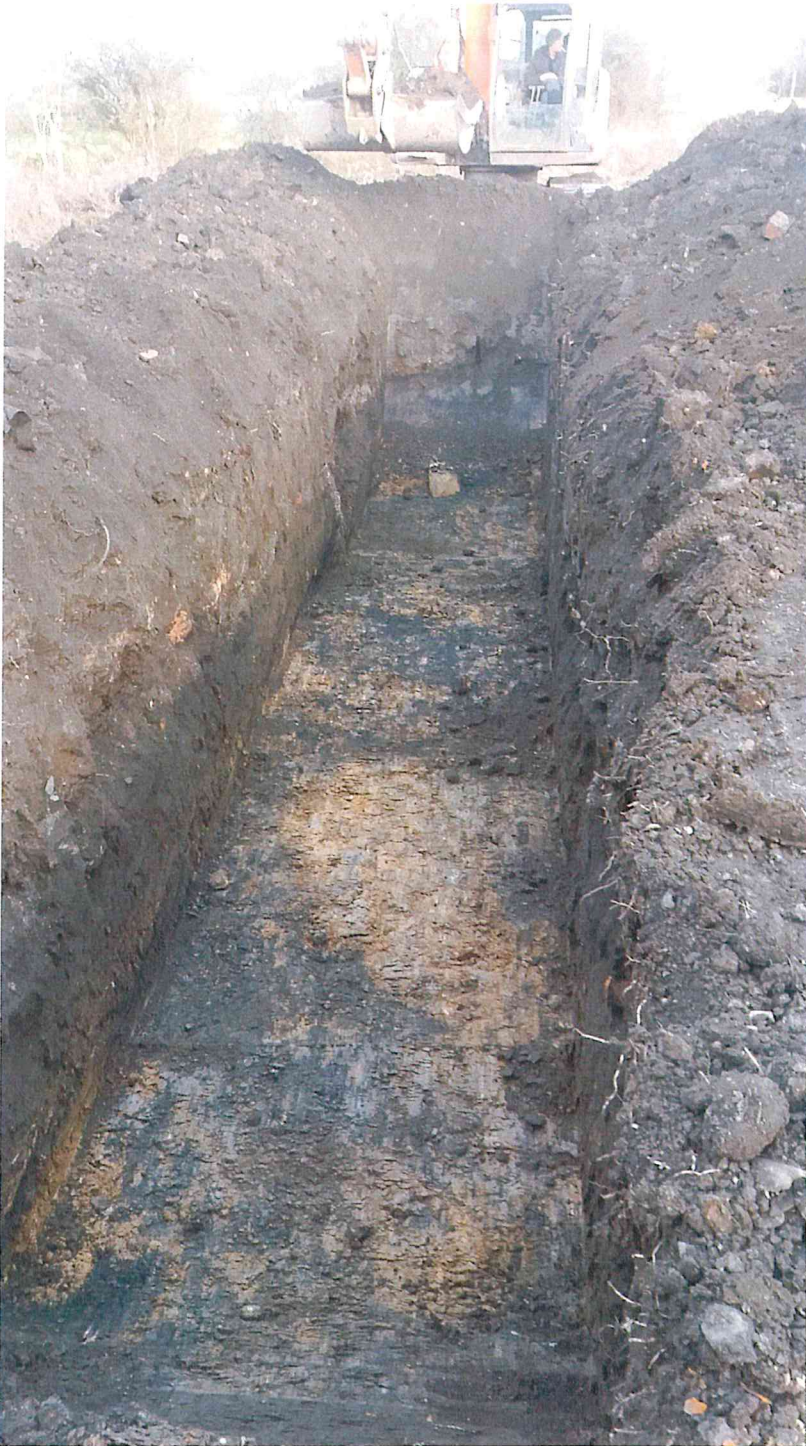
Photograph 13 typical Excavation

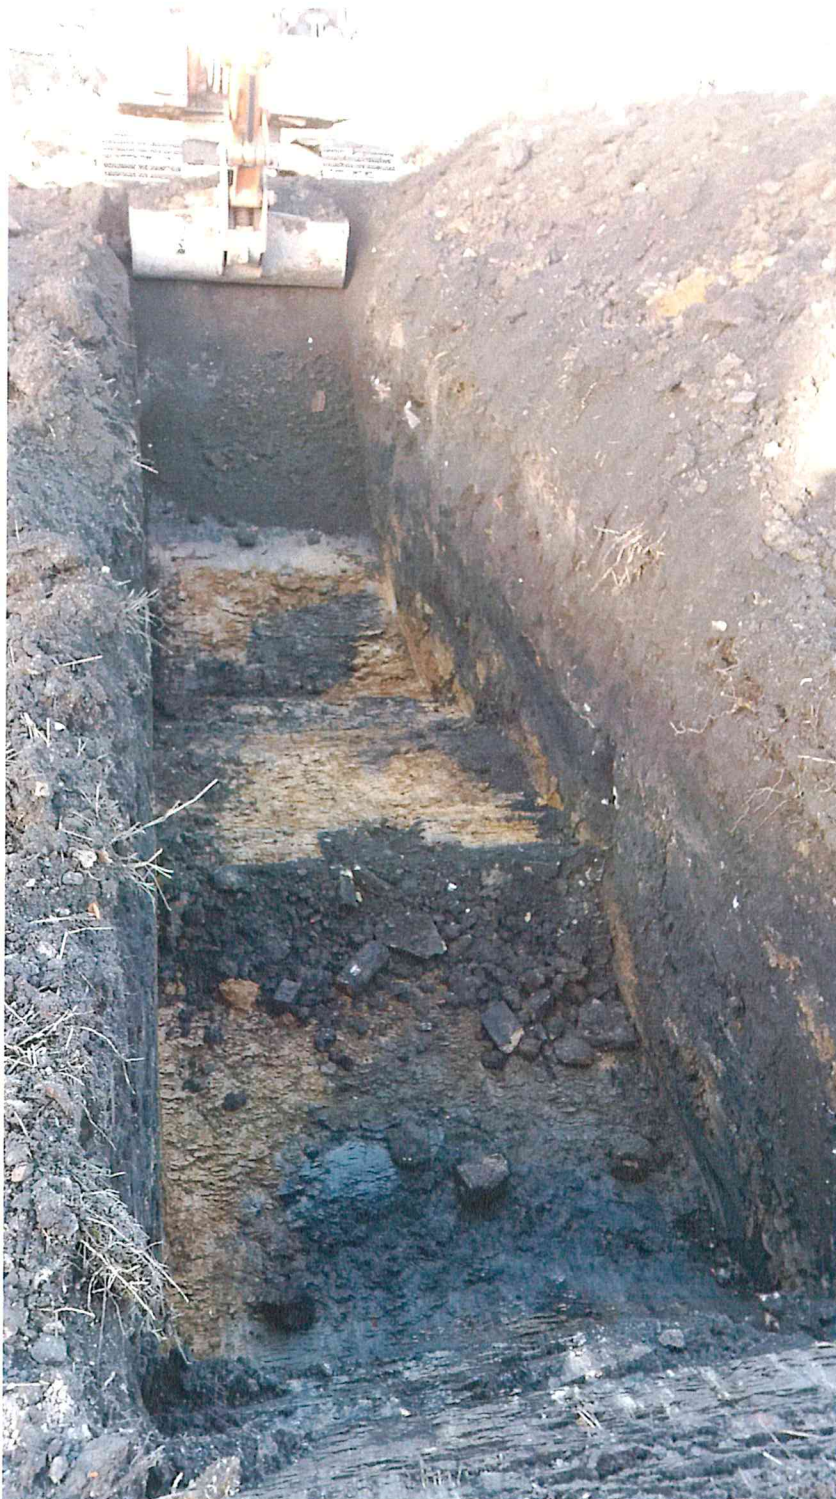
Photograph 14 Typical excavation
