## **Appendix F – Metro Rod Wincan Report**

## CCTV SURVEY REPORT

| Site Address: | Ipsen Biopharm, Ash Road North, Wrexham, LL13 9UF |

Project Name Opus Ipsen Biopharm 396204

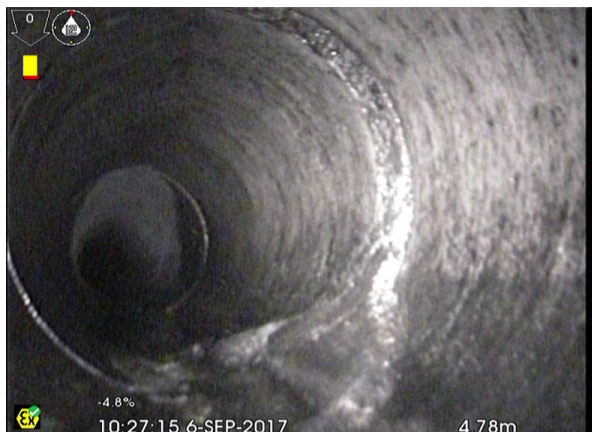
**Section 1/ C1 to C2** – The culvert is in a good, clean, serviceable condition. A few items were highlighted on the report including minor encrustation, a metal object in invert, a hole where mortar is missing on a joint and a poorly constructed butt joint (from 900mm to 750mm) where water is seeping into the culvert (likely ground waters).

C2X\_d2a7c5d0-a28b-47b8-ab8c-a537c3cedf05\_20170912\_081251\_626.jpg, 00:00:59, 4.78m  
Attached deposits, encrustation from 4 o'clock to 7 o'clock, 3% cross-sectional area loss

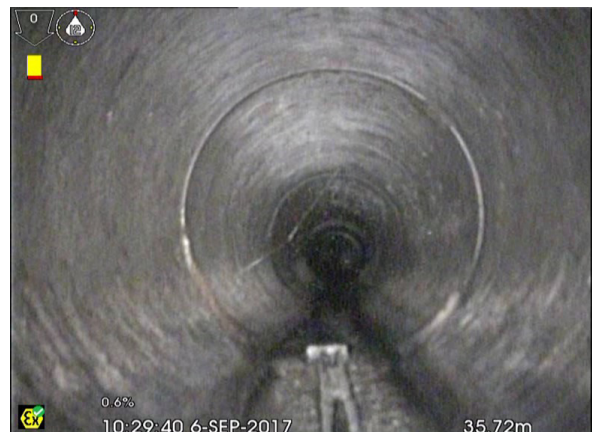
| Section | Pipe Ref | Grade | Description |
|---|---|---|---|
| 1 | C2X | 5 | Other obstacles, other object in invert at 6 o'clock, 5% cross-sectional area loss |

C2X\_cf1d6884-148c-4efe-a6a2-4aed3da1a56c\_20170912\_081617\_357.jpg, 00:03:25, 35.72m  
Other obstacles, other object in invert at 6 o'clock, 5% cross-sectional area loss

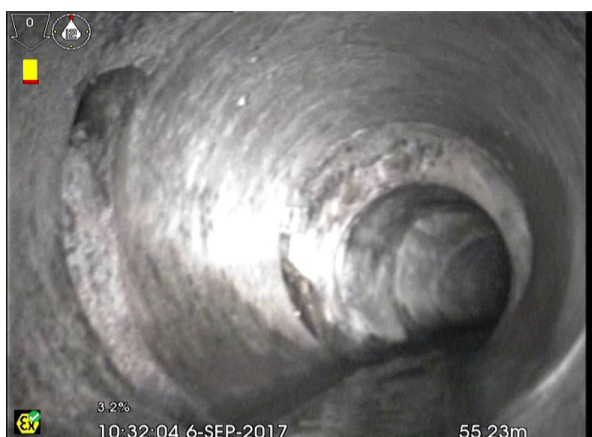
| Section | Pipe Ref | Grade | Description |
|---|---|---|---|
| 1 | C2X | 4 | Hole in drain/sewer at joint at 10 o'clock |

C2X\_0138c975-5a35-443c-a87d-6be0f242e17a\_20170912\_082116\_611.jpg, 00:05:48, 55.23m  
Hole in drain/sewer at joint at 10 o'clock

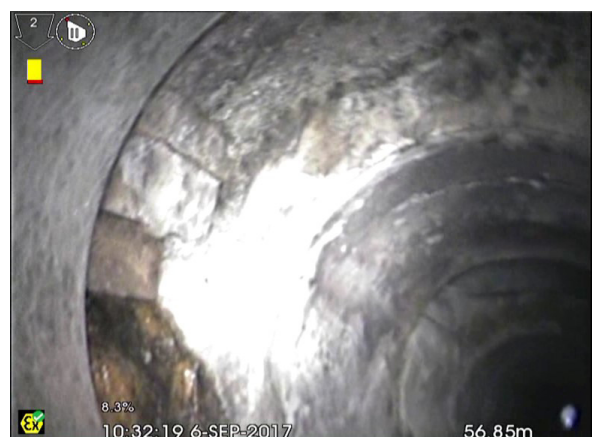
C2X\_957cfd90-7a00-4091-8a0f-8d68fef4e719\_20170912\_082246\_721.jpg, 00:06:03, 56.85m  
Open joint, large

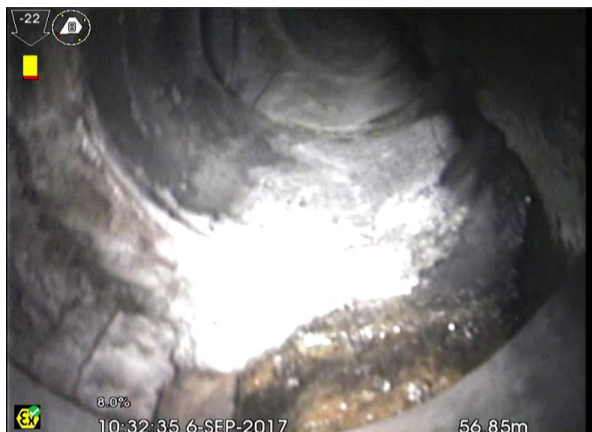
Infiltration, seeping at 9 o'clock

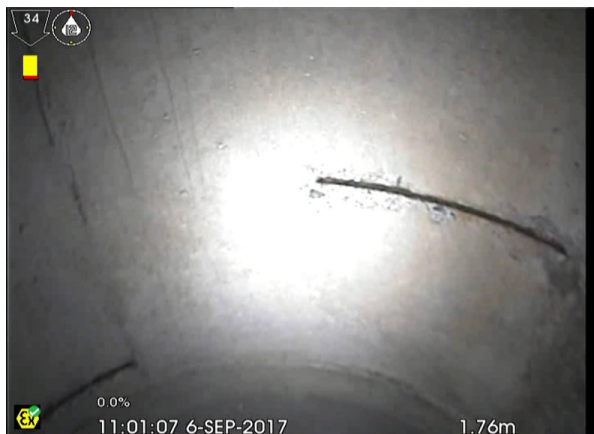
**Section 2/ C2 to C3 (Headwall)** - The culvert is in a good, clean, serviceable condition. The survey has highlighted that a few of the re-bars within the concrete appear to be exposed however, this is likely a fault during casting. Some minor encrustation was also highlighted on a singular joint.

C3\_H.wallX\_b095e7d3-d8d0-44b8-8bac-07e653b6e7ff\_20170912\_083155\_352.jpg, 00:00:38, 1.76m  
General remark

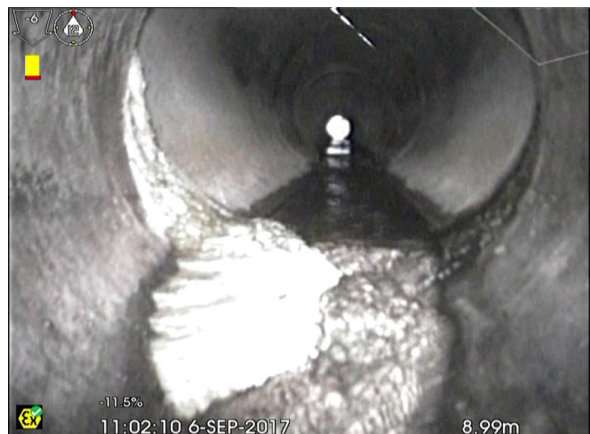
| Section | Pipe Ref | Grade | Description |
|---|---|---|---|
| 2 | C3/H.wallX | 3 | Attached deposits, encrustation from 5 o'clock to 7 o'clock, 5% cross-sectional area loss |

C3\_H.wallX\_cae23a6f-c0cc-48f1-a634-35f3af4b8d59\_20170912\_083506\_942.jpg, 00:01:40, 8.99m  
Attached deposits, encrustation from 5 o'clock to 7 o'clock, 5% cross-sectional area loss

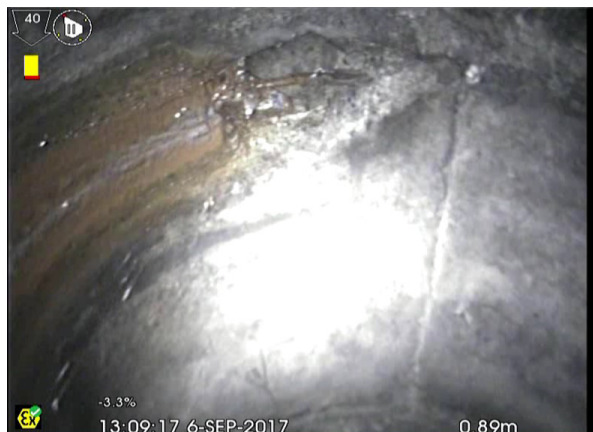
**Section 3/ C3 to C4** - The culvert is in a good, clean, serviceable condition. The survey revealed a potential entry point for ground water (or leak from service) at approx. 0.89mts (but may be hidden connection). This is entering the culvert at a steady pace (dripping). We also discovered that a cast iron pipe has likely been moled through the culvert at approx. 14.04mts which is also allowing water to ingress (dripping) through the holes where the pipe has broken through.

| 1:441 | Position m | Code | Observation | Grade |
|---|---|---|---|---|
| | 0.89 | ID | Infiltration, dripping at 10 o'clock | 0 |
| | 0.89 | CN | Connection other than junction at 1 o'clock, diameter: 100mm: appears to be cast iron pipe | 0 |

C1X\_fad6a9a5-0175-48cf-aa51-6d8a3521a665\_20170912\_084205\_694.jpg, 00:00:22, 0.89m  
Infiltration, dripping at 10 o'clock

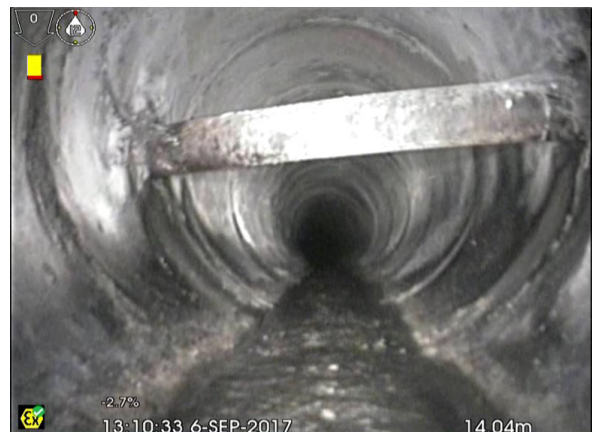
| Section | Pipe Ref | Grade | Description |
|---|---|---|---|
| 3 | C1X | 5 | Other obstacles, other from 3 o'clock to 9 o'clock, 10% cross-sectional area loss |

| 1:441 | Position m | Code | Observation | Grade |
|---|---|---|---|---|
| | 14.04 | OBZ | Other obstacles, other from 3 o'clock to 9 o'clock, 10% cross-sectional area loss: cast iron pipe through pipe likely water main. water ingress on | 5 |

C1X\_06a23d8d-747e-412d-b068-9f247a6ee966\_20170912\_084547\_481.jpg, 00:01:38, 14.04m  
Other obstacles, other from 3 o'clock to 9 o'clock, 10% cross-sectional area loss

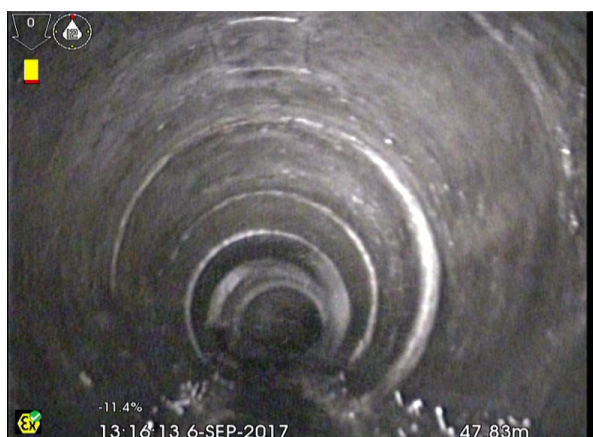
| 1:441 | Position m | Code | Observation | Grade |
|---|---|---|---|---|
| | 47.83 | REM | General remark: assume window cut through pipe and re-mortared in position | 0 |

C1X\_424818c4-04ed-423b-ba67-503e54586c3e\_20170912\_085223\_515.jpg, 00:04:28, 47.83m  
General remark
