Cheshire  
Ecology Ltd.

**CORNISH HALL BARNS  
AUDIT OF BAT MITIGATION STRATEGY**

## **EXECUTIVE SUMMARY**

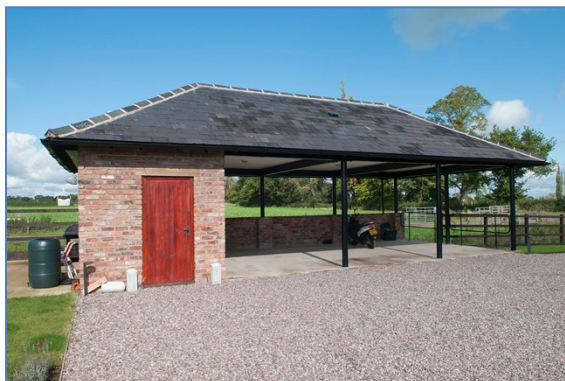
| External illumination of car port. | There are two small roof lights in the ceiling of the car port and a pedestrian light near the access door. This has a baffle fitted to throw prevent any light from shining above the horizontal axis (see Photograph 1). |

Photograph 1: Approximately 75% of the building is occupied by the car port.

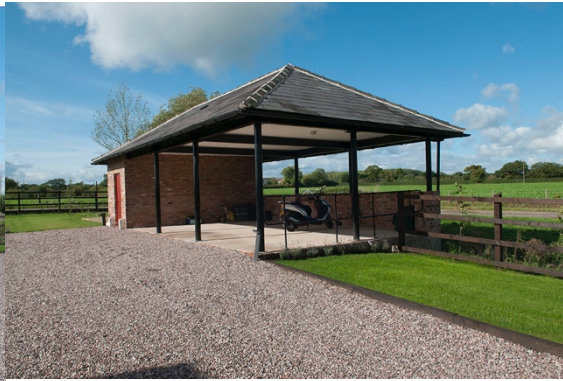
Photograph 2: The car port is situated beside the stream.

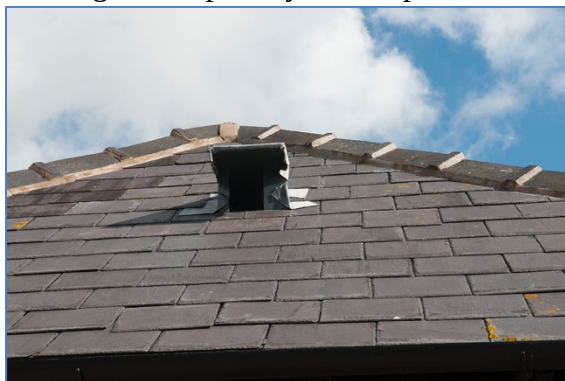
Photograph 3: A Habitat entrance had been placed on the western side of the roof.

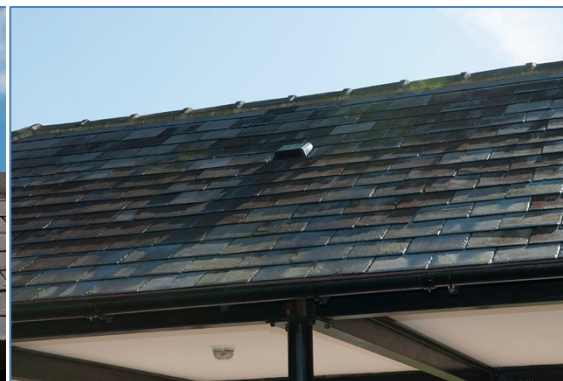
| Habibat bat access slates will be installed into the roof, one on the northern pitch and the other on the southern pitch. | Implemented. |

Photograph 4: There is also an entrance on the northern side of the roof.

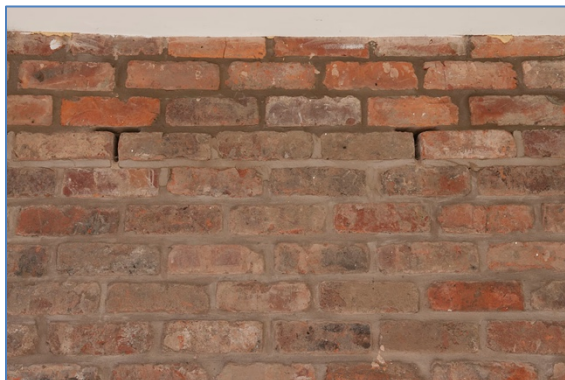
| Small gaps have been left in the mortar to allow bats into the wall cavity. | Implemented. Two T-shaped holes have been created. There was no evidence that they were being used. |

Photograph 5: Two T-shaped slots have been left to allow crevice-living species to gain access.

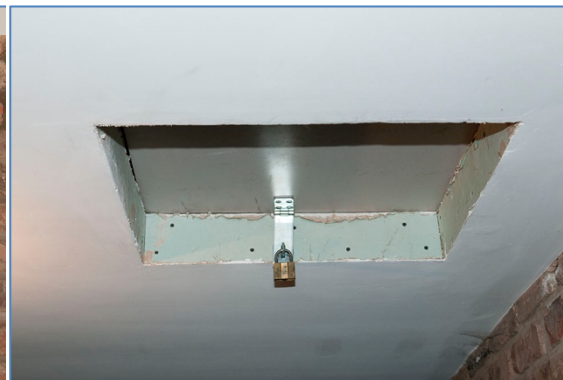
| Requirement | Has this been adhered to? |
|---|---|
| Access to the loft is restricted to authorised personnel. | Implemented. |

Photograph 6: Access is controlled by a separate padlock.

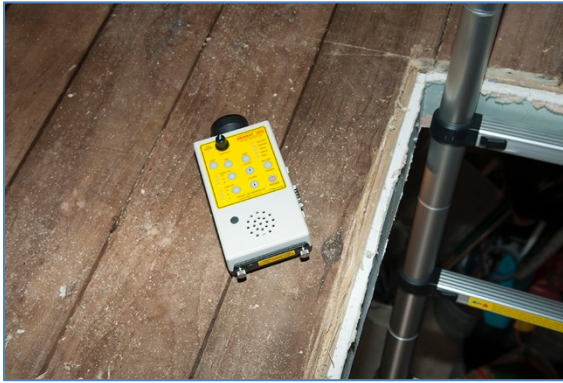
- 3.1.6 The interior of the loft was checked with Anabat SD2 before it was inspected. There was no evidence that bats were present and there were no bat droppings or other field signs to show that they had visited the loft since it had been constructed.

Photograph 7: There was no evidence that bats are currently using the loft.

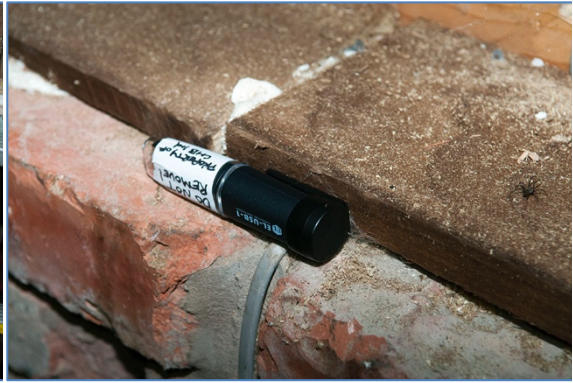
| A thermal data logger will be installed to monitor the temperature of the roost. | Implemented. A data logger had been placed at the entrance to the loft. This appears to be working. A print out is shown in Appendix B. |

Photograph 8: The data-logger appears to be working correctly.

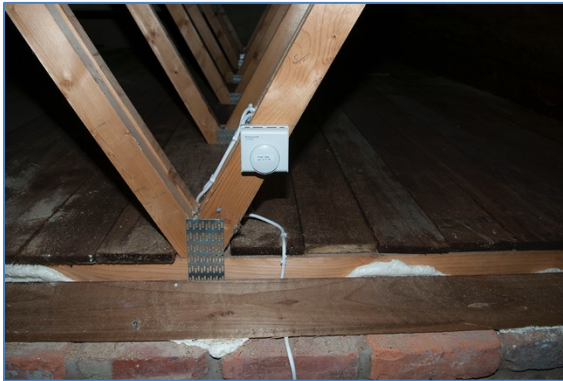
| A Devi mat or a dry mount system will be installed at the east end of the barn. | Implemented. We have been advised that a Devi mat would be a fire risk in such a confined space. A shrouded heating element has been recommended by a qualified electrician as a safer method of heating the bat loft. |

Photograph 9: The heater has a separate thermostatic control.

- 5.1.1 The site should be checked in November to determine whether the thermostat and heater are maintaining the correct temperature. The thermostat is currently set at +5°C to ensure that the loft remains frost free.
- 5.1.2 The first monitoring inspection is scheduled for June 2018. We recommend that a static bat detector should be left in the loft at the beginning of December 2017 for one week to determine whether it is being used by bats. It may be possible to modify the structure or management if bats are failing to use it. The data logger should be checked at the same time to ensure that the correct minimum temperature is being maintained.
- 5.1.3 A more substantial hatch should be installed for the loft entrance. This should be done before bats occupy the loft.

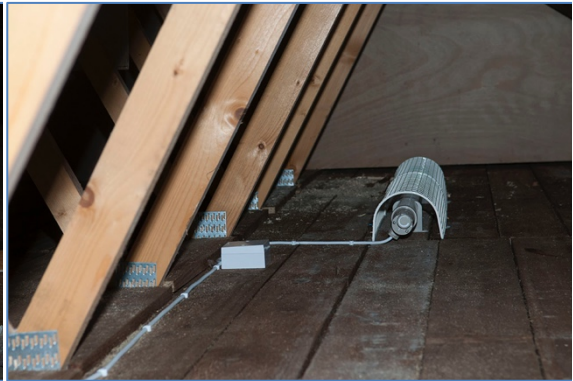
Photograph 10: The heater also appears to be functioning correctly.

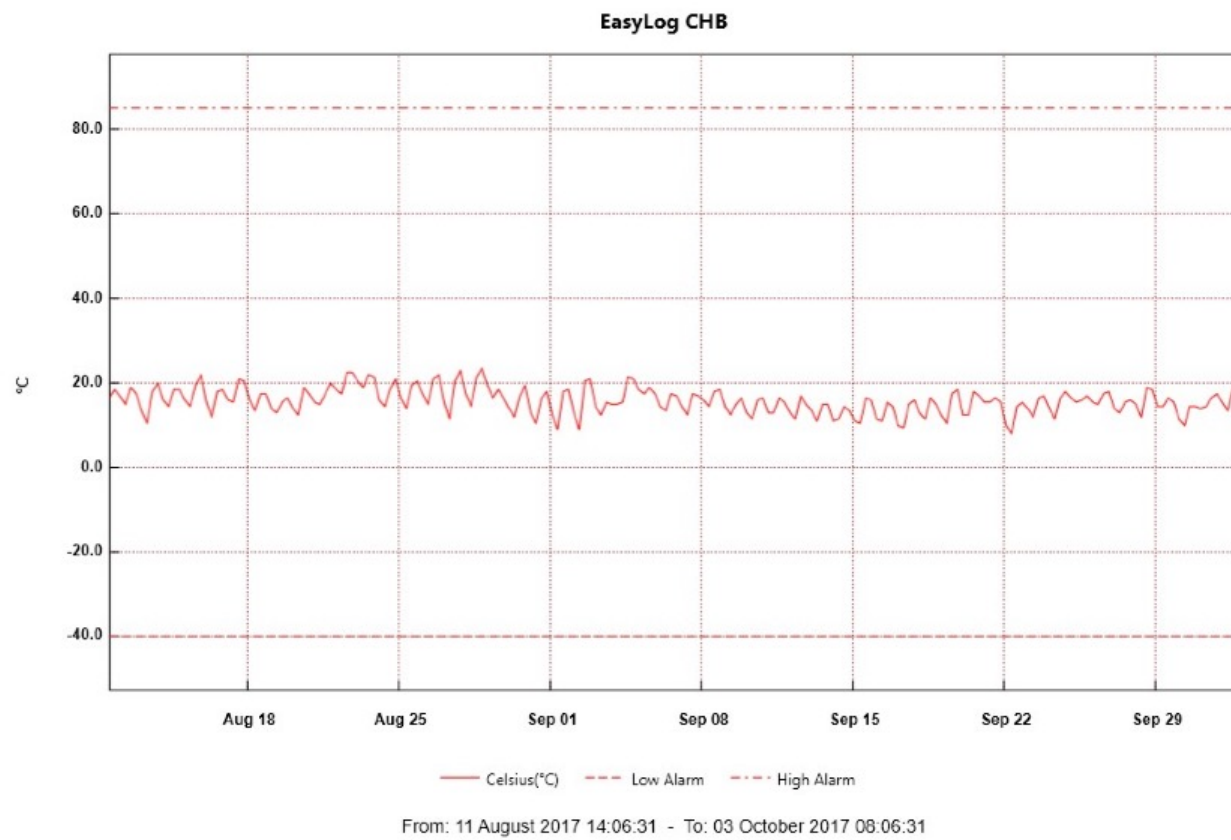
**APPENDIX B: PRINT OUT FROM DATA LOGGER**

- 3.1.4 An Easy Log EL-USB-1 datalogger has been placed inside the building near the loft hatch. A print out from the data logger is included in Appendix B.
