## BRYMBO MACHINE SHED, NESTING BIRD SURVEY

**18/07/2017**

Report Ref EE.373/RH

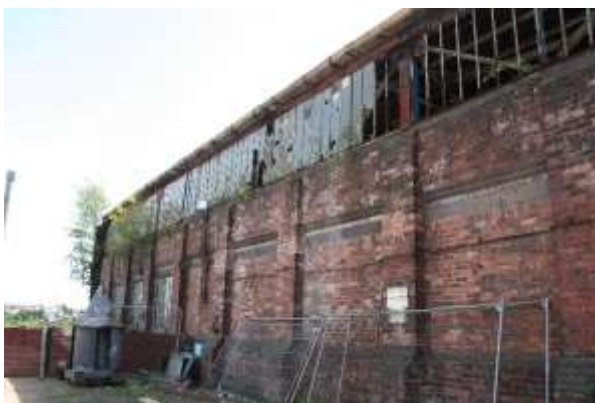
The initial proposed works are to re-roof the structure including adding insulation within the roofing structure, and to install new windows throughout. Therefore following the renovation the building will be sealed, not allowing access into the building for birds. Pictures 1 and 2 illustrate the exterior of the building from the north and west. The glass is missing from a large amount of the window frames throughout the building allowing easy access for birds at present. As well as this there were also large gaps present between steel beams and walls providing ample access opportunity and nesting potential and gaps surrounding the wooden doors providing access.

**PICTURE 1. EXTERIOR FROM THE NORTH SIDE.**

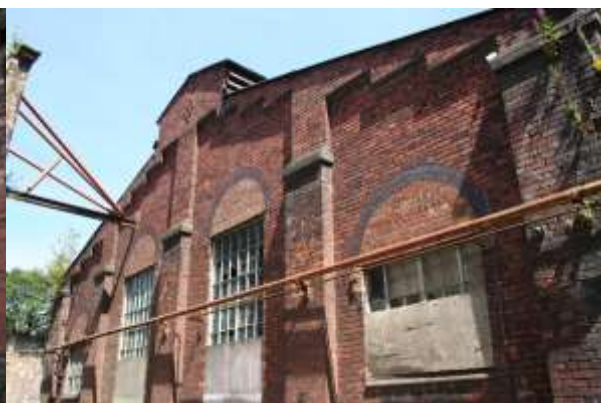
**PICTURE 2. WEST ELEVATION FROM THE NORTH.**

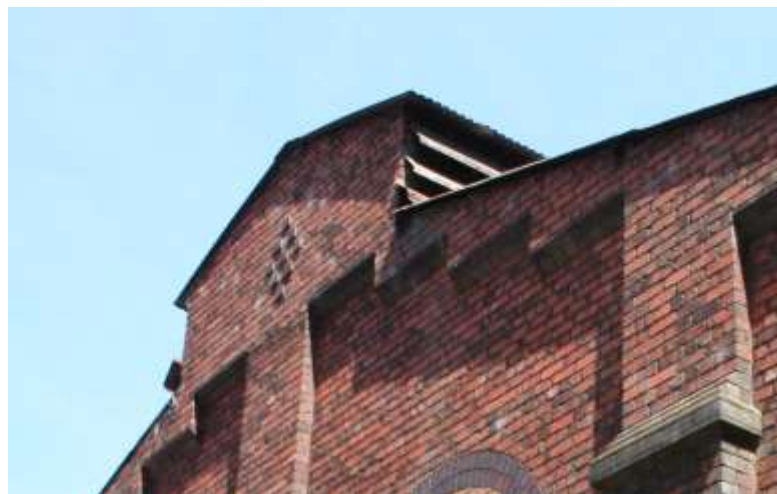
On the two gable ends of the building there are metal sheets which appear to be vents on the tallest section of the building. This would again provide nesting opportunity, or access to the interior.

**PICTURE 3. VENTS ON THE GABLE END**

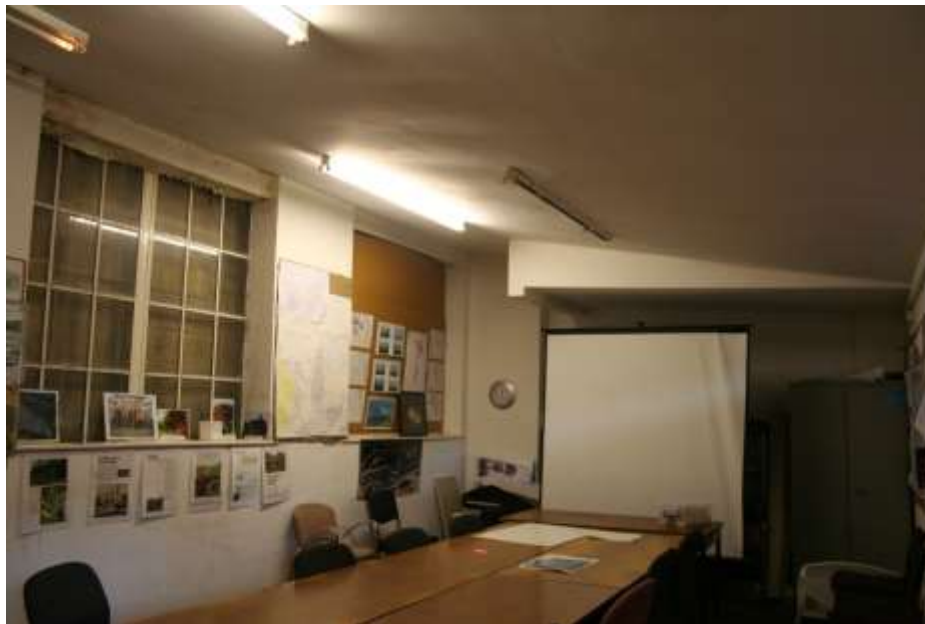
Currently the interior of the building is largely open plan with some inbuilt meeting rooms, offices and toilets which have their own walls and roof (picture 4).

**PICTURE 4. MEETING ROOM WITHIN THE MACHINE SHOP**

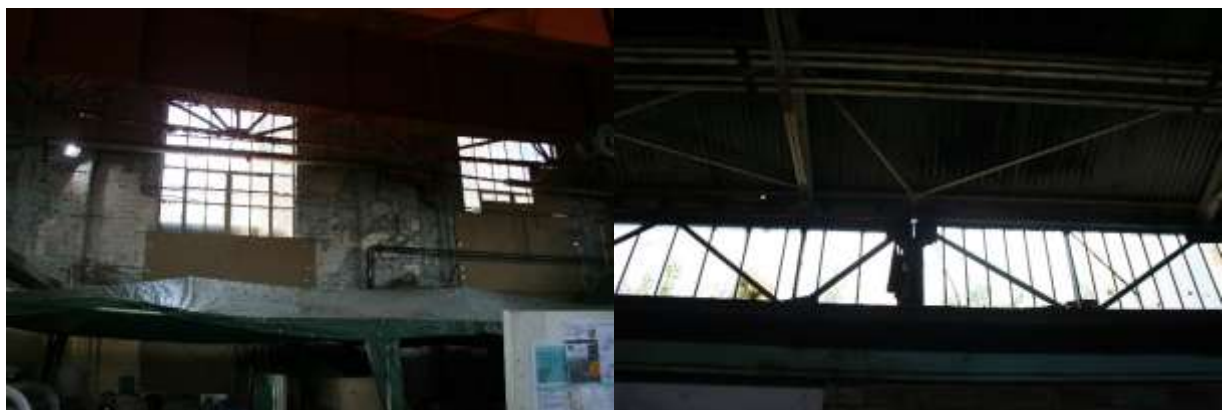
Although access into the whole building was obtained, due to the height of the building there were many areas which could not be definitely ruled out as having nests present due to the ledges from the steel which made “platforms” where birds could nest upon.

**PICTURE 5. OLD CRANE PROVIDING ACCESS TO THE GABLE**

**PICTURE 6. EXAMPLE OF GAP BETWEEN THE METAL WORKS AND ALSO LEDGES PRESENT WITHIN THE BUILDING**

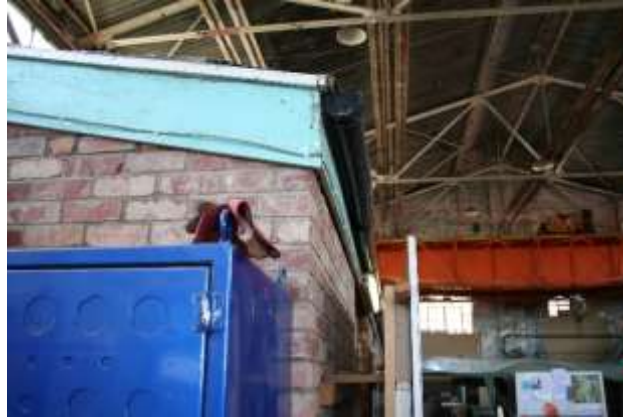
The buildings within the Machine Shop also had their own barge boards (see picture 7) however, none of these provided nesting potential.

**PICTURE 7. BUILDINGS WITHIN THE MACHINE SHOP AND METALWORK PRESENT**

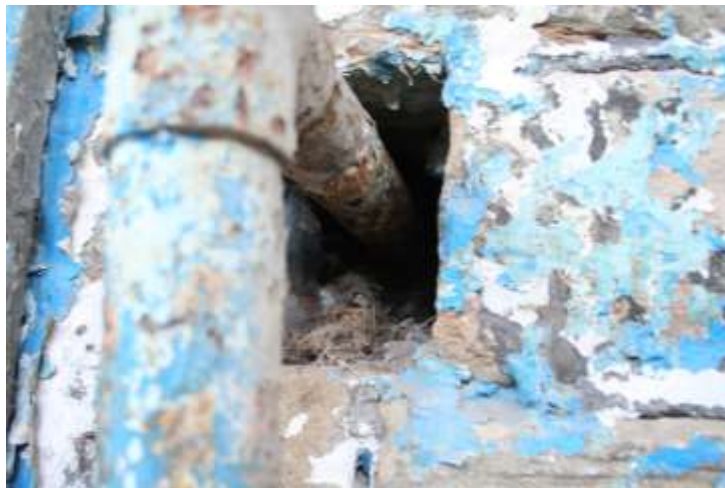
The lower ground floor of the building was very draughty due to the broken glass in the gable end windows. This section of the building also had stone walls. There was one gap present in the stone wall where a pipe emerges out of the gap, the remains of an old birds nest were present within this gap.

**PICTURE 8. OLD BIRDS NEST WITH GAP IN THE WALL**

- 5.3 One old birds nest was observed in a hole in the stone work on the lower ground floor.
- 5.4 Due to the height and the presence of many ledges within the building, it is possible that bird nests may have been present but unable to be seen.
