# Conversion of Outbuildings, Charity Farm, Haighton La, Bangor-on-Dee, Wrexham

## Structural Appraisal Report

June 2017

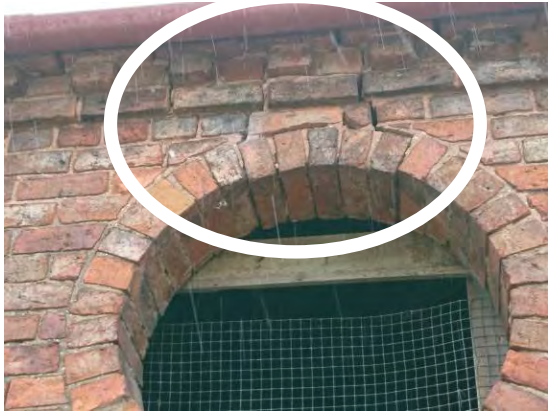
The overall condition of the elevations are considered to be fair. Loose brickwork was apparent to the bullseye opening on the front elevation (see Photo 6). Several of the bricks have been dislodged in the arch ring also. Vertical bed joint cracking was noted extending below the opening to approximately 1.2m above ground level (see Photo 7). The cracking was noted as up to 2mm wide at opening level. Diagonal bed joint cracking was noted extending to eaves level above the opening into Room 4. The cracking was noted as up to 2mm wide at lintel level. The edges of the all of the cracking was noted as weathered. The pattern of cracking is indicative of a slight historic settlement of the front corner. Loose brickwork was apparent above the door opening to the left hand side elevation. No lintel is provided externally and the presence of a severely rotted lifting beam would appear to be contributory. The area should be rebuilt as part of the conversion. Mortar to bed joints is lime based generally and was noted as reasonably firm when probed. Spalling and erosion to isolated brick units was apparent throughout the elevations. This is not uncommon in buildings of this age where brick units are porous and soft and susceptible to frost action.

Photo 6 – Loose brickwork above opening and to arch ring.

- Replace isolated spalled brick units with similar. Locally rebuild areas of loose brickwork. Repoint elevations by raking out existing pointing to a minimum depth of 40mm. New pointing shall comprise a traditional lime mortar finished flush with the face of the masonry.

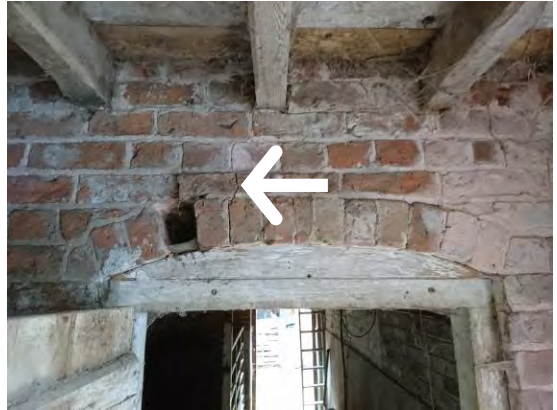
Photos 9 – Cracking above internal opening.  
Note missing brick.

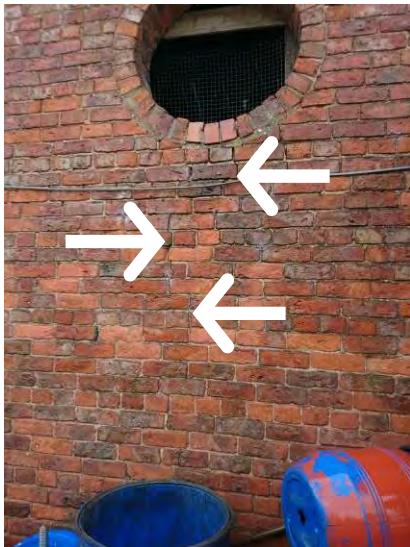
Vertical cracking and loose brickwork was apparent in the gable elevation of Room 9 above the bullseye window. The top five bricks to the arch ring have dropped along with the brickwork above. The cracking was noted as up to 5mm wide above the opening and 2mm below. The pattern of movement is consistent with a slight settlement at the front corner of the building. Staining was apparent to brickwork on both sides of the internal wall at the base of valley over Room 9. The defect appears longstanding and is indicative of failed flashings in the valley.

Photo 7 – Cracking below bullseye opening.

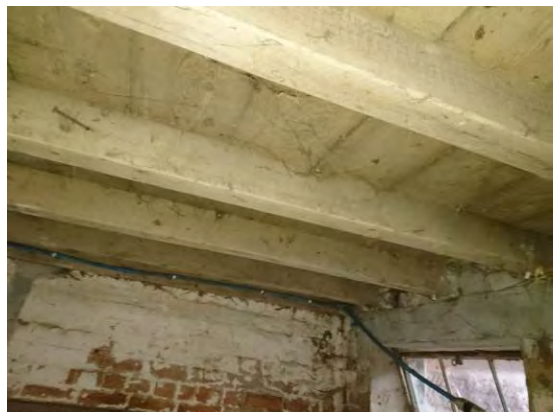
The boarded finishes, joists and intermediate beams to the first floors over show evidence of minor deterioration due to insect infestation (see Photo 10). No section losses were apparent, however several of the joists and beams appear undersized for the span and imposed loadings.

Photo 10 – Typical condition  
of first floor construction.

- Remove sheeting to shippon roof. Prepare and repaint retained steel sections as necessary. Install new insulated roof over.
- Strengthen or replace first floor construction. Provide lateral restraint strapping as necessary secured to external and internal walls and extending across three floor joists.

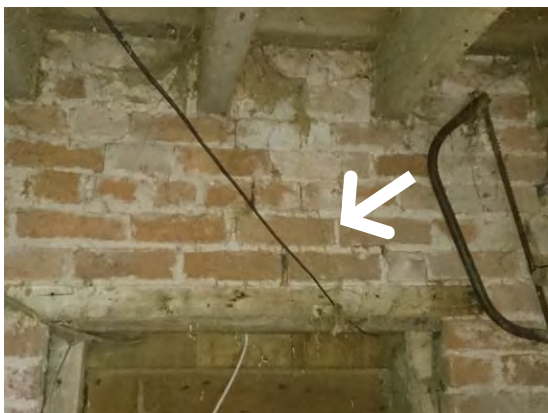
Photo 8 – Cracking above internal opening.

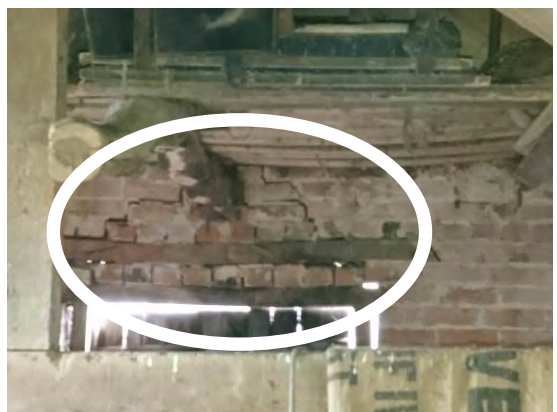
Severe distortion was apparent to the lintel over the external door opening to Room 7 (see Photo 11). This is due to the lintel being inadequate to support the reaction from a timber lifting beam installed over the opening. The brickwork is loose and replacement lintels will

Photo 11 – Inadequate lintel and loose  
brickwork above opening.

- Replace timber lintels to external and internal openings with proprietary precast concrete or steel units.
- Install injected chemical or sheet dpc at least 150mm above ground level to external and internal walls of the original part of the building. A ten year insurance backed guarantee should be provided for all materials and installation.

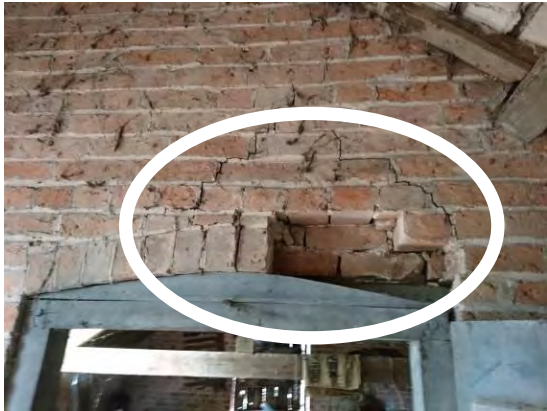
be required. The arched brick lintel to one side of the door between Rooms 7 and 8 has partially collapsed with several bricks being missing (see Photo 12). This has resulted in significant cracking in the brickwork above.

Photo 12 – Missing brickwork above opening.  
Note cracking above.

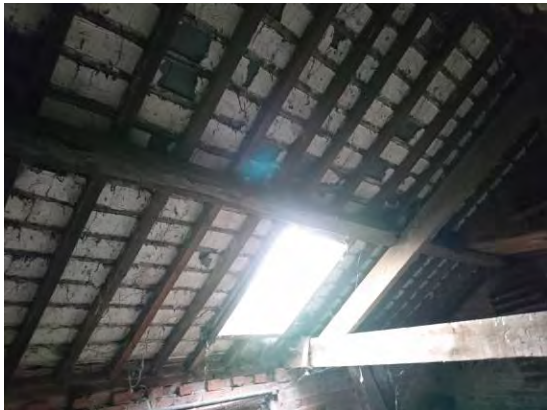
The slated finishes are generally laid directly over the rafters with torching internally. However over Rooms 9, 10 and 11, a felt membrane has been installed over part of the roof which would suggest that the roof has been re-laid in the past. Several small holes were noted to the slated finishes within Rooms 7, 8 and 11. Severe water penetration was apparent below the valley over Room 9 which has resulted in severe degradation to the timber below. The remainder of the roof timbers show evidence of minor deterioration as a result of insect infestation and minor weather penetration over an extended period (see Photo 13). The defects are particularly prevalent below roof lights which appear to be leaking. The intermediate trusses show evidence of slight deterioration. The roof construction requires extensive minor repair with some isolated timber renewal.

Photo 13 – Typical condition of  
roof construction

- Remove existing slated finishes to barn and set aside for re-use. Inspect existing timbers and replace as necessary. Relay slated finishes on treated battens over breathable membrane. Modifications to roof construction will be required to increase headroom at first floor level.

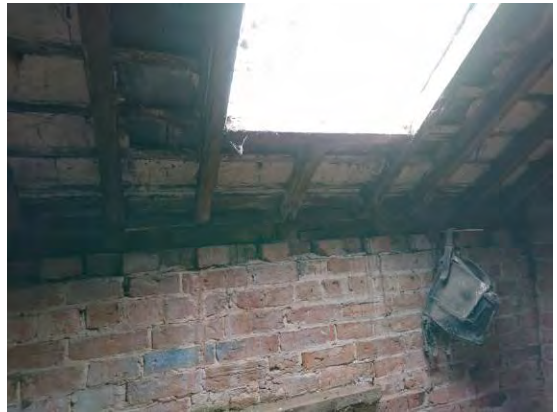
Staining was apparent to roof sheeting adjacent to roof lights, joints and adjacent to the purlins (see Photo 19). The staining is generally minor except under the roof lights where green staining would suggest that the defect is longstanding. Several small holes were apparent to the sheeting which are allowing water to penetrate the sheeting. Minor surface corrosion was noted to the steel purlins and roof trusses, though no significant section losses were apparent.

Photo 19 – Staining to sheeting.
