# Arboricultural Report

Land off Tudor Drive  
Penley  
Wrexham

*For the purpose of dealing with all tree issues in accordance with  
BS5837:2012 Trees in Relation to design, demolition and  
construction: Recommendations for a development at the site*

Survey date:  
27<sup>th</sup> February 2017

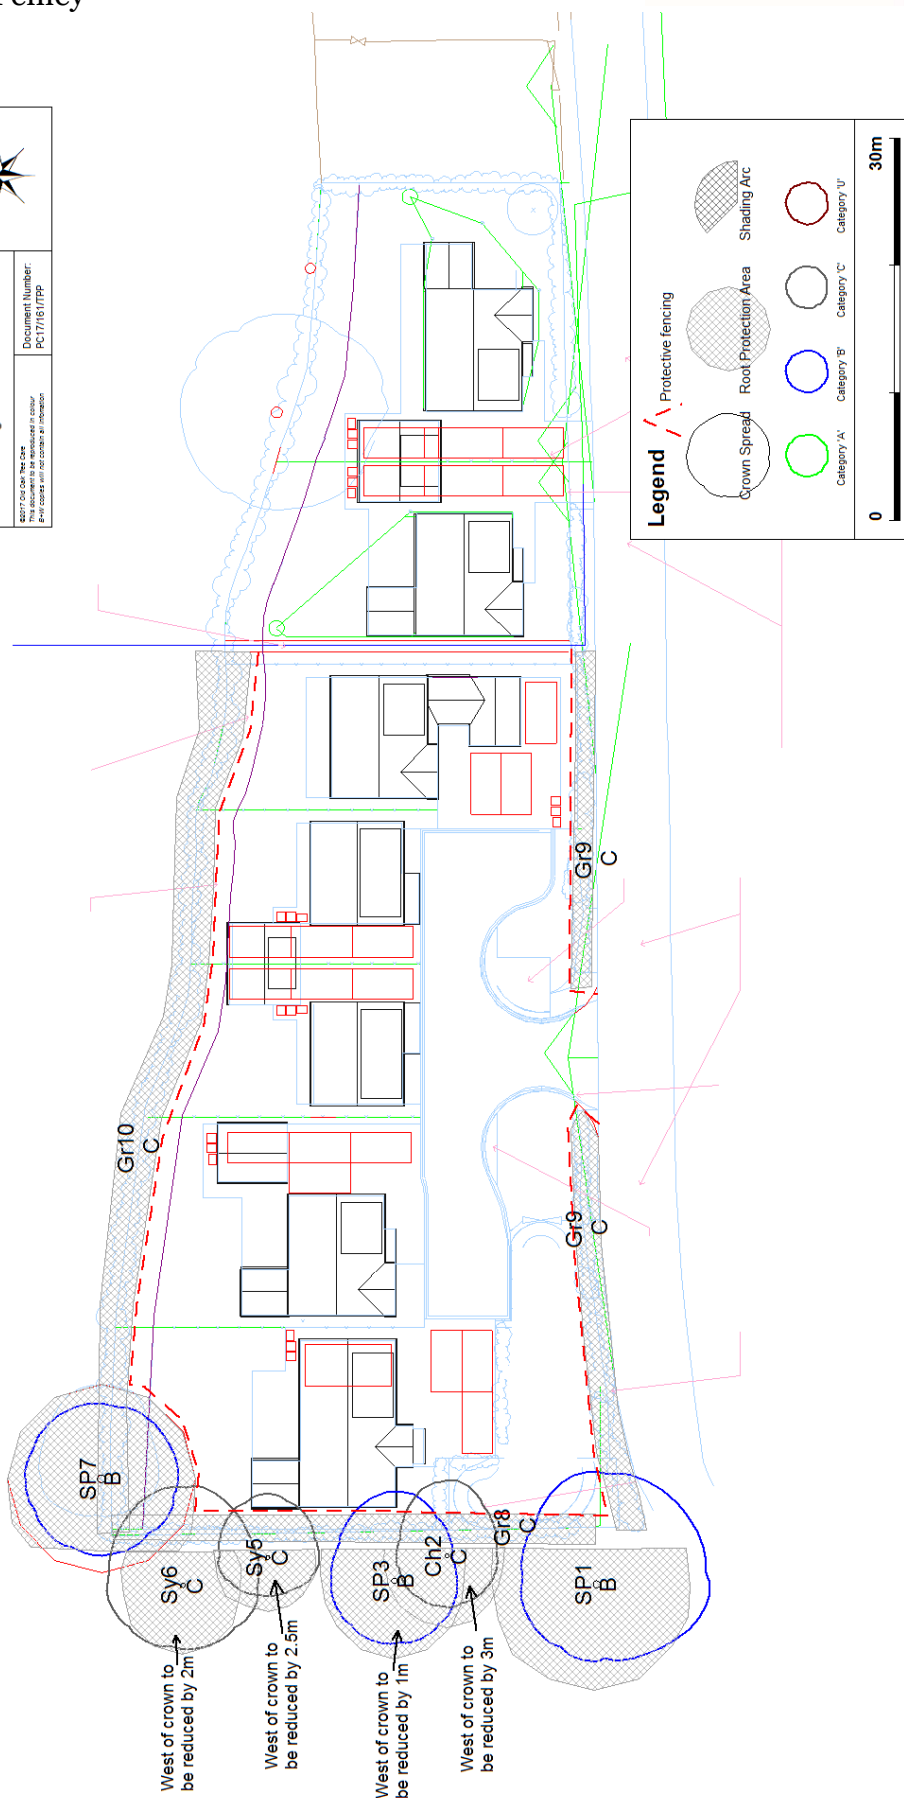
**Summary TPP**  
Land off Tudor Drive, Penley,  
Wrexham.

**Tree Constraints Plan with Proposed Development**  
**Showing all trees, crown dimensions,**  
**tree categories and Root Protection Areas (RPAs)**

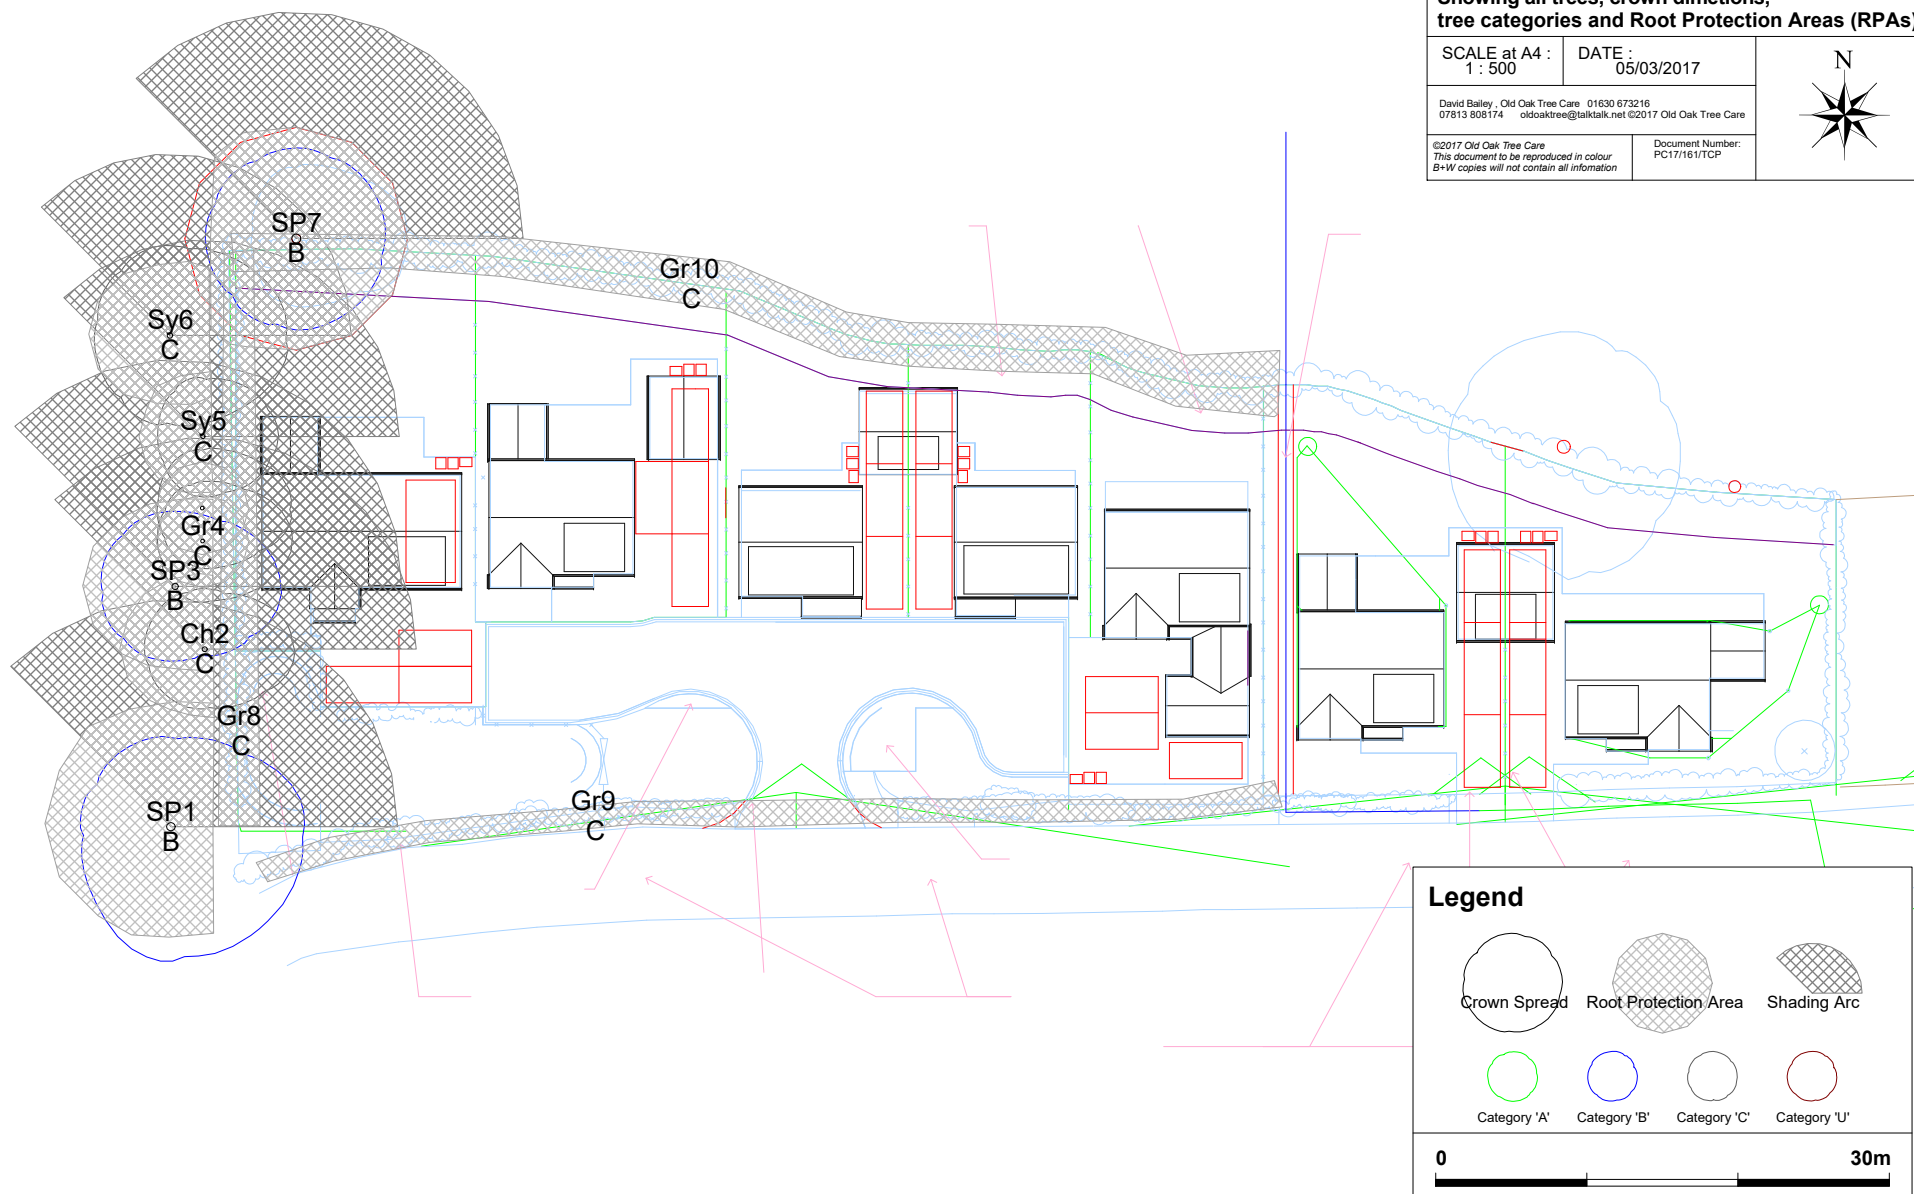
Document Number:  
PC17/161/TCP

**Tree Constraints Plan with Proposed Development**  
**Showing all trees, crown dimensions,**  
**tree categories and Root Protection Areas (RPAs)**
