# **Wrexham Island Green**

## **Arboricultural Survey Report**

August 2015

**Client Name:** Henderson RWF .  
**Document Reference:** WIB15092-100-R-5-4-3-LB  
**Project Number:** WIB15092

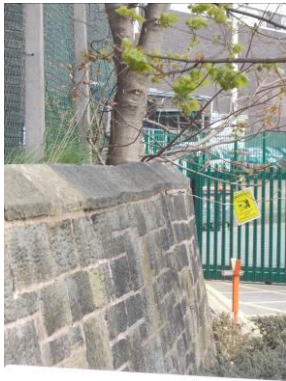
Photograph 5

- 2.3. Some self-sown trees and woody vegetation were recorded on and immediately adjacent to the Study Area boundary. This typically comprised Sycamore (*Acer pseudoplatanus*), Goat Willow (*Salix caprea*) and occasional Norway Maple (*Acer platanoides*) which are either pioneer species or from seed derived from the adjacent amenity tree plantings. Tree and tree group T3 and G11, (respectively) were recorded growing immediately adjacent to retaining walls. These trees appeared to be causing modest deflection to the retaining wall through natural root development, (Photograph 5). Tree T31 comprised a mature multi-stemmed Sycamore growing on the Study Area boundary, (Photograph 6). This tree is conspicuous in that it appears to pre-date the current commercial development and land use.

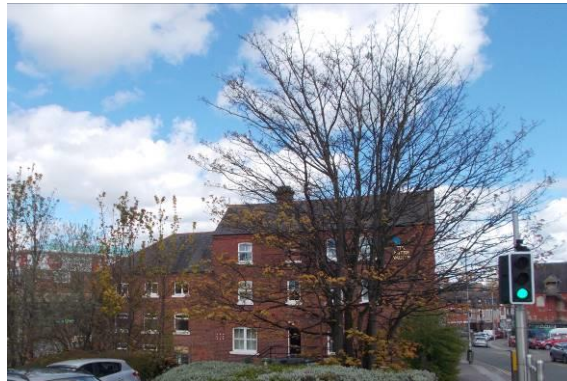
Photograph 6

- 2.6. Two individual trees comprising T1 (Photograph 8) and T31, (Photograph 6) both Sycamore were also graded as being 'B' Category being of medium value in this context. This was on account of their relative maturity and amenity contribution to the public realm and/or Study Area.

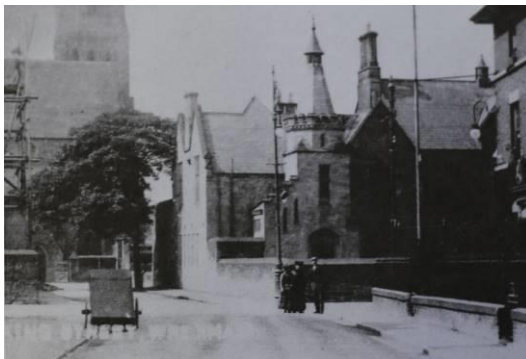
Photograph 7<sup>8</sup>

- 2.4. One mature Sycamore (T1) was recorded growing in St. Marks Road immediately to the north of the Study Area. A historic photograph (dating from 1910) suggests the canopy growth of this tree over the last 100 years appears to have been extremely modest, (Photographs 7 and 8). This is likely to be due to the challenging rooting conditions within which this tree is growing. Despite several pruning wounds and cavities the tree still provides amenity value to a location otherwise dominated by built form.

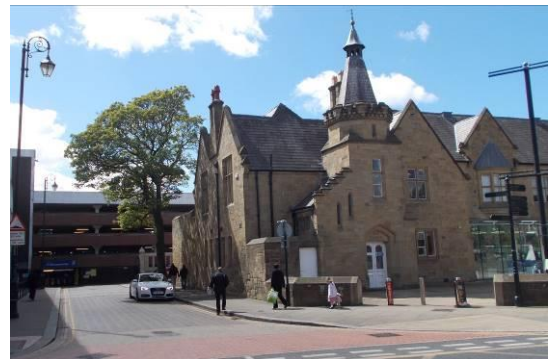
Photograph 8

- 5.4. One mature Sycamore (T1) was recorded growing in St. Marks Road immediately to the north of the Study Area. The canopy growth of this tree over the last 100 years appears to have been extremely modest, and is likely to be due to the challenging rooting conditions within which this tree is growing.

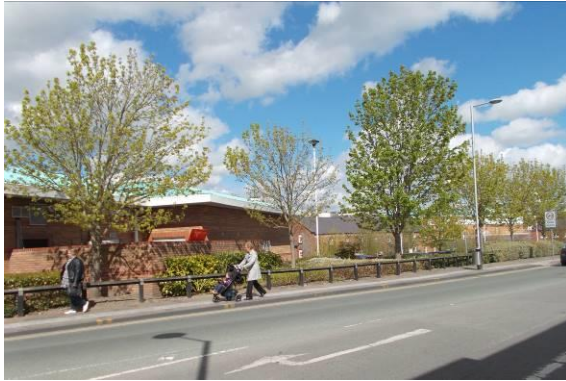
Photograph 9

- 2.5. The majority of trees and tree groups within the survey have been graded as 'C' Category, being of low value in this context. This is due to a combination of quality and immaturity and with suitable management, many trees could reasonably be expected to increase in value as they mature. Despite their relative immaturity, tree groups G27 and G36 were collectively graded as 'B' Category being of medium value in this context, (Photographs 9 and 10). This was due to a combination of the Norway

Maple species having general suitability to these locations and the collective contribution and longevity these trees could provide on the Study Area boundary.
