**Photographic Survey Report**  
**The Barn, Old Hall Farm, Erbistock,**  
**Wrexham**

Planning Reference: ERB P/2011/0091

Report number: W15/2379

June 2015

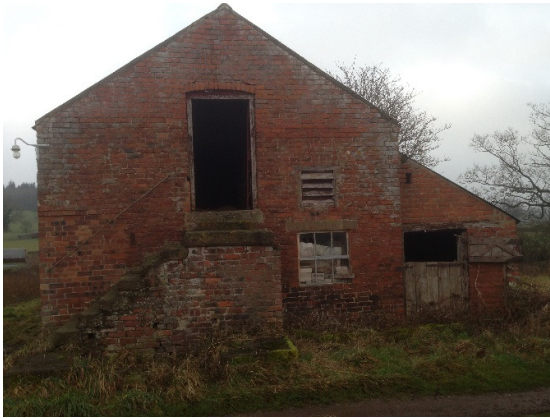
- Photo 1:** View of the south elevation of the barn, with the lean-to visible on the right.
- Photo 2:** Full east elevation, with both lean-to's visible. (Right-most to be demolished).

**Photograph 1:** South elevation of barn, looking north.

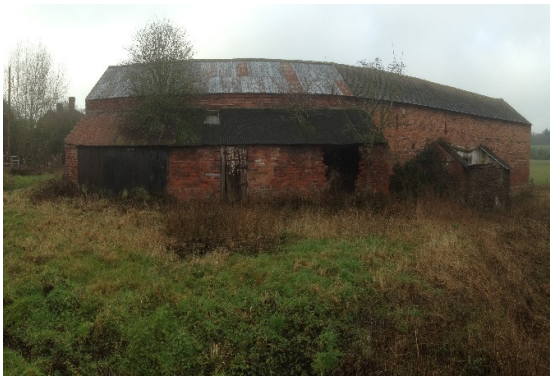
**Photograph 2:** East elevation of barn, showing lean-to. Looking west.

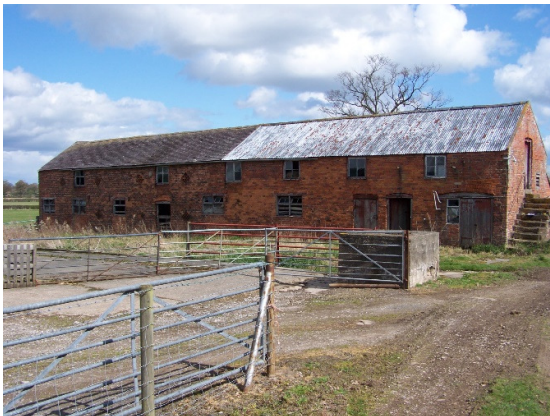
- Photo 3:** Full west elevation, with the external stairs leading to the first floor visible.
- Photo 4:** Image of the lean-to which is to be demolished due to it being damaged beyond repair.

**Photograph 3:** West elevation of barn, looking east.

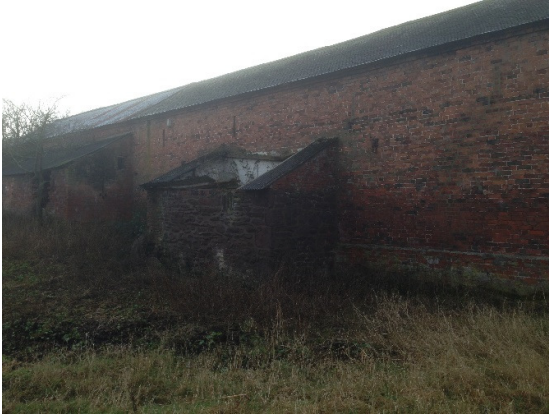
**Photograph 4:** Lean-to on the centre of the east side, to be demolished.

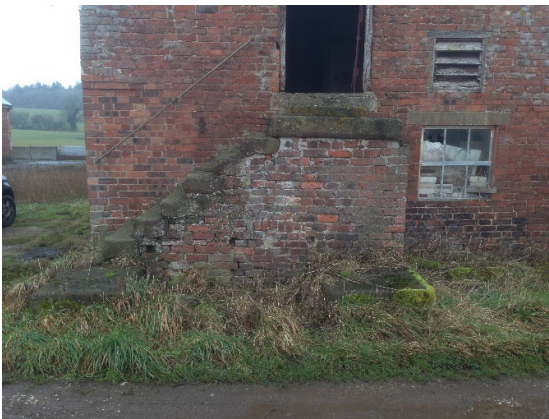
- Photo 5:** Enhanced image of the south staircase leading up to the first floor.
- Photo 6:** South lean-to to be retained. Image taken from the south facing north.

**Photograph 5:** Staircase on the south elevation.

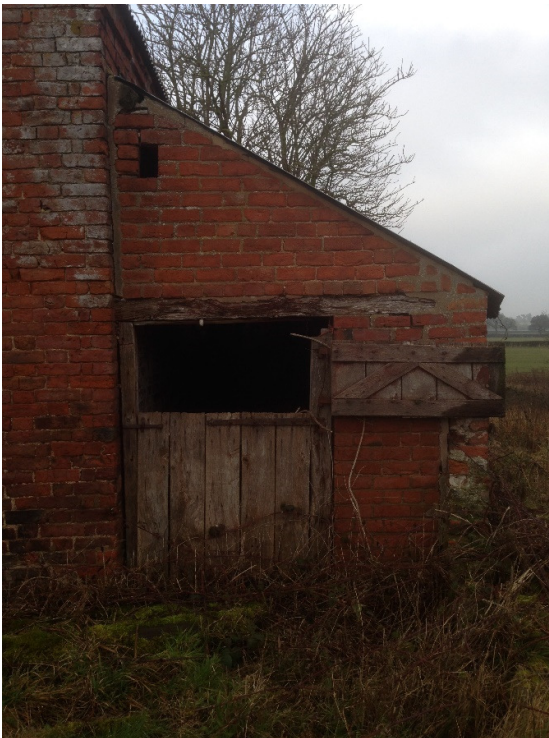
**Photograph 6:** Doorway on southern lean-to.

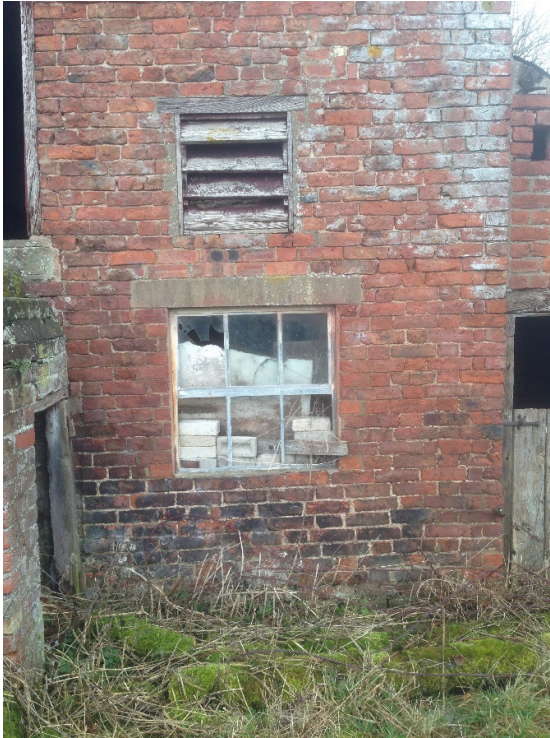
- Photo 7:** Image shows the standard window style, along with the detail of an air vent.
- Photo 8:** Image shows detail of a timber doors, situated below a brick soldier arch.

**Photograph 7:** Ground floor window and first floor air vent on south elevation.

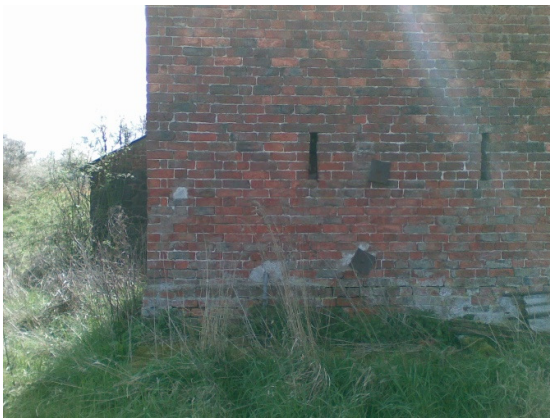
- Photo 9:** Image shows brick detail on the west elevation, detail is repeated along the north section of the west elevation.
- Photo 10:** Image shows brick detail on the north elevation of the barn.

**Photograph 10:** Brick detail located on the north elevation.

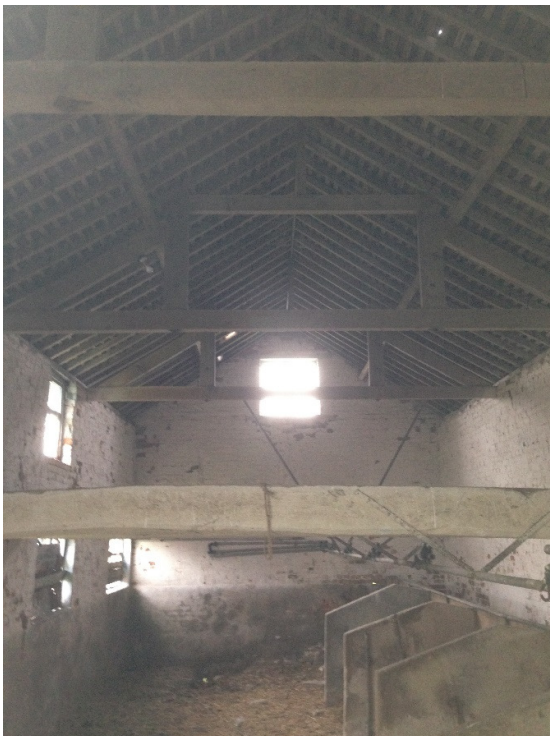
- Photo 11:** Image shows roof truss over the ground floor of the barn. Above the void in the north section.
- Photo 12:** Image shows roof truss detail on the first floor of the barn in the south section.

**Photograph 11:** Truss detail over void in north section of building.

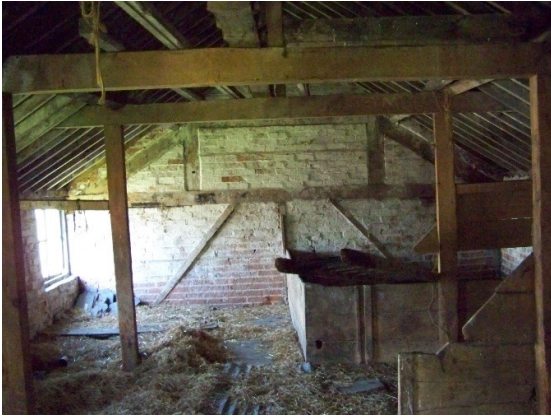
**Photograph 12:** Queen Post Truss detail on the first floor, south section of building.

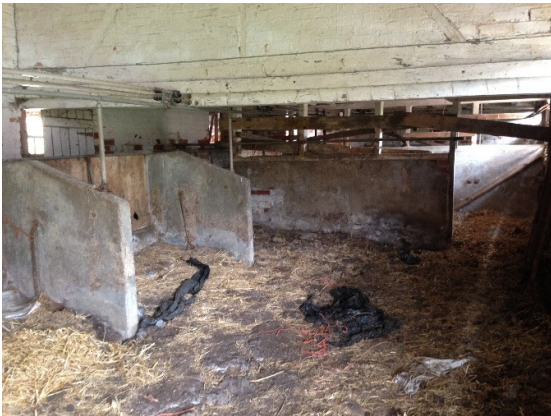
- Photo 13:** Image shows cattle stalls in the north section of the barn. To be removed when work commences.

**Photograph 13:** Cattle stalls in northern section of building. To be removed.

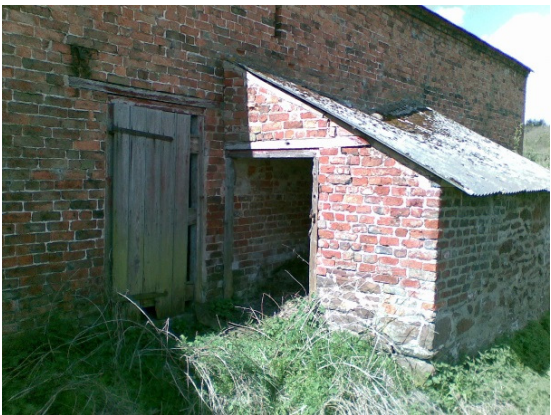
**Photograph 14:** Failed lean-to. To be removed

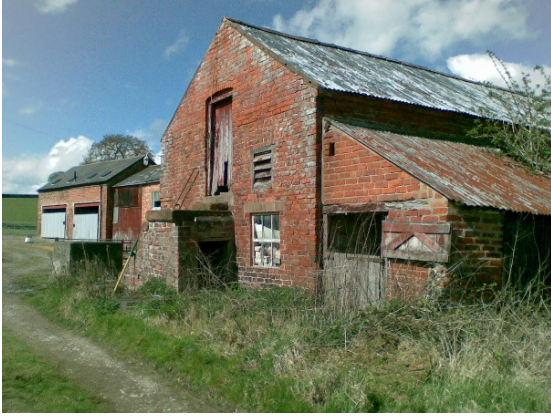
**Photograph 15:** East lean-to to be retained

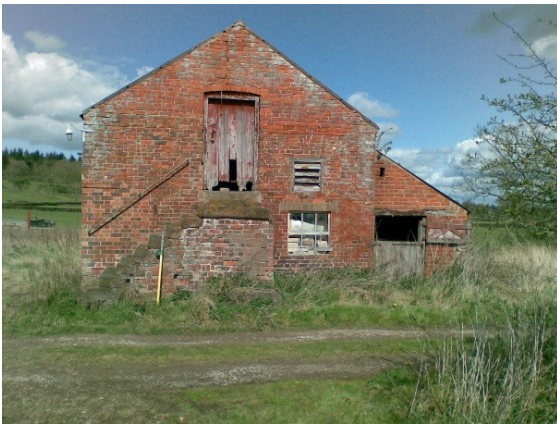
**Photograph 16:** Granary steps to south side

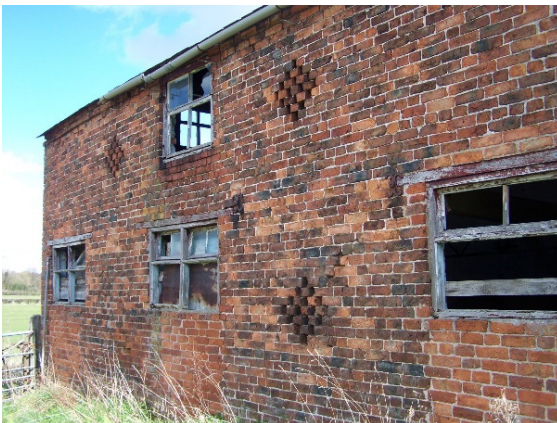
**Photograph 17:** Evidence of former openings bricked up

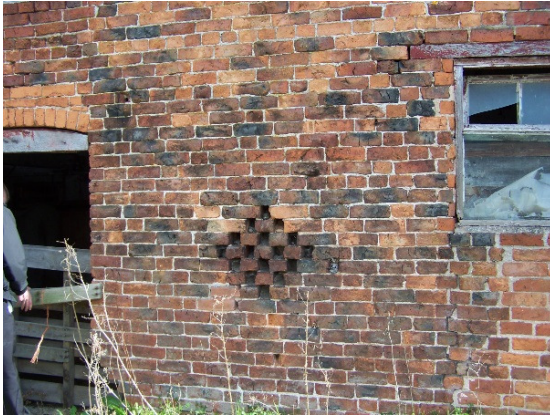
**Photograph 18:** Ventilation details

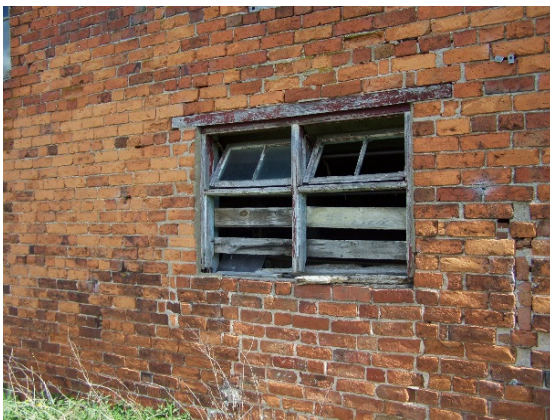
**Photograph 19:** Later window under timber lintel

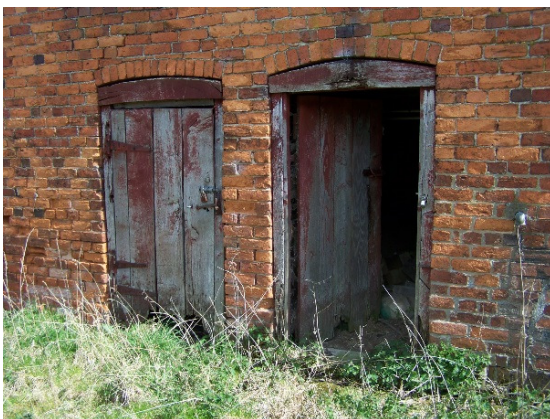
**Photograph 20:** Simple arched heads to openings

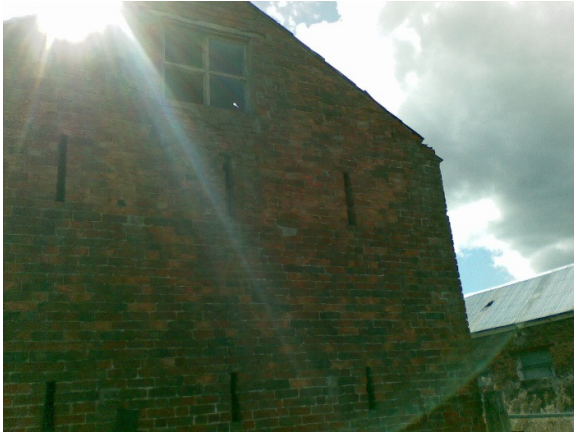
**Photograph 21:** North elevation window and ventilation slot detail

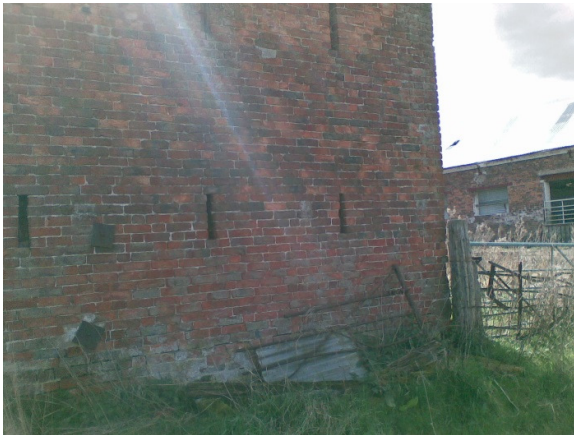
**Photograph 22:** North elevation window and ventilation slot detail

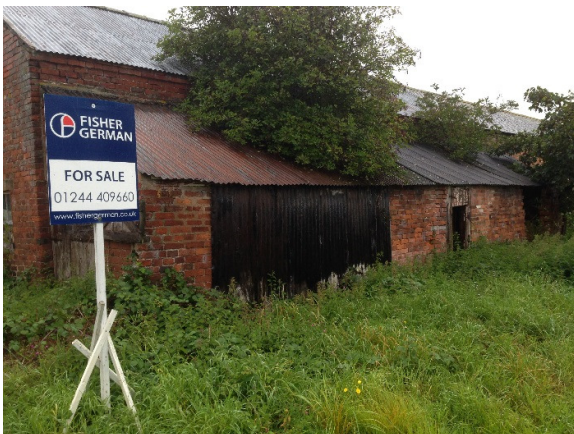
**Photograph 23:** East elevation of lean to
