## List of Plates:

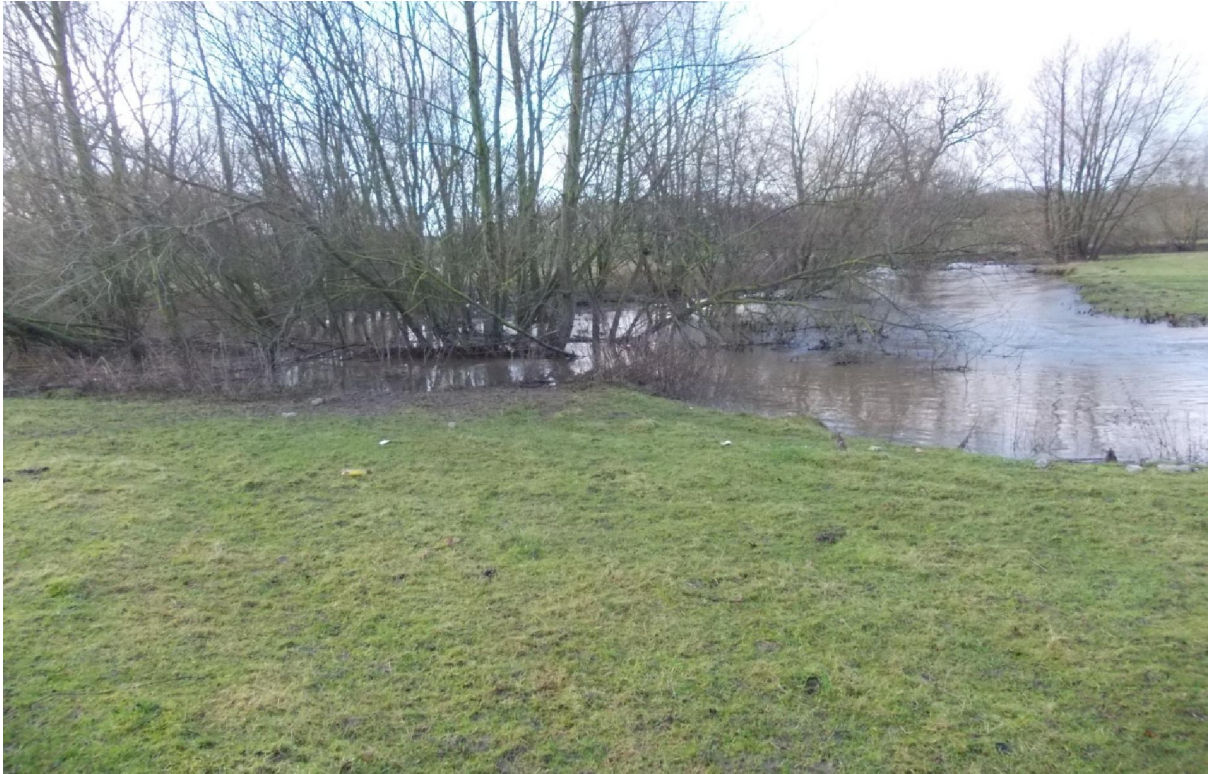
Plate 1: River Clywedog (receptor) - looking west upstream with flooded ox-bow lake on left where site outfall is located (07-01-2014).

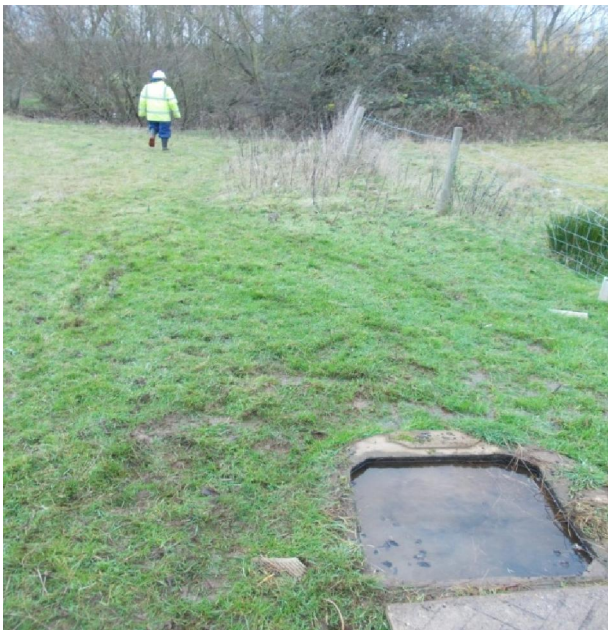
Plate 2: Blocked drain leading to outfall to ox-bow lake located North of SS11-06-1 (10-12-2014).

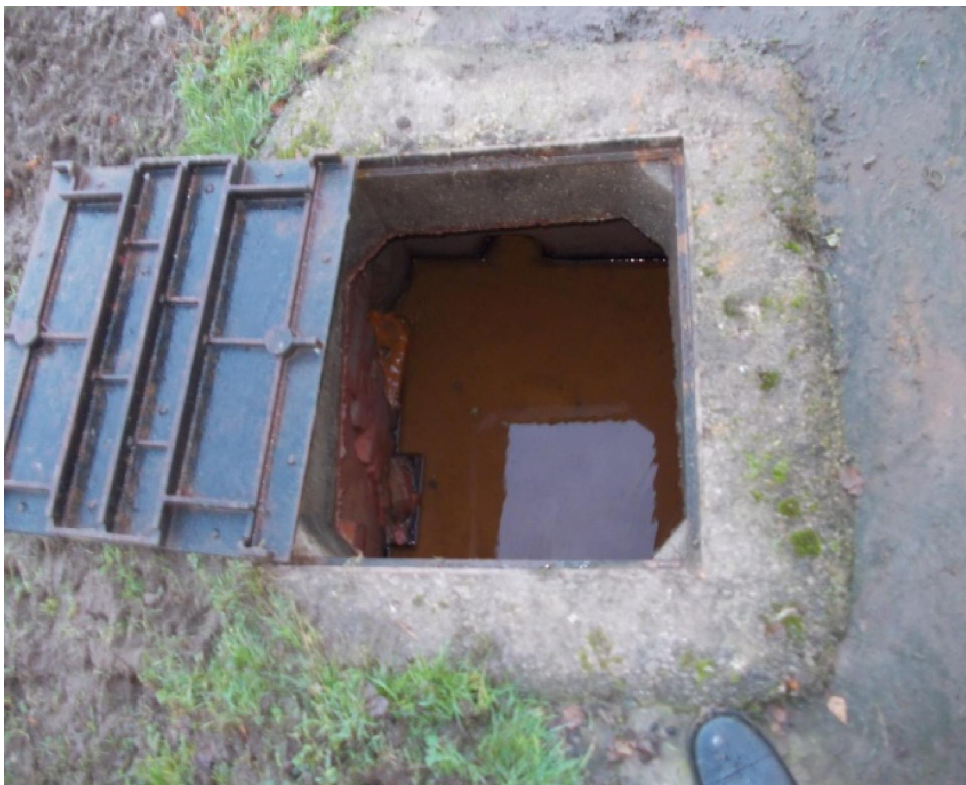
Plate 3: French drain Interceptor NW Corner SS11-07-1 (10-12-2014).

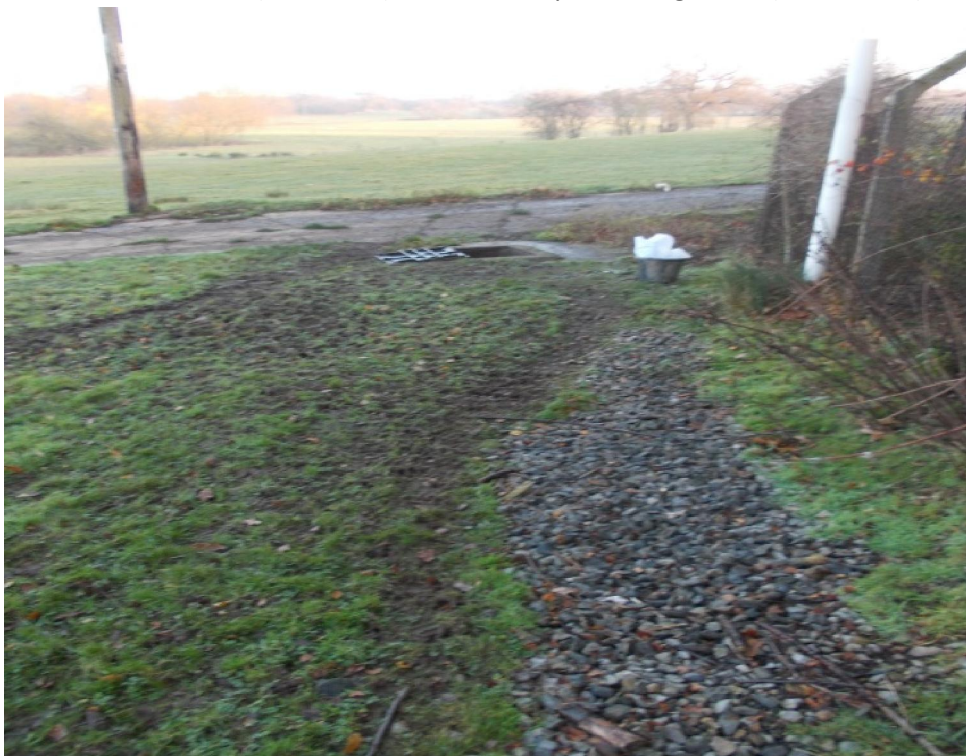
Plate 4: French Drain (SS11-07-1) NW Boundary – Looking North (10-12-2014).

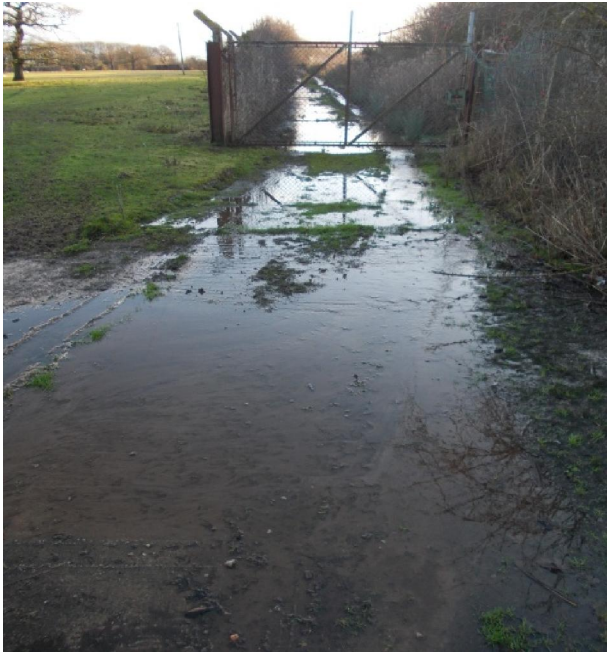
Plate 5: Looking East along Northern boundary towards SW2/SS11-05-1. Track has flowing water from a leaking water main on site flowing off site onto neighbouring farm land (10-12-2014).

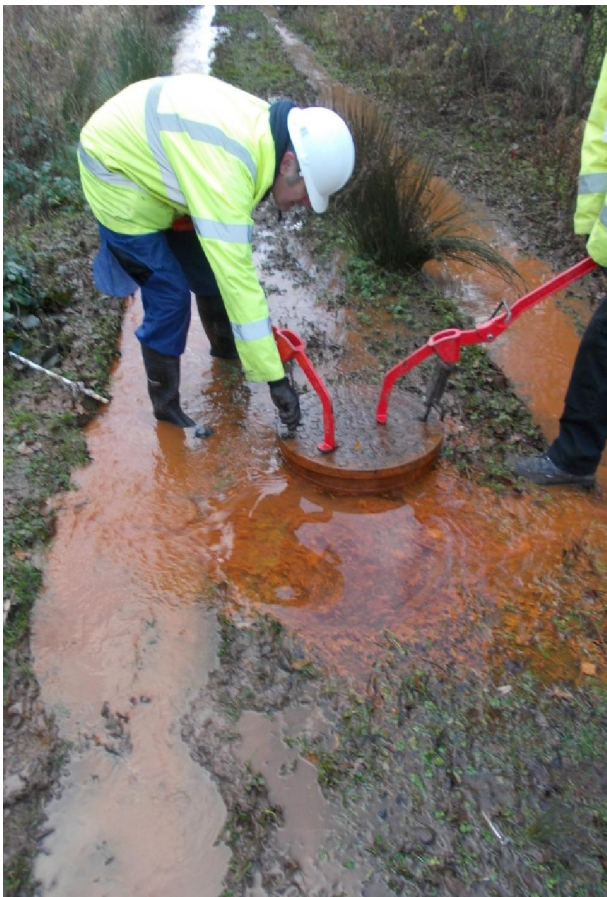
Plate 6: Leaking Water Main on Northern boundary track SS11-05-01 (10-12-2014).

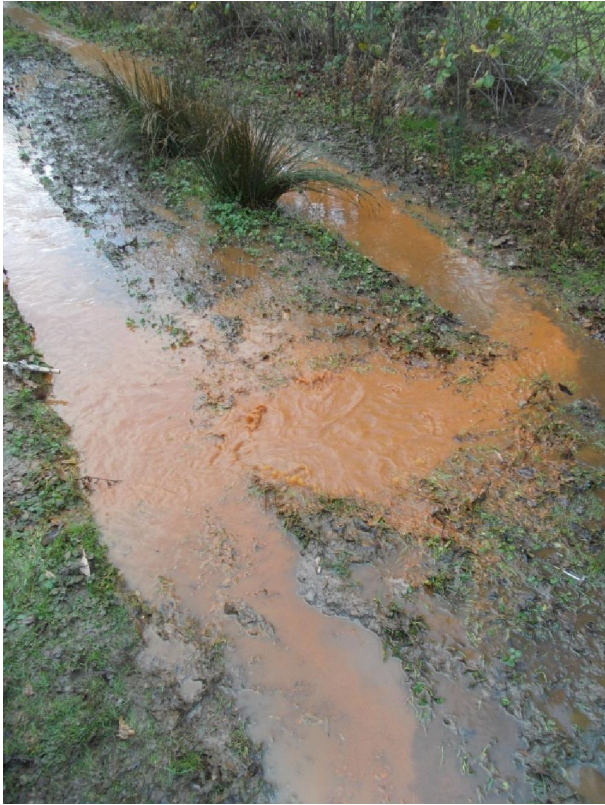
Plate 7: Leaking Water Service on Northern boundary track SS11-05-01 (10-12-2014).

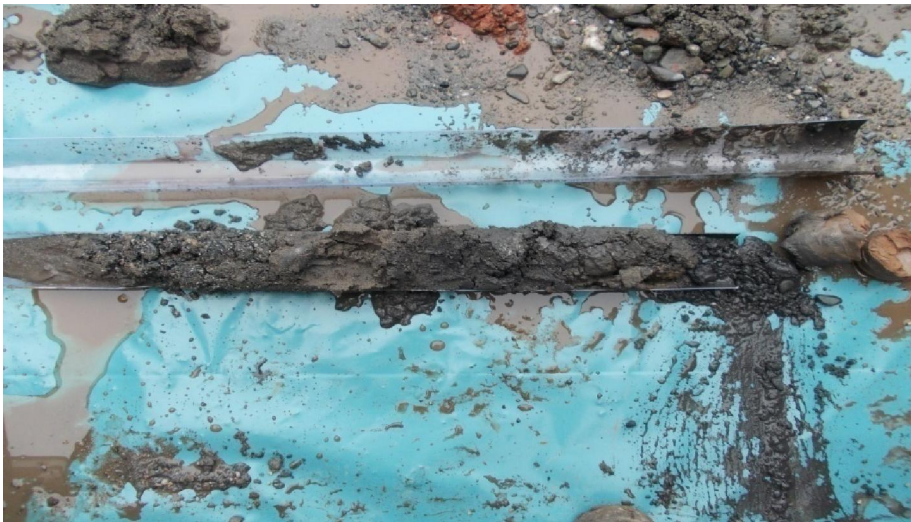
Plate 8: BH2 - Training Centre – Window sample (approx 1m sample liner length 26-11-13)

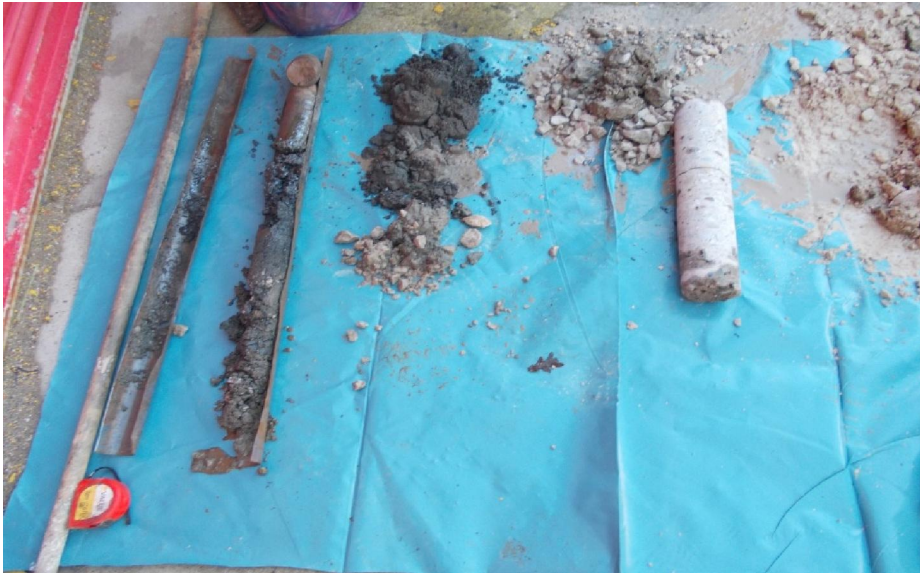
Plate 9: BH23 Garage – Window sample (approx 1m sample liner lengths 09-12-2013)

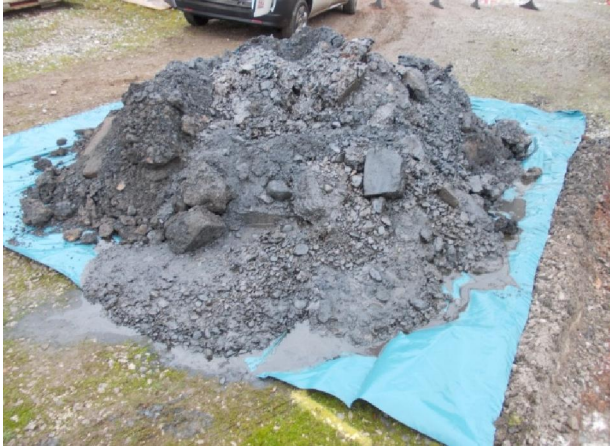
Plate 11: TP6 – Example of Material for Treatment (28-11-2013)

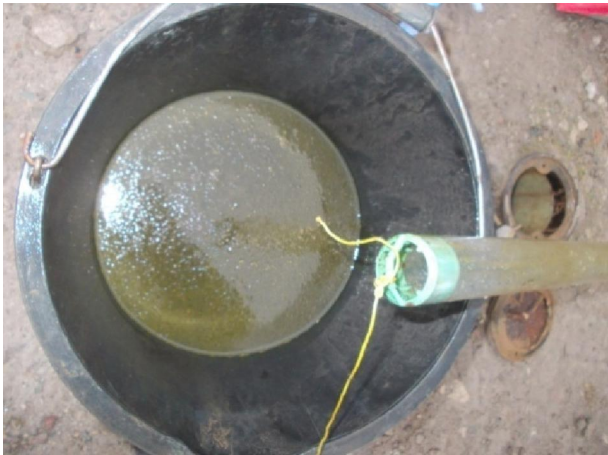
Plate 13: MW11-08B Groundwater by Garage (12-12-2013)

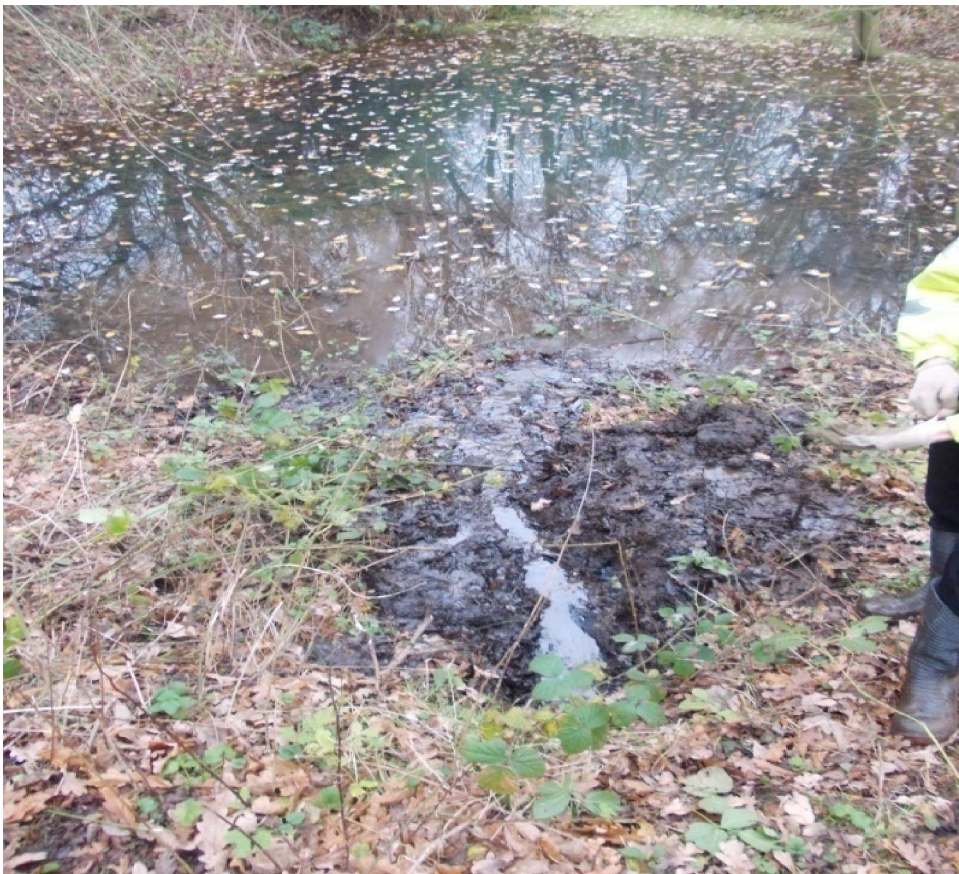
Plate 14: Looking East from Outfall SS11-03-01 onto pond located in SW Corner (13-12-2013)

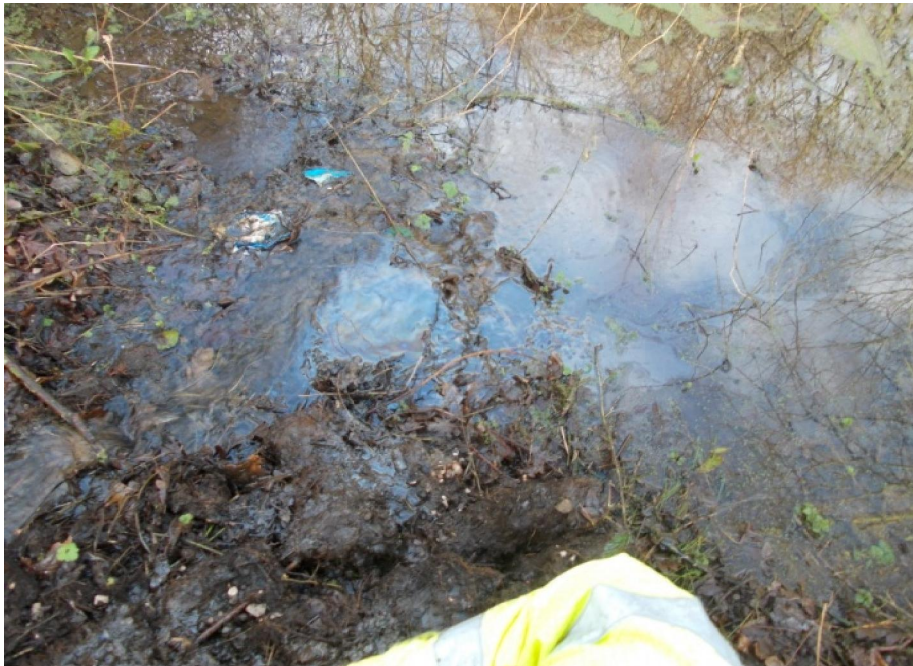
Plate 15: Contamination on pond water surface from outfall (13-12-2013)

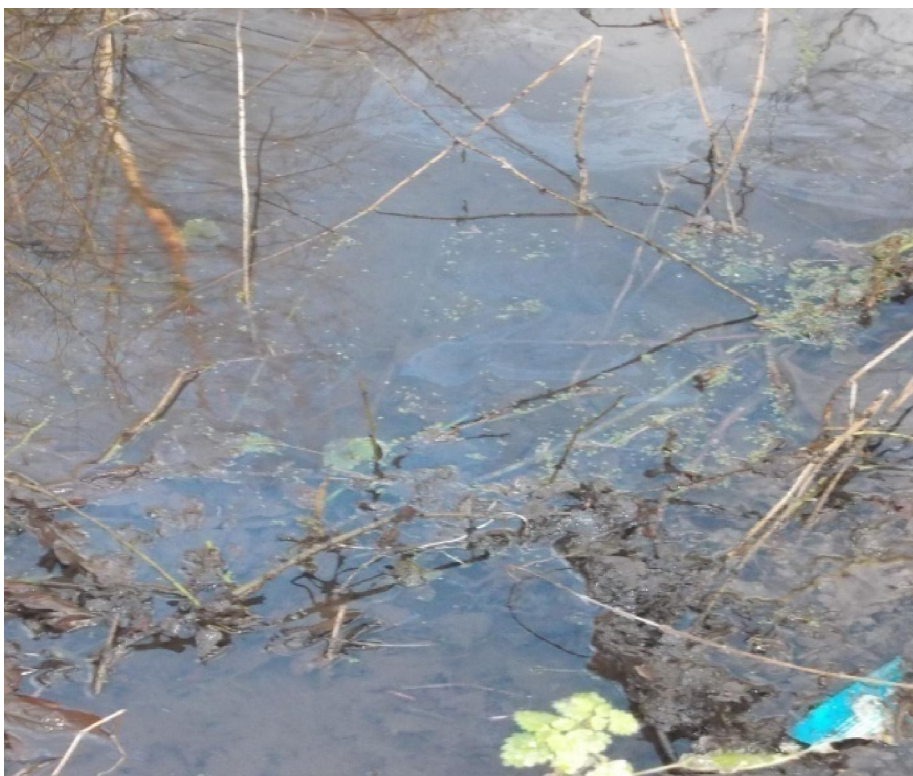
Plate 16: Contamination on pond water surface from outfall (13-12-2013)

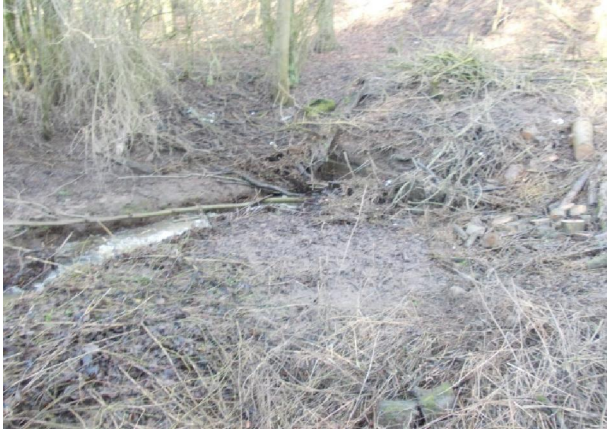
Plate 17: Blocked Culvert upstream of Bedwell Tip (12-12-2013)

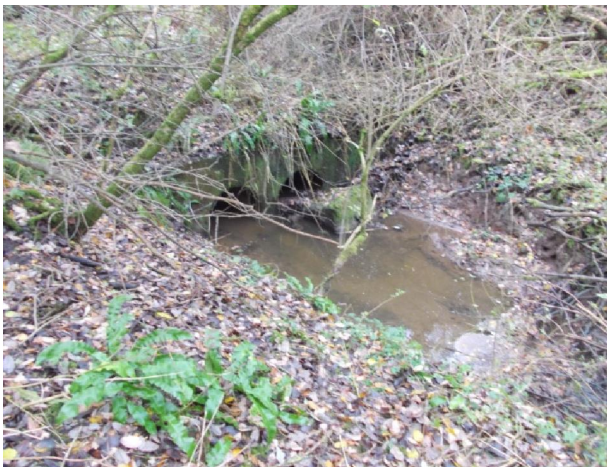
Plate 18: Blocked culvert -only one side flowing by Bedwell Tip (12-12-2013)

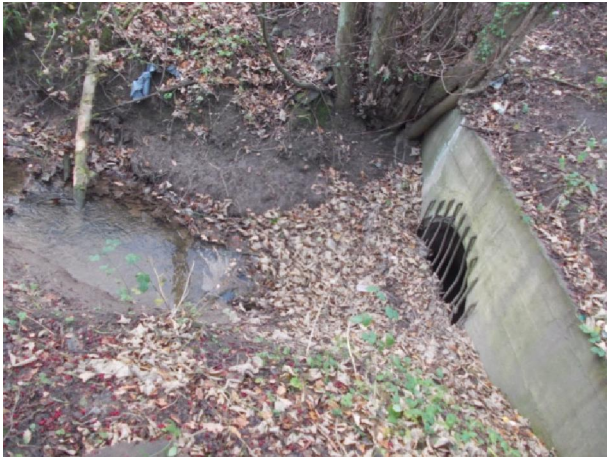
Plate 19: Blocked Culvert in eastern area of Bedwell Brook at site boundary by entrance to site (12-12-2013)

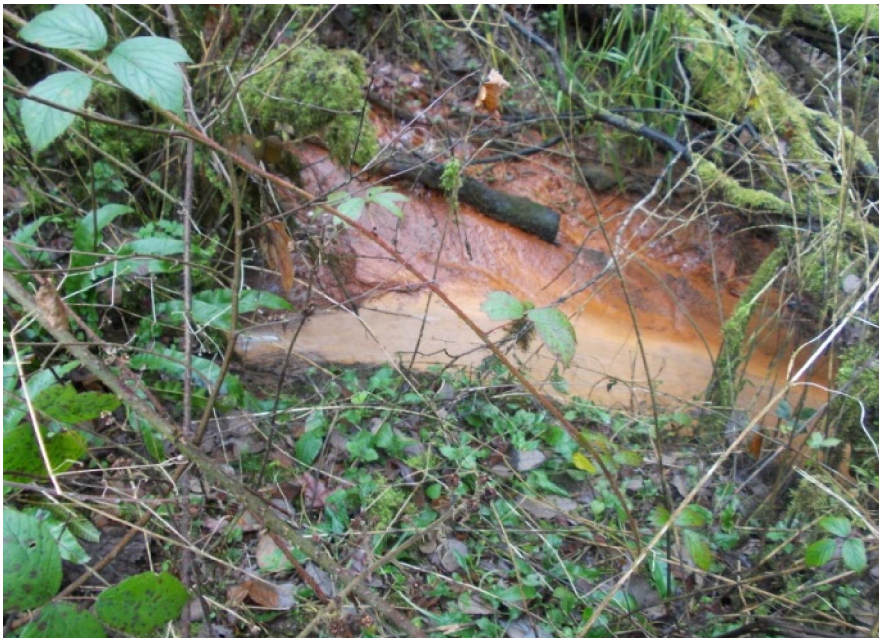
Plate 20: Leachate Outbreak besides outfall pipe into Brook at Bedwell Tip (12-12-2013)

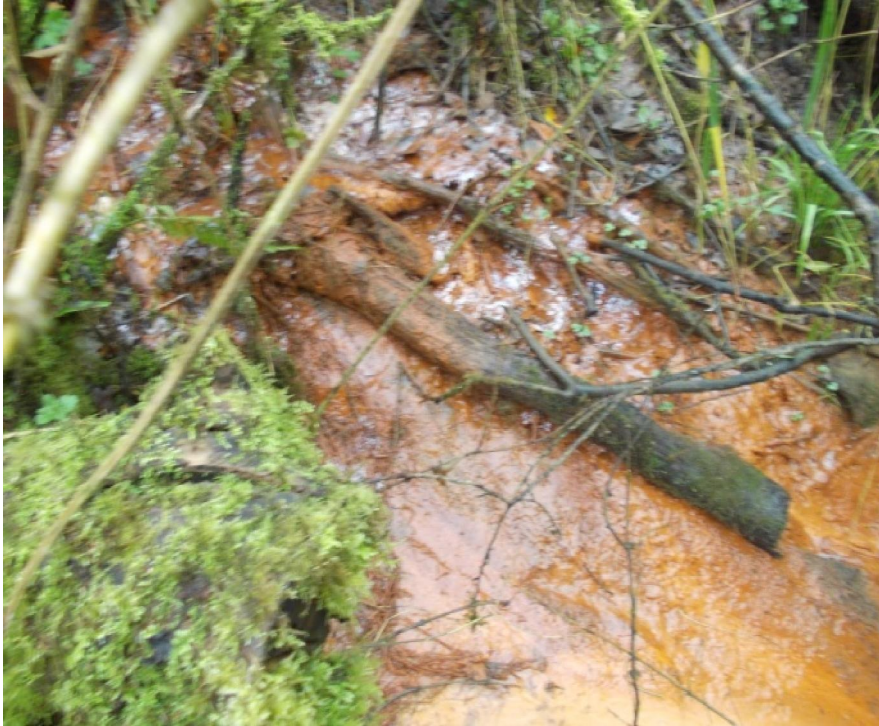
Plate 21: Leachate Outbreak besides outfall pipe into Brook at Bedwell Tip (12-12-2013)

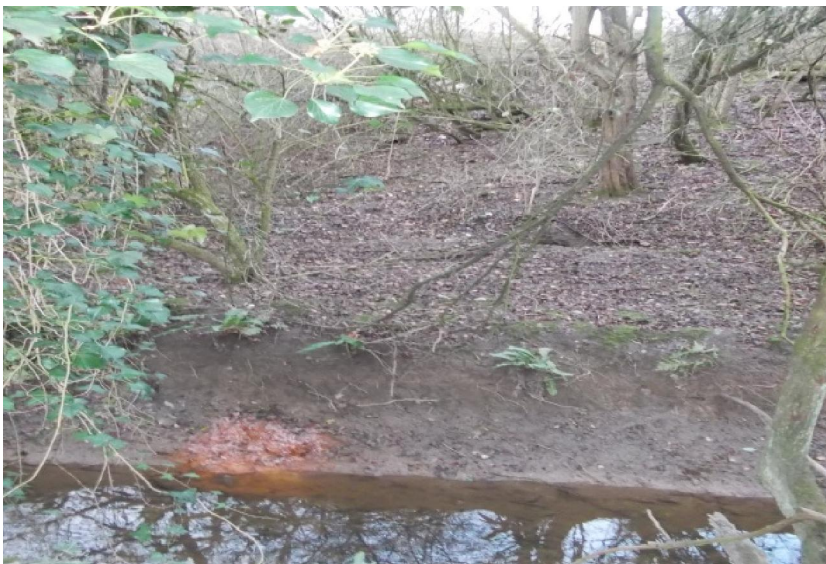
Plate 22: Staining in brook bank by tip and marked as RB1 on plan (12-12-2013)

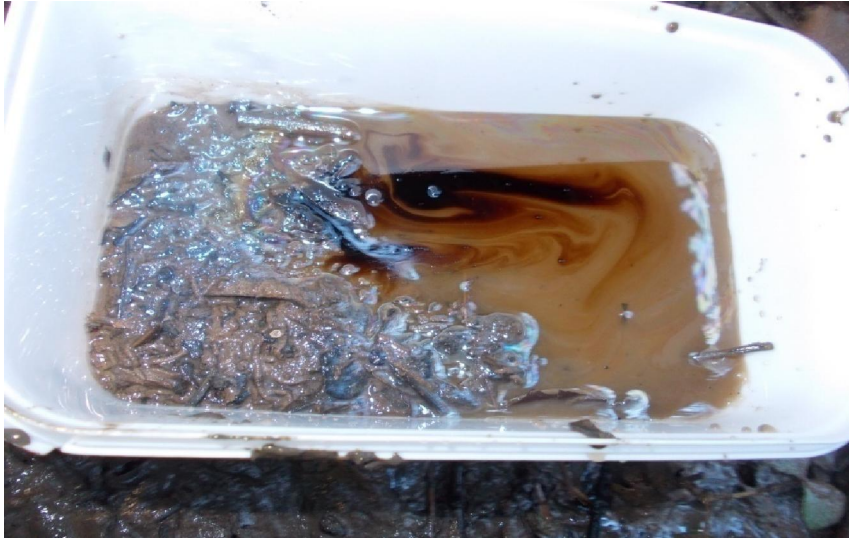
Plate 23: Bedwell Brook Sediment SD2 (10-12-2013)

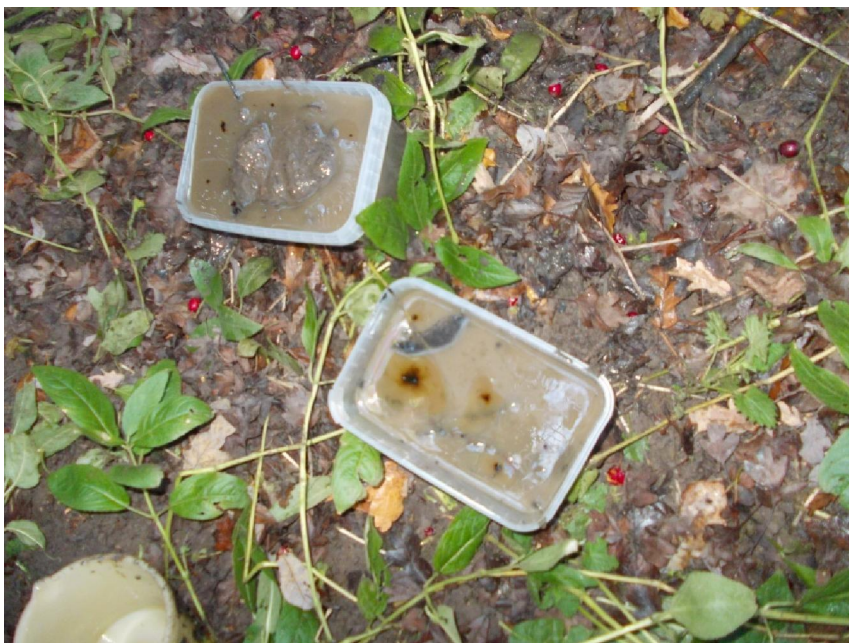
Plate 24: Bedwell Brook Sediment SD2 (10-12-2013)

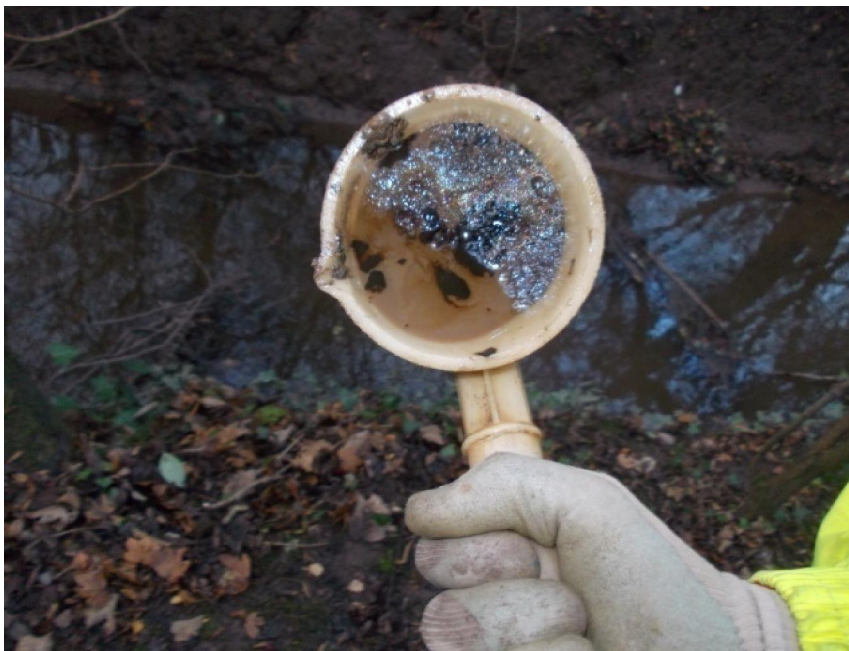
Plate 25: Bedwell Brook Sediment SD2 (10-12-2013)

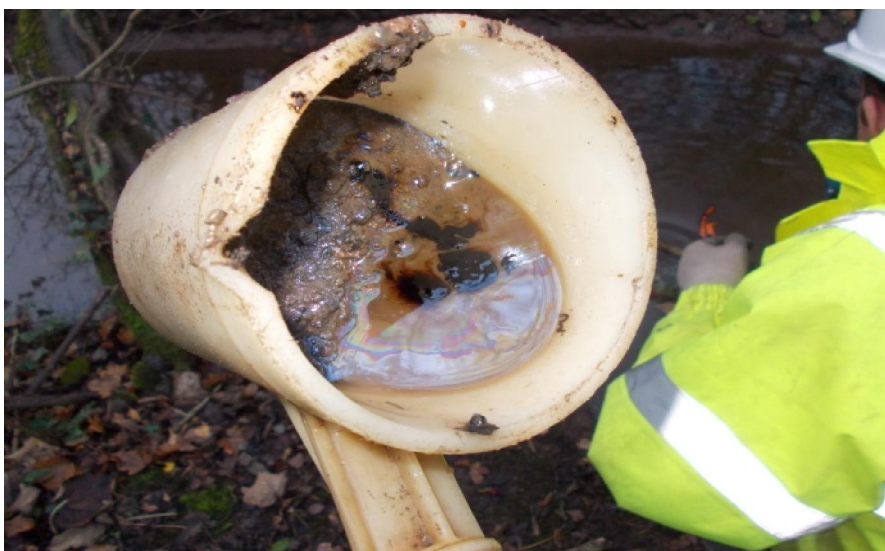
Plate 26: Bedwell Brook Sediment SD2 (10-12-2013)

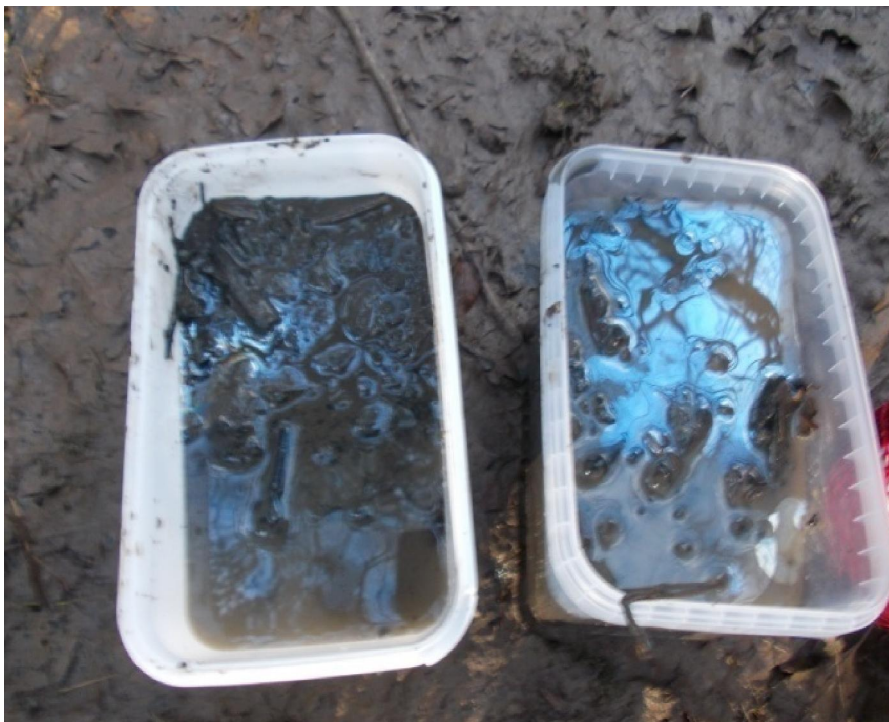
Plate 27: Bedwell Brook Sediment SD4 (10-12-2013)

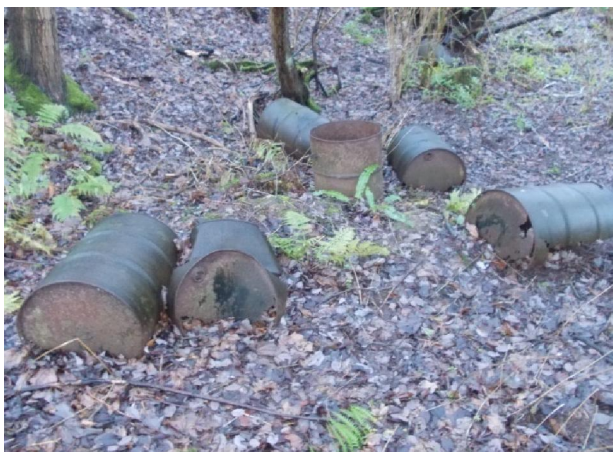
Plate 28: Waste on Bedwell Brook Banks (10-12-2013)
