## PHOTOGRAPHS

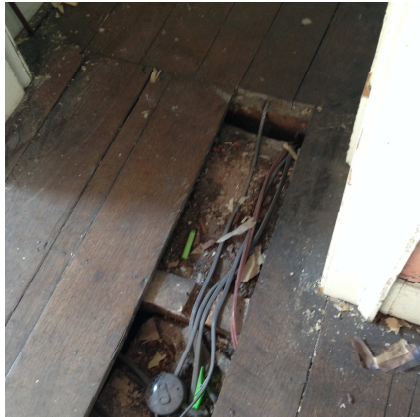
The second floor wiring is in need of stripping out and reforming

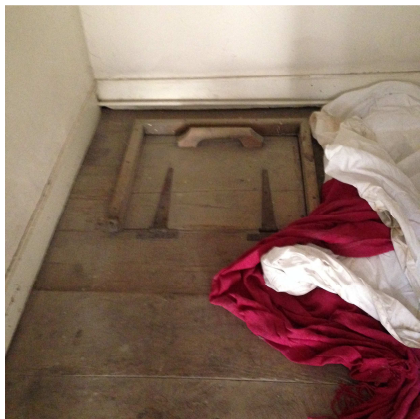
The existing second floor fire escape route is not fit for purpose. A new staircase is proposed in order to make the rooms habitable.

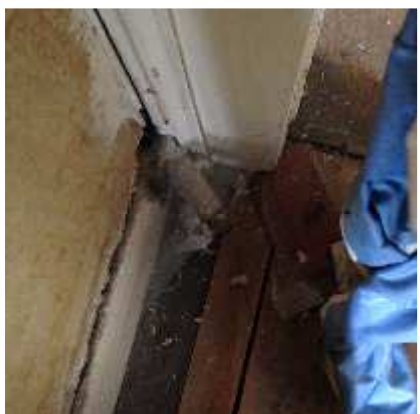
Previous services have been fitted in a poor and unsightly manner

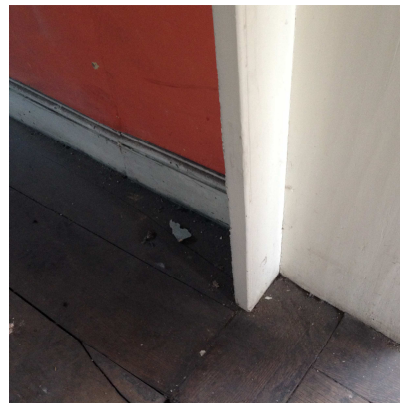
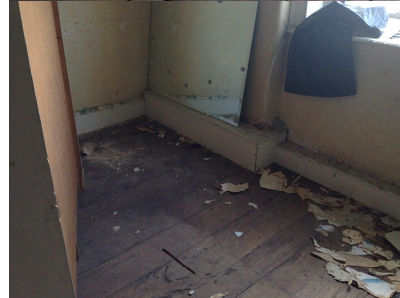
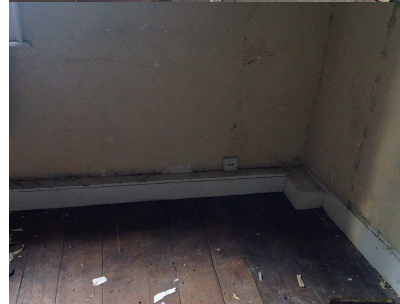
Skirting is in poor condition, missing and parts have been replaced with softwood torus, parts have been ripped out and replaced with pipe boxing

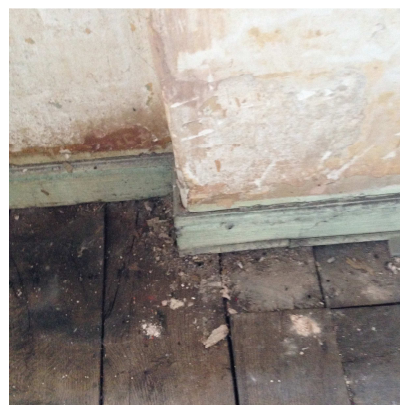
The plaster on external walls is poor
