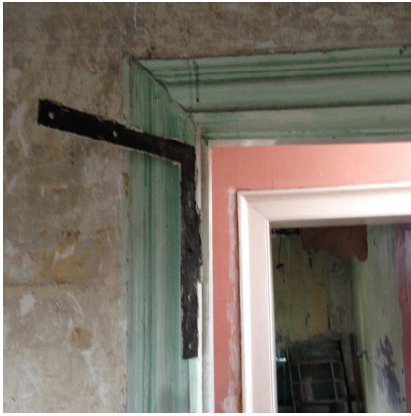
Joinery is mismatched, missing and in need of overhauling

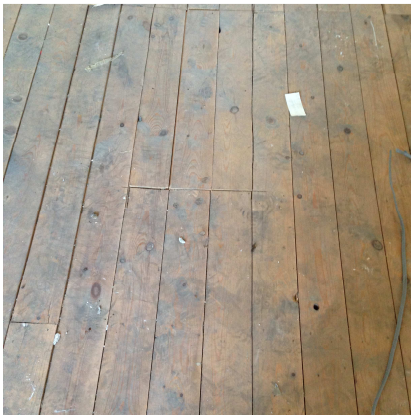
The floorboards proposed to be lifted to form the new stairwell are modern T&G

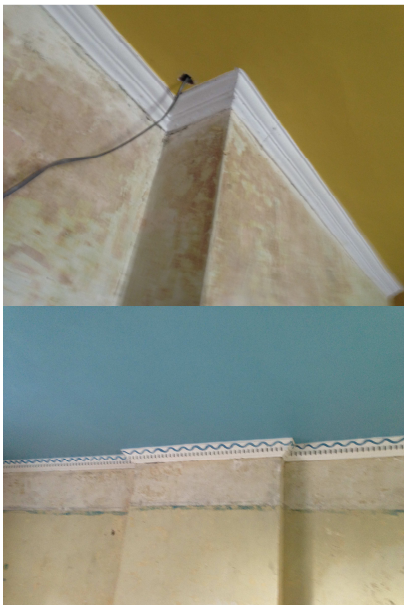
Two lots of cornices are in situ at SF level which will be repaired and maintained

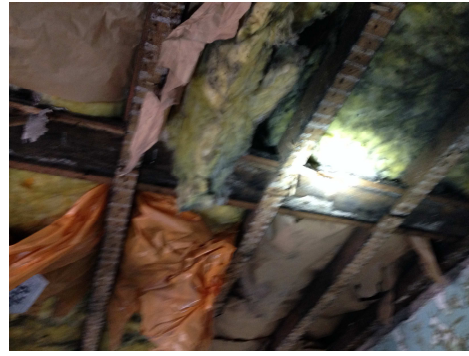
Some of the ceilings are no longer in situ

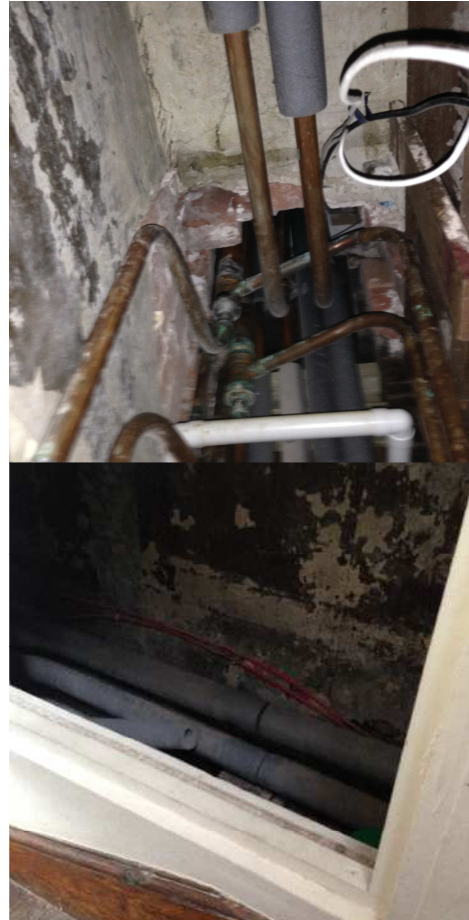
The concealed void behind the existing back staircase needs to be upgraded to 1 hour fire rating (this can be carried without affecting the finishes)
