**Condition Survey  
Ruabon Brickworks  
Haford Road  
Johnstown  
WREXHAM**

## **Condition Survey @ Johnstown, Wrexham**

**Date of survey:** Tuesday 11<sup>th</sup> August 2009  
**Weather Conditions:** Sunny and Dry  
**Undertaken By:** Robert Tait and Penny Smith

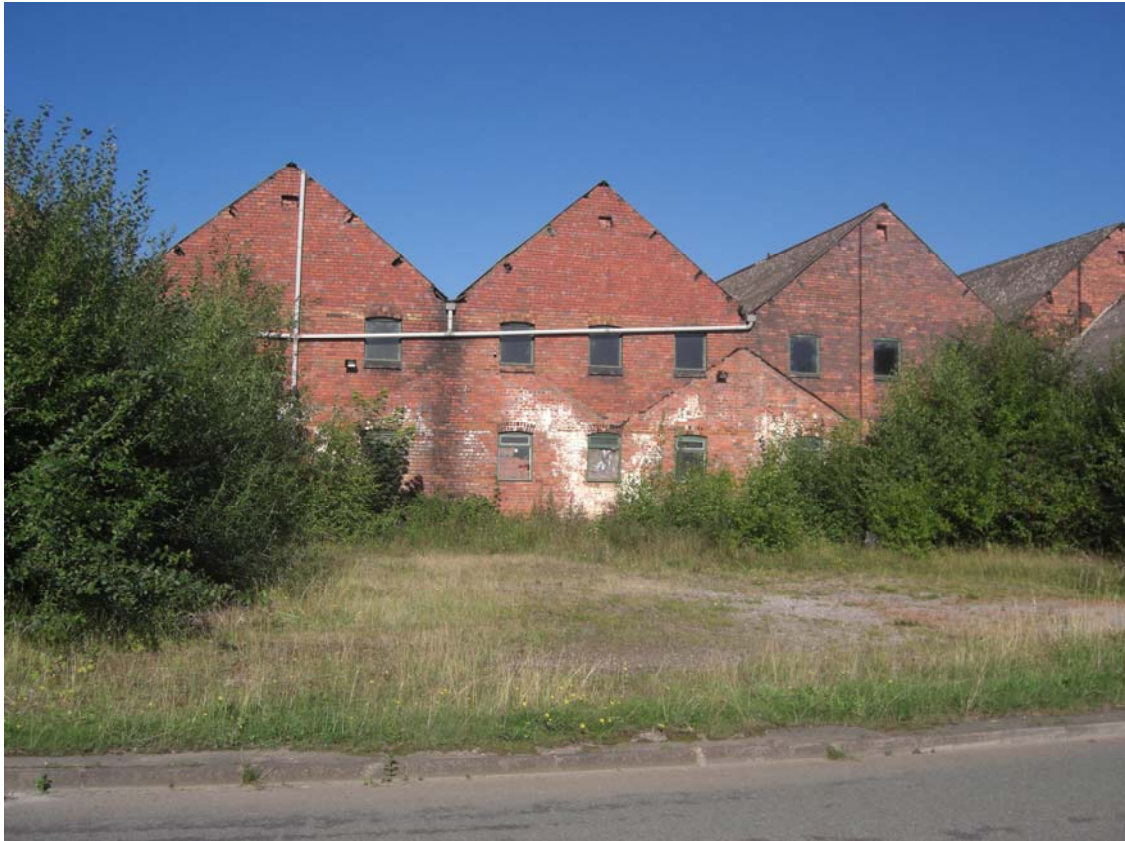
Part B Front showing area of Demolition

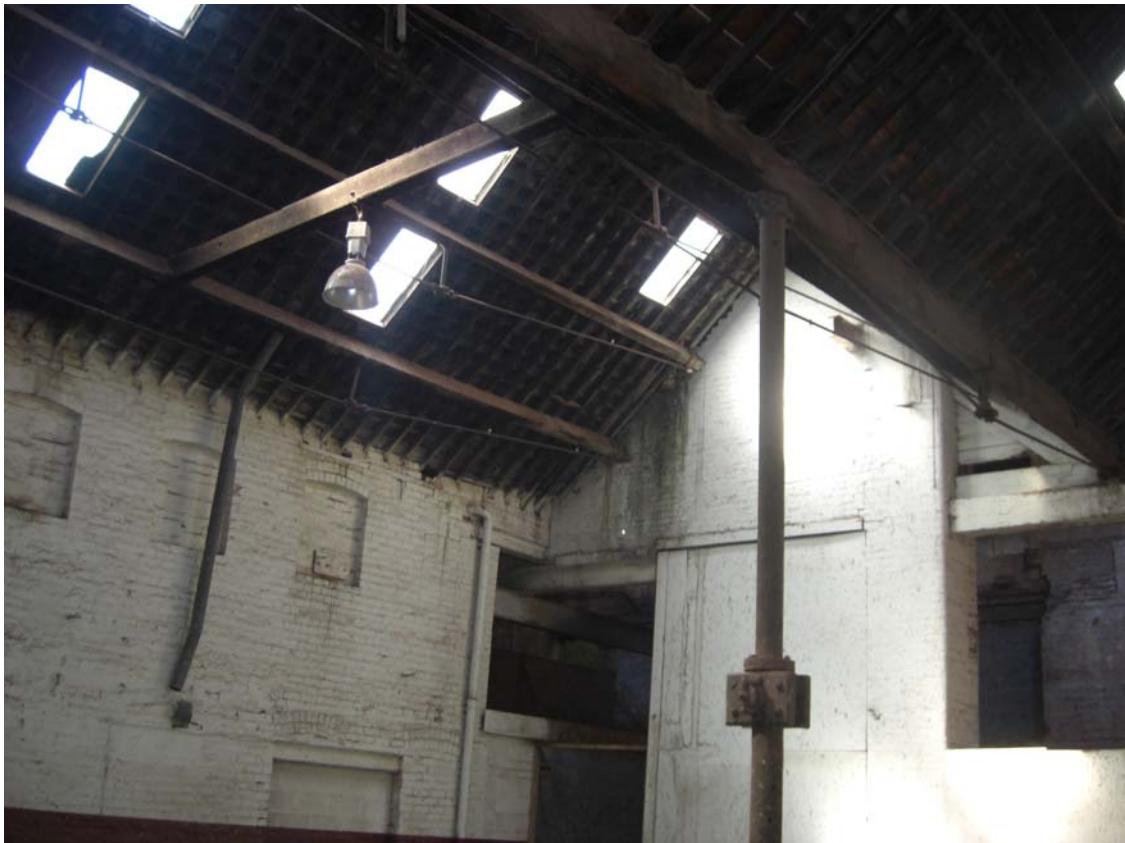
Typical Internal Part B - With roof prop

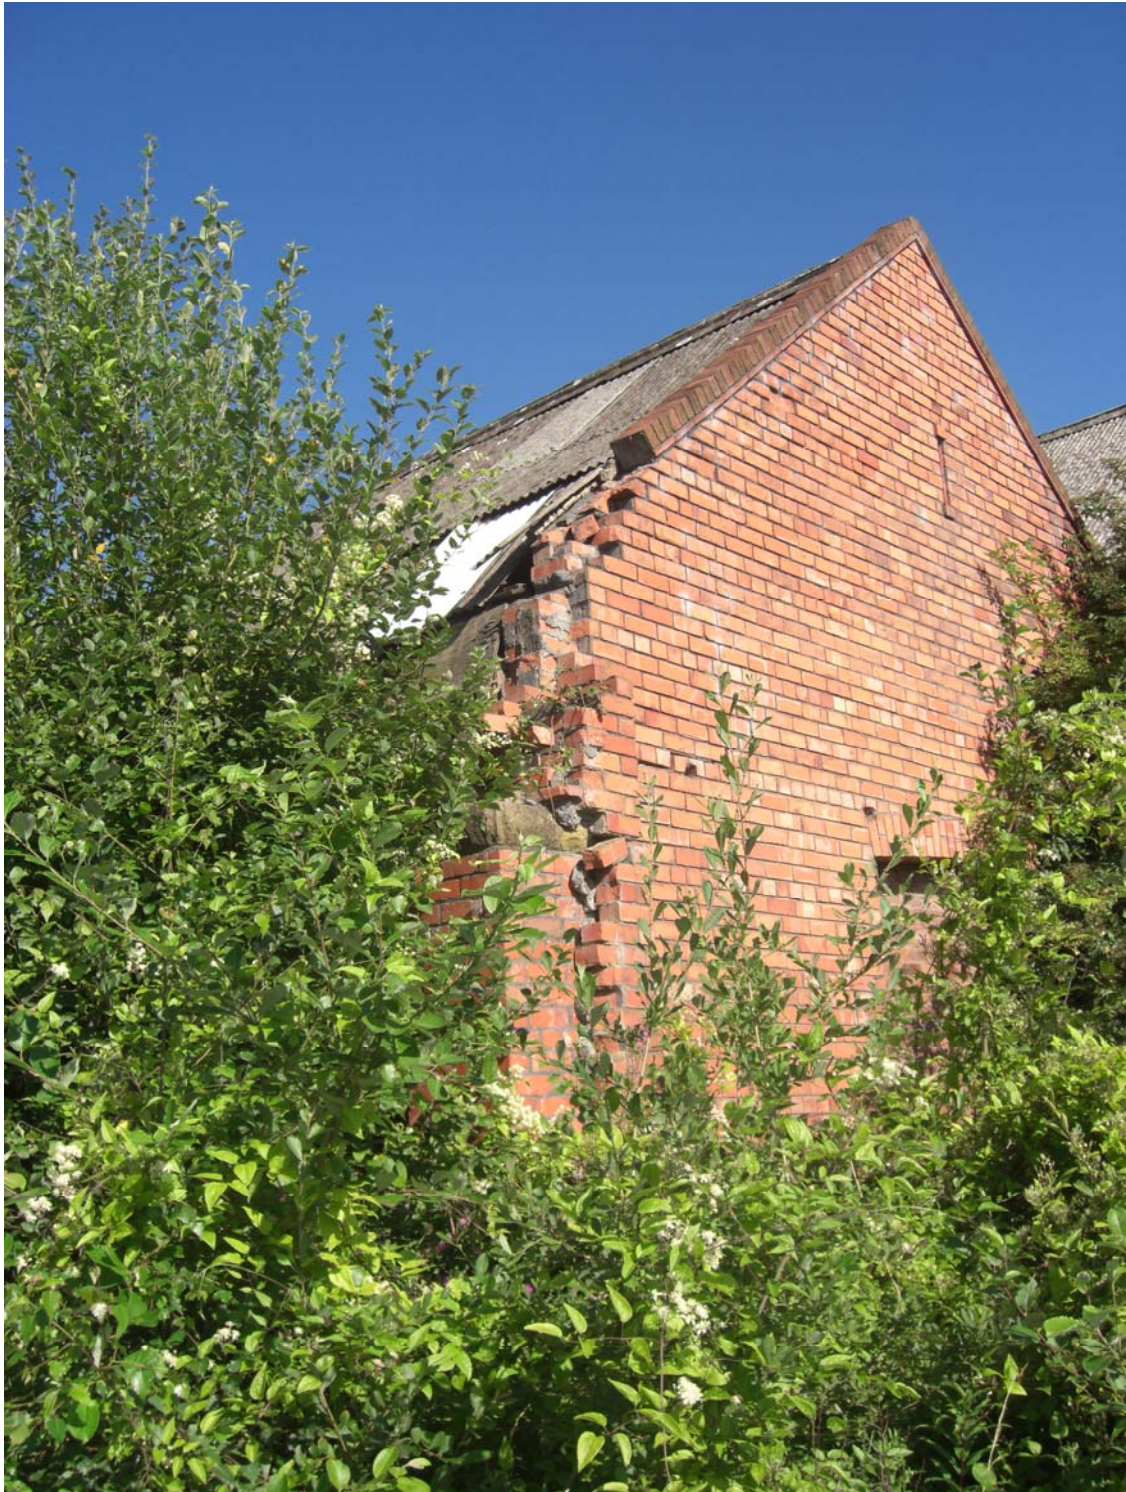
Damage to Front Part B Extension

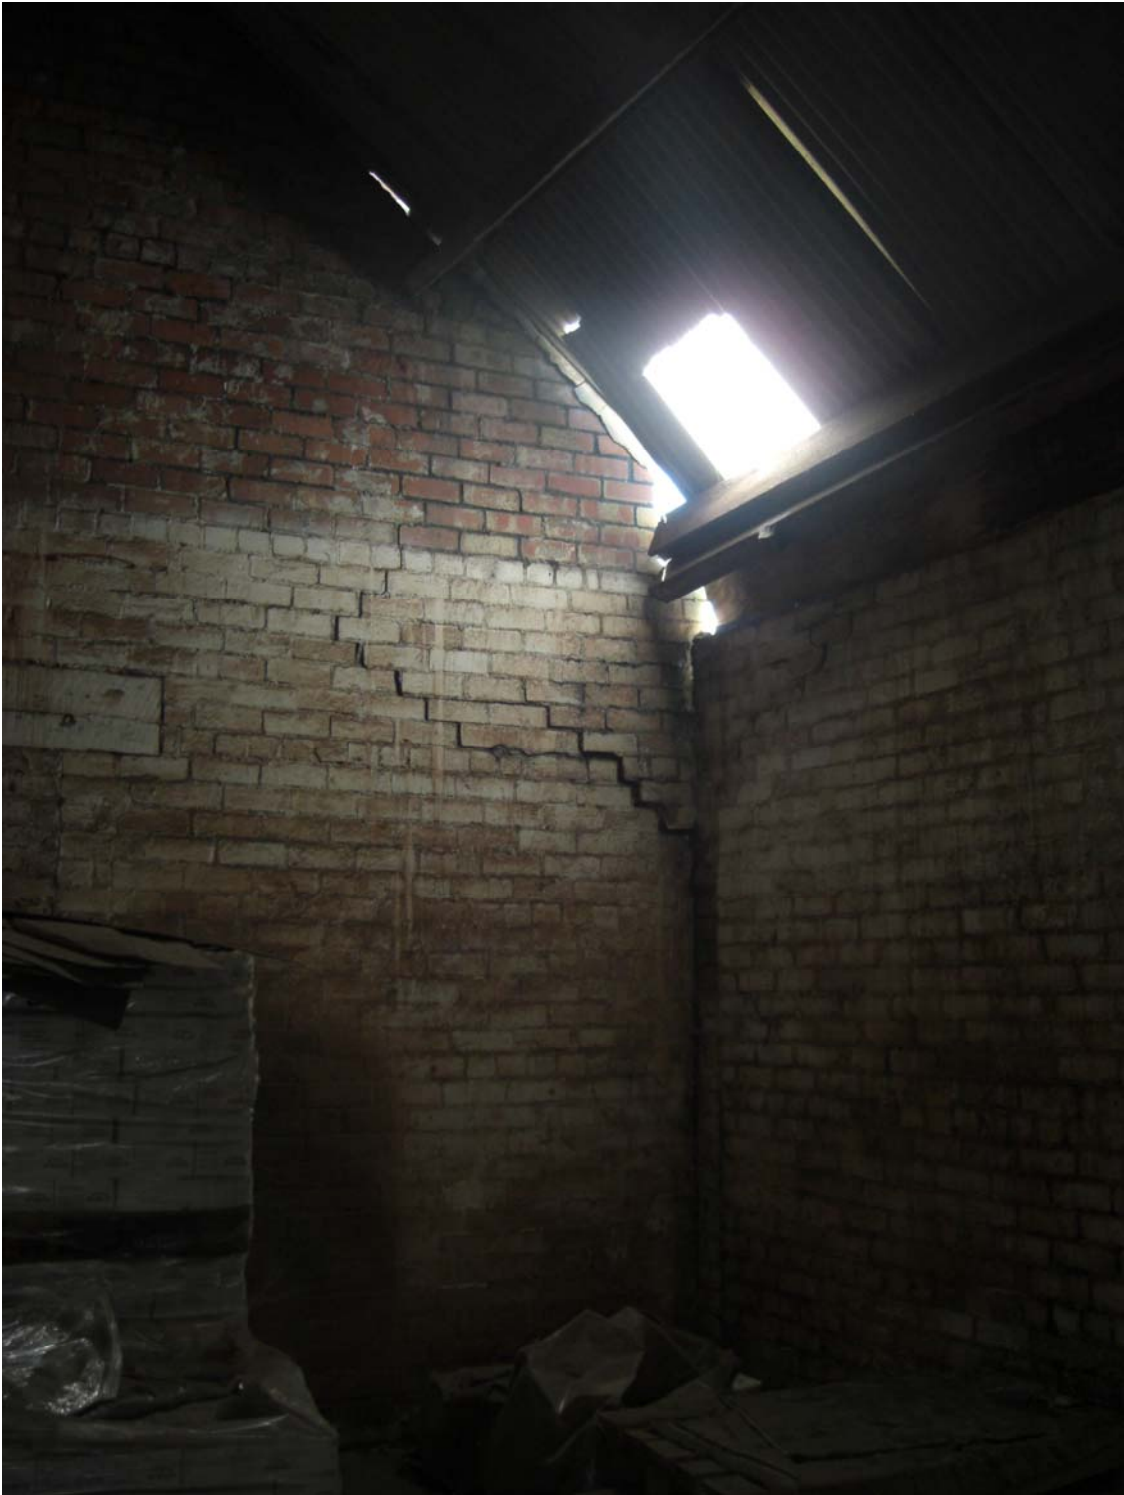
Internal with no support to timber beam

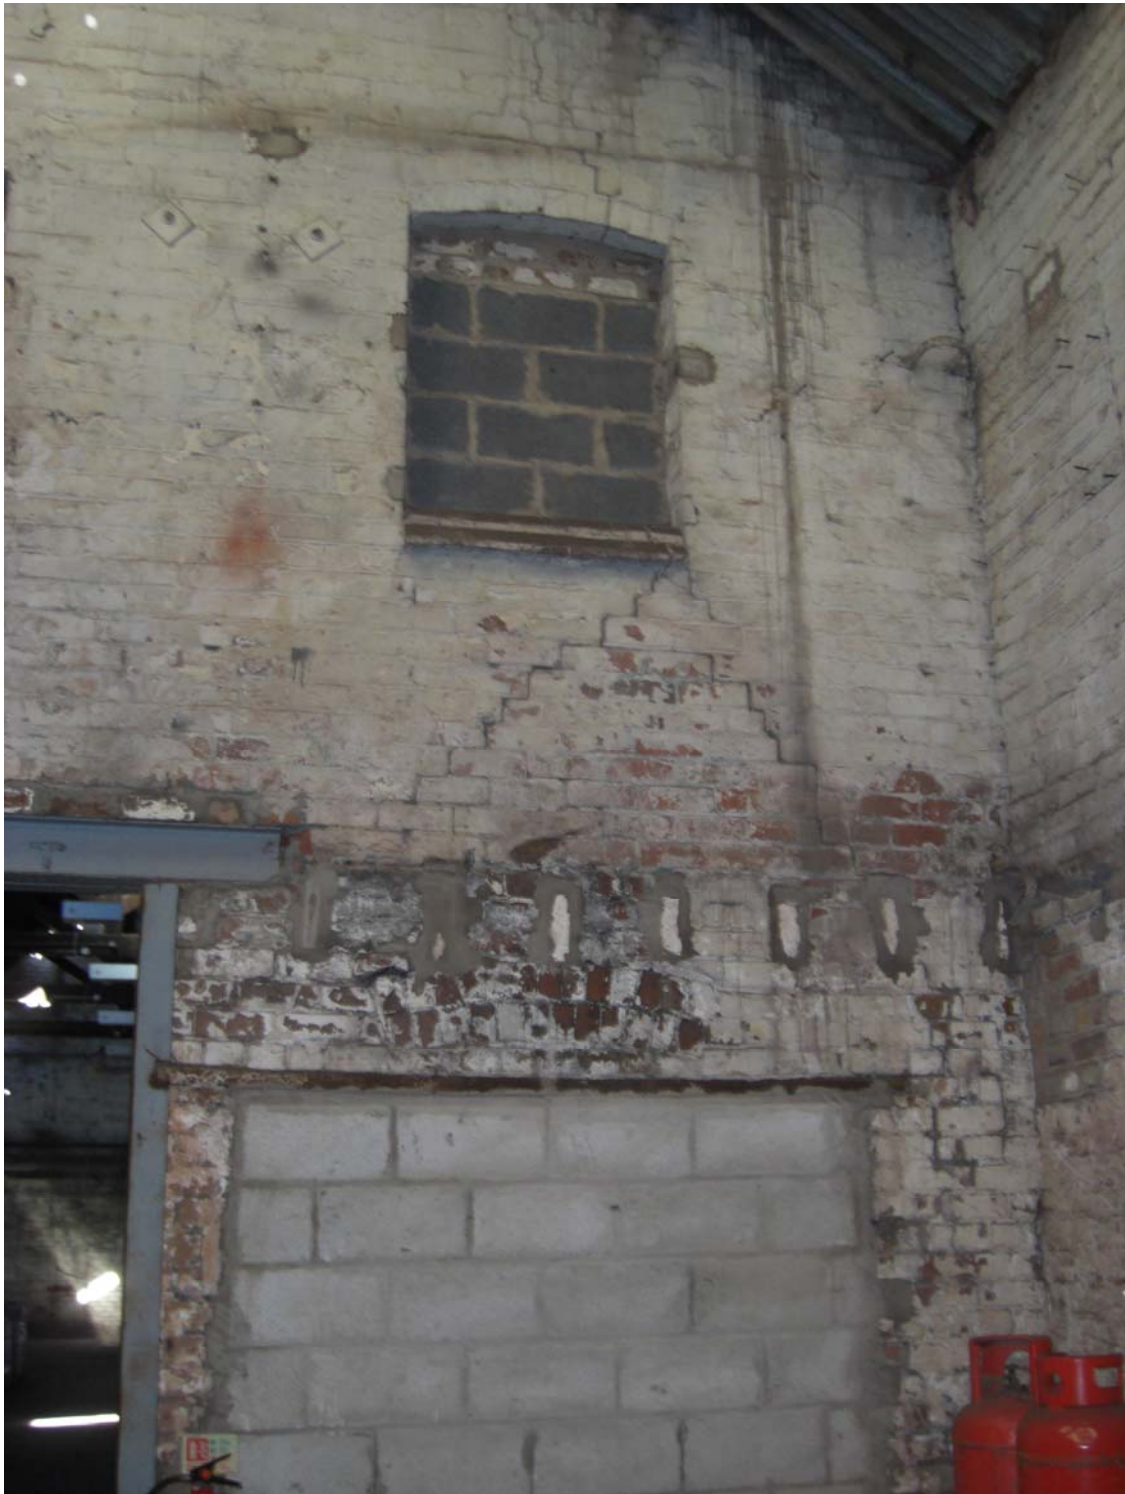
Various areas of cracking to the supporting brickwork to area C was apparent however no intrinsic overall patterns were discerned and specifically nothing which might indicate any lack of foundation performance. Specifically the east corner of the southern most extended bay has failed as eaves level this possibly being related to adjacent demolition works. Very noticeable out of plumb of the brickwork was noted both to the North side wall and correspondingly to the east west running internal walls. Some areas of significant internal leaning of the upper gable walls were apparent. There were numerous areas of obvious water penetration through the roof with there being significant water staining to timber beams supporting the internal valley gutters. It was noted that the north external gutter had significant vegetation growth and therefore it may be assumed that the internal gutters would have had a similar lack of maintenance. Although the timber roof trusses in the main appeared adequate there was significant deterioration to the valley support beams and some truss bearings. In isolated areas local failure had obviously occurred and temporary propping had been positioned. In other areas additional strengthening had been provided to beams and trusses.

Typical Crack Damage to Part B

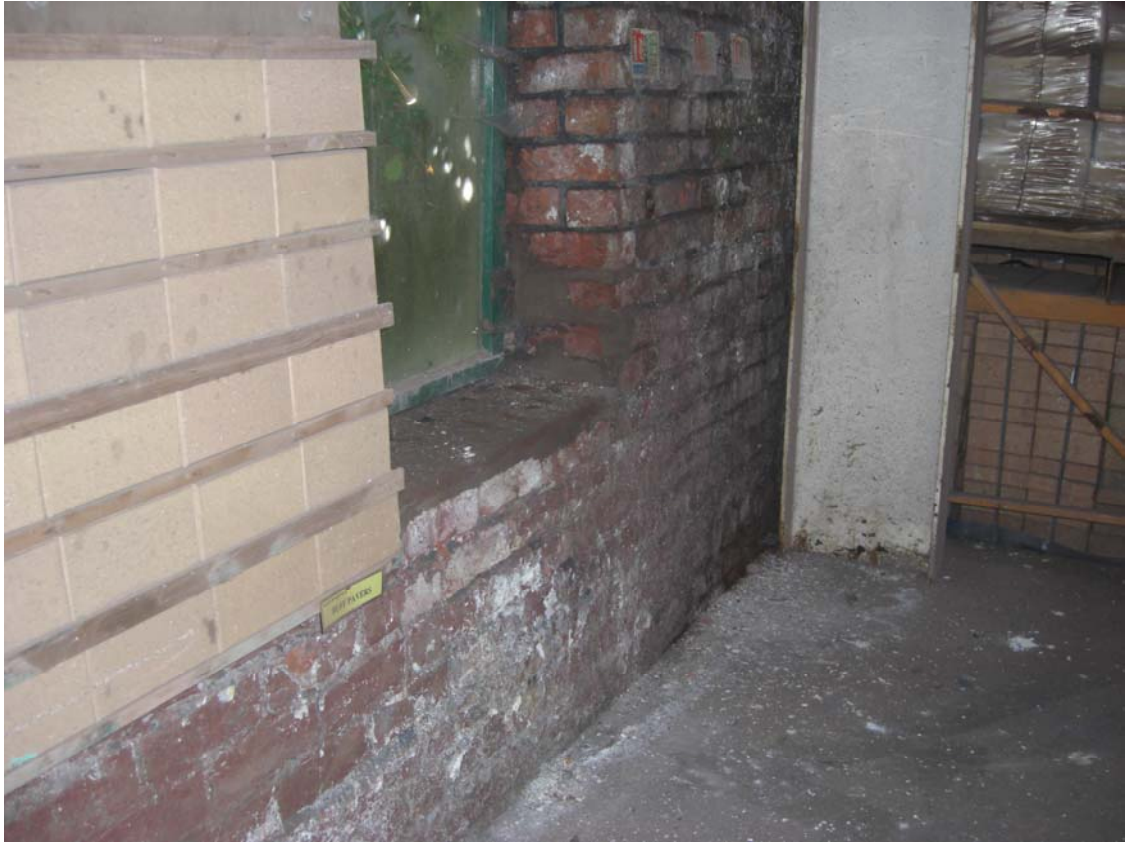
Much of the structure of Part A was covered due to it's fitting out as either offices or a canteen. The open areas however were considered to be similar to parts B and C in terms of water penetration and resulting timber decay. In the finished areas significant low level damp was apparent.

Typical low level damp Part A

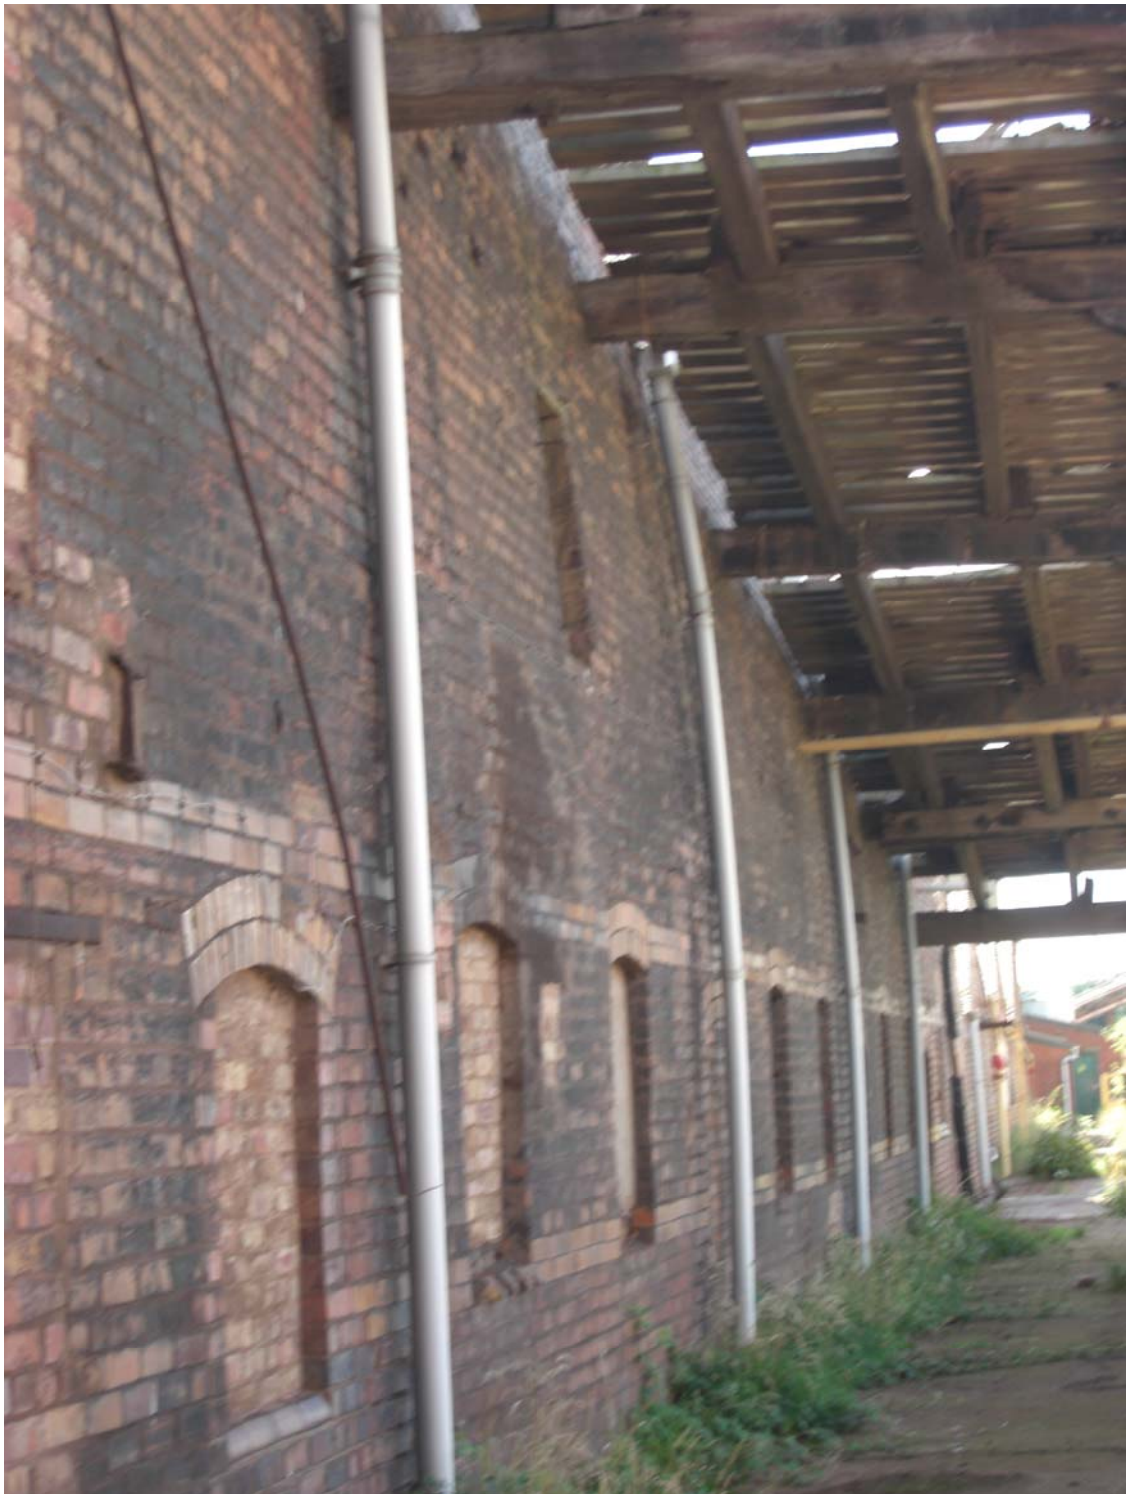
Rear of Part C Showing 'Lean In' of head to wall

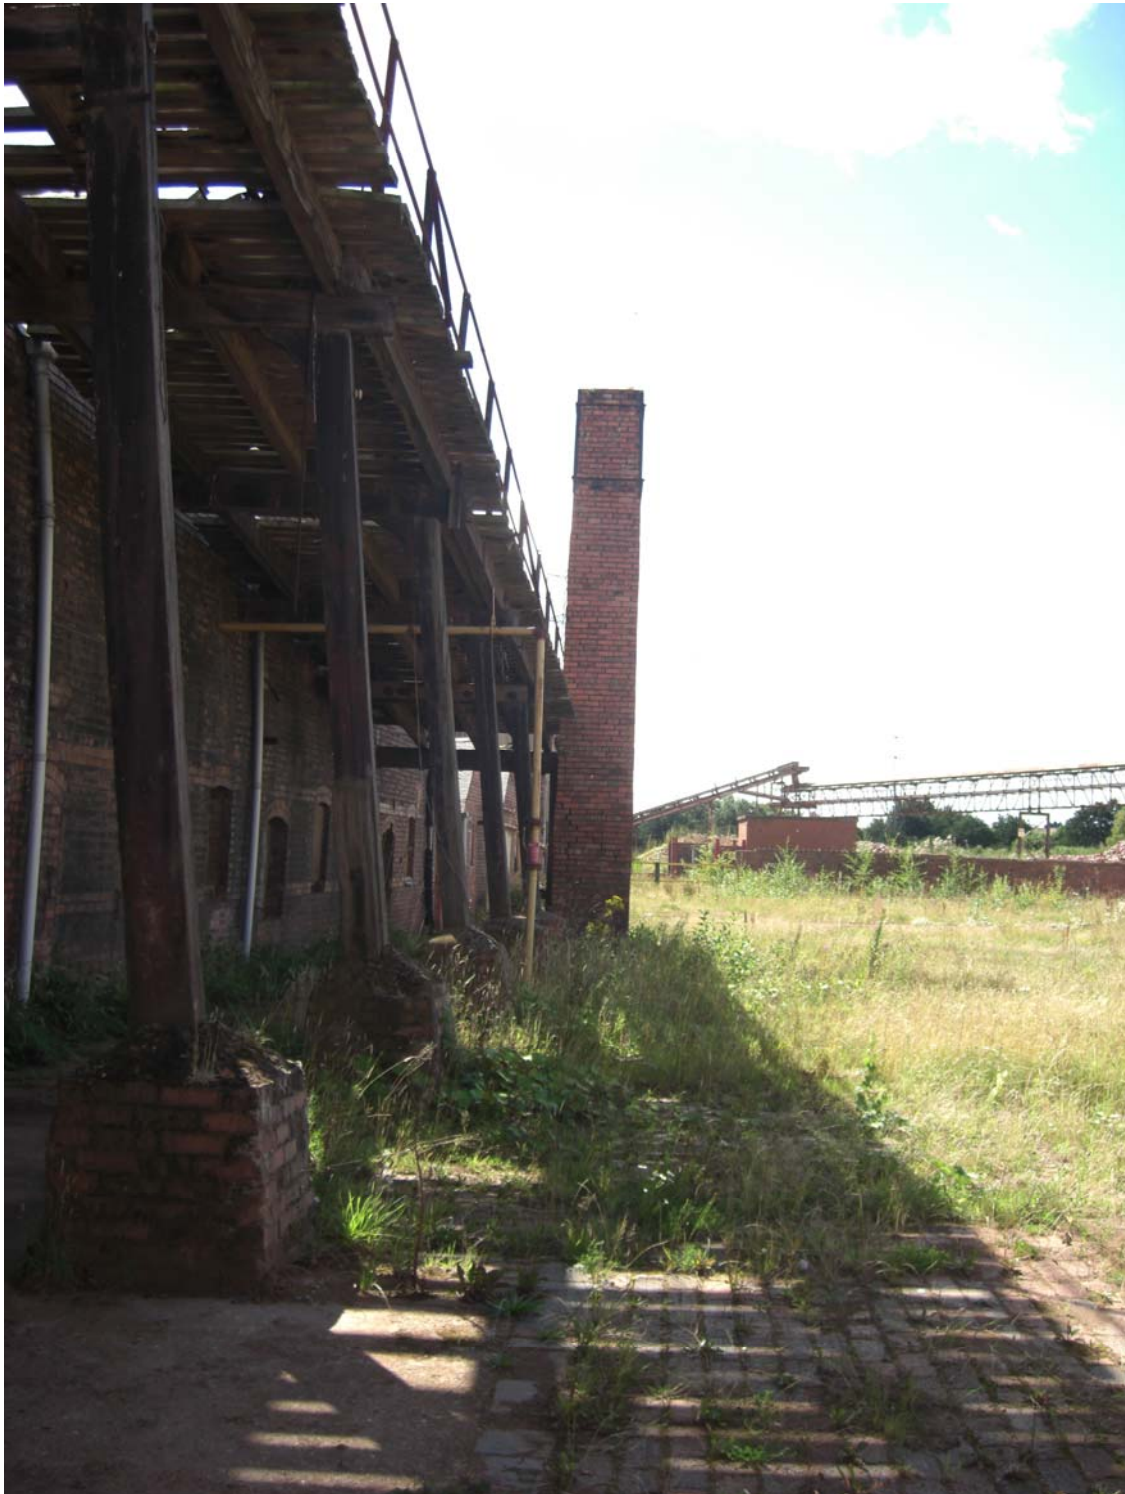
Part C exhibits many of the defects noted in B although the level of maintenance may be somewhat improved. Significant water penetration still prevailed however with resulting timber decay. In addition to high level water penetration significant low level damp was also noted. Very severe out of plumb was noted to the west upper gables where a timber runway structure was attached.

Rear of Part C Timber Runway Structure showing lean in support columns

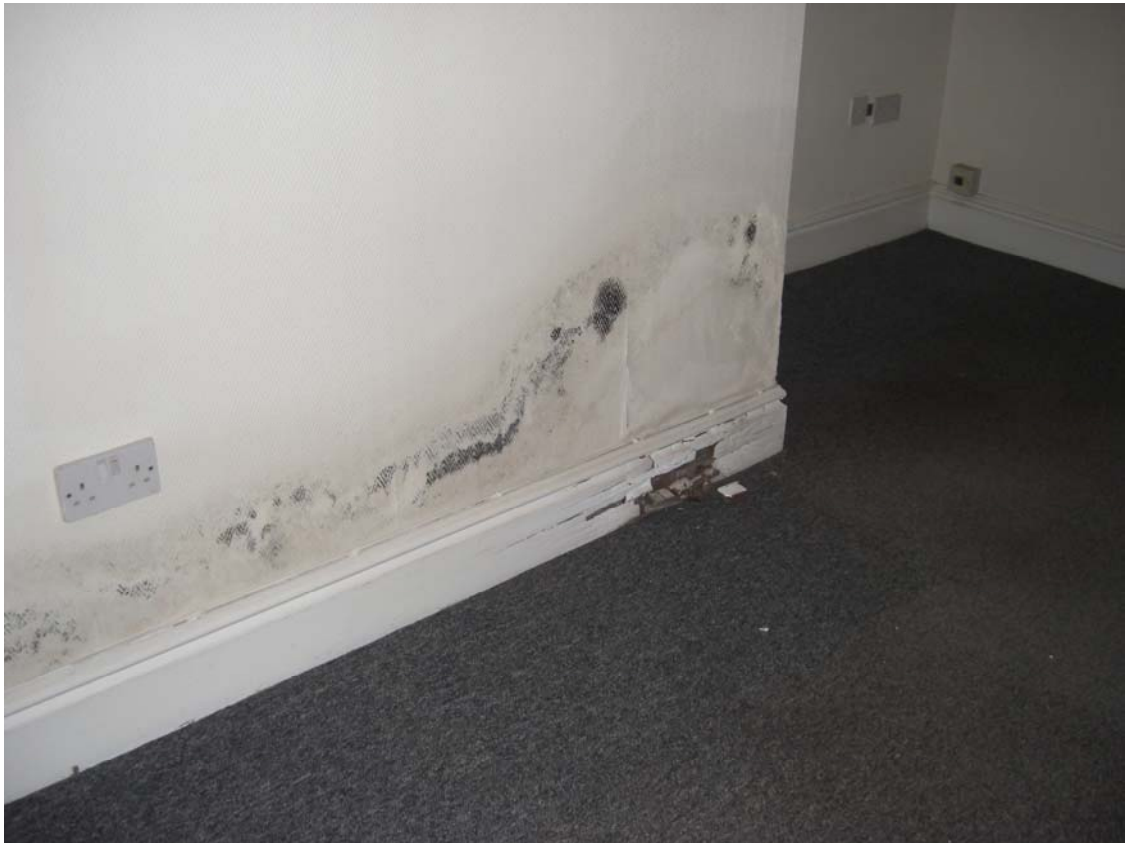
Damp to Office areas

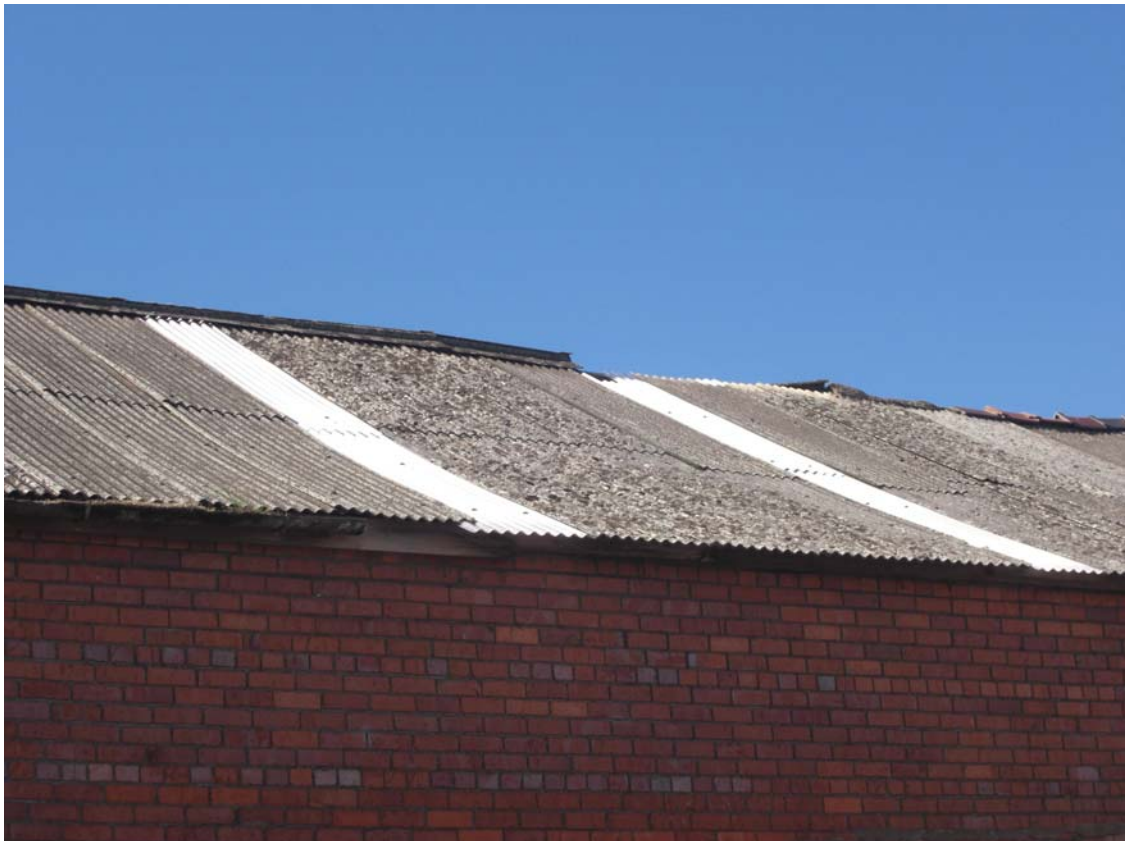
Missing Ridge Part B

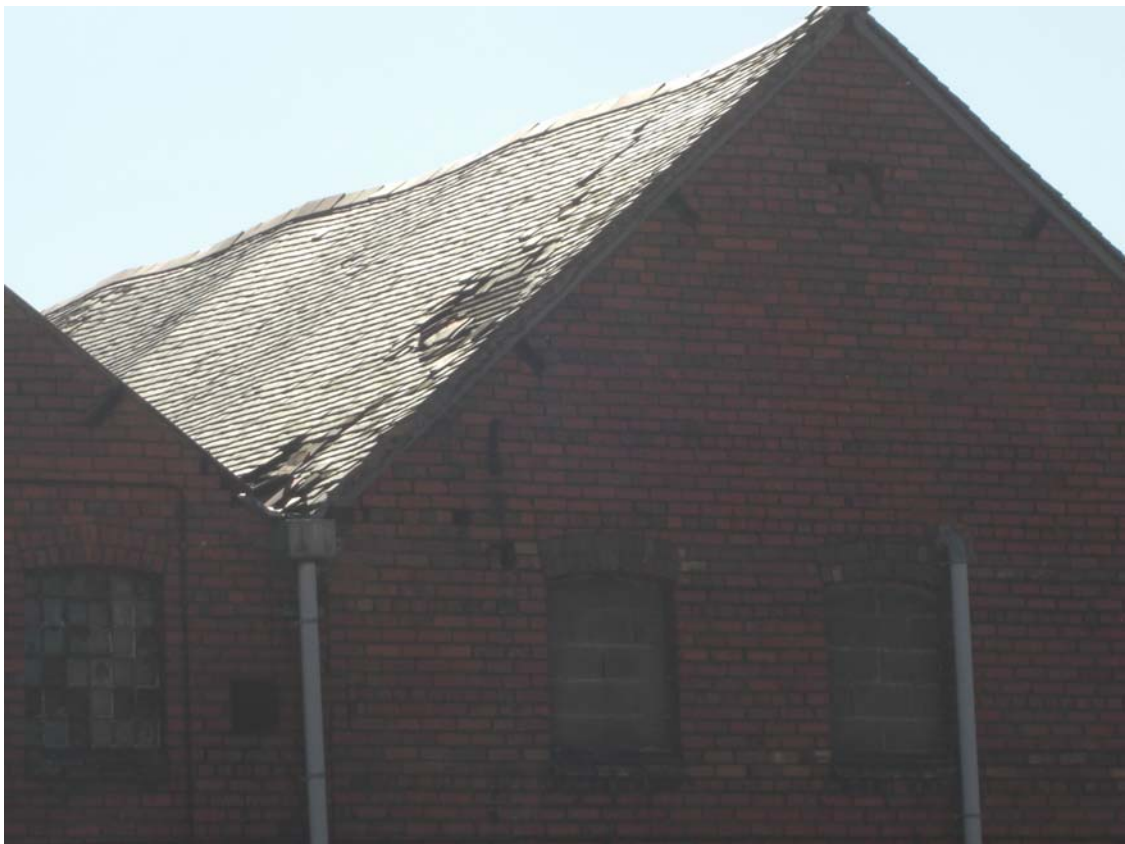
Deformed Roof & Damaged Tiling - Original Finish Part B

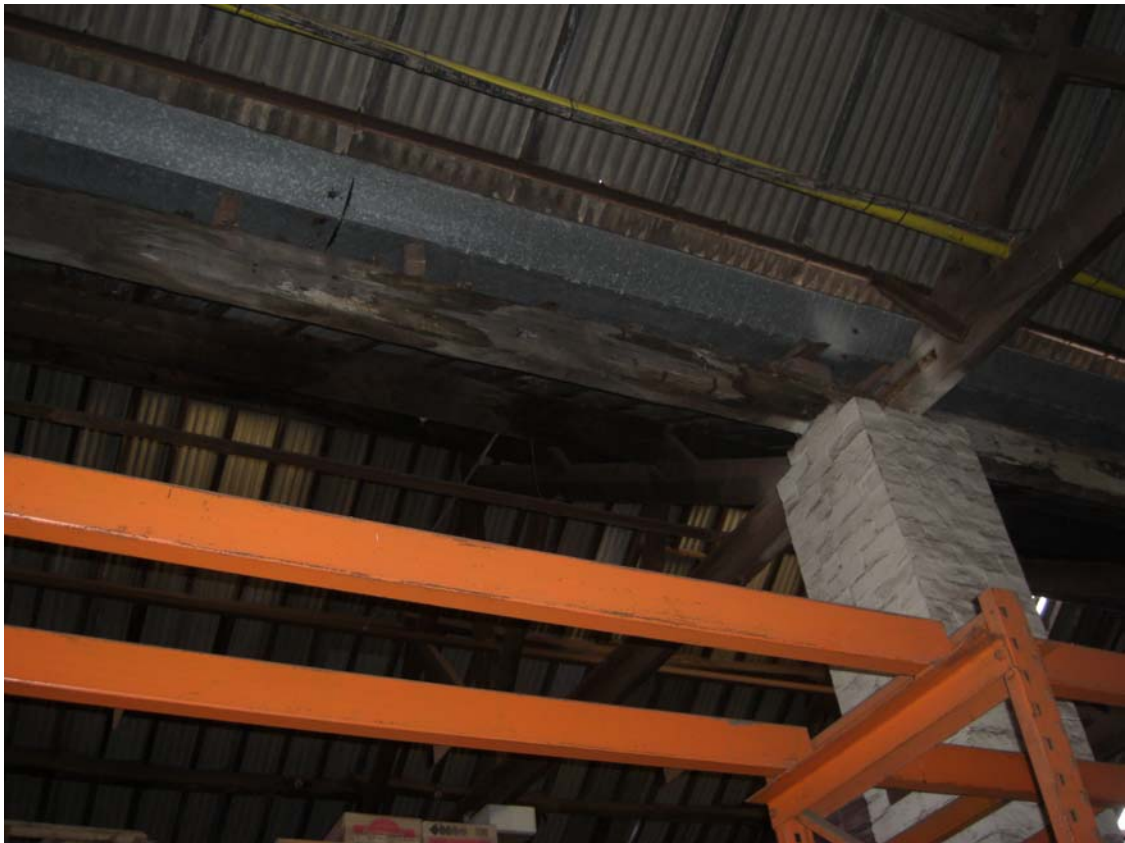
Replaced Internal Gutter with staining to timber support beam - Part B

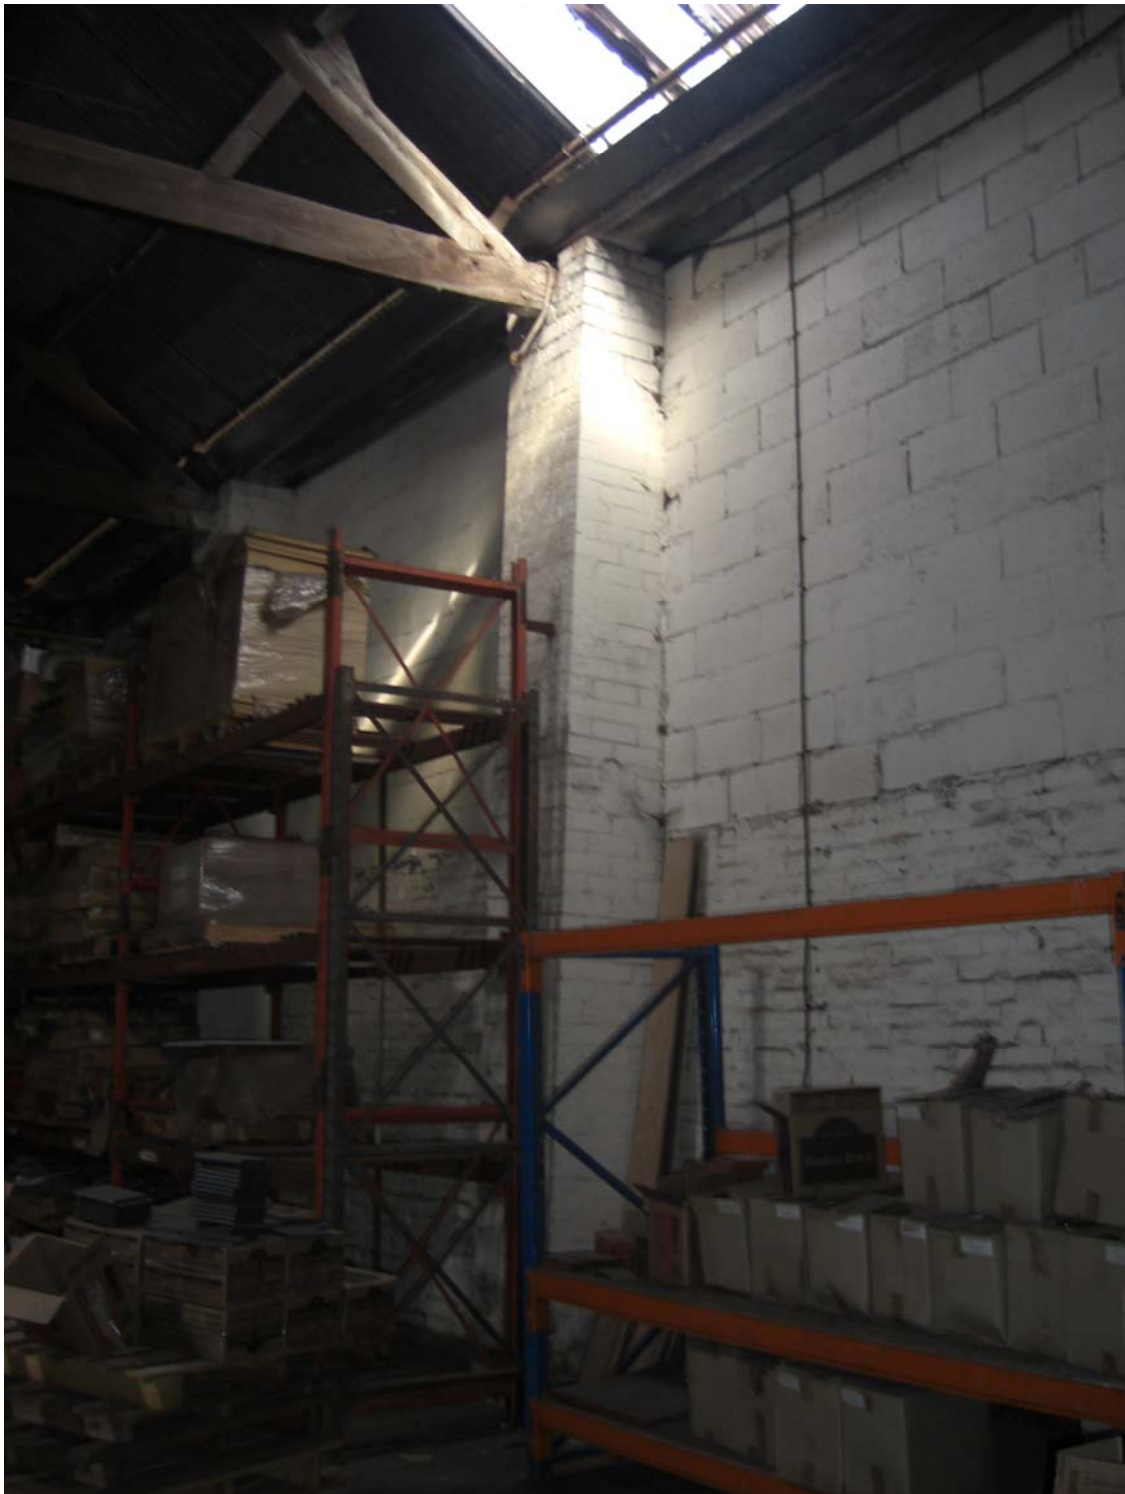
Out of Plumb wall / pier - Part B

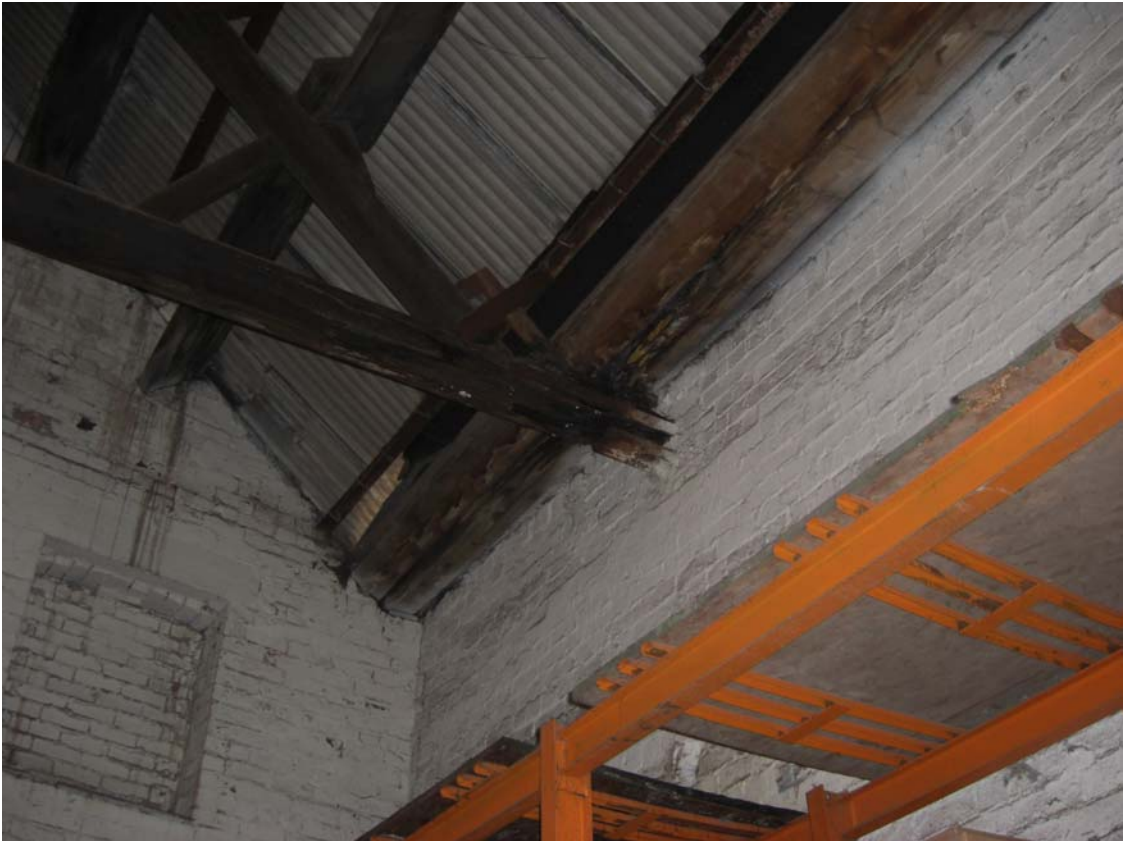
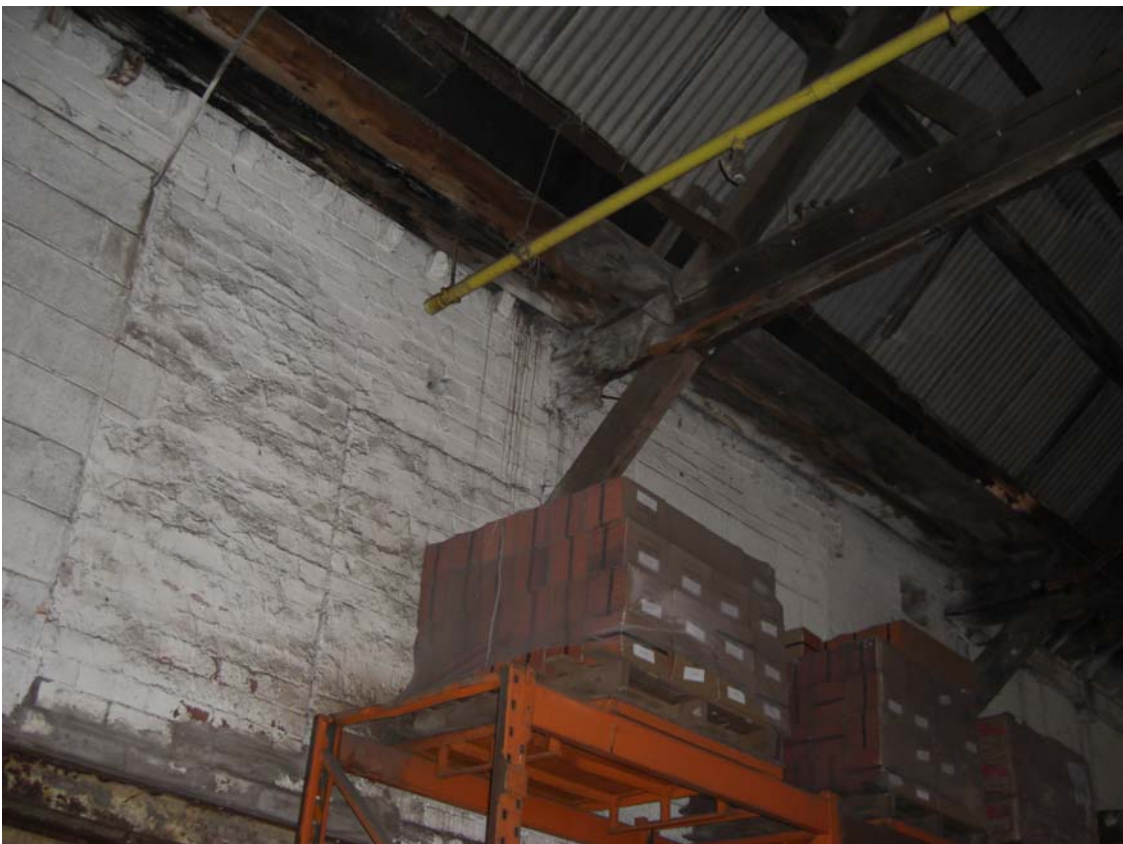
Water Penetration evidence at truss support / gutter - Part B

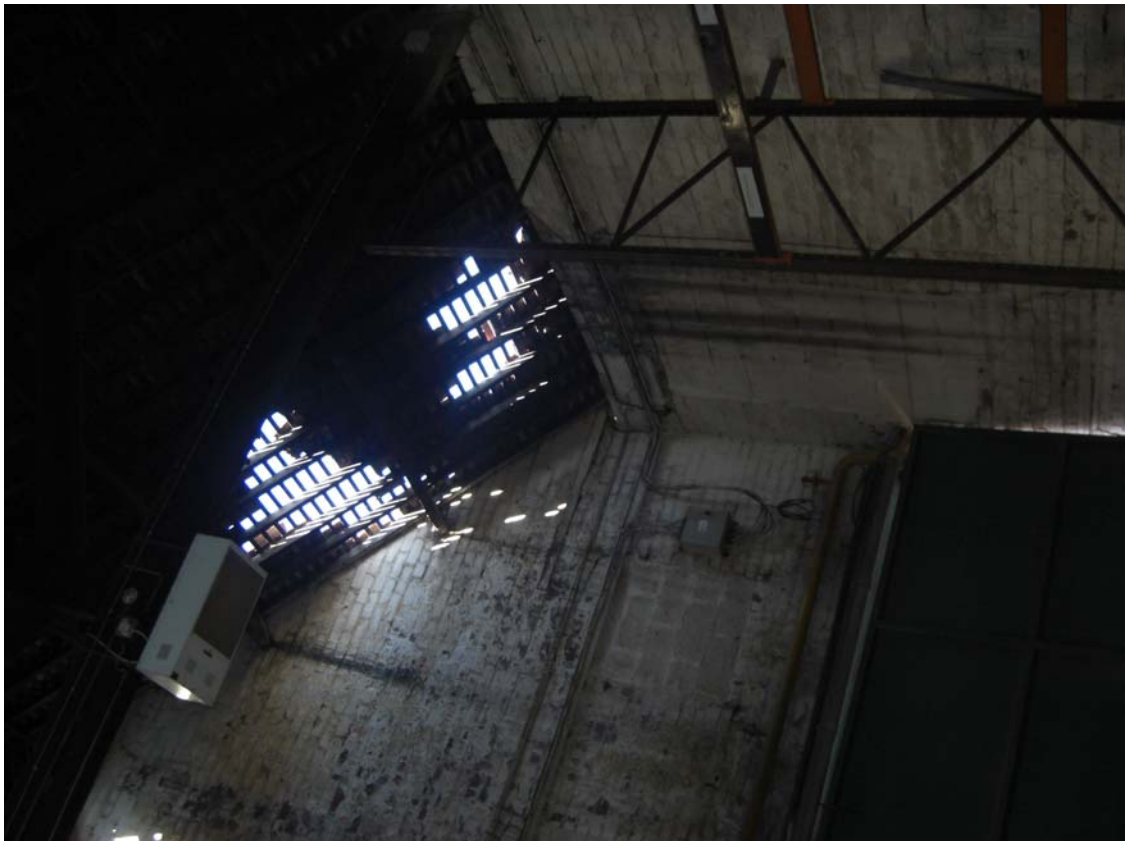
Typical Roof covering failure - Part B

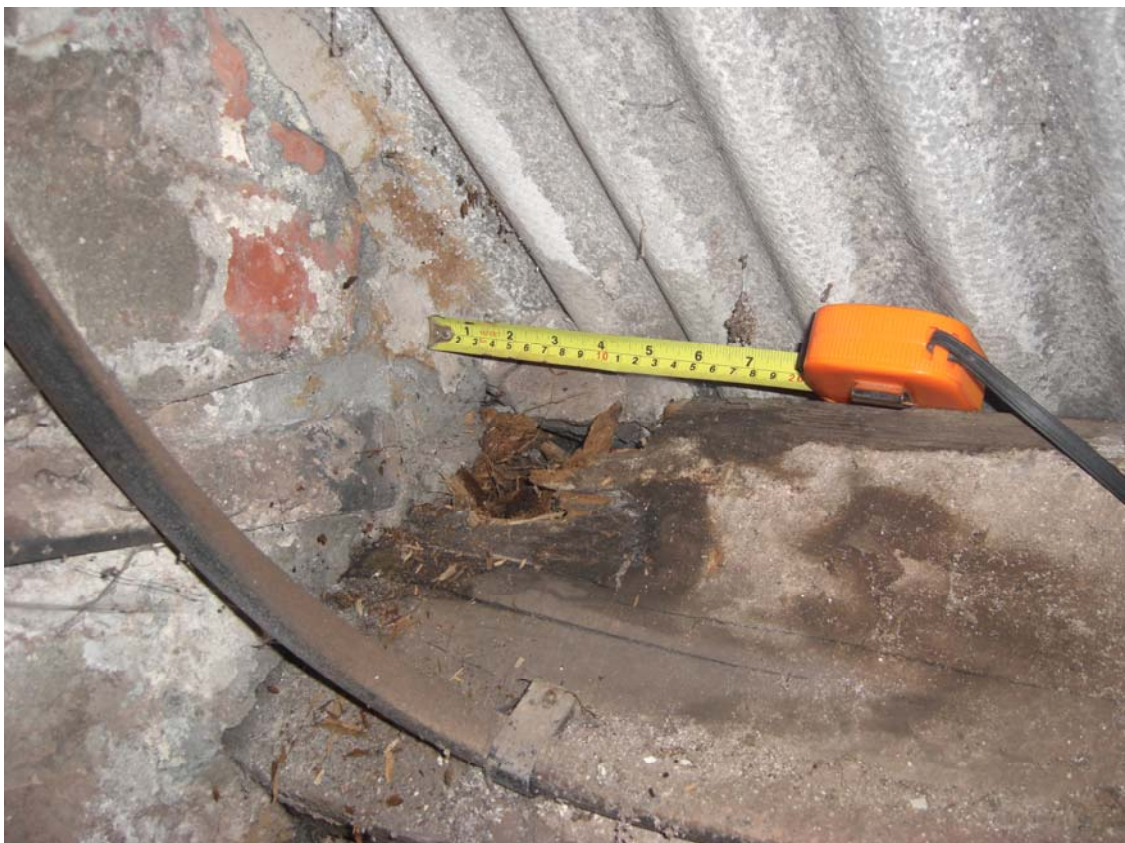
Item 1 of the above represents the most significant problem. There has been an obvious lack of adequate maintenance over a prolonged period of time and many key roof elements have been compromised. One trial high level investigation of an area appearing 'relatively solid' from ground level revealed considerable rot. It must be assumed that in addition to the obvious areas that there are many other areas significantly affected. In our opinion the roof may become structurally unstable in the short to medium term particularly given its form where it is susceptible to exceptional snow fall loading on internal valleys.

Trial detail examination of gutter support beam Part b showing extensive decay

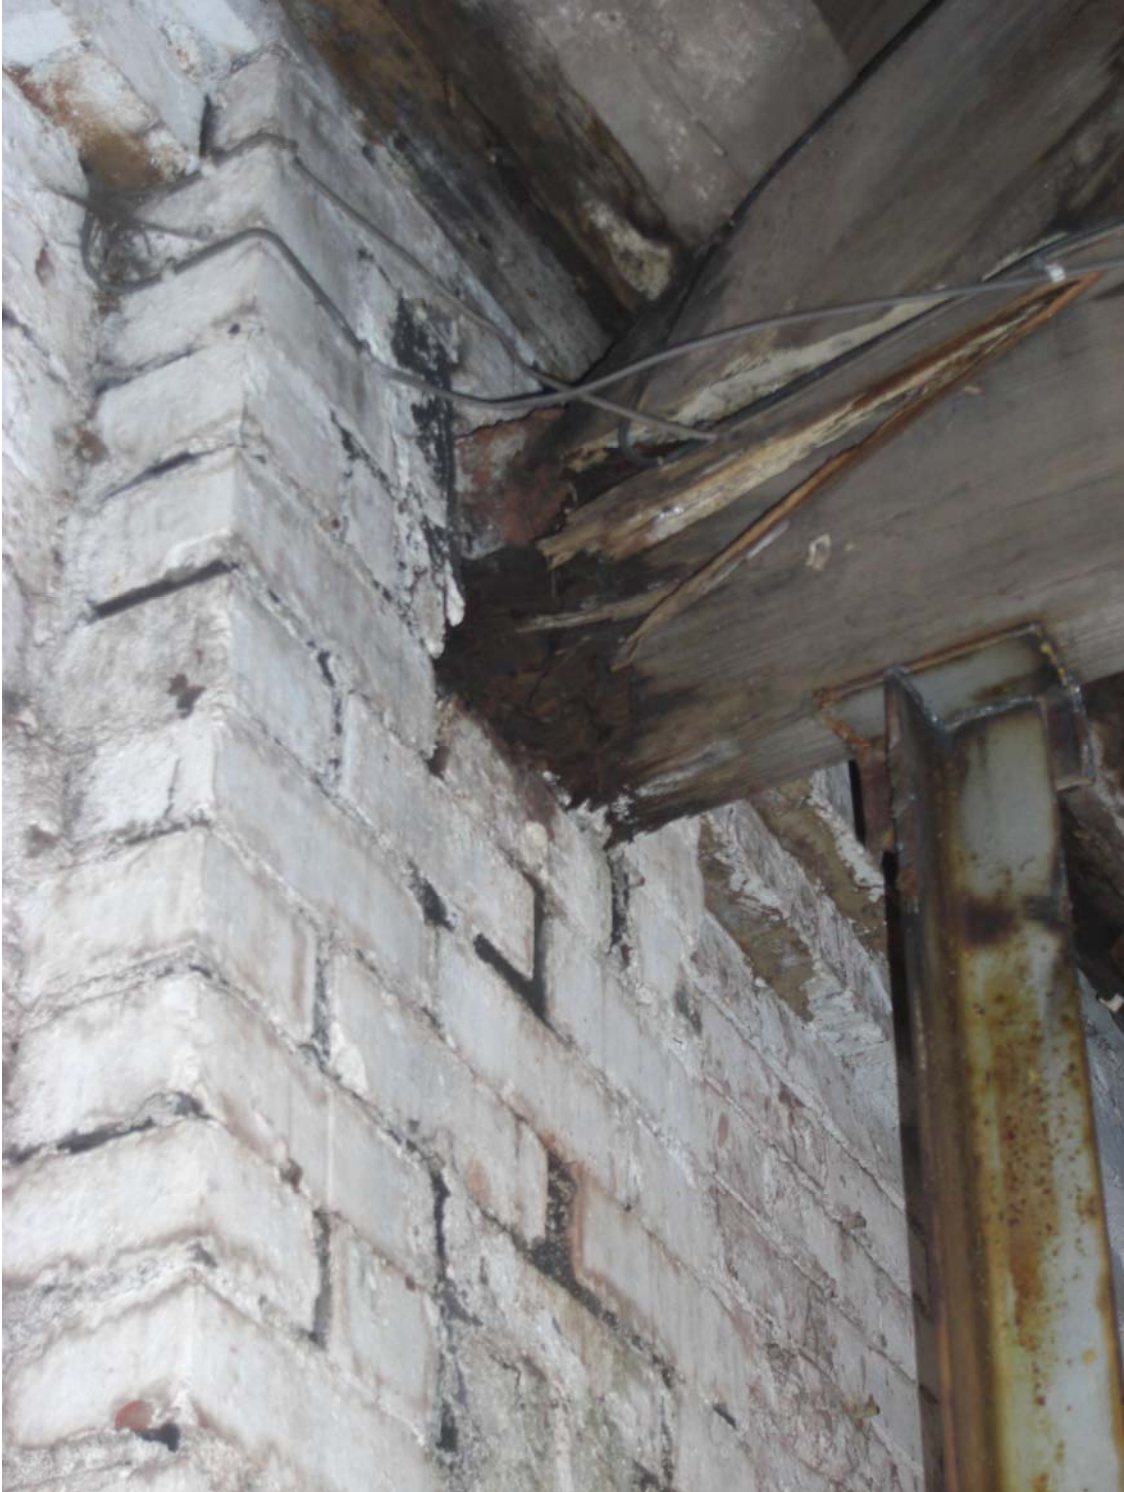
Failed truss support due to decay with steel prop – Part B
