**Condition Survey  
Ruabon Brickworks  
Haford Road  
Johnstown  
WREXHAM**

## **Condition Survey @ Johnstown, Wrexham**

**Date of survey:** Tuesday 11<sup>th</sup> August 2009  
**Weather Conditions:** Sunny and Dry  
**Undertaken By:** Robert Tait and Penny Smith

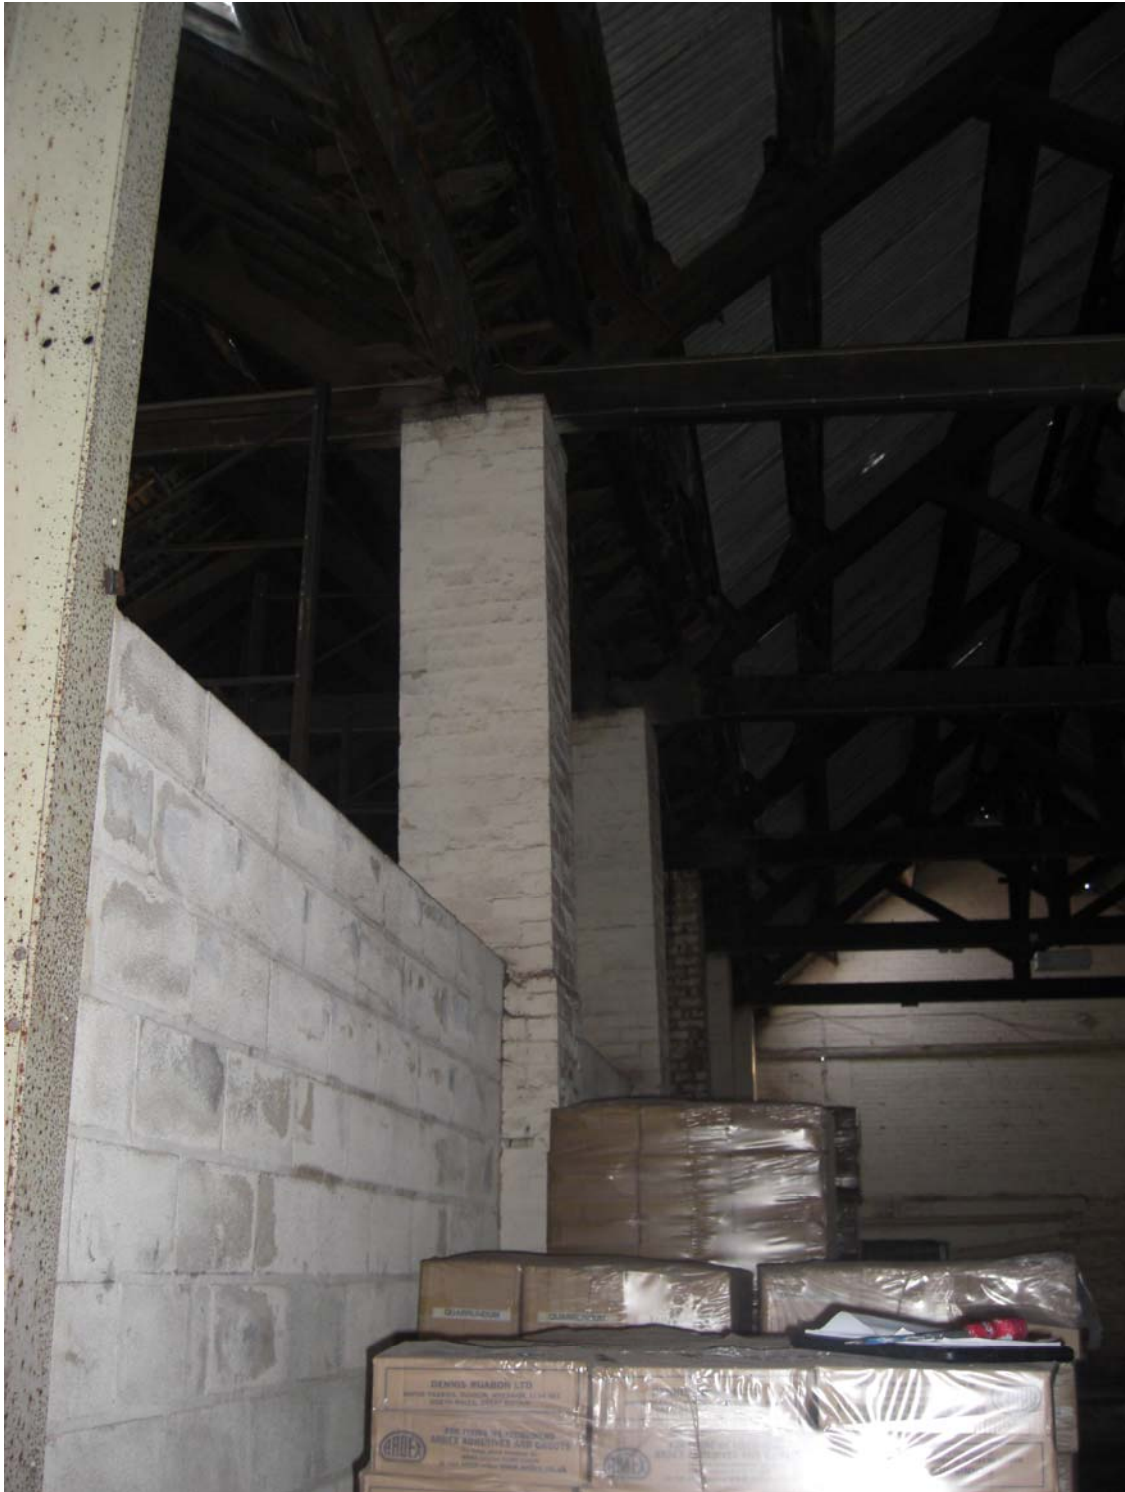
Out of plumb internal pier - Part B

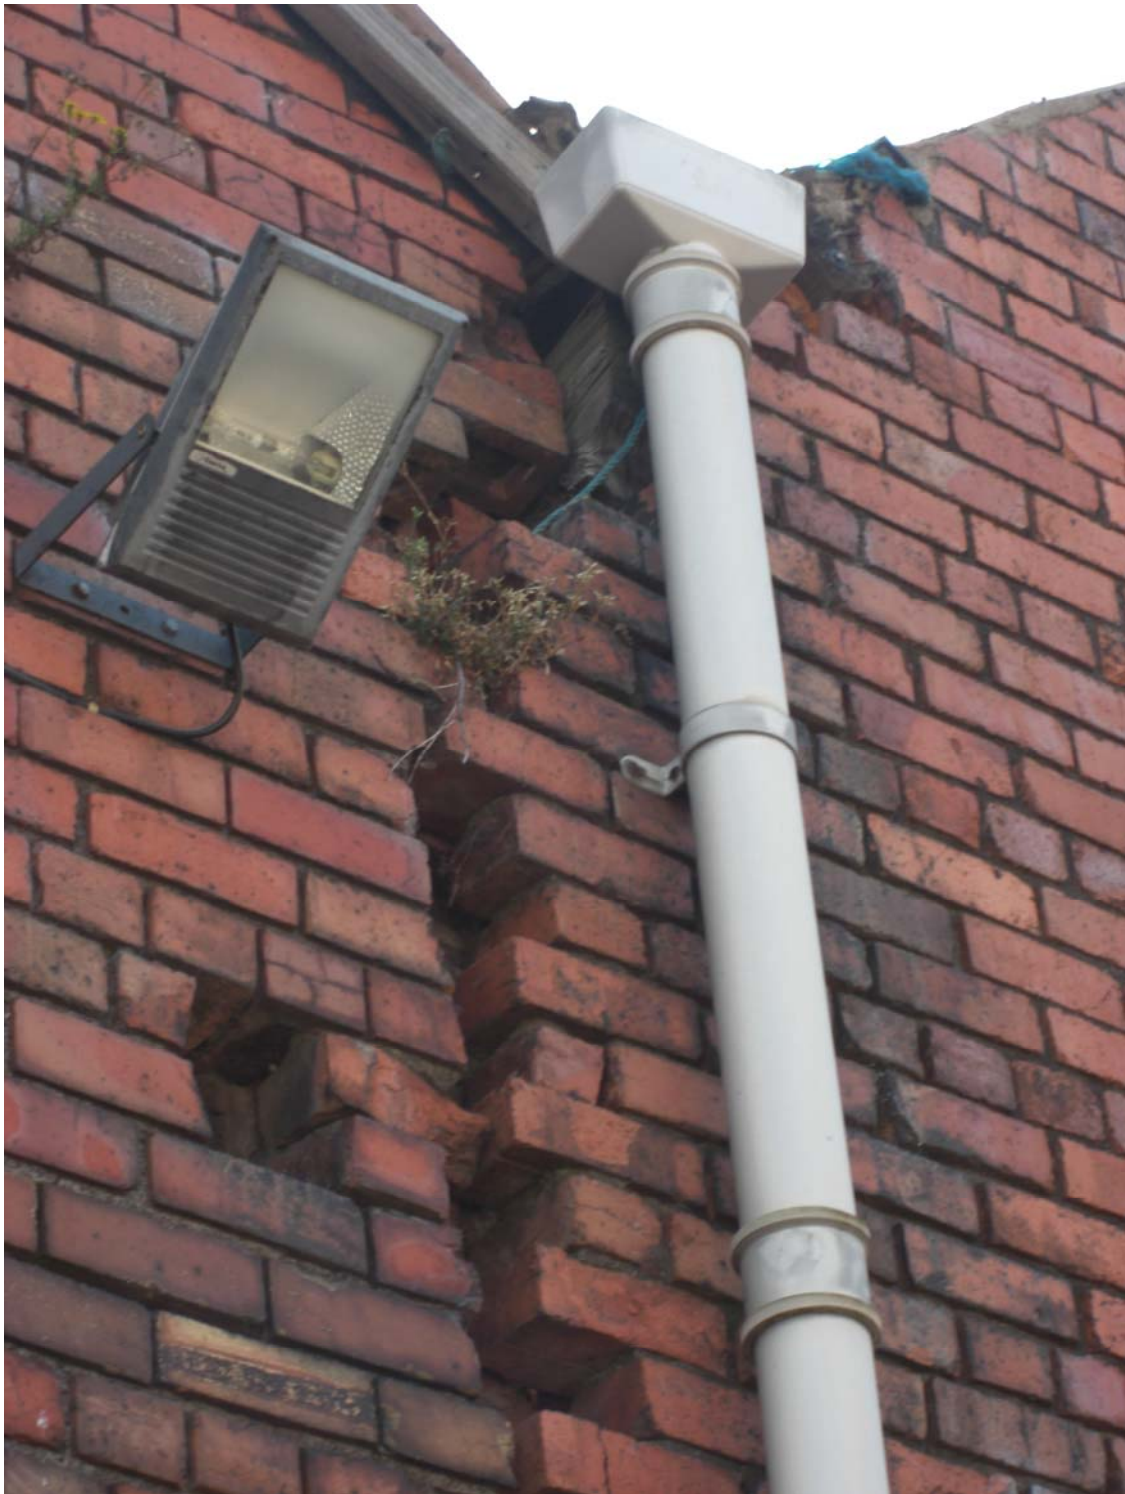
Rear Elevation Part B showing relative displacement at construction joint with Left Hand Side 'leaning in' at Head
