## **Refurbishment & Demolition Survey for Asbestos Content Materials**

**Former District Office  
Former Gas Works  
Maelor Works  
Marchweil  
Wrexham, LL13 0UW**

***Report No. KW / Q2652 / 13***

**Survey Date/s: 09 / December / 2013**

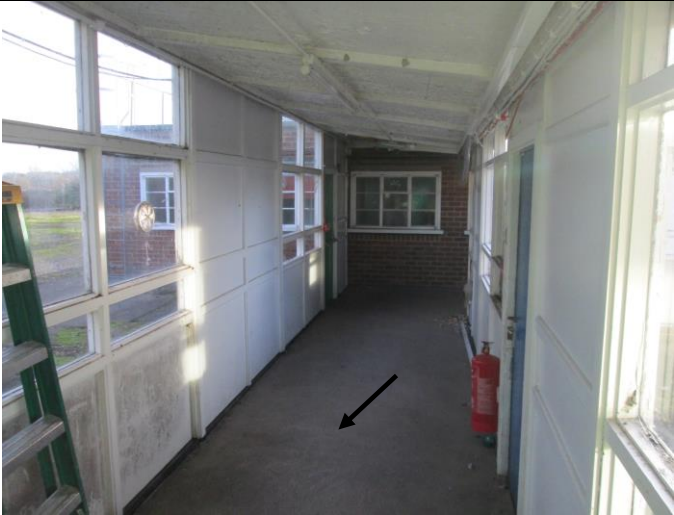
### 4.5 Sample Results, Algorithm and Recommendations

| <b>Item / Material &amp; Quantity:</b> | Vinyl floor covering to covered walkway.<br>Approx 32m <sup>2</sup> | | |
| <b>Surface Treatment:</b> | None – Fair Condition | | |
| <b>Comments / Recommendations:</b> | Vinyl floor covering to covered walkway sampled and found to contain no Asbestos material. No further actions required. | | |

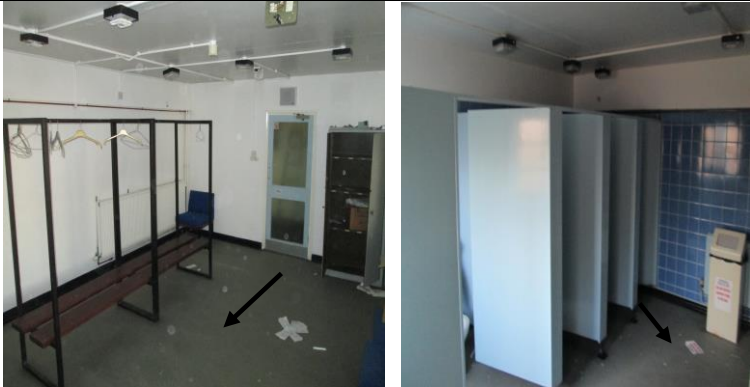
### 4.6 Sample Results, Algorithm and Recommendations

| <b>Item / Material &amp; Quantity:</b> | Vinyl floor covering to ladies changing room and toilets.<br>Approx 55m <sup>2</sup> | | |
| <b>Surface Treatment:</b> | None – Fair Condition | | |
| <b>Comments / Recommendations:</b> | Vinyl floor covering to ladies changing room and toilets sampled and found to contain no Asbestos material. No further actions required. | | |

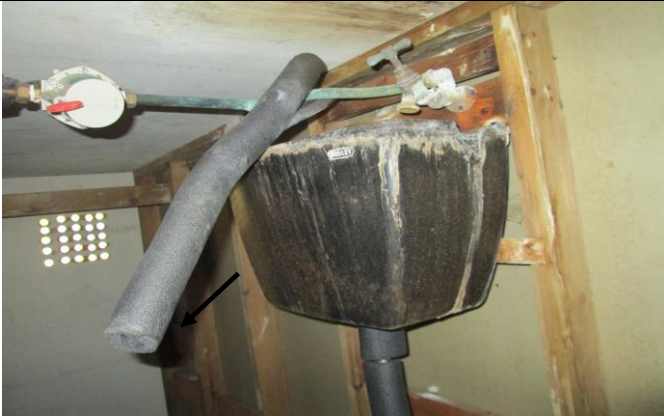
### 4.7 Sample Results, Algorithm and Recommendations

| <b>Item / Material &amp; Quantity:</b> | Cistern to void behind urinals.<br>1 x cistern | | |
| <b>Surface Treatment:</b> | None – Fair Condition | | |
| <b>Comments / Recommendations:</b> | Cistern to void behind urinals within men's toilets sampled and found to contain no Asbestos material. No further actions required. | | |

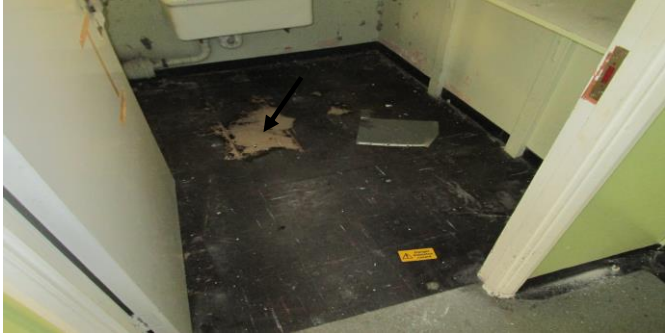
### 4.8 Sample Results, Algorithm and Recommendations

| <b>Item / Material &amp; Quantity:</b> | Asbestos content double layered floor tiles ( Black & Beige ) to Men's toilets – Cleaners store floor<br>Approx 8m <sup>2</sup> in total. | | |
| <b>Surface Treatment:</b> | None - Poor Condition. | | |
| <b>Material Assessment Algorithm Score:</b> | 4 | | |
| <b>Priority Assessment Algorithm Score:</b> | 4 | | |
| <b>Comments / Recommendations:</b> | Asbestos content floor tiles are in poor condition and present a Low Risk if left undisturbed. Recommend safe removal prior to any refurbishment works that may disturb the floor tiles, removal must be carried out under controlled conditions utilizing appropriate RPE / PPE with all waste material disposed of under special waste regulations. | | |

Asbestos floor tiles are in fair / poor condition and present a Low Risk if left undisturbed. Recommend safe removal prior to any refurbishment works that may disturb the materials, removal must be carried out under controlled conditions utilizing appropriate RPE / PPE with all waste material disposed of under special waste regulations.

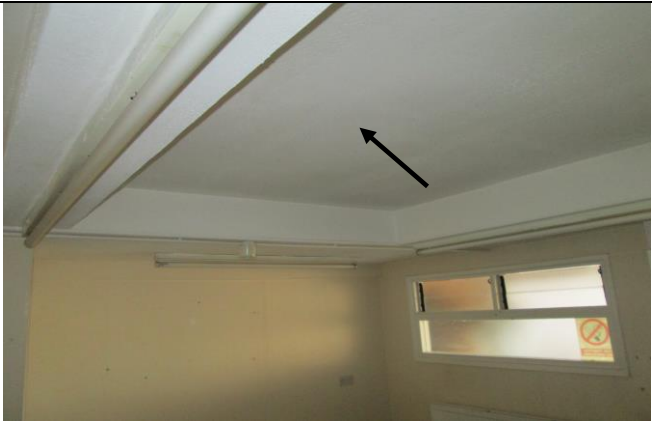
### 4.9 Sample Results, Algorithm and Recommendations

| <b>Item / Material &amp; Quantity:</b> | Textured coating ( Artex ) to ceiling<br>Approx 20m <sup>2</sup> in total. | | |
| <b>Surface Treatment:</b> | Painted – Fair Condition | | |
| <b>Comments / Recommendations:</b> | Textured coating ( Artex ) to ceiling within Room 1 store sampled and found to contain no Asbestos material. No further actions required. | | |

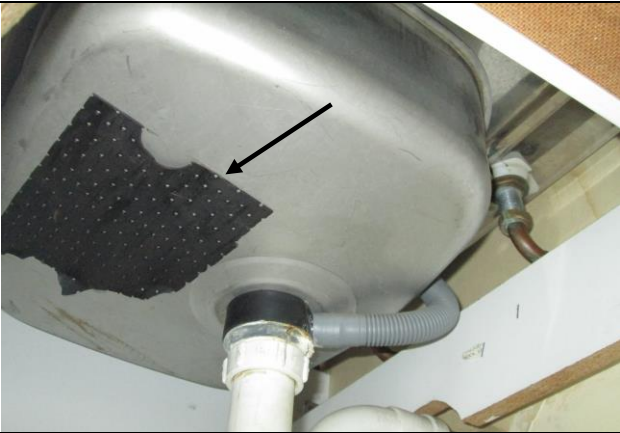
### 4.10 Sample Results, Algorithm and Recommendations

| <b>Item / Material &amp; Quantity:</b> | Bituminous sink pad to underside of sink.<br>1 x sink pad | | |
| <b>Surface Treatment:</b> | None – Fair Condition | | |
| <b>Comments / Recommendations:</b> | Bituminous sink pad to underside of sink sampled and found to contain no Asbestos material. No further actions required. | | |

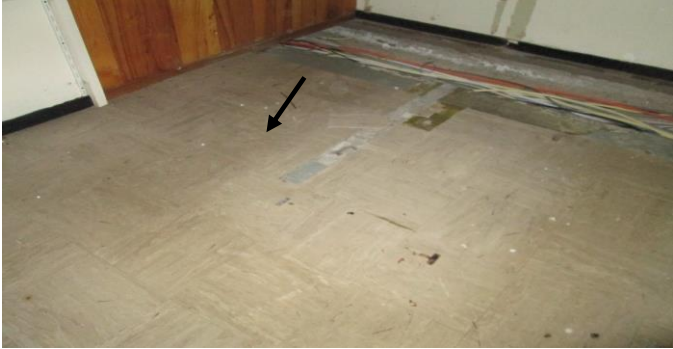
### 4.11 Sample Results, Algorithm and Recommendations

| <b>Item / Material &amp; Quantity:</b> | Asbestos content grey floor tiles under beige vinyl floor tiles to Maintenance Stores flooring<br>Approx 12m <sup>2</sup> in total. | | |
| <b>Surface Treatment:</b> | None - Poor Condition. | | |
| <b>Material Assessment Algorithm Score:</b> | 4 | | |
| <b>Priority Assessment Algorithm Score:</b> | 4 | | |
| <b>Comments / Recommendations:</b> | Asbestos content floor tiles are in poor condition and present a Low Risk if left undisturbed. Recommend safe removal prior to any refurbishment works that may disturb the floor tiles, removal must be carried out under controlled conditions utilizing appropriate RPE / PPE with all waste material disposed of under special waste regulations. | | |

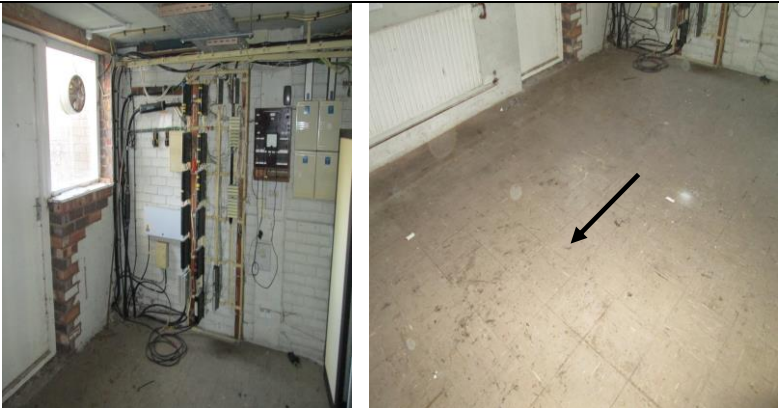
### 4.12 Sample Results, Algorithm and Recommendations

| <b>Item / Material &amp; Quantity:</b> | Floor tiles ( Beige ) throughout Room 2.<br>Approx 28m <sup>2</sup> in total. | | |
| <b>Surface Treatment:</b> | None – Fair Condition | | |
| <b>Comments / Recommendations:</b> | Floor tiles ( Beige ) throughout Room 2 sampled and found to contain no Asbestos material. No further actions required. | | |

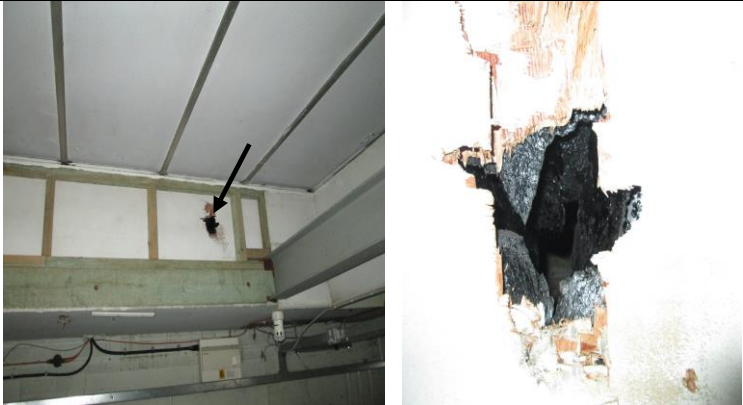
### 4.13 Sample Results, Algorithm and Recommendations

| <b>Item / Material &amp; Quantity:</b> | Felt surrounding flashing to skylights above ceiling.<br>Approx 10m <sup>2</sup> in total. | | |
| <b>Surface Treatment:</b> | None – Fair Condition | | |
| <b>Comments / Recommendations:</b> | Felt surrounding flashing to skylights sampled and found to contain no Asbestos material. No further actions required. | | |

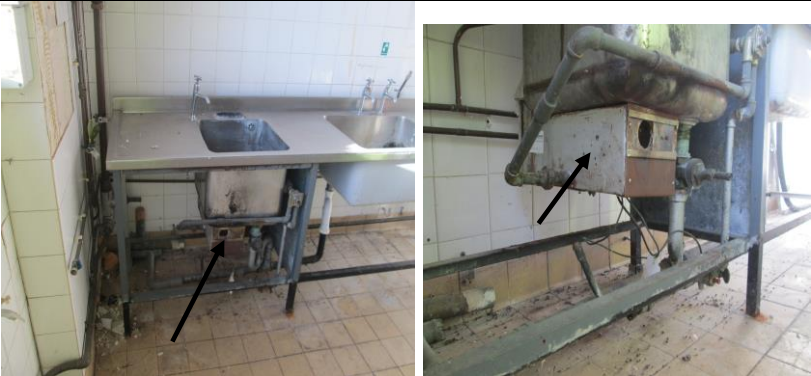
### 4.14 Sample Results, Algorithm and Recommendations

| <b>Item / Material &amp; Quantity:</b> | Asbestos Insulation Board ( AIB ) panelling to disposal unit under left side sink. Approx 1m <sup>2</sup> in total. | | |
| <b>Surface Treatment:</b> | None - Poor Condition. | | |
| <b>Material Assessment Algorithm Score:</b> | 6 | | |
| <b>Priority Assessment Algorithm Score:</b> | 8 | | |
| <b>Comments / Recommendations:</b> | Asbestos Insulation Board ( AIB ) is in poor untreated condition and presents a <b>Medium Risk</b> . Recommend safe removal <u>by a HSE licensed contractor</u> prior to any refurbishment works that may disturb the AIB, removal must be carried out under controlled conditions utilizing appropriate RPE / PPE with all waste material disposed of under special waste regulations. | | |

Asbestos Insulation Board ( AIB ) is in poor condition and presents a **Medium Risk** if left undisturbed. Recommend safe removal by a HSE licensed contractor prior to any refurbishment works that may disturb the AIB panels , removal must be carried out under controlled conditions utilizing appropriate RPE / PPE with all waste material disposed of under special waste regulations.

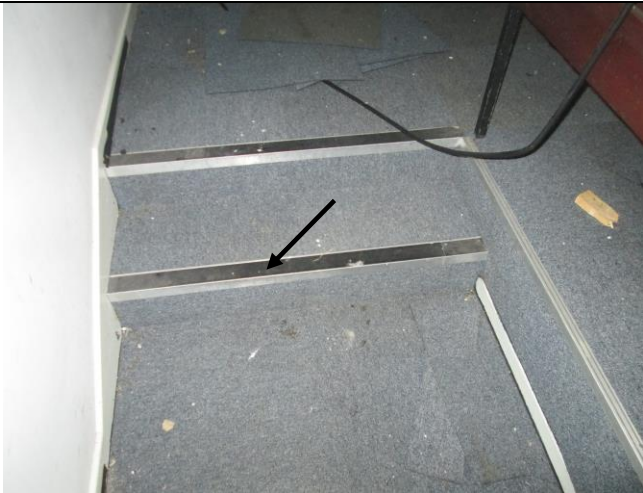
### 4.15 Sample Results, Algorithm and Recommendations

| <b>Item / Material &amp; Quantity:</b> | Protective stair nosing strips<br>2 x stair nosings | | |
| <b>Surface Treatment:</b> | None – Good Condition | | |
| <b>Comments / Recommendations:</b> | Protective stair nosing strips sampled and found to contain no Asbestos material. No further actions required. | | |

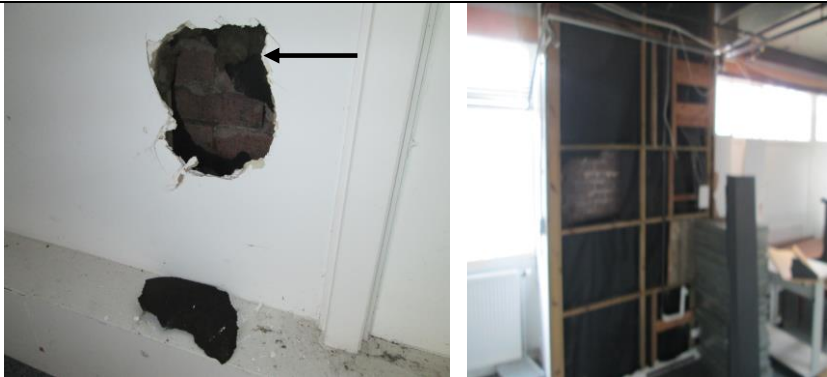
### 4.16 Sample Results, Algorithm and Recommendations

| <b>Item / Material &amp; Quantity:</b> | Felt type damp proof membrane throughout internal to external wall voids. | | |
| <b>Surface Treatment:</b> | None – Poor Condition | | |
| <b>Comments / Recommendations:</b> | Felt type damp proof membrane sampled and found to contain no Asbestos material. No further actions required. | | |

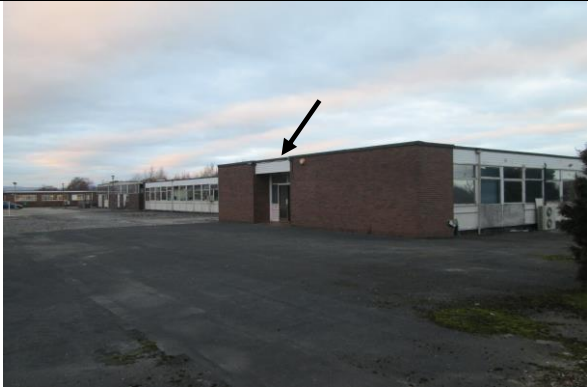
### 4.17 Sample Results, Algorithm and Recommendations

| <b>Item / Material &amp; Quantity:</b> | Asbestos content textured coating ( Artex ) to entrance lobby vestibule ceiling. Approx 8m <sup>2</sup> in total. | | |
| <b>Surface Treatment:</b> | Painted - Good Condition. | | |
| <b>Material Assessment Algorithm Score:</b> | 4 | | |
| <b>Priority Assessment Algorithm Score:</b> | 3 | | |
| <b>Comments / Recommendations:</b> | Asbestos content textured coating ( Artex ) to entrance lobby ceiling is in good condition and present a Low Risk if left undisturbed. Recommend safe removal prior to any refurbishment works that may disturb the ceiling, removal must be carried out under controlled conditions utilizing appropriate RPE / PPE with all waste material disposed of under special waste regulations. | | |

Asbestos content textured coating ( Artex ) to lobby ceiling is in good condition and presents a Low Risk if left undisturbed. Recommend safe removal prior to any refurbishment works that may disturb the textured coatings, removal must be carried out under controlled conditions utilizing appropriate RPE / PPE with all waste material disposed of under special waste regulations.

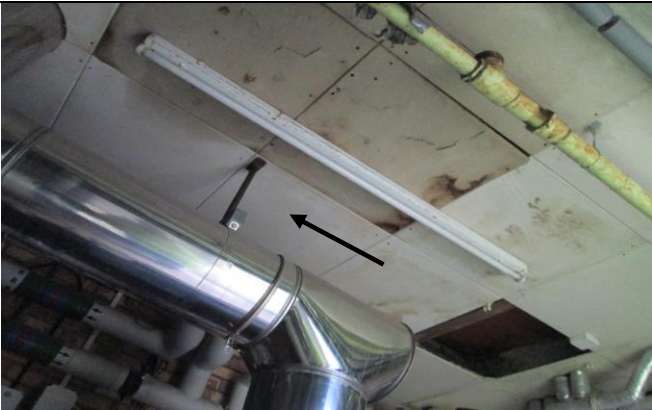
### 4.18 Sample Results, Algorithm and Recommendations

| <b>Item / Material &amp; Quantity:</b> | Ceiling tiles to main boiler room suspended grid.<br>Approx 14m <sup>2</sup> in total. Visually typical of superlux tiles. | | |
| <b>Surface Treatment:</b> | None – Fair Condition | | |
| <b>Comments / Recommendations:</b> | Ceiling tiles to main boiler room suspended grid sampled and found to contain no Asbestos material. No further actions required. | | |

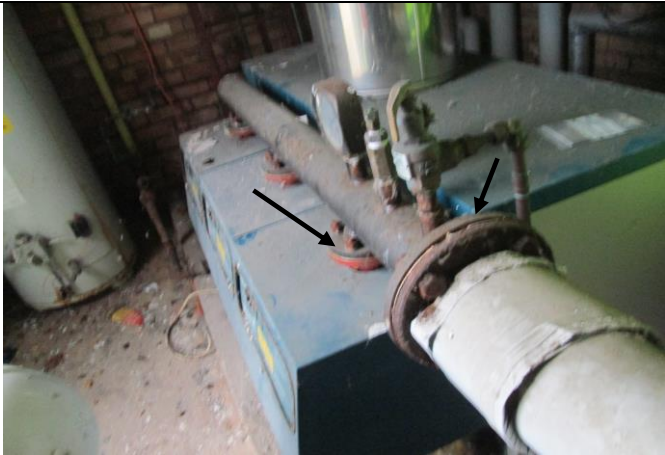
### 4.19 Sample Results, Algorithm and Recommendations

| <b>Item / Material &amp; Quantity:</b> | Gaskets within boiler service pipe work flange joints. | | |
| <b>Surface Treatment:</b> | None – Fair Condition | | |
| <b>Comments / Recommendations:</b> | Gaskets within boiler service pipe work flange joints sampled and found to contain no Asbestos material. No further actions required. | | |

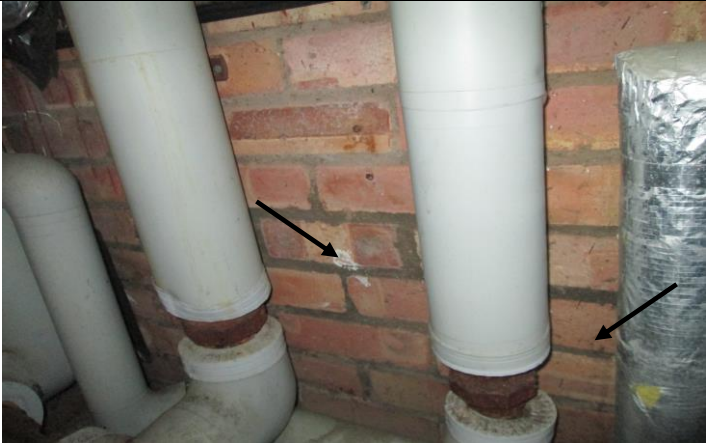
### 4.20 Sample Results, Algorithm and Recommendations

| <b>Item / Material &amp; Quantity:</b> | Residues to main boiler room rear and side walls behind pipe work. | | |
| <b>Surface Treatment:</b> | None – Poor Condition | | |
| <b>Comments / Recommendations:</b> | Residues to main boiler room rear and side walls behind pipe work sampled and found to contain no Asbestos material. No further actions required. | | |

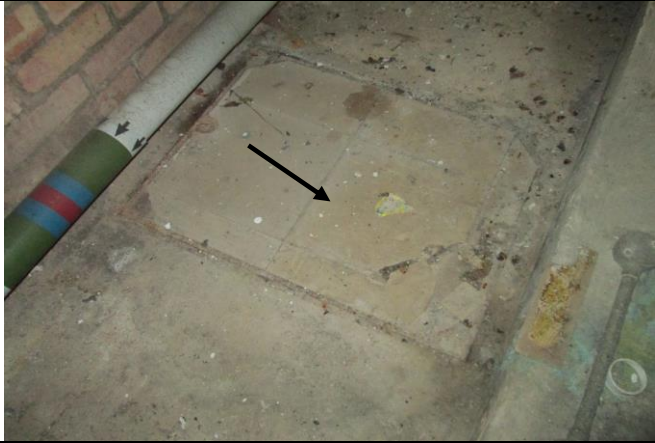
### 4.21 Sample Results, Algorithm and Recommendations

| <b>Item / Material &amp; Quantity:</b> | Floor tiles ( yellow ) floor behind boilers.<br>Approx 1m <sup>2</sup> in total. | | |
| <b>Surface Treatment:</b> | None – Good Condition | | |
| <b>Comments / Recommendations:</b> | Floor tiles ( yellow ) floor behind boilers sampled and found to contain no Asbestos material. No further actions required. | | |

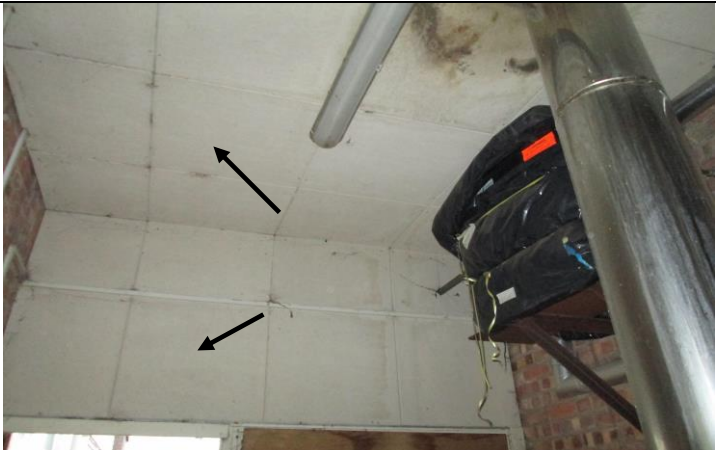
### 4.22 Sample Results, Algorithm and Recommendations

| <b>Item / Material &amp; Quantity:</b> | Ceiling tiles and wall tiles to plant room.<br>Approx 18m <sup>2</sup> in total. Visually typical of superlux tiles. | | |
| <b>Surface Treatment:</b> | None – Fair Condition | | |
| <b>Comments / Recommendations:</b> | Ceiling and wall tiles within plant room sampled and found to contain no Asbestos material. No further actions required. | | |

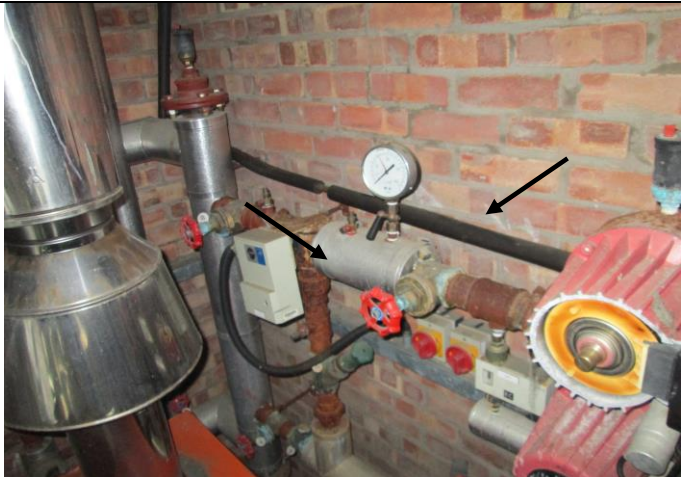
### 4.23 Sample Results, Algorithm and Recommendations

| <b>Item / Material &amp; Quantity:</b> | Residues to plant room rear wall behind pipe work. | | |
| <b>Surface Treatment:</b> | None – Poor Condition | | |
| <b>Comments / Recommendations:</b> | Residues to plant room rear wall behind pipe work sampled and found to contain no Asbestos material. No further actions required. | | |

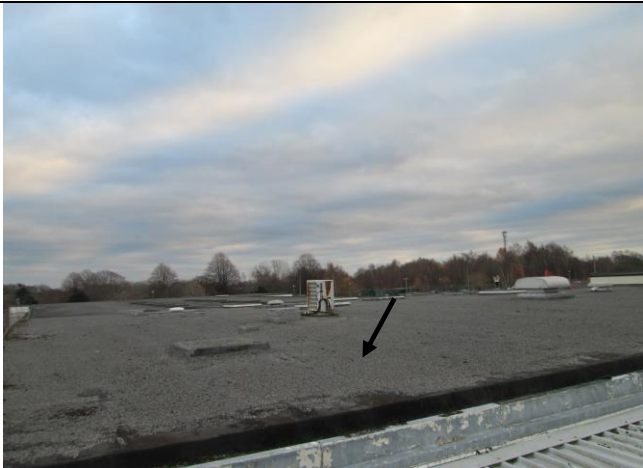
### 4.24 Sample Results, Algorithm and Recommendations

| <b>Item / Material &amp; Quantity:</b> | Roofing felt covering to main flat roof above offices. | | |
| <b>Surface Treatment:</b> | None – Good Condition | | |
| <b>Comments / Recommendations:</b> | Roofing felt covering to main flat roof above offices sampled and found to contain no Asbestos material. No further actions required. | | |
