## Listed Building Consent Application

### Corner Farm

### Penley

### Annotated Photographs

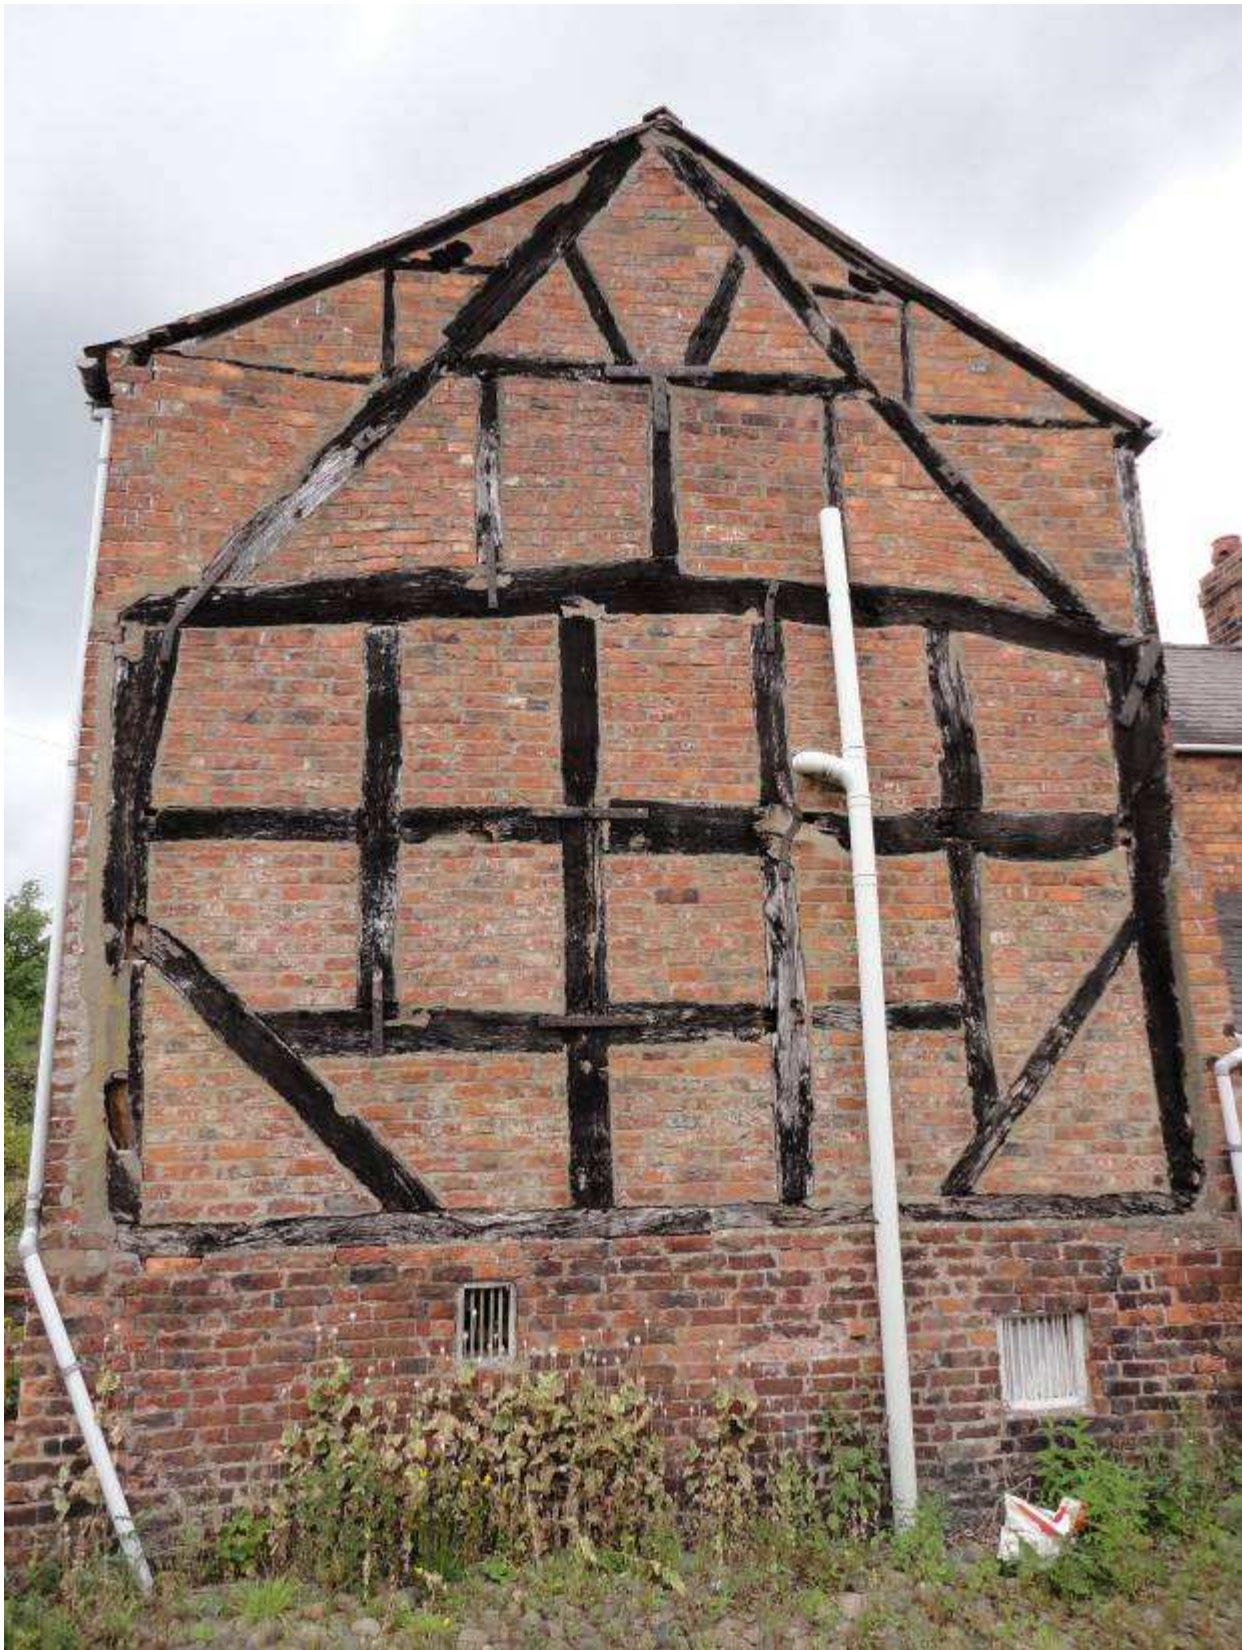
Detail of timber framed gable end and brick plinth to be rebuilt due to advanced state of decay of the oak timbers and joints and also because of the deflection of the brick plinth and individual brick panels (refer to engineers report). The new oak frame is to follow the design of the existing frame, including the raised eaves, which is a later alteration done to provide bedrooms in the attic (see survey, section and design and method statement provided by Oaq Ltd and Heritage Planning Consultancy). Note metal grilles to basement area. The soil and vent pipe is proposed for removal.

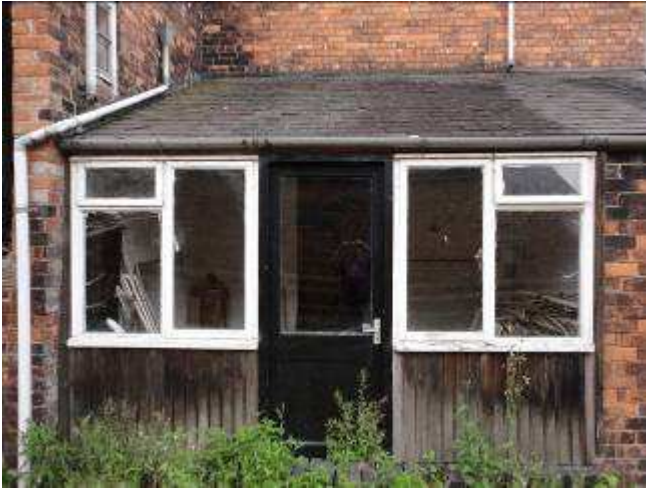
Detail of glazing and doorway to Utility room to be replaced with new green oak glazed frame (see detailed drawings provided by Oaq Ltd).

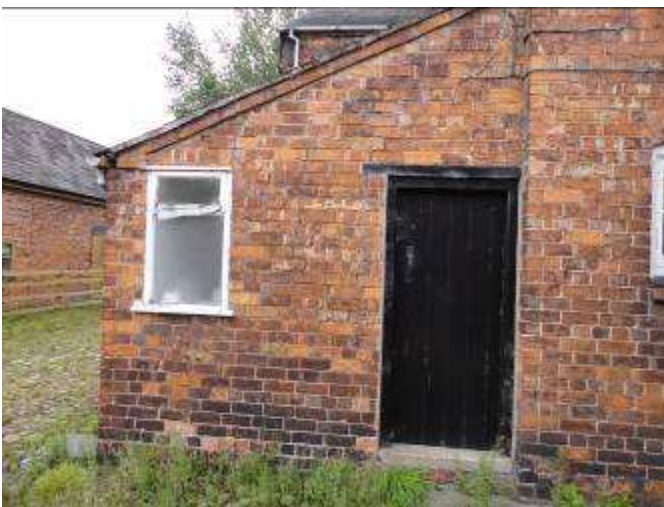
Detail of door to WC to be removed and opening blocked up to window cill level

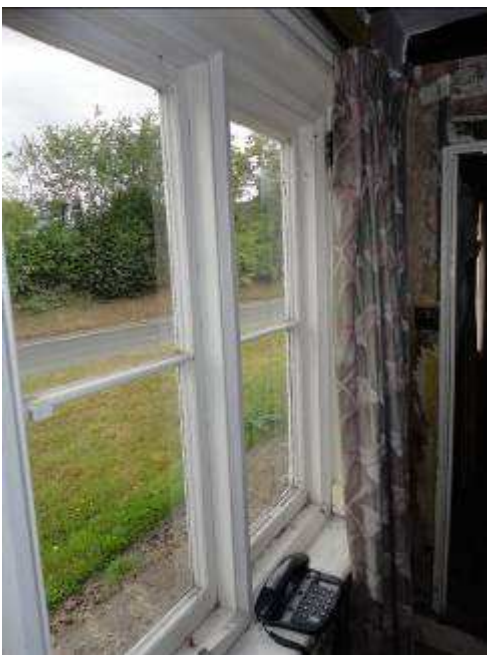
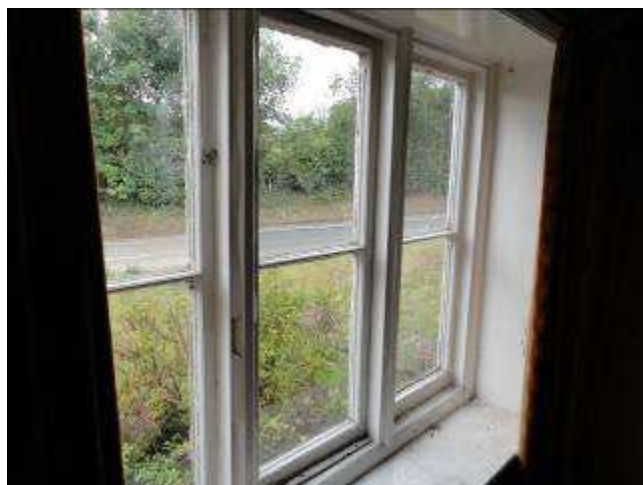
Details of typical 19<sup>th</sup> century timber casement windows to be found throughout the property, all of which are to be repaired in-situ. Secondary glazing to be installed within the reveal of the window with mullions in-line with existing mullions and made of white powder coated aluminium.
