Our ref: 7962si

Site Investigation Report  
for land at  
Cwrt Pentwmpath,  
Llay

21<sup>st</sup> December 2022

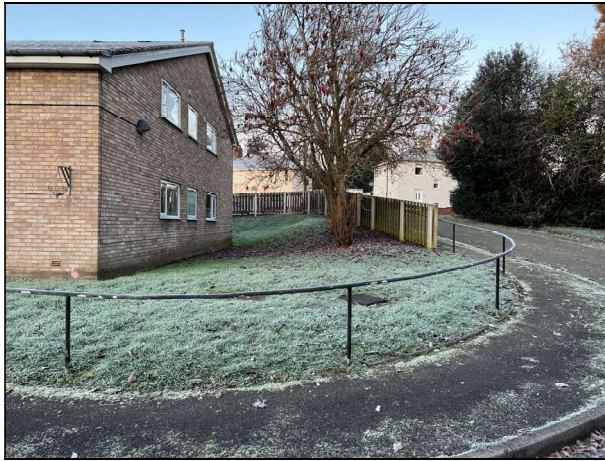
*Photograph 1: View to the north showing site access road and east end of current apartment block*

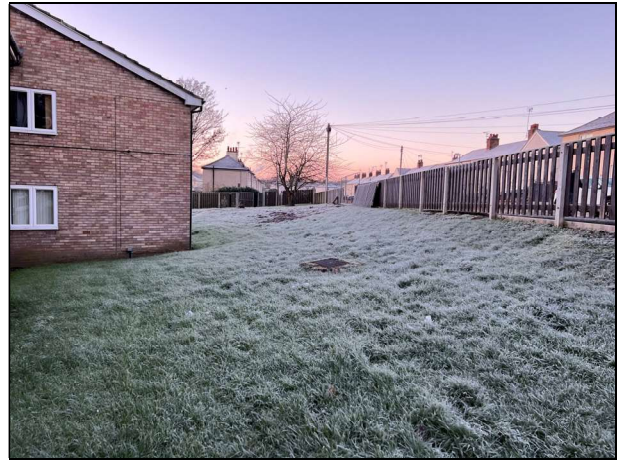
*Photograph 2: View to the south west along the front of the apartment blocks, with slope up to Eighth Avenue and telegraph pole/overhead BT lines in west corner of site*

A BT telegraph pole was located on the western site boundary with overhead wires extended across the western part of the site to the buildings (see Photograph 2). A street light was present in the far west corner and far north corner of the site and a further light was located adjacent to the car park. Manholes for soakaways were observed in the east of the site.

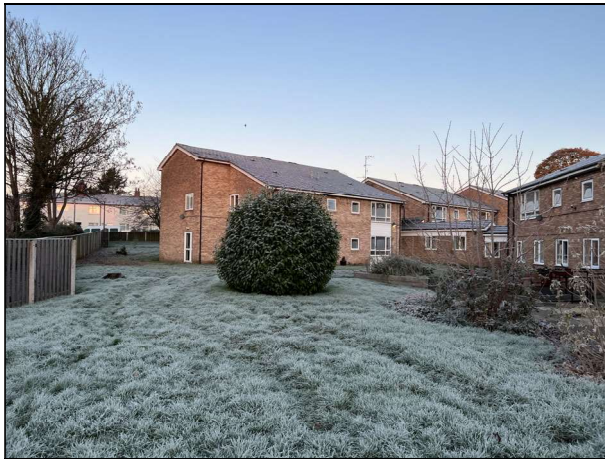
*Photograph 3: View to the north west*

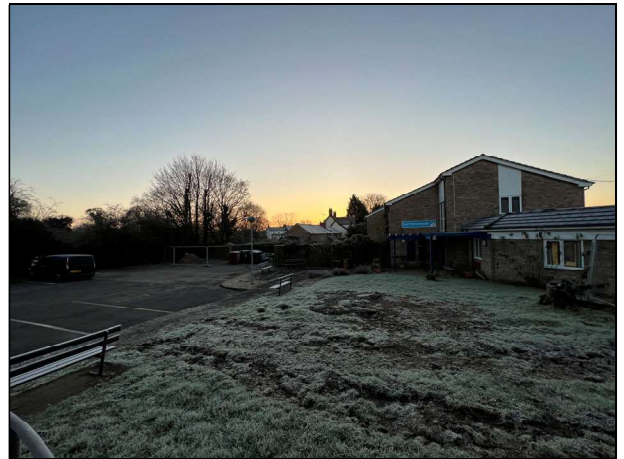
*Photograph 4: View to the south east across the current car park*

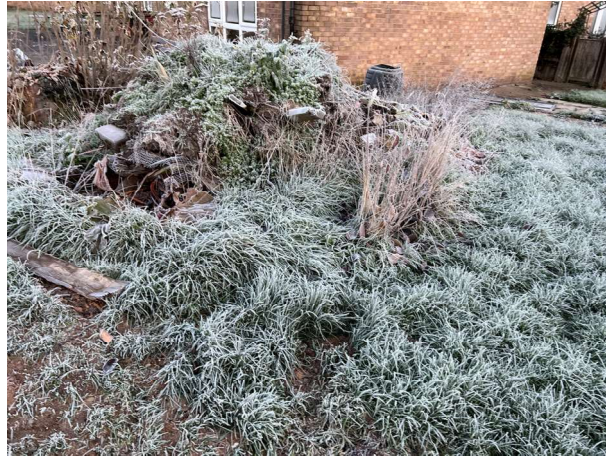
The site was surrounded by board fencing along the western boundary, which followed part of the access road. The private gardens were fenced off with mesh and board fences. Rail fencing followed the access paths and access road. A waste heap, covering an area approximately 1m x 1m, including soil, wire mesh, wooden planks and concrete was located to the west of the site (see Photograph 5).

*Photograph 5: Waste heap in west of site*

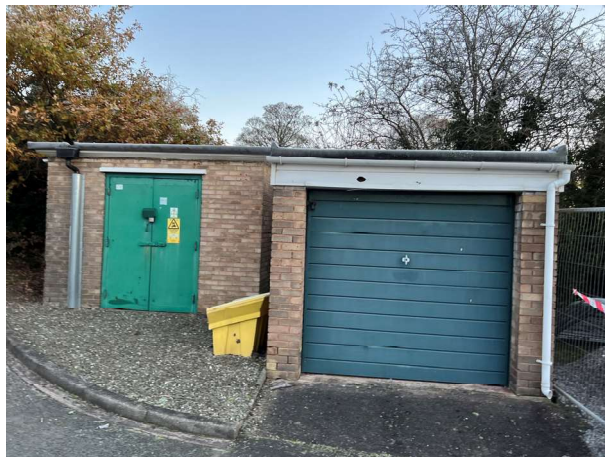
An electrical sub-station was located immediately next to the garage (see Photograph 6) and backing onto the central part of eastern boundary. A coarse limestone gravel, clear of vegetation, was present around the sub-station with turf beyond the gravel surround to the northern side. No evidence of possible contamination was observed around the outside of the sub-station.

*Photograph 6: View to the north west*

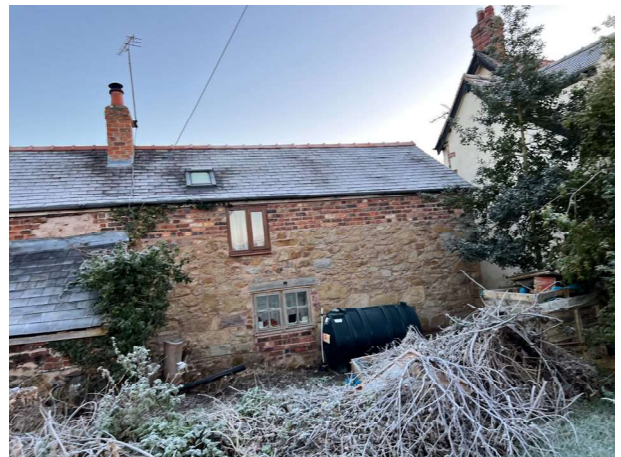
*Photograph 7: View to the south east across the current car park*

As shown in Drawing No. 7962/AP, presented in Appendix 16, the site was bounded by Eighth Avenue to the north west and a public footpath to the south west, with residential properties beyond to the north, west and south of the site. A field was located adjacent to the north east of the site. An above ground domestic kerosene fuel tank was noted adjacent to the far south east corner of the site boundary, as shown in Photograph 7.
